# INITIAL FIRE SAFETY INSPECTION REPORT

**Factory name: ILMEEYAT APPARELS LIMITED (New Building 3)**  
**RSC ID: 24782**

**Factory Address: Jamirdia, Valuka, Mymensingh.**

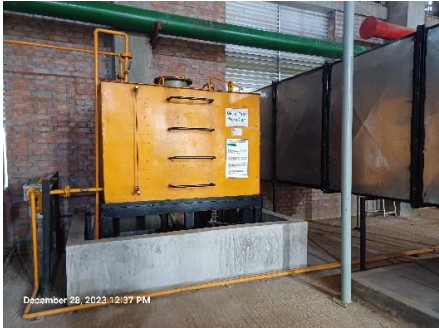
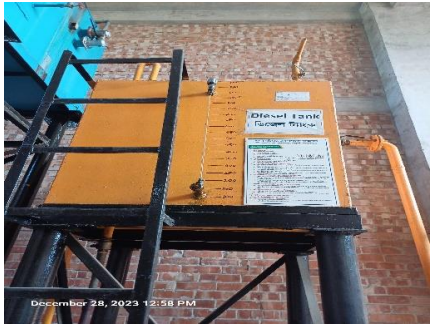
| SI No. | Category | Findings | Required Action | Remediation Time Frame |
|---|---|---|---|---|
| 1 | Fire Rated Construction | Diesel fuel storage (2400 L) was located inside the generator room and Diesel fuel storage (1000 L) was located inside the boiler room. | <p>A license must be obtained in accordance with the Petroleum Act for all storage of Class II petroleum greater than 1000 L (264 gal) individually and 2000 L (528 gal) aggregate.</p> <p>Or, Separate the diesel fuel storage with 2- hr. fire rated construction.</p> | Within 3 months |

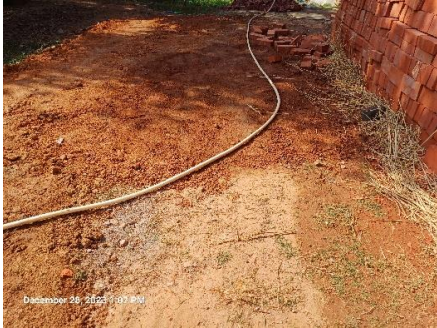
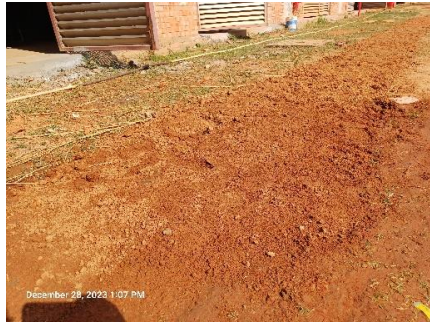
| 2 | Means of egress | Walking surface is not slip resistant and not leveled at exit discharge path.<br><br>(Substation & Generator Building & Boiler & Compressor Building) | Walking surfaces, including stairway treads shall be uniformly slip resistant.<br><br>And level the walking surface to the public way. | Within 1 month |

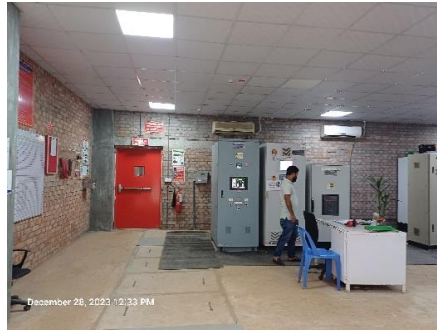
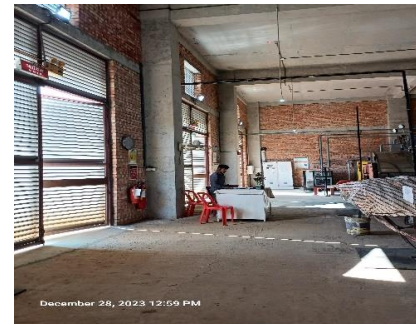
| 3 | Means of egress | Aisles not provided and properly marked.<br><br>(Substation & Generator Building & Boiler & Compressor Building) | Provide minimum aisle widths of 36-in. | Within 1 month |

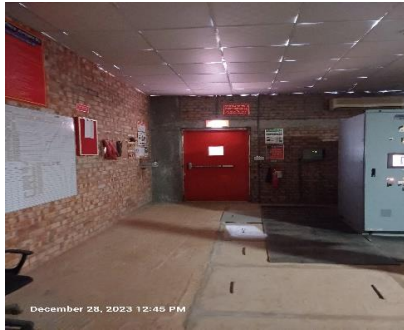
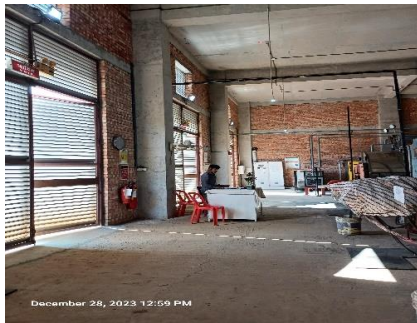
| 6 | Emergency Lighting | Based on the number and location of emergency lights observed, adequate illumination levels are not anticipated along egress routes. | Test the emergency lighting system on each floor and provide additional emergency fixtures to supply adequate illumination along the means of egress. Provide a minimum illumination of 10 lux at the floor level within exit stairs and along exit discharge paths and a minimum 2.5 lux along exit access aisles. | Within 2 months |

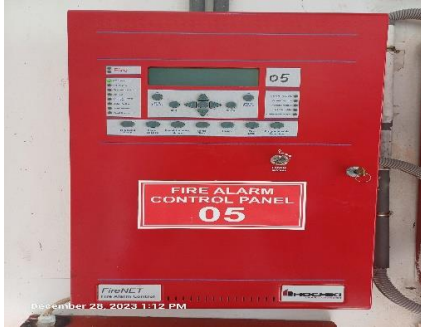
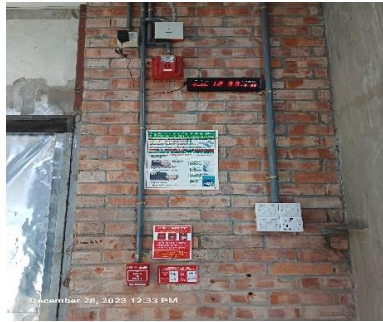
| 8 | Fire Alarm & Detection system | Automatic fire alarm and detection system installation has been found complete which requires detailed review to confirm compliance with NFPA 72 and The RSC Technical Guidelines (Standard). | Submit the fire alarm system design to RSC for review. Once the design is reviewed, install and modify the fire detection and alarm system throughout the buildings in accordance with review comment, RSC Technical Guidelines (Standard) and NFPA 72. After installation the owner shall conduct internal testing and commissioning and then contact the RSC for witness of final acceptance testing. Also inspect, test and maintain the fire alarm system, and keep written records on-site, in accordance with Table-14.3.1 of NFPA 72. | Design Review within 2 months and installation/modification within 4 months |
