# INITIAL FIRE SAFETY INSPECTION REPORT

**Eusebio Sporting (Bangladesh) Limited**

**RSC ID: 11628**

**Date: 08-February-2024**

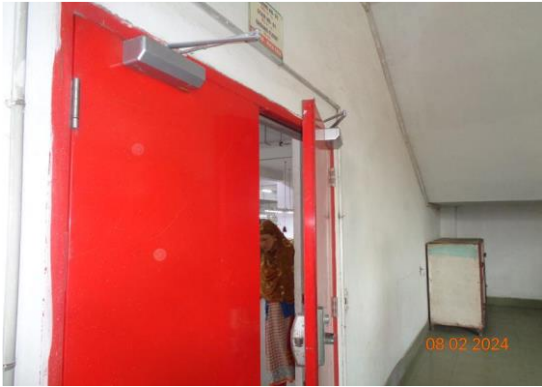
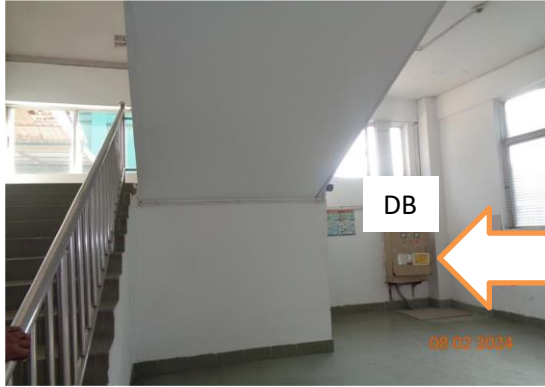
| SI No. | Category | Findings | Required Action | Remediation Time Frame |
|---|---|---|---|---|
| F-01 | Fire Rated Construction | The exit stairs are not separated from other spaces due to unprotected openings and penetrations . Location: Building 1, Building 2, Building 3, Building 4, Building 5. | <p>Stair shall be enclosed with a minimum 2-hr fire-rated construction. Seal all unprotected openings and provide minimum 1.5-hr fire rated doors to separate the exit stairs from work areas and other building spaces on all floor levels.</p> <p>The clearance under the bottom of a door shall be a maximum of 3/4 in. (19 mm).</p> <p>Penetrations into and through an exit enclosure shall be prohibited with the exception of required exit doors, sprinkler piping, standpipes, electrical raceway for fire alarm equipment, and electrical conduit serving the exit enclosure.</p> <p>Ensure that the fire doors are self-closing, positive latching and that they are provided with fire exit (panic) hardware where serving production floors. If fire doors are required to be held open for functional reasons, provide automatic-closing devices tied to the fire alarm system.</p> | Within 3 months |

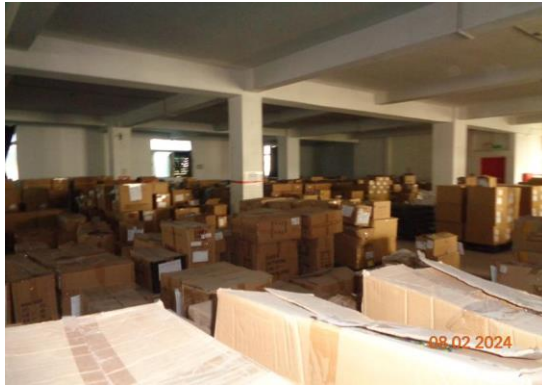
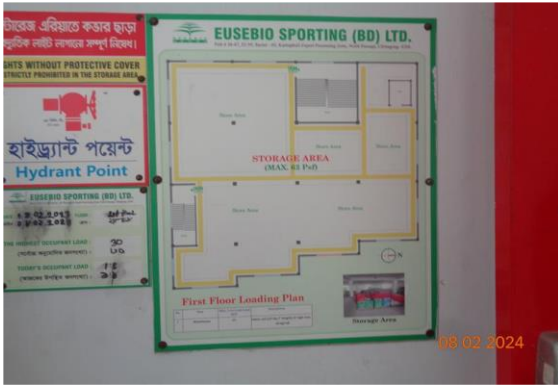
| F-02 | Fire Rated Construction | Storage room/areas discharges directly into the exit stair enclosure at ground floor. Location: Building 3, Building 4. | <p>Openings from exit enclosure to storage room, generator and transformer spaces shall be provided with a vestibule with fire rated construction and openings.</p> <p>The minimum width of a vestibule shall not be less than 1.1 m nor less than the width of the corridor leading to the vestibule. The minimum length of a vestibule in the direction of escape travel shall be 1.8 m.</p> | Within 3 months |

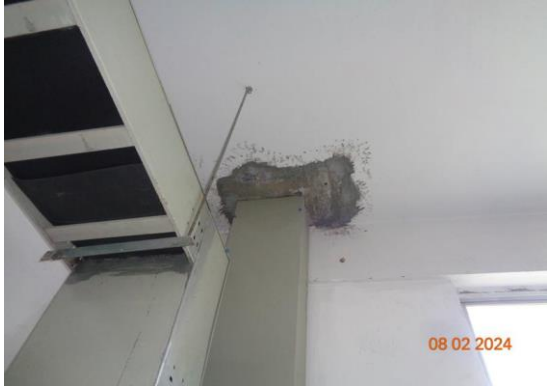
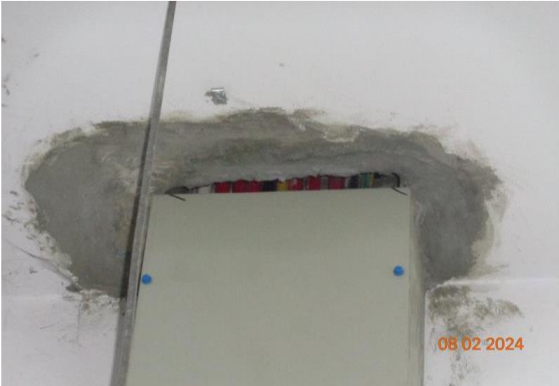
| F-03 | Fire Rated Construction | Penetrations through floor/ceiling assemblies due to electric cable, PVC pipe are found unsealed. Location: Building 1, Building 4, and Building 5. | <p>Seal all penetrations and openings in floor/ceiling assemblies by a listed through-penetration fire stop system tested in accordance with ASTM E814 or approved alternative standard to maintain minimum 3-hr. fire resistance rating. Installation shall be as per manufacturer published installation guideline and the certification authority's design criteria to ensure the required fire-rating.</p> <p>or,</p> <p>Provide a minimum 2-hr fire rated shaft to separate the penetration from each floor if required.</p> | Within 3 months |

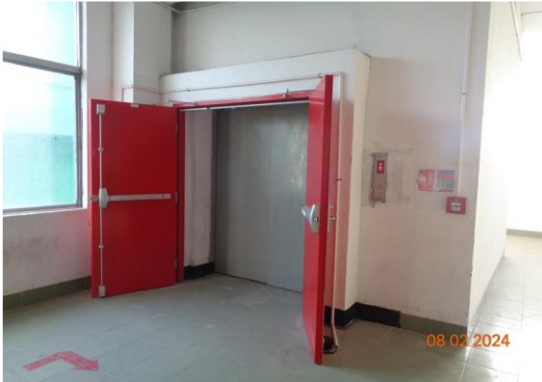
| F-04 | Fire Rated Construction | Elevator shafts open into the inside of production floor. Location: Building: 01, Building: 03, Building: 04, Building: 05 | <p>Elevator shaft shall be separated from production area by 2 hours fire rated construction.</p> <p>Provide a minimum 2-hr fire-rated shaft and 1.5-hr fire rated lift landing doors or 1.5-hr rated opening protection from each floor level and seal all penetrations in floor/ceiling assemblies to maintain the fire separation.</p> | Within 3 months |

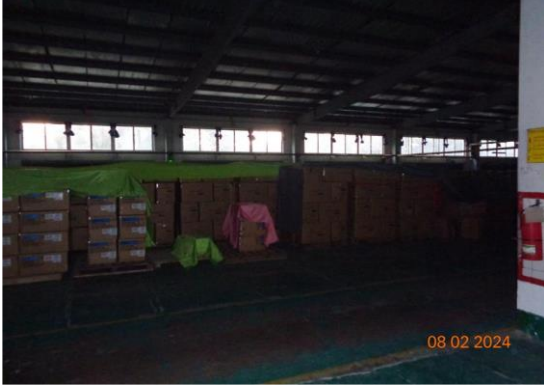
| F-05 | Fire Rated Construction | Rooms used for storage of combustible materials are not separated from the surrounding occupancy/areas. Location: Shed: 01. | Rooms used for storage of combustible materials shall be separated from the surrounding occupancy with a minimum 1 hour construction. | Within 3 months |

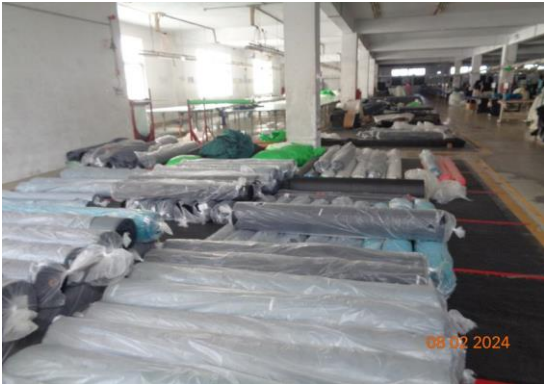
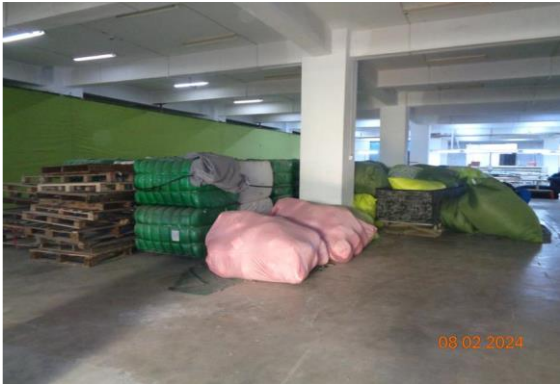
| F-06 | Fire Rated Construction | Areas used for in-process storage of combustible materials are open to the surrounding occupancy. Location: Building: 01 and Building: 04 | <p>Provide defined storage areas and limit the storage arrangement as follows:</p> <p>Maximum height of 2.45 m and maximum area of 23 m<sup>2</sup> and is separated by a minimum 3.0 m (10ft) from other storage areas and they do not exceed 10 percent of the building area of the story in which they occur.</p> <p>or,</p> <p>If sprinkler protected, Maximum height 12 ft (3.66 m) and maximum area of 1000 ft<sup>2</sup> (93 m<sup>2</sup>) and separated by a at least 25 ft (7.62 m) and does not constitute more than 10 percent of the building area or 4000 ft<sup>2</sup> (372 m<sup>2</sup>) of the sprinklered area, whichever is greater.</p> <p>or,</p> <p>Enclose the storage area from the surrounding occupancy with a minimum 1 hour construction.</p> | Within 3 months |

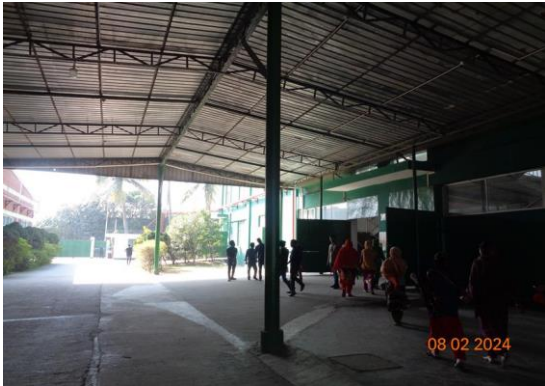
| F-08 | Means of Egress | Exit stair(s) is discharge the occupants inside the building. Location: Building: 01. | <p>1. Modify stair to discharge directly outside.<br/>Or<br/>2. Provide 2-hr fire-rated exit passageway leading directly outside (vestibules to separate any storage areas).</p> <p>Note: A maximum of 50 percent of the number and capacity of the exit enclosures can discharge through areas on the level of exit discharge where all the conditions described in RSC building standard 6.17.3 are met.</p> | Within 3 months |

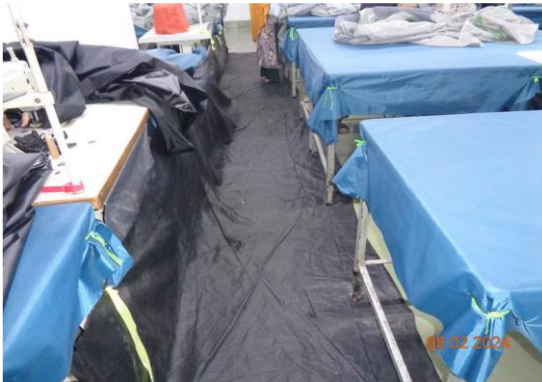
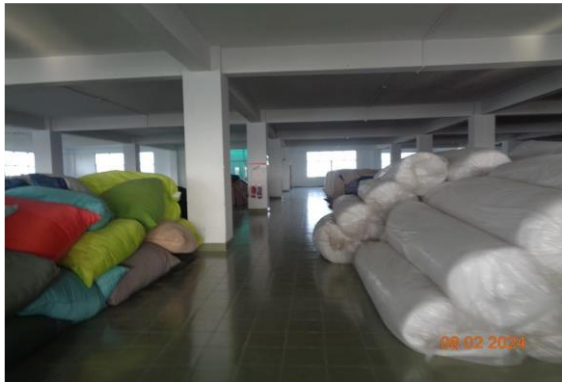
| F-9 | Means of Egress | The available clear width of the egress aisles were found less than 36 inch. Location: Building: 01, Building: 04 and Shed: 01. | Aisles shall be provided with a minimum unobstructed clear-width of 0.9 m (36 in.). The path of egress travel along a means of egress shall not be interrupted by any obstruction. | Within 3 months |

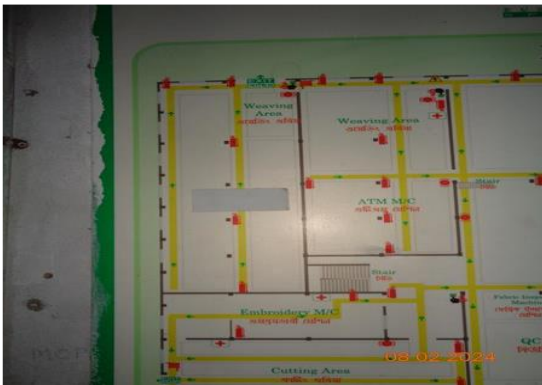
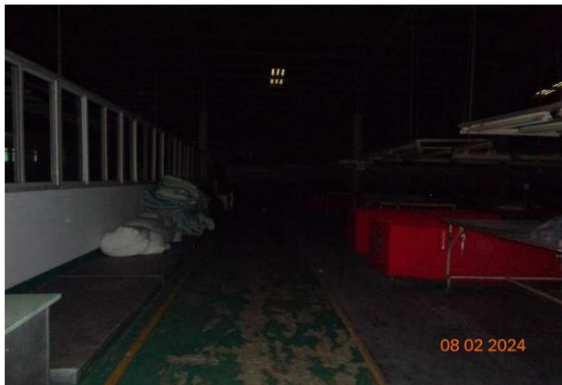
| F-10 | Means of Egress | Common path of egress travel exceeds 75 feet. Location: Printing Section of Shed: 01 | Reconfigure the egress arrangement to reduce the maximum common path of travel to not more than 23 m (75 ft). | Within 3 months |

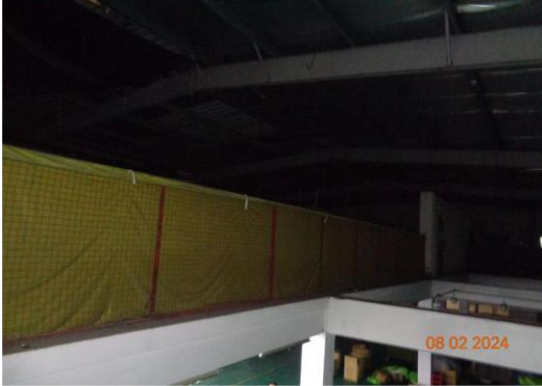
| F-11 | Means of Egress | No adequate guard is provided at the open sides of the means of egress. The existing guard is unstable, posing a falling hazard. Location: Mezzanine floor, Shed: 01. | Adequate Guards shall be provided at all open sides of means of egress that exceed 760 mm (30 in.) above the floor or finished ground below. | Within 3 months |

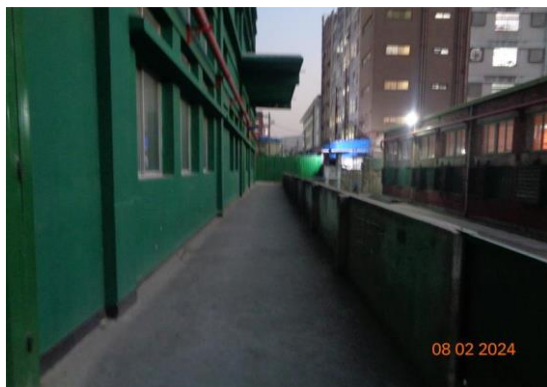
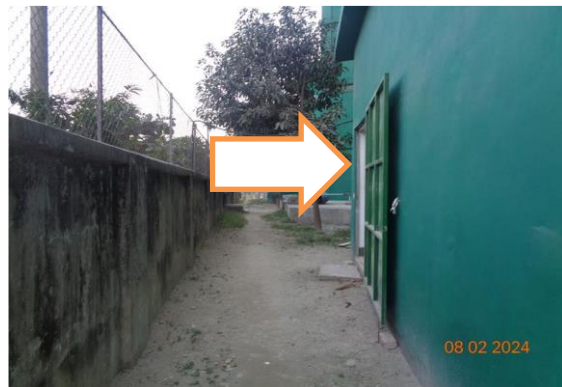
| F-12 | Means of Egress | The exit discharge paths serving the exit stair were less than 10 ft wide and were not separated from the building interior. Location: Stair 3 of Building: 04 (not separated from compressor room), Stair 1 of Building: 05. | Egress courts less than 3050 mm (10 ft) in width (as measured from the building and the adjacent property line) shall be provided with walls having a 1--hr fire resistance rated construction for a distance of 3050 mm (10 ft) above the floor of the court. | Within 3 months |

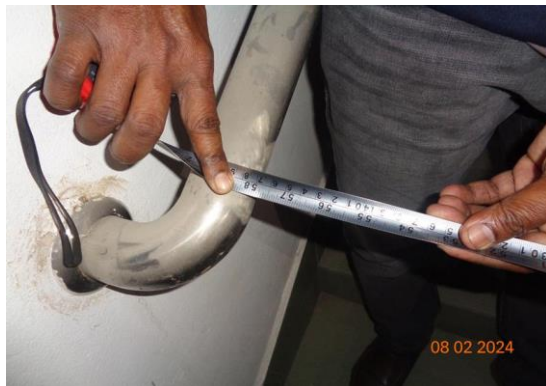
| F-13 | Means of Egress | The stairs have a width less than the required minimum of 1.5 meter (60 inches). Location: Building: 04 & Building: 05. | Stairs shall have a minimum width of 1.5 m (60 in.). Landings with same width as the stair clear width shall be provided at each level and at intermediate landings. | Within 3 months |

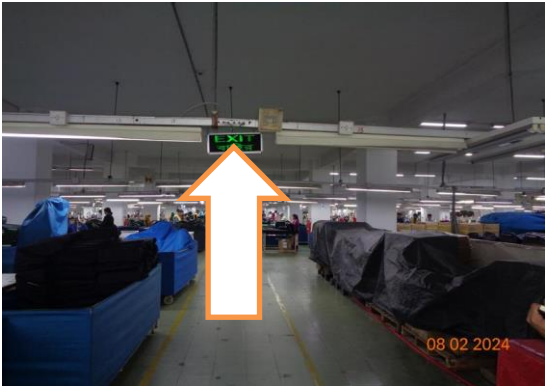
| F-14 | Means of Egress | Headroom clearance is found less than 6 feet 8 inches through means of egress due to exit sign.<br>Location: Building: 01. | All means of egress shall have a minimum ceiling height of 2.3 m (7 ft 6 in.) with projections from the ceiling not less than 2.03 m (6 ft 8 in.) | Within 3 months |

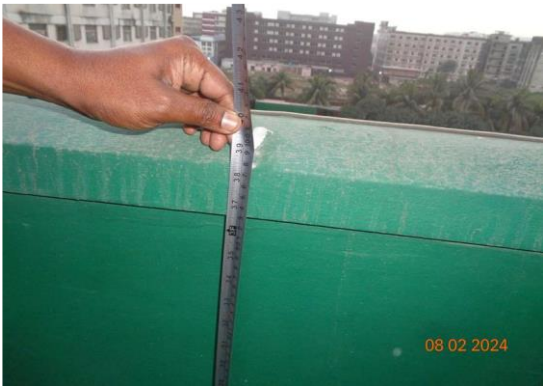
| F-15 | Means of Egress | The occupiable roof was not provided with an adequate parapets or guards. Location: Building: 05. | All occupiable roofs shall be provided with parapets or guards with a minimum height of 1067mm (42 in.). | Within 3 months |

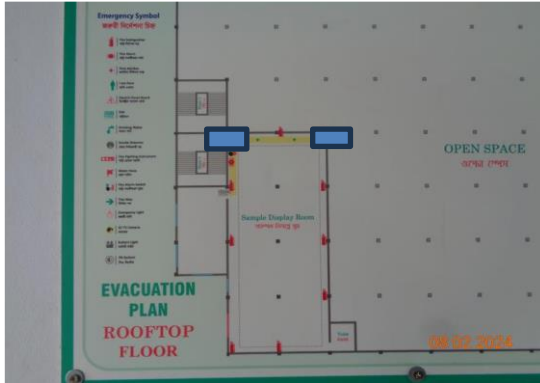
| F-16 | Means of Egress | The exit doors are not remotely located from each other such that a single fire event could compromise both exits. Location: Top floor (Display Room) of Building: 01. | <p>Modify exit arrangement or provide additional exit and</p> <p>Ensure that the exit doors or means of egress openings are located a distance apart equal to not less than one-half of the length of the maximum overall diagonal dimension of the building or area to be served measured in a straight line between exits or egress openings.</p> | Within 3 months |
| <p>The image is a photograph of a printed evacuation plan for a rooftop floor. It shows a layout of a building with several rooms and corridors. Two exit doors are highlighted with blue rectangles. A yellow line indicates the path of egress from these doors. The plan is labeled 'EVACUATION PLAN ROOFTOP FLOOR' and 'OPEN SPACE'. There is also a date stamp '08-03-2024' at the bottom right.</p> | | | | |

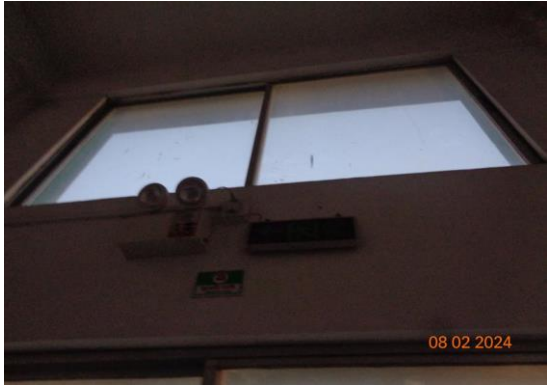
| F-20 | Egress Lighting | Exit signs were not provided at several exits and few exit signages were not illuminated during testing. Location: Building: 01, Building: 03, Building: 04, Building: 05 and Shed: 01. | Lighted exit signs shall be placed at entrance to an exit. Additional exit signs shall be placed throughout the facility anywhere the continuation of the egress is not obvious.<br><br>Lighted exit signs shall be provided with either battery backup or uninterruptable power supply systems and shall be continuously illuminated. | Within 2 months |

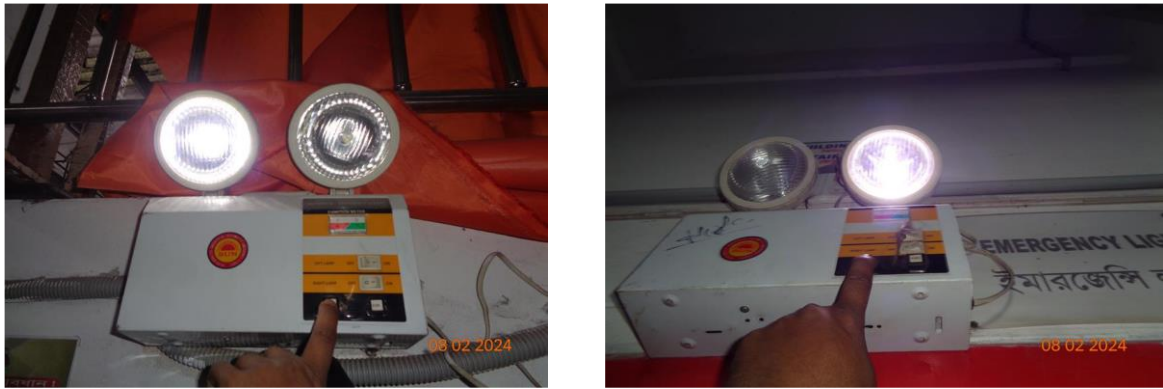
| F-21 | Egress Lighting | Manual on-off switch is provided for emergency lighting / exit signage units. | Remove manual on/off switches from emergency lighting / exit signage units to prevent them from being switched off. | Within 2 months |

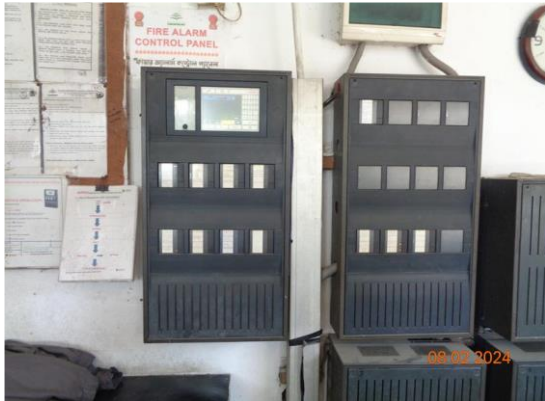
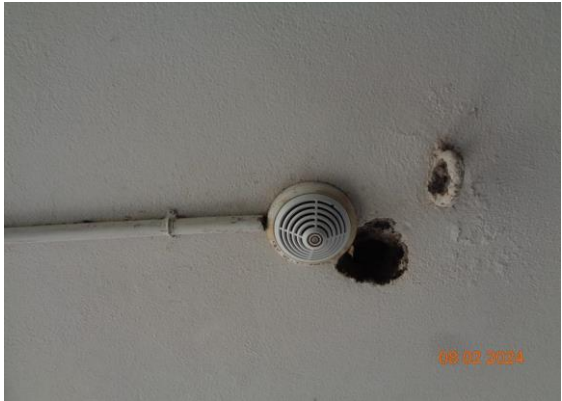
| F-25 | Fire Alarm & Detection System (FADS) | The factory has installed a fire alarm and detection system that requires a detailed review to confirm compliance with NFPA 72 and RSC Technical Guidelines (Standard). Location: All Structures. | <p>Submit the fire alarm and detection system design to RSC for review.</p> <p>Once the design is reviewed, install and modify the fire detection and alarm system throughout the building in accordance with review comment, RSC Technical Guidelines (Standard) and NFPA 72.</p> <p>After installation the owner shall conduct internal testing and commissioning and then contact the RSC for witness of final acceptance testing.</p> | Design within 2 month and modification/ installation with 4 months |

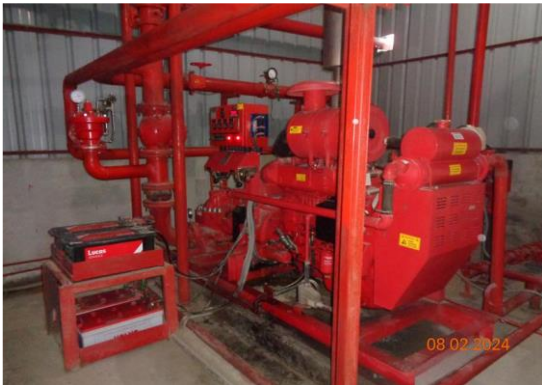
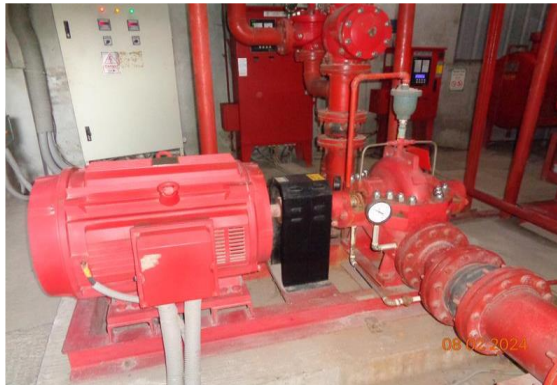
| F-27 | Fire Suppression System (SUPS) | <p>The highest occupied floor of the main building is over 33 feet above grade, mandating class III standpipe. The factory has installed class III standpipe, requiring a detailed review to ensure compliance with NFPA 13, 14, 20, 22, and 24 and RSC Technical Guidelines (Standard). ass I standpipe. Location: Building: 01, Building: 2, Building: 03, Building: 04, Building: 05</p> | <p>Submit the fire Suppression System (fire pump, standpipe and sprinkler) design to RSC for review.</p> <p>Once the design is reviewed, install and modify the fire Suppression System throughout the building in accordance with review comment, RSC Technical Guidelines (Standard) and NFPA 14, 20, 22 and 24.</p> <p>After installation the owner shall conduct internal testing and commissioning and then contact the RSC for witness of final acceptance testing.</p> | Design within 2 month and modification/ installation with 4 months |
