# INITIAL FIRE SAFETY INSPECTION REPORT

## Valmont Fashions (Extension)

RSC ID: 25609

# Fire Safety Inspection Report

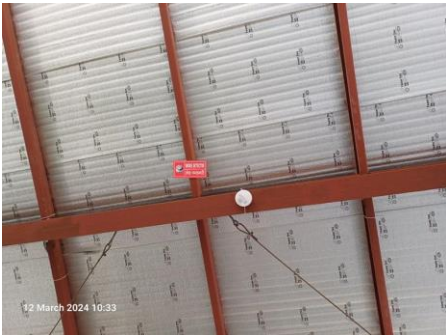
| F-1 | Fire Alarm & Detection System (FADS) | <p>The fire alarm system is antiquated, not a listed system and does not provide alarm and notification features consistent with acceptable standards.</p> <p>Fire alarm and detection system installation complete which requires detailed review to confirm compliance with NFPA 72 and RSC Technical Guidelines (Standard).</p> | <p>Replace the fire alarm system with a new, listed addressable fire alarm system in accordance with NFPA 72.</p> <p>Complete the fire alarm installation as per NFPA 72. Submit drawings, testing records, equipment certification and other relevant documentation to the RSC prior installation for review.</p> <p>"Design &amp; Installation of Fire Alarm system shall be in accordance with RSC standard and NFPA 72. Submit design, documents and calculations to RSC for review prior installation/modification. After installation the owner shall contact the RSC for witness of conducting the final acceptance testing of the fire detection &amp; alarm system installation.</p> <p>Also inspect, test and maintain the fire alarm system, and keep written records on-site, in accordance with NFPA 72."</p> | Design Review within 2 months and installation within 4 months. |

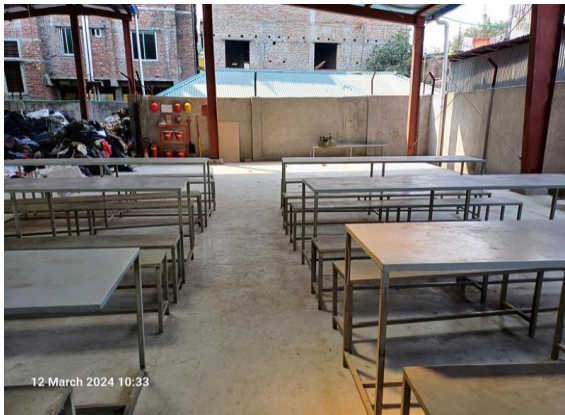
| F-3 | Mean of Egress | The width of egress aisles is less than 36-in. on dining area. | Provide minimum aisle widths of 36-in. | Within 1 month |

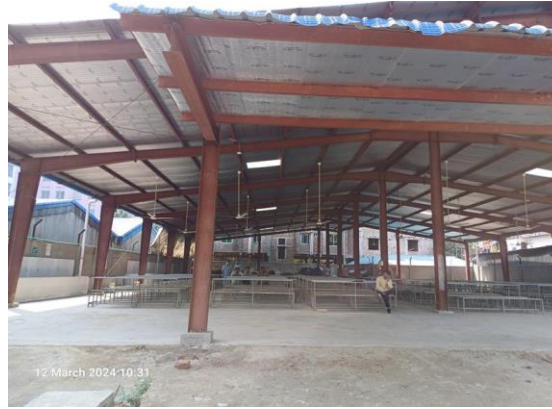
| F-4 | Emergency Lighting | Based on the number and location of emergency lights observed, adequate illumination levels are not anticipated along egress routes. | Test the emergency lighting system on each floor and provide additional emergency fixtures to supply adequate illumination along the means of egress. Provide a minimum illumination of 10 lux at the floor level within exit stairs and along exit discharge paths and a minimum 2.5 lux along exit access aisles. | Within 1 Month |

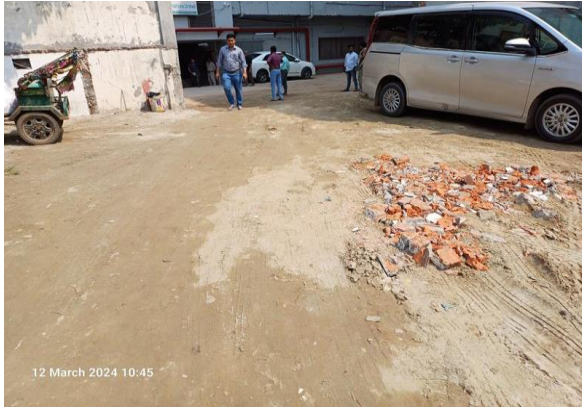
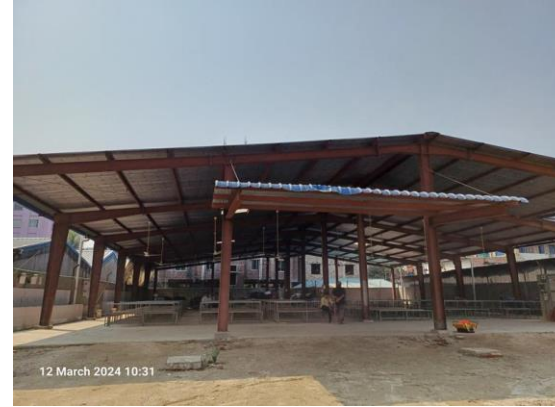
| F-6 | Mean of Egress | Egress path found obstructed on exit discharge position where Changes in elevation of walking surfaces exceed 6.35 mm (1/4 in) but not provided with a beveled slope. | Walking surfaces shall be mostly level; however, shall not exceed a slope of 1 in 20 in the direction of travel unless meeting the requirement for ramps in RSC Standard 6.10. | Within 3 months |

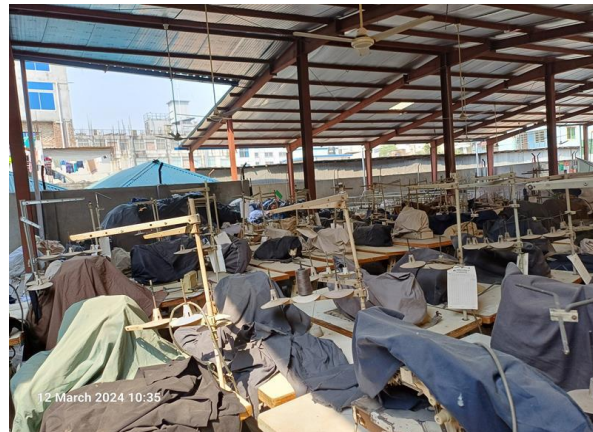
| F-7 | Fire Rated Construction | Rooms used for combustible storage are not separated by fire rated construction in the dining area | Separate the dedicated storage rooms by minimum 1-hr fire-rated construction. Provide 0.75 hr. fire rated door and seal all penetrations and openings by 0.75 hr. (45 Minutes) | Within 3 months |

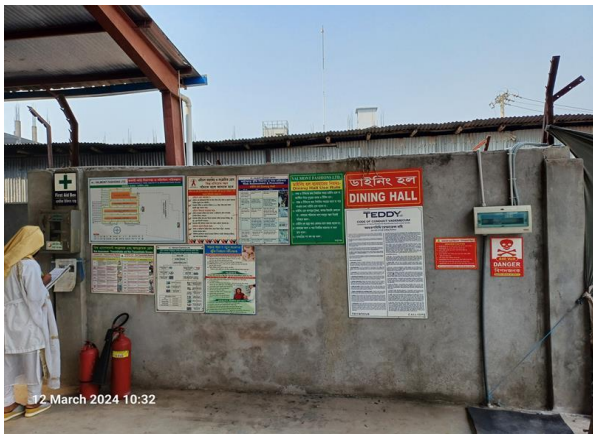
| F-7 | Human Element Program | The required no smoking signs are not present in the factory. | Smoking is prohibited in any garment factory building or separate storage building. Signs shall be posted in Bengali and English at all building entrances. If the factory creates a designated smoking area outside the building, information of these areas will be posted on the signs. | Within 1 Month |
