# INITIAL FIRE SAFETY INSPECTION REPORT

**Factory Name:** Hop Lun Apparel Limited (Extension)

**RSC ID:** 25664

**Date:** 28-March-24

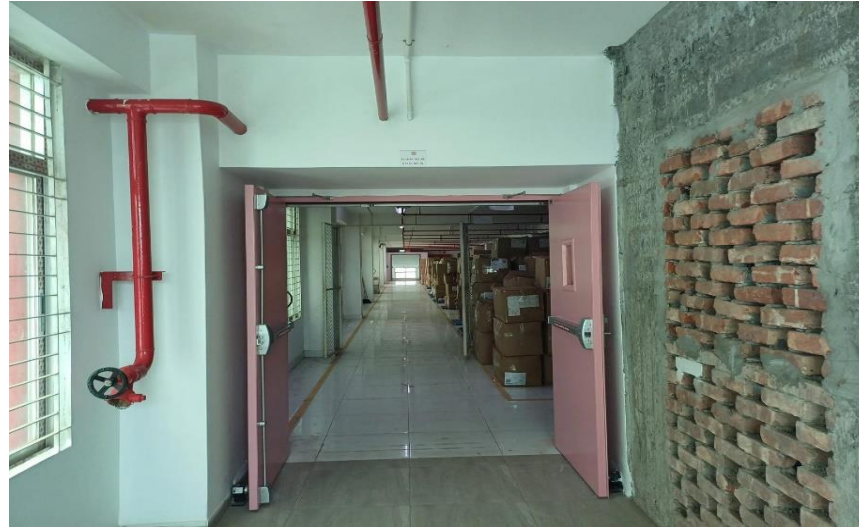
| SI No. | Category | Findings | Required Action | Remediation Time Frame |
|---|---|---|---|---|
| 1 | Fire Rated Construction | Store room discharged directly into the exit stair enclosures. | Openings from exit enclosure to storage shall be provided with a vestibule with fire rated construction and openings. Provide a 2 hr. fire rated door on the exit stair side and a 1- hr. fire rated door on the storage side. Ensure that the fire rating of the vestibule construction matches that of the exit stair enclosure. | Within 3 months |

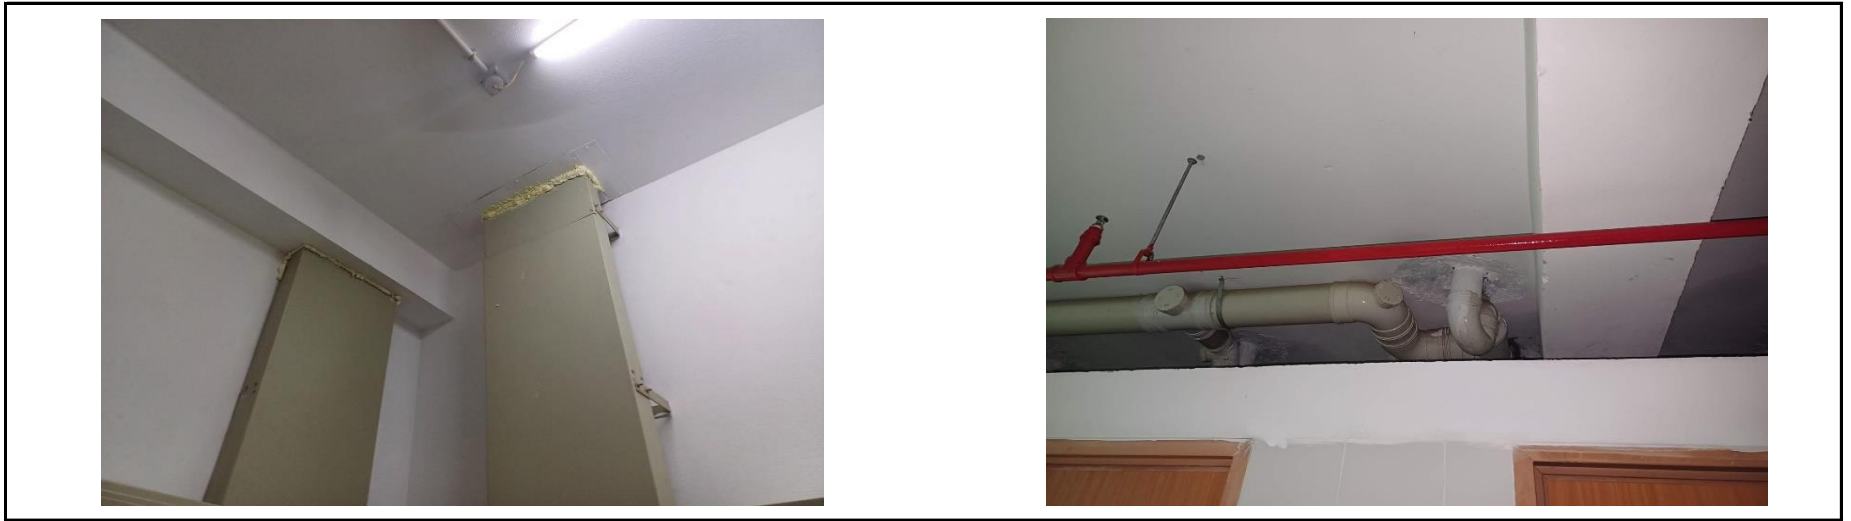
| 2 | Fire Rated Construction | <p>Penetrations through fire rated ceiling assemblies are not properly sealed.</p> <p><b>Locations: Electrical and plumbing penetrating pipes going through the fire rated assemblies.</b></p> | <p>Seal all penetrations and openings in ceiling (full thickness of the floor/ceiling) assemblies by fire rated materials to maintain the fire resistance rating.</p> <p>Provide a minimum 2-hr fire rated shaft to separate the utility risers from each floor if required.</p> <p><b>If fire stopping materials with proprietary design are used for seal, then it shall be classified for the purpose it is used for. Also the installation shall be as per the proprietary design it has been tested with.</b></p> | Within 3 months |

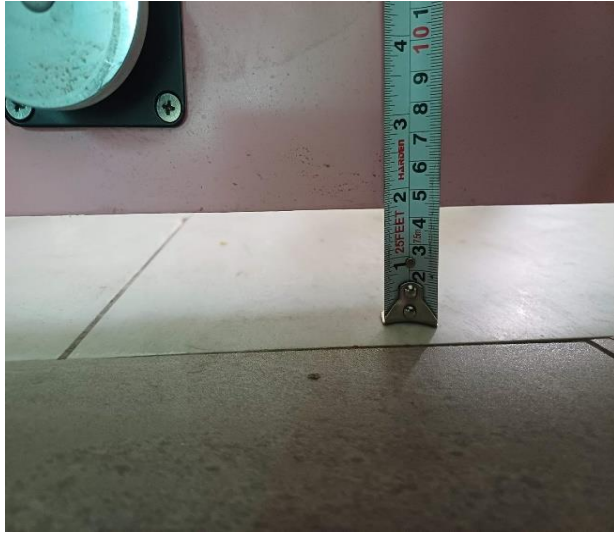
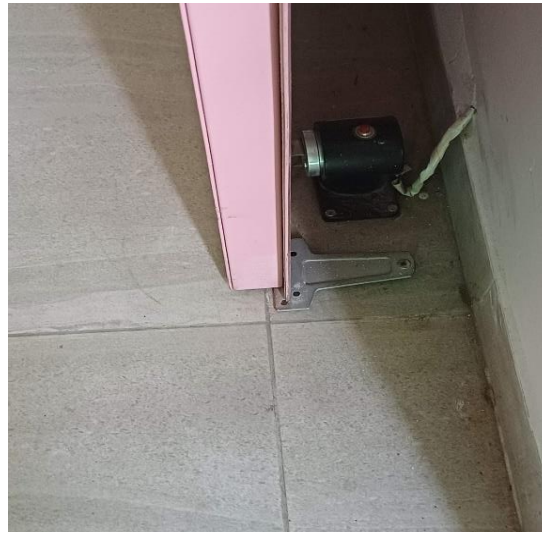
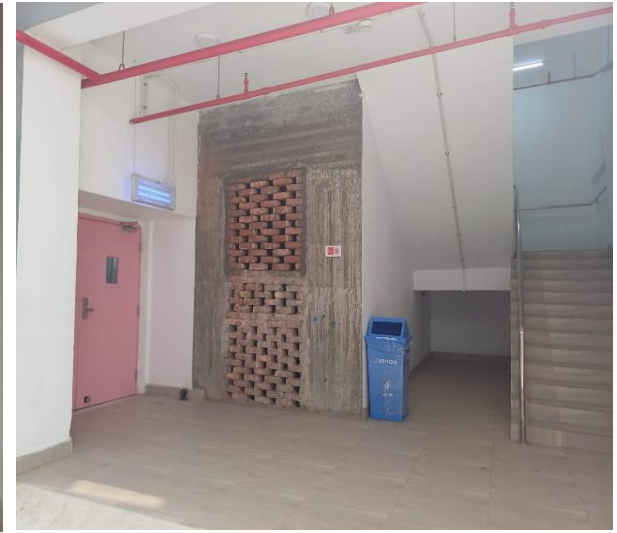
| 3 | Fire Rated Construction | <p>Fire doors has been installed in the openings of required fire rated assemblies (Exit stairs), However, fire doors were found with following issues</p> <ol style="list-style-type: none"> <li>1. Doors were kept open by means of door wedges.</li> <li>2. Doors were found with excessive clearance.</li> </ol> | <p><b>Install the fire door as per NFPA 80.</b></p> <p>Ensure that the fire doors are self-closing and positive latching and that they are provided with fire exit (panic) hardware where serving production floors. If fire doors are required to be held open for functional reasons, provide automatic closing devices tied to the fire alarm system.</p> <p>The clearance under the bottom of a fire door shall be a maximum of 19 mm. From edges and top shall be limited to a maximum 4.8 mm. All measurement shall be taken from the "pull side" of the door.</p> <p><b>Any modification of fire doors beyond the job site preparation shall be approved by the door manufacturer.</b></p> | Within 3 months |

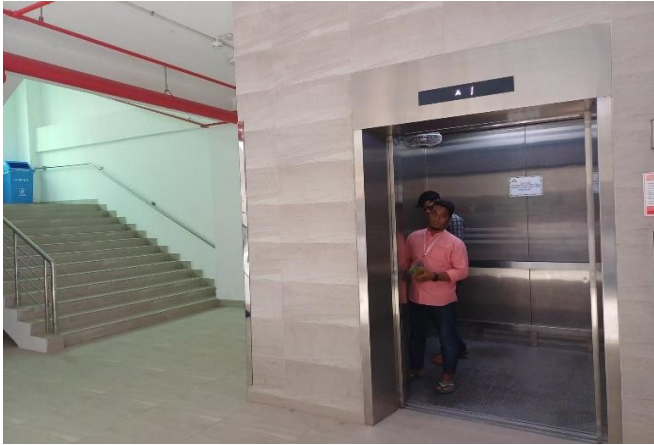
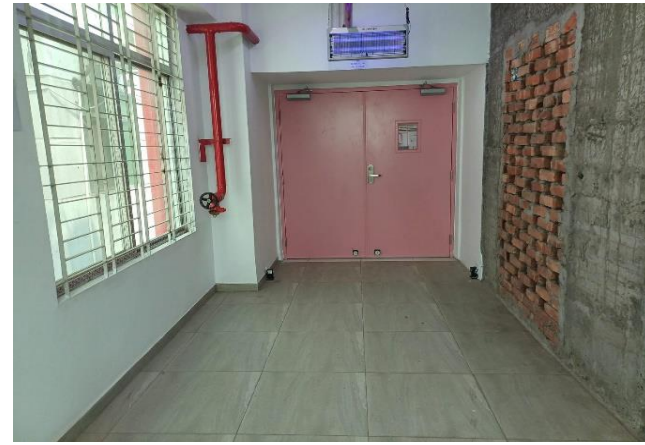
| 4 | Fire Rated Construction | Elevator shafts are directly open into the exit stair enclosure. | <p>Modify the elevator shaft as per RSC Technical Guideline (Standard) V1-6.14.3. An exit stairway shall not be built around a lift shaft unless both of them are located in a smoke proof enclosure and made of a material with fire resistance rating required for the type of construction of smoke proof enclosure. So, rearrange the facility to provide separate enclosure for lifts. If not possible anyway then provide a minimum 2-hr fire- rated elevator shaft with listed fire rated lift landing door to separate from each floor level.)</p> | Within 3 months |

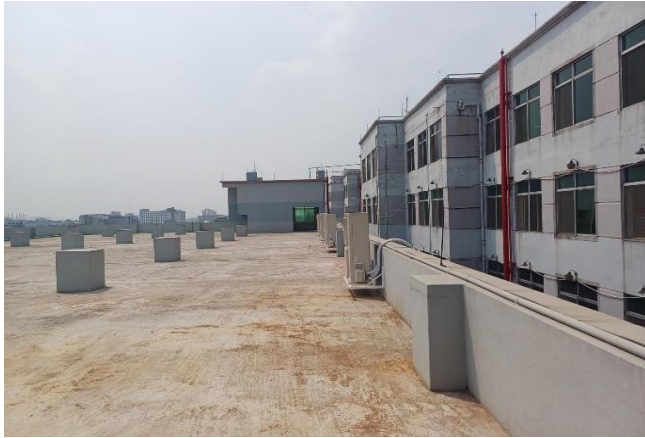
| 5 | Means of Egress | Parapets or guards are provided in occupied roof which is less than 1067mm (42 inch.). | Provide parapets or guards with a minimum height of 1067mm (42 inch.). | Within 3 months |

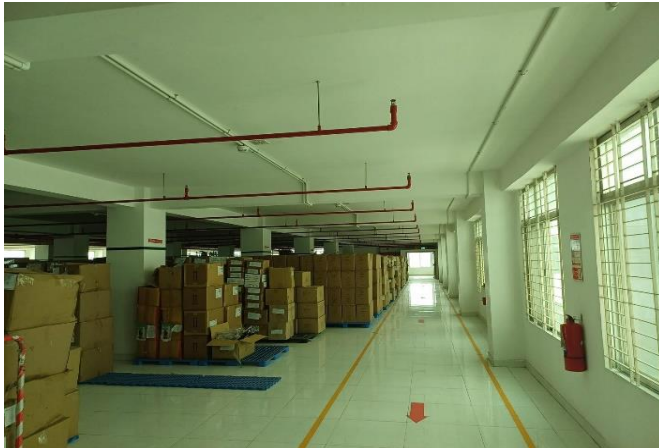
| 6 | Emergency Lighting | <p>Directional signs are not provided where direction of the path of travel to an exit has changed.</p> <p><b>Location: 1st to 7th Floor</b></p> | <p>Illuminated directional signs shall be provided where there is a change in the direction for the path of travel and the direction to an exit is not obvious.</p> | Within 1 month |

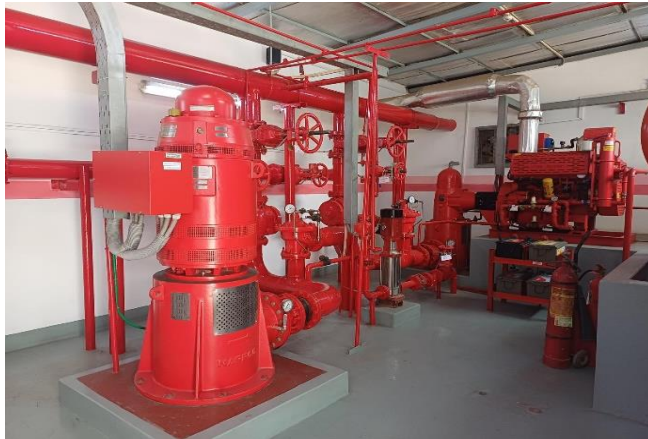
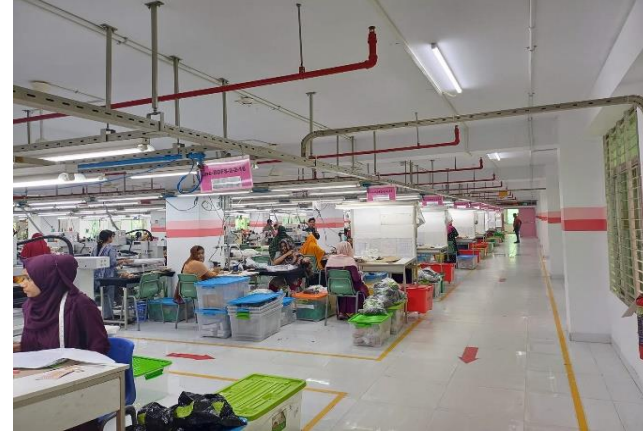
| 7 | Fire Protection System (Sprinkler) | <p>Sprinkler system installation requires detailed review to confirm compliance with NFPA 13, 14, 20, 22 and RSC technical guideline.</p> <p>T&amp;CVI of the sprinkler system with common fire pump has been conducted and accepted for Old ID_9670, However the building-2, Hop Lun Apparel Ltd (Extension) was not part of the inspection.</p> | <p>Submit as-built drawings, testing records, equipment certification and other relevant documentation to the RSC for review and approval/acceptance test.</p> | <p>Design submission- within 2 months;<br/>Modification if required- within 3 months</p> |

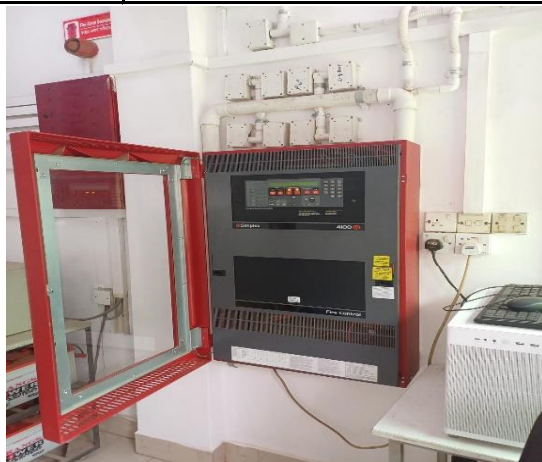
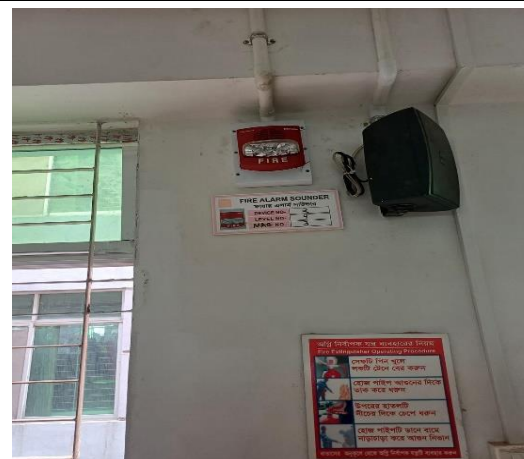
| 8 | Fire Alarm and Detection System | <p>An addressable fire alarm &amp; detection system found installed during inspection day.</p> <p>The fire alarm and detection system installation requires detailed review to confirm compliance with NFPA 72.</p> | <p>Design &amp; Installation of Fire Alarm &amp; Detection system shall be in accordance with RSC technical guideline and NFPA 72. Submit design, documents and calculations to RSC for review prior installation/modification. After installation the owner shall contact the RSC for witness of conducting the final acceptance testing of the fire detection &amp; alarm system installation. Also inspect, test and maintain the fire alarm system, and keep written records on-site, in accordance with NFPA 72</p> | <p>Design Submission within 2 months</p> <p>Installation / modification 3 months</p> |
