# INITIAL FIRE SAFETY INSPECTION REPORT

Concept Knitting.(Extension).

RSC ID: 24981

Address: Tilargati, Sataish Bazar, Tongi, Gazipur

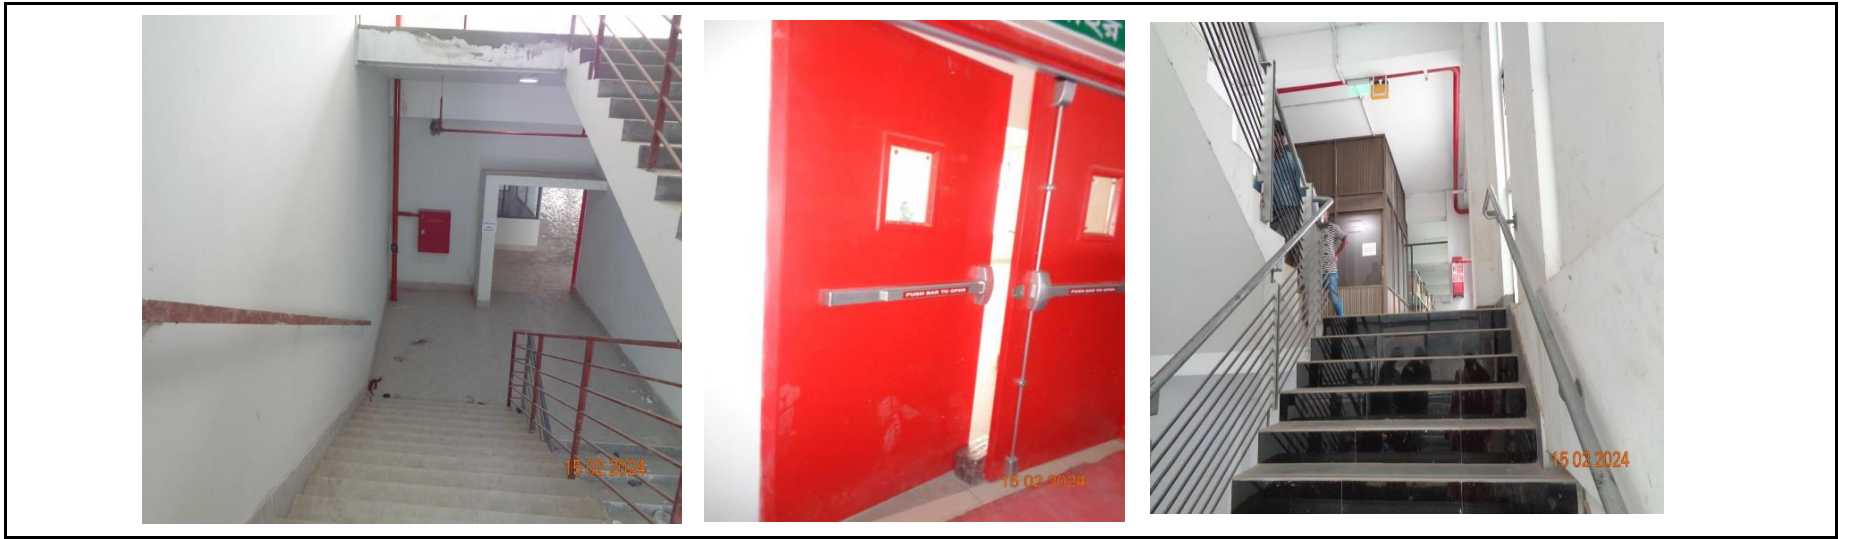
SI No.	Category	Findings	Required Action	Remediation Time Frame
F-1	Fire Rated Construction	<p>The exit stair enclosures are not properly separated from work areas and other spaces on each floor by fire-rated construction.</p> <p><b>Location:</b> New Garments Building &amp; Utility Building.</p>	<p>The exit stair enclosure shall be provided with a minimum 1-hr fire resistance rating for buildings with 3 or fewer stories and a minimum of 2- hr. fire resistance rating for buildings 4 or more stories.</p> <p>Provide 0.75 hr. fire rated door and seal all penetrations and openings by 1 hr. fire rated fire rated barrier construction for building with 3 or fewer stories. Provide 1.5 hr. fire rated door and seal all penetrations and openings by 2 hr. fire rated fire rated barrier construction for building with 4 or more stories.</p> <p>Ensure that the fire doors are self-closing and positive latching and that they are provided with fire exit (panic) hardware where serving production floors. If fire doors are required to be held open for functional reasons, provide automatic closing devices tied to the fire alarm system.</p>	Within 3 Months

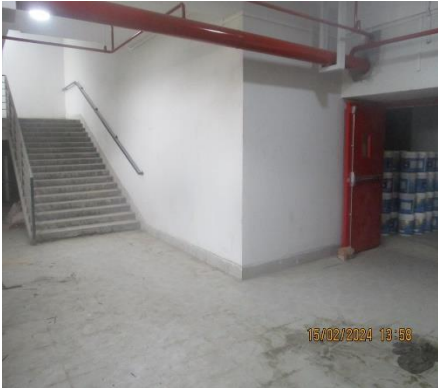
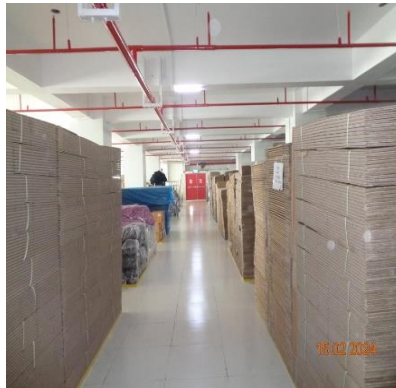
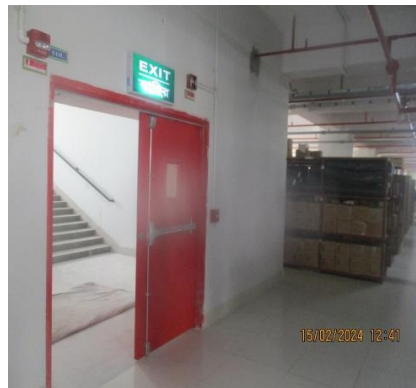
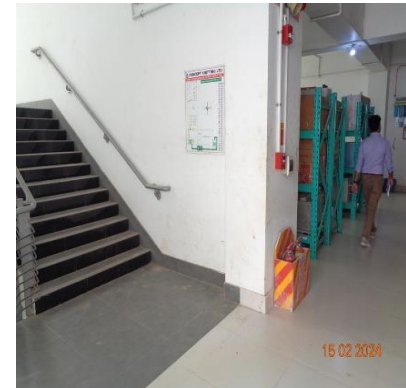
F-2	Fire Rated Construction	<p>Storage rooms and basement area discharge directly into exit stair enclosure without vestibule.</p> <p><b>Location:</b> New Garments Building &amp; Utility Building.</p>	<p>Openings from exit enclosure to storage and basement shall be provided with a vestibule with fire rated construction and openings. Provide a 1.5 hr. fire rated door on the exit stair side and a 1- hr. fire rated door on the storage room side. Ensure that the fire rating of the vestibule construction matches that of the exit stair enclosure.</p>	Within 3 Months
-----	-------------------------	--	---	-----------------

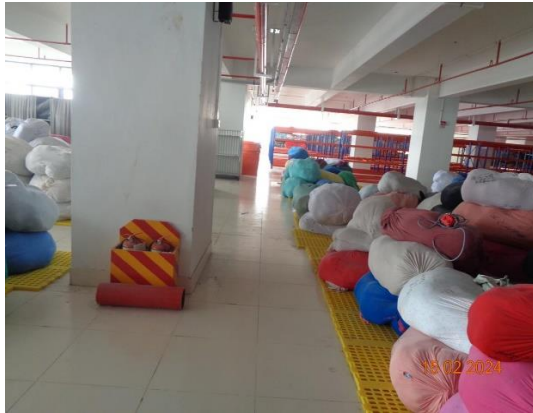
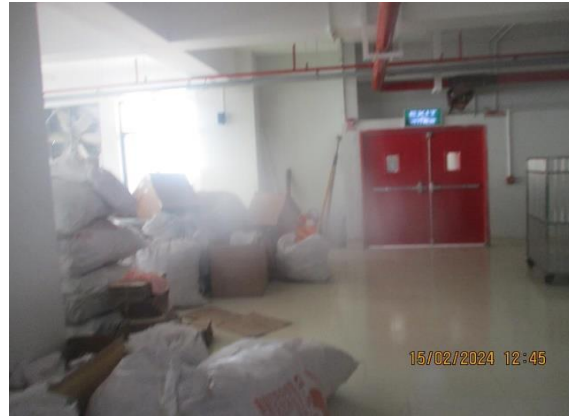
F-3	Fire Rated Construction	<p>Areas used for combustible storage open to the factory are not separated by fire rated construction.</p> <p><b>Location:</b> New Garments Building &amp; Utility Building.</p>	<p>Separate the dedicated storage rooms by minimum 1-hr fire-rated construction. Provide 0.75 hr. fire rated door and seal all penetrations and openings by 1 hr. fire rated fire rated barrier construction.</p> <p>Where separate storage rooms are not feasible, provide defined storage areas and limit the storage arrangement as follows:</p> <ul style="list-style-type: none"> <li>- Maximum height of 2.45m (8ft.) , maximum area of 23m<sup>2</sup> (250 ft<sup>2</sup>) and 3m (10ft.) clear distance from adjacent another unenclosed combustible storage.</li> <li>-If the building/floor is sprinkler protected: maximum height of 3.66m (12ft.) and maximum area of 93m<sup>2</sup> (1000 ft<sup>2</sup>) and 3m (10ft.) clear distance from adjacent another unenclosed combustible storage.</li> </ul>	Within 3 Months

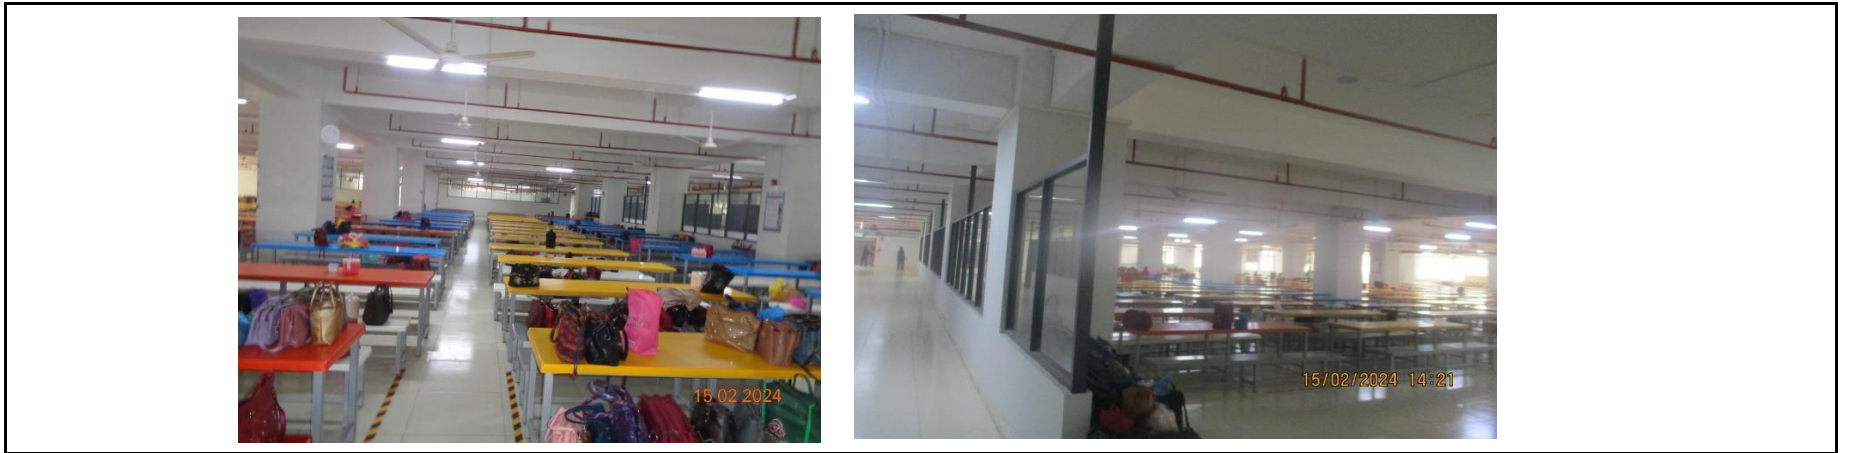
F-5	Fire Rated Construction	<p>Dining area (I-3, capacity-1500) was not separated by fire rated construction with adjacent sample (G-2) section.  <b>Location:</b> New Garments Building.</p>	<p>The dining area (I3) is not permitted with moderate hazard occupancies (G2) following table 3.2.1 of BNBC-2020. Required number of exits for entire dining arrangement shall lead directly to safe discharge path without passing through another occupancies.</p>	Within 3 months

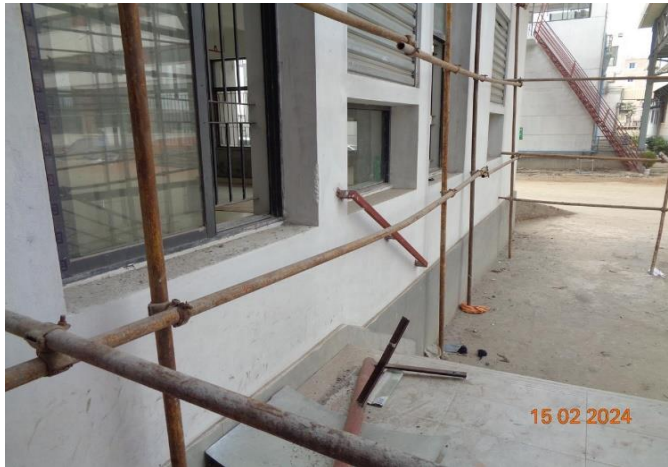
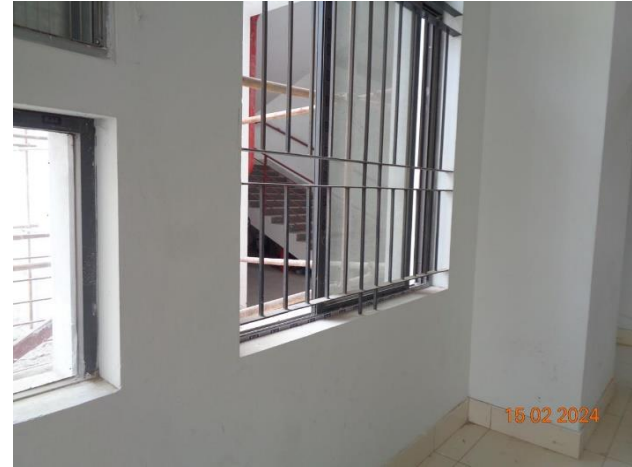
F-6	Fire Rated Construction	<p>The exit discharge path was not fire separated with production floor. The egress court was not properly fire rated. The egress court has unprotected openings within 10 ft height were available with garments building.</p>	<p>An egress court serving as a portion of the exit discharge shall be open to the sky or provided with a fire resistance rated enclosure the same as the exit enclosure. Egress courts less than 3050 mm (10 ft) in width (as measured from the building and the adjacent property line) shall be provided with walls having a 1-hr fire resistance rated construction for a distance of 3050 mm (10 ft) above the floor of the court.</p>	Within 3 months
-----	-------------------------	---	---	-----------------

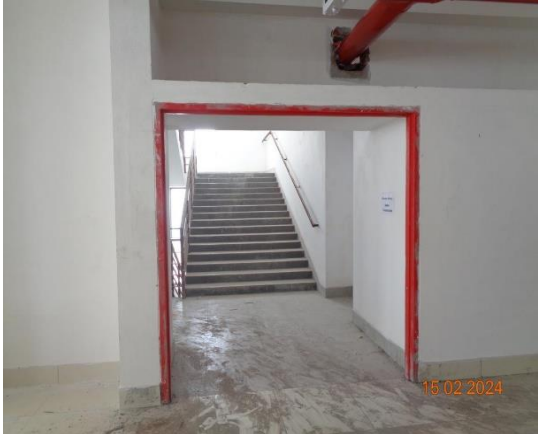
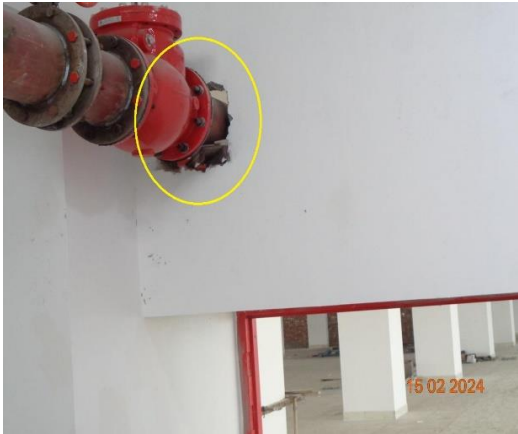
F-7	Fire Rated Construction	<p>Unsealed penetrations and openings are located in exit stair enclosures.</p> <p><b>Location:</b> New Garments Building.</p>	<p>Seal all penetrations and openings in exit stair enclosure walls to maintain the fire separation.</p>	<p>Within 3 months</p>
<div style="display: flex; justify-content: space-around;">

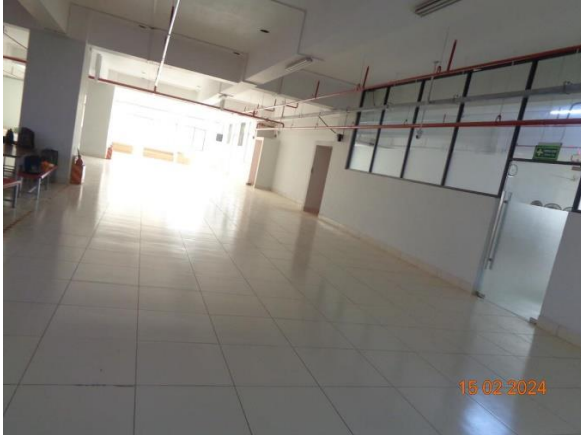
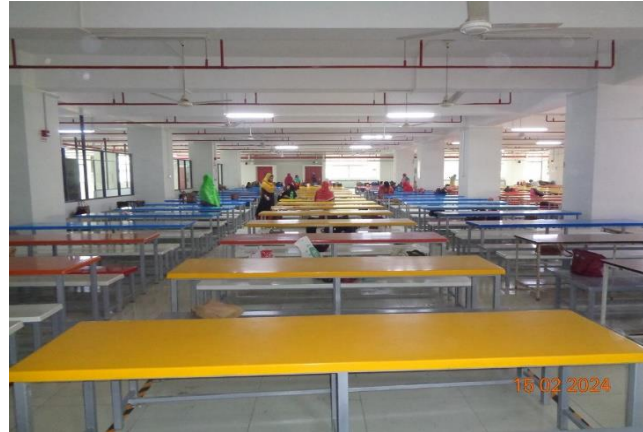
</div>				
F-8	Fire Rated Construction	<p>Childcare (C1) &amp; medical (D2) was not separated from dining (I3) &amp; production (G2) section.</p> <p><b>Location:</b> New Garments Building.</p>	<p>Separated the childcare &amp; medical from surrounding occupancies following table 3.2.1 of BNBC-2020.</p>	<p>Within 3 months</p>

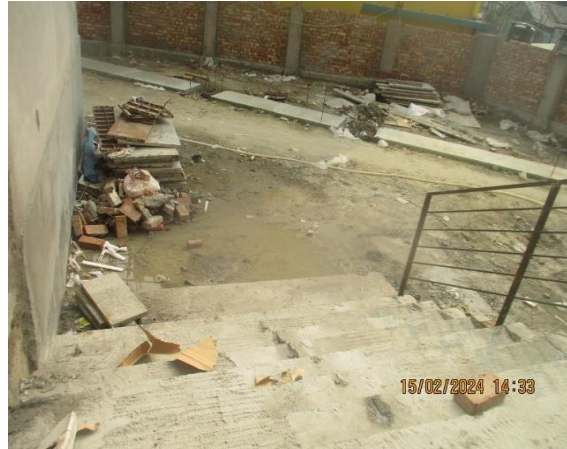
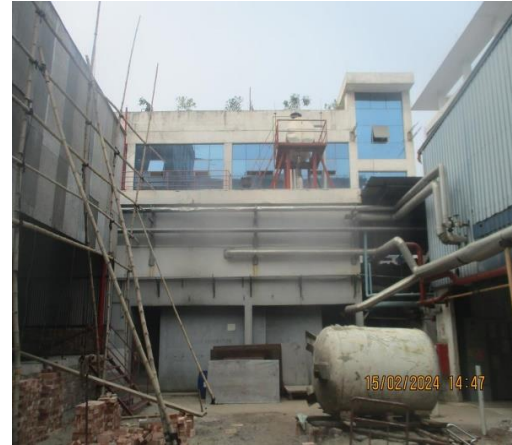
F-10	Means of Egress	<p>Egress path found obstructed and uneven on exit discharge position.</p> <p><b>Locations:</b> New Garments Building &amp; Utility Building.</p>	<p>Remove unnecessary items and level exit path to the public way.</p>	<p>Within 1 Month</p>

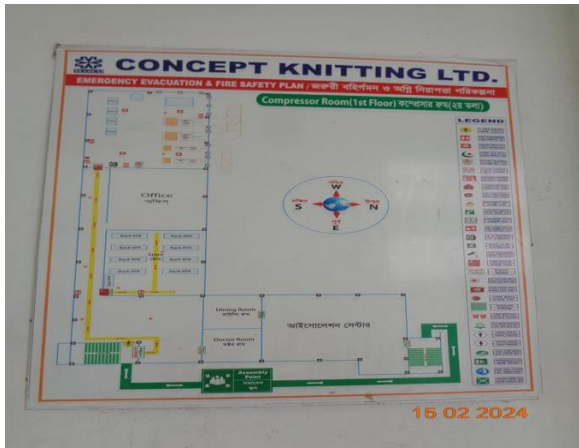
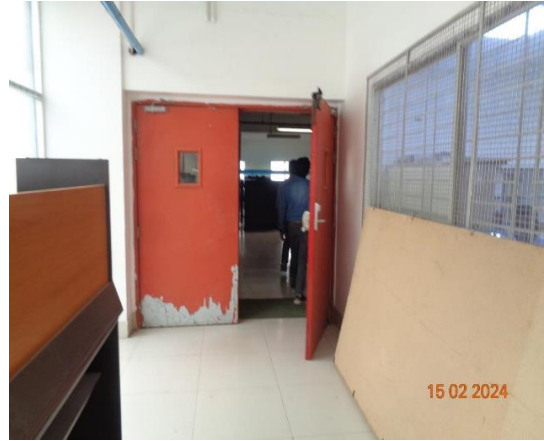
F-11	Means of Egress	Single exit provided from compressor room located at 1st floor of Utility building.	Provide additional means of egress in accordance with RSC standard 6.3 .	Within 1 Month
------	-----------------	---	--	----------------

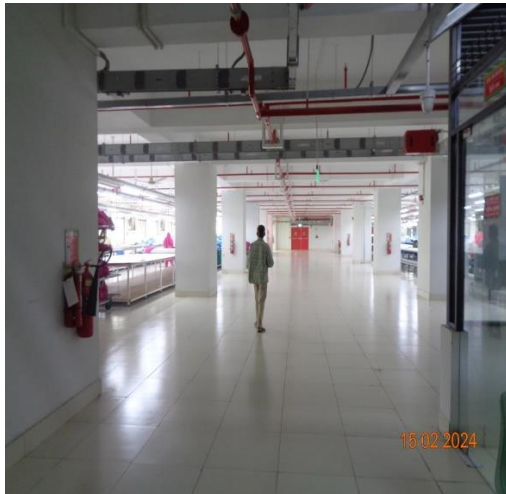
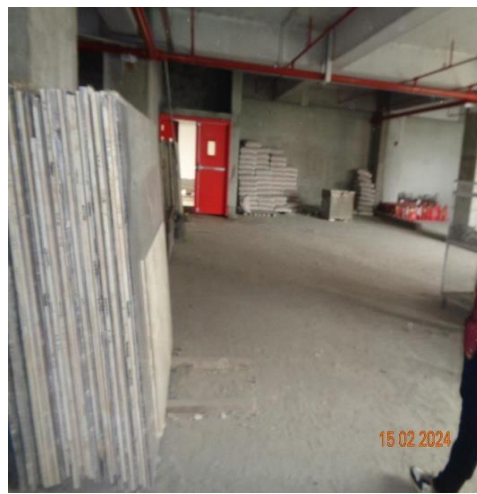
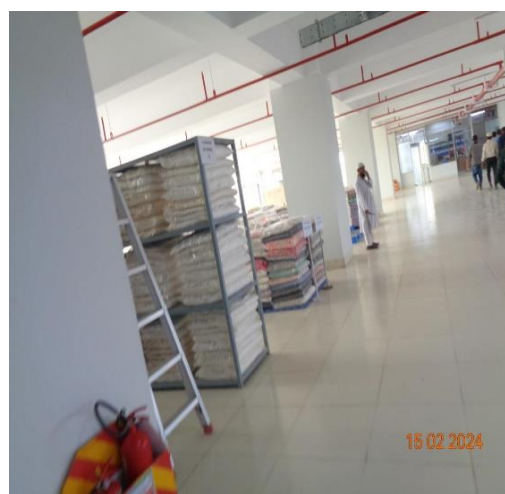
F-13	Means of Egress	<p>Inadequate aisle marking is provided.  <b>Location:</b> New Garments Building.</p>	<p>Provide minimum aisle widths of 36-inch. All the aisles shall be marked properly and free from any kind of obstruction.</p>	<p>Within 1 Month</p>
------	-----------------	---	--	-----------------------

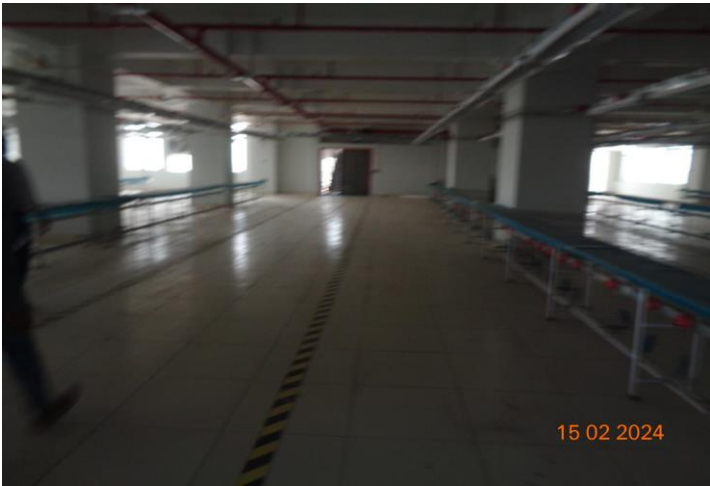
F-17	Emergency Lighting	Based on the number and location of emergency lights observed, adequate illumination levels are not anticipated along egress routes and at exit stairs on all floors.	Test the emergency lighting system on each floor and provide additional emergency fixtures to supply adequate illumination along the means of egress. Provide a minimum illumination of 10 lux at the floor level within exit stairs and along exit discharge paths and a minimum 2.5 lux along exit access aisles.	Within 1 Month

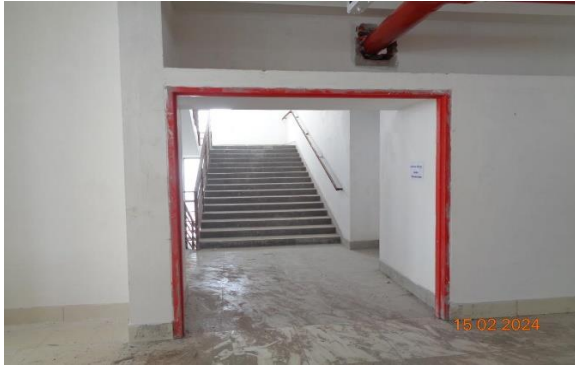
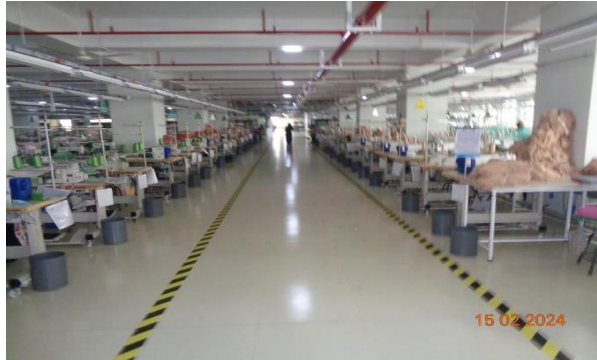
F-18	Emergency Lighting	Exit signage & directional exit sign was not provided along a path of egress.	Provide exit signs above all building exits to the exterior, all doors to the exit stairs and along all paths of travel where a change of direction is not obvious. Lighted exit signs shall be provided with either battery backup or uninterruptable power supply systems and shall be continuously illuminated.	Within 1 month

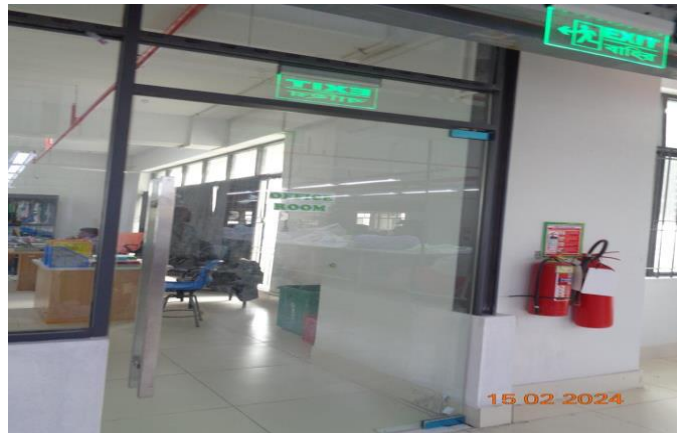
F-19	Emergency Lighting	Exit signs were placed in areas that were not exits.	Remove exit signs (double sided) from noted areas to avoid confusion from actual exits.	Within 1 month
------	--------------------	--	---	----------------

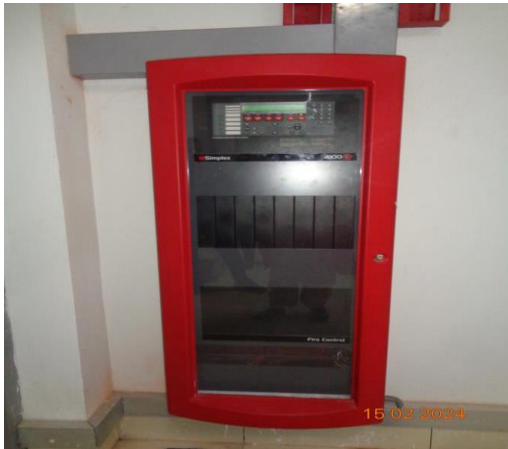
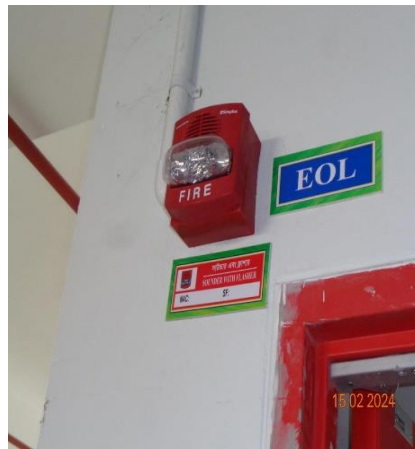
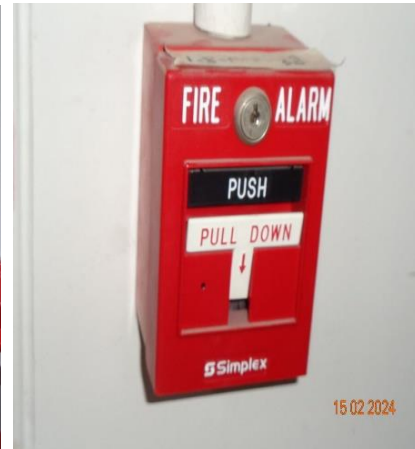
F-20	Inspection Testing and Maintenance of Emergency lighting	Inspection, testing, and maintenance for the emergency lighting system was not in accordance with RSC technical guidelines (standard).	Inspect, test and maintain the emergency lighting system in accordance with RSC technical guidelines (standard). Keep written records on-site.	Within 1 month
F-21	Fire Alarm & Detection System (FADS)	The fire alarm and detection system installation requires detailed review to confirm compliance with NFPA 72 and RSC standard.	Submit as-built drawings, testing records, equipment certification and other relevant documentation to the RSC for review and approval/acceptance test.	Design Review within 2 months and installation/modification within 4 months.

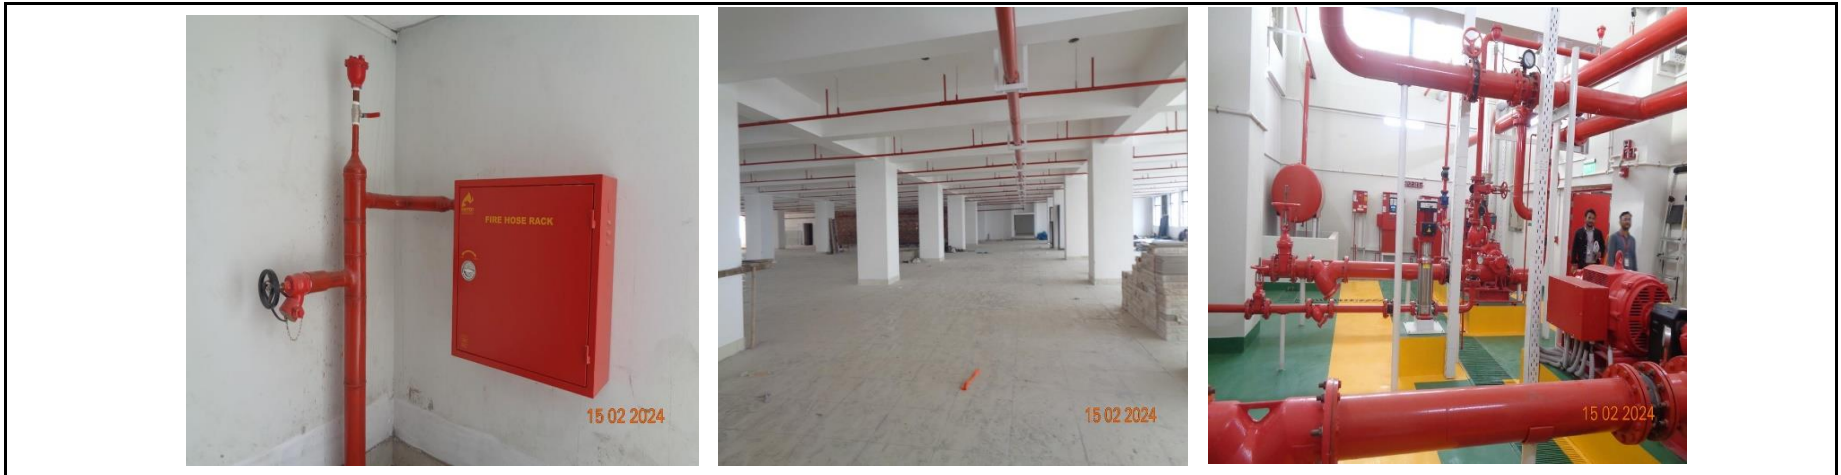
F-22	ITM of Fire Alarm and Detection System	Inspection, testing, and maintenance for the fire alarm system is not in accordance with NFPA 72.	Inspect, test and maintain the fire alarm system, and keep written records on-site, in accordance with NFPA 72. (After Installation)	Within 1 month after installation.
F-23	Fire Suppression System (SUPS)	Sprinkler system is mandatory for the building based on height. The system installed for the New Garments Building along with standpipe system. However, both the system requires detailed review to confirm compliance with NFPA 13, 14, 20, 22, 24 and RSC Technical Guidelines (Standard).	Submit as-built drawings, testing records, equipment certification and other relevant documentation to the RSC for review. Once reviewed, install or modify the sprinkler, standpipe system and pump throughout the building in accordance with RSC standard and NFPA 13, 14 and 20. The factory management shall contact RSC to conduct the final acceptance testing after the installation, testing & commissioning.	Design Review within 2 months and installation/modification within 4 months.
