FIRE SAFETY INSPECTION REPORT

MUAZUDDIN TEXTILE LTD.

**PLOT # 235/236, EAST CHANDURA, SHIFIPUR,
KALIAKOR, GAZIPUR**

March 18, 2014

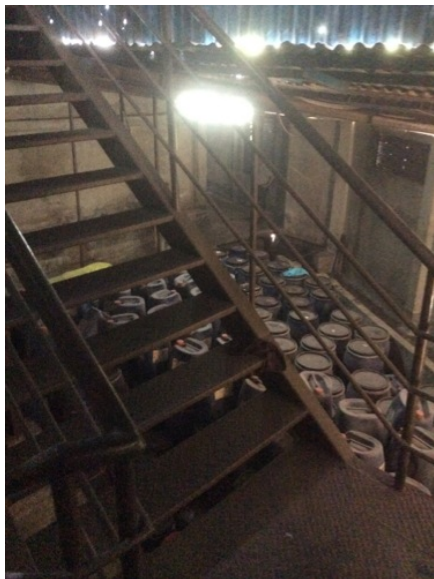
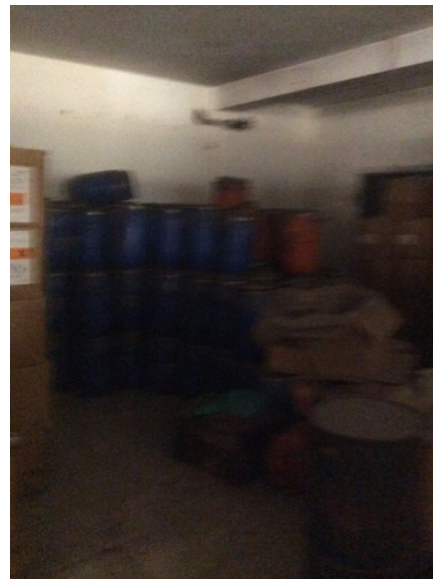
No.	Category	Finding	Recommendation	Remediation Timeframe
F-1	Fire Rated Construction	<p>Hazardous materials and flammable liquid storage area is not separated by fire-rated construction (openings, non-rated doors, penetrations).</p> <p>Base of stairwell on North Side of building.</p>	<p>Separate the hazardous materials / flammable liquid storage room by a minimum 2-hr fire-rated construction. Seal and/or protected all openings to maintain the required fire separations.</p>	<p>Within 3 months</p>

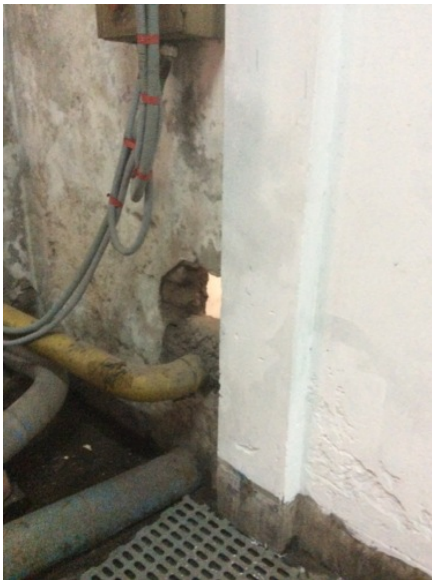
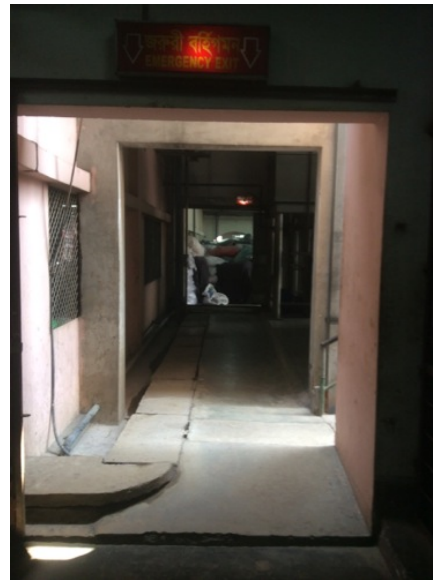
F-2	Fire Rated Construction	<p>The boiler / generator / transformer room is not separated by fire-rated construction (openings, non-rated doors, penetrations). They are in a separate building but that building is connected to the main factory building.</p>	<p>Separate the boiler / generator / transformer room by a minimum 2-hr fire-rated construction. Seal and/or protected all openings to maintain the required fire separations</p>	<p>Within 3 months</p>
-----	-------------------------	--	---	------------------------

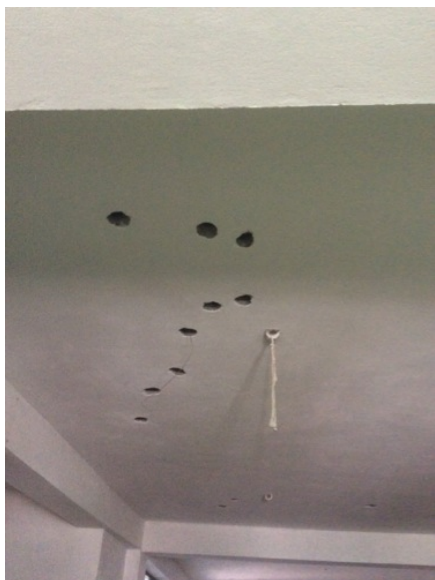
F-3	Fire Rated Construction	<p>Unsealed penetrations and openings are located in the fire-rated floor/ceiling assemblies. There were holes in the ceilings of all floors.</p>	<p>Provide a minimum 2-hr fire-rated shaft to separate the utility risers from each floor level. Seal all penetrations and openings in floor/ceiling assemblies to maintain the fire separation.</p>	<p>Within 3 months</p>
-----	-------------------------	---	--	------------------------

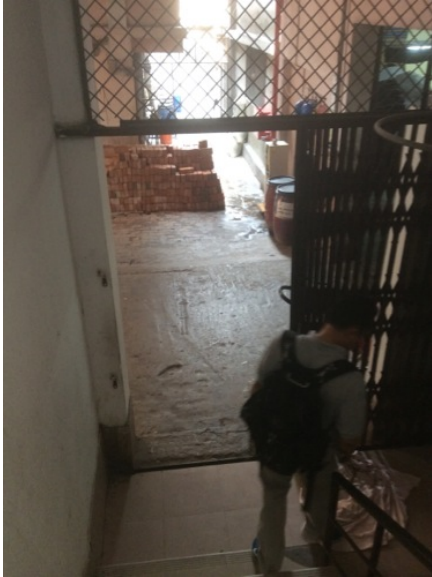
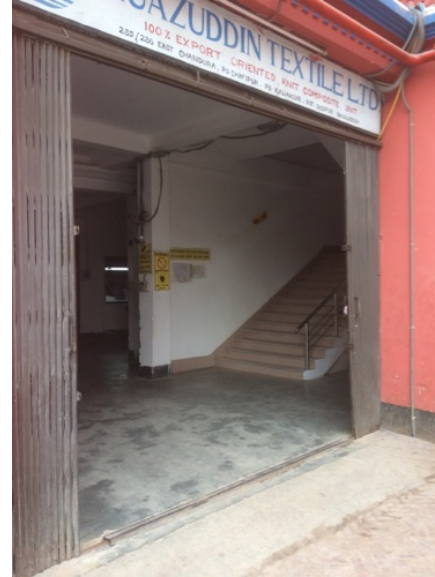
F-4	Fire Rated Construction	The exit stairs are not separated from work areas and other spaces on each floor by fire-rated construction.	Provide minimum 1.5-hr fire rated doors and seal all unprotected openings to separate the exit stairs from work areas and other building spaces on all floor levels. Ensure that the fire doors are self-closing and positive latching and that they are provided with fire exit (panic) hardware where serving production floors. If fire doors are required to be held open for functional reasons, provide automatic-closing devices tied to the fire alarm system.	Within 3 months
-----	-------------------------	--	---	-----------------

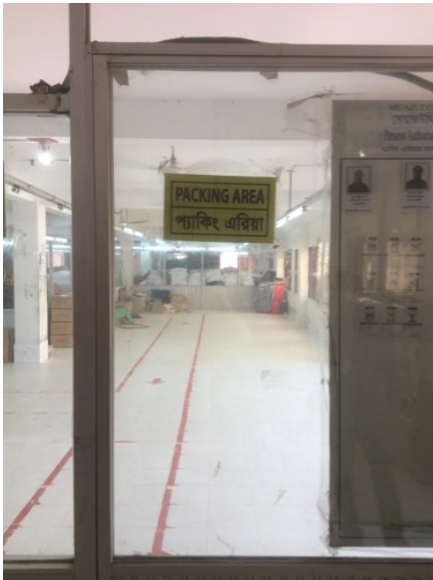
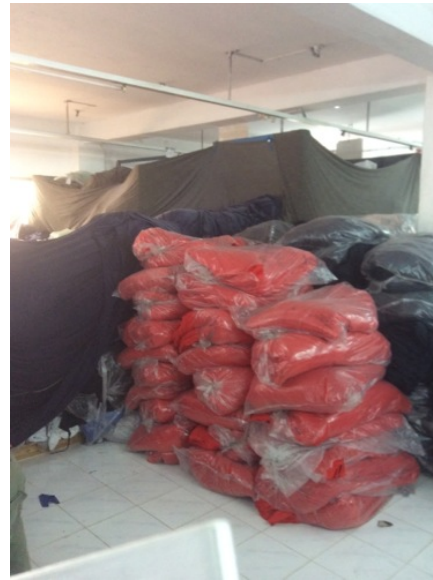
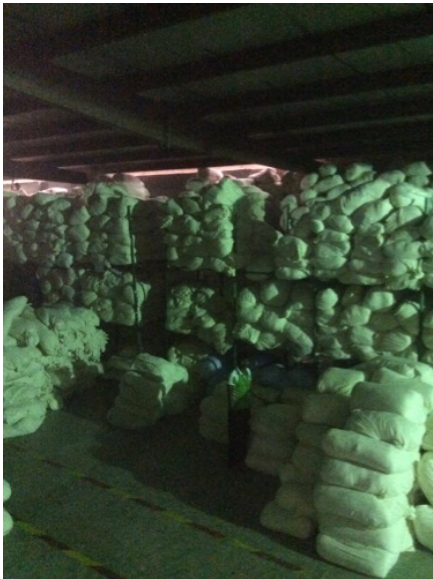
F-5	Fire Rated Construction	Areas used for combustible storage throughout the factory are not separated by fire-rated construction.	Provide dedicated storage rooms separated by minimum 1-hr fire-rated construction.	Within 3 months
			<p>Where separate storage rooms are not feasible, provide defined storage areas and limit the storage arrangement as follows:</p> <ul style="list-style-type: none"> - Maximum height of 2.4m and maximum area of 23m² - If sprinkler protected: maximum height of 3.66m and maximum area of 93m² 	
			<p>Separate areas of unenclosed combustible storage by a minimum clear distance of 3m.</p>

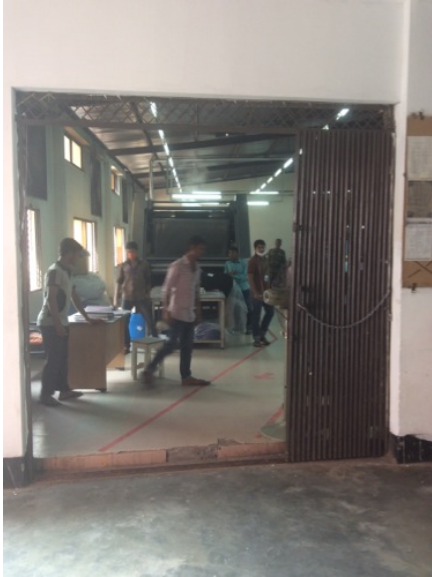
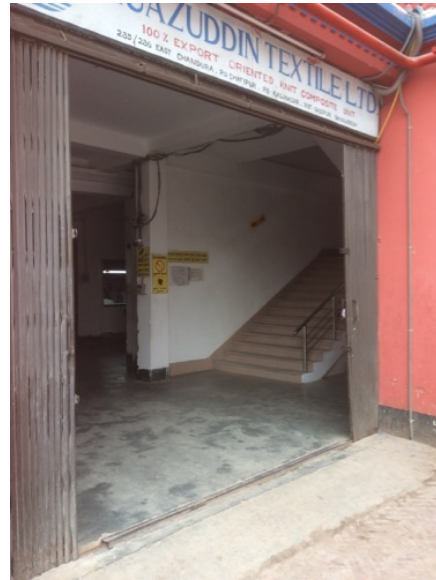
F-6	Egress	<p>Egress doors / gates with locking features are provided at building exits, exit stairs, along egress routes, exit discharge.</p> <p>Locations:</p> <p>All Exits</p> <p>Doors were unlocked at time of inspection.</p>	<p>Remove locking features from all egress doors / gates.</p> <p>If locks are required for security reasons, utilize special door locking features complying with NFPA 101.</p>	Immediate
-----	--------	--	---	-----------

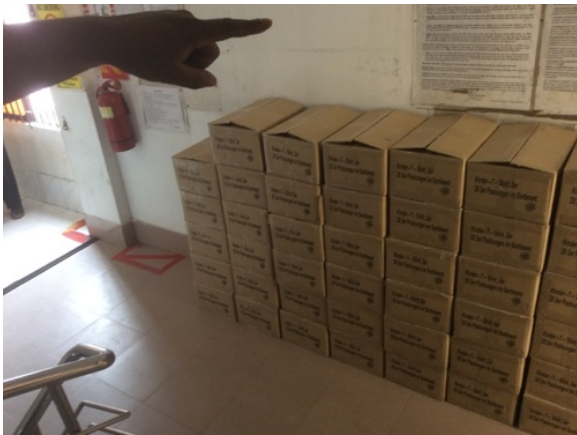
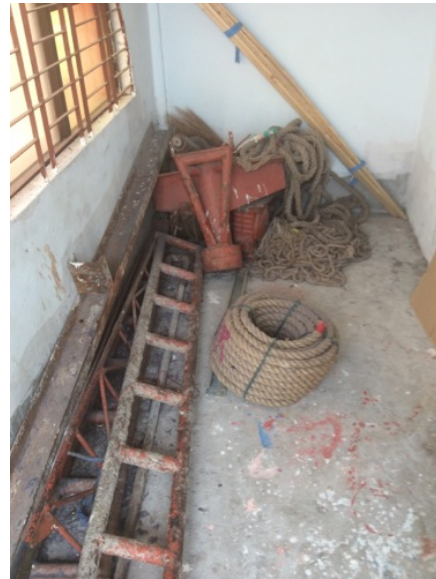
F-7 Egress

Storage was located in the exit stairs.

Remove all storage from exit stairs and egress paths.

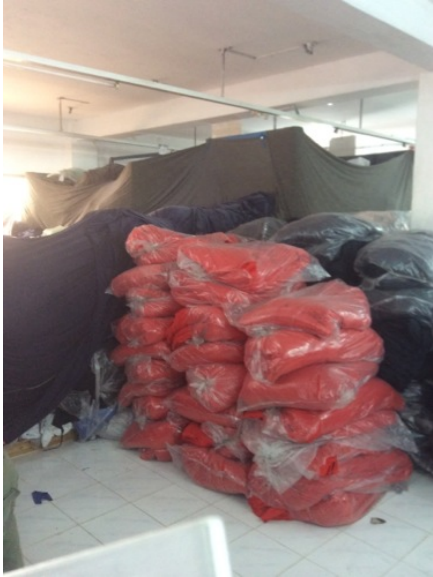
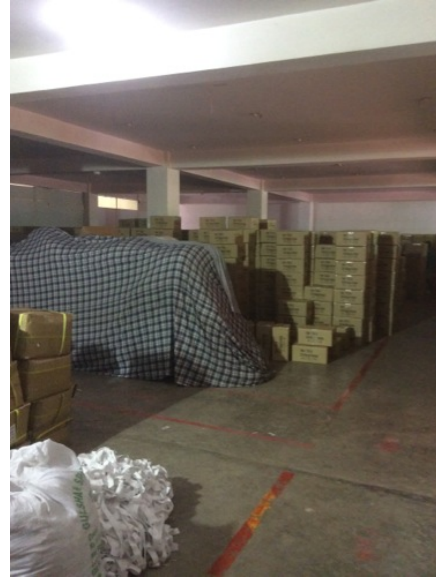
F-8 Egress

Storage was located in the egress path.

Keep egress paths and stairs clear of storage.

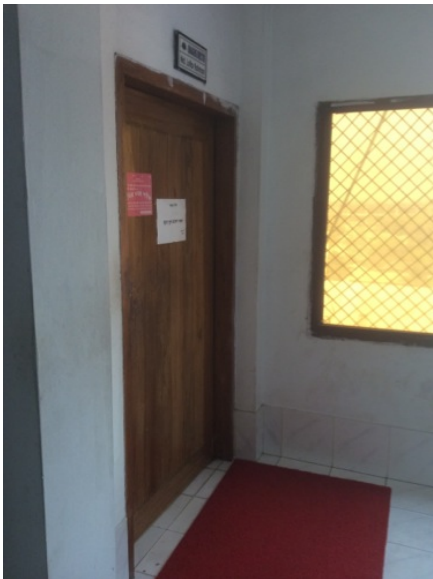
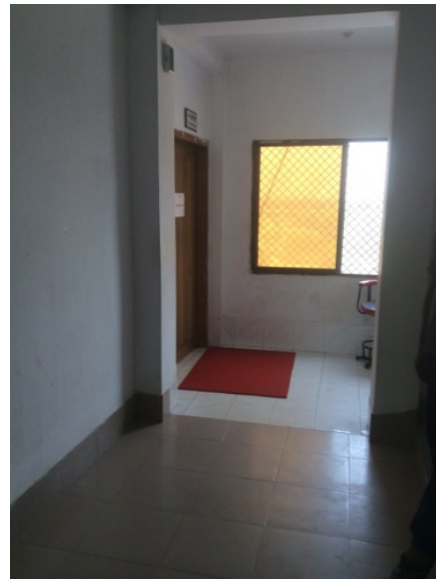
F-9 Egress

Exit stair door does not swing in the direction of egress travel.

Modify the egress door to swing in the direction of egress travel.

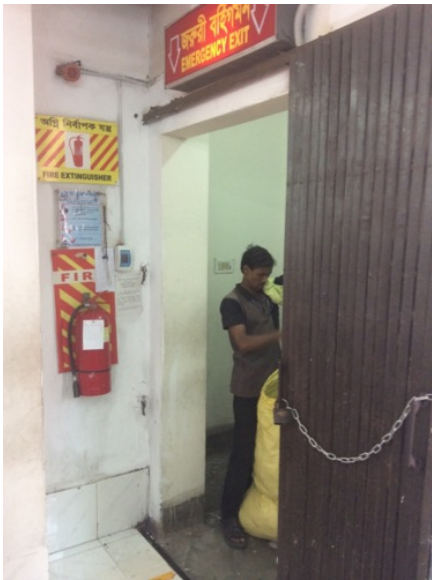
F-10	Egress	Collapsible gates / sliding doors are provided at building exits, exit stairs, along egress routes, and exit discharge.	Replace all gates / sliding doors along the means of egress with side-hinged, swinging egress doors.	Within 1 month
		Locations:	If locks are required for security reasons, utilize special door locking features complying with NFPA 101.	
		All exits

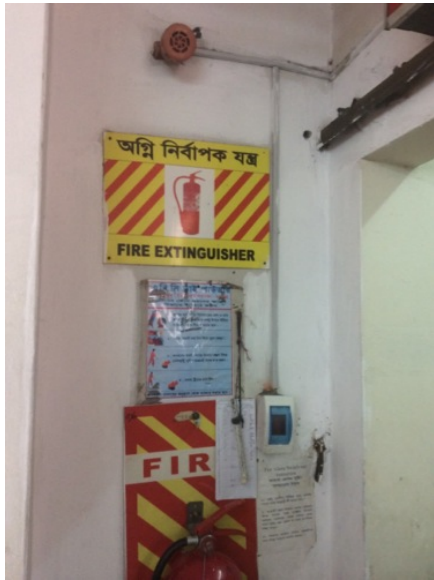
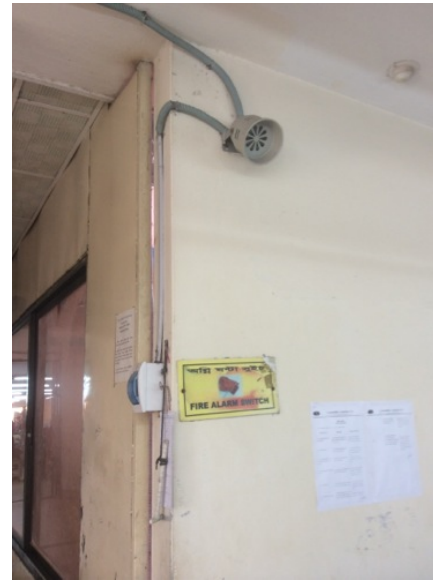
F-15	Fire Protection	The fire alarm system does not appear to provide adequate audible notification coverage. All Floors.	Provide additional notification appliances such that the fire alarm system is audible throughout the building in accordance with NFPA 72.	Within 6 months

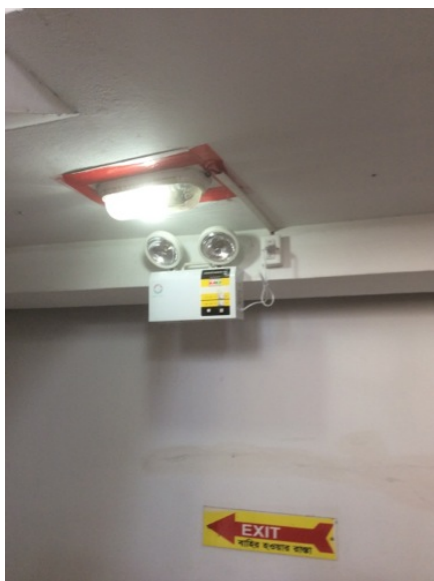
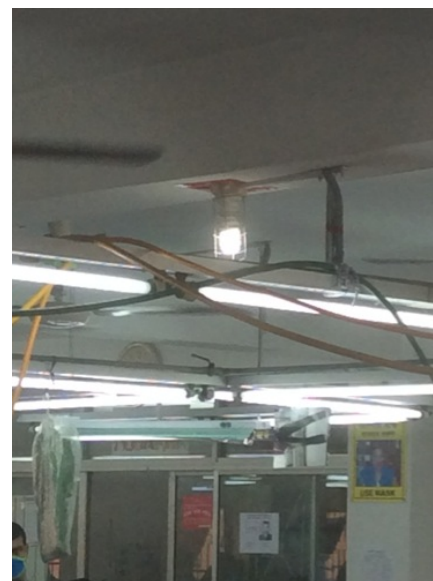
F-16 Egress Lighting

Based on the number and location of emergency lights observed, adequate illumination levels are not anticipated along egress routes.

Test the emergency lighting system on each floor and provide additional emergency fixtures to provide adequate illumination along the means of egress. Provide a minimum illumination of 10 lux at the floor level within exit stairs and exit discharge paths and minimum 2.5 lux along exit access aisles.
