# **FIRE SAFETY INSPECTION REPORT**

**NIPA FASHIONWEAR, LTD.**  
**SELINA TOWER, HOLAN ROAD**

**ACCORD**  
on Fire and Building Safety in Bangladesh

March 19, 2014

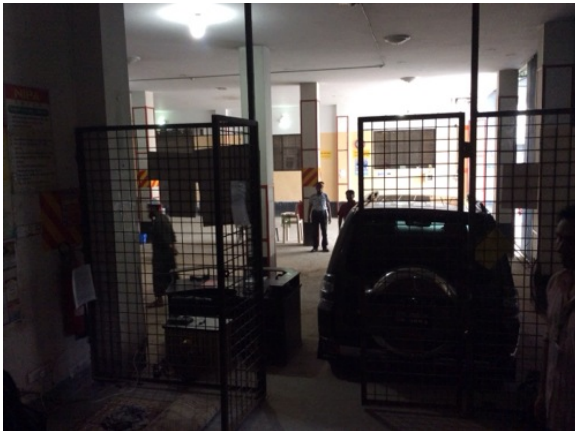
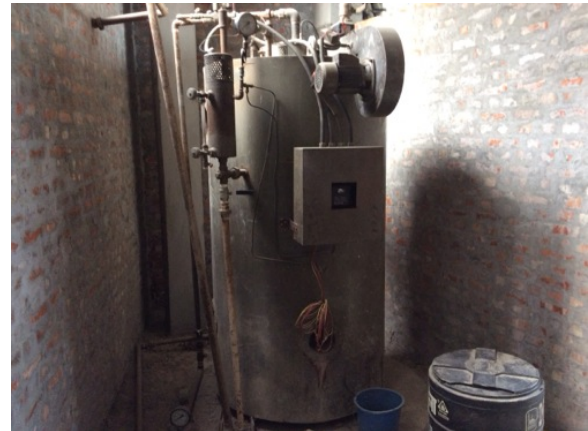
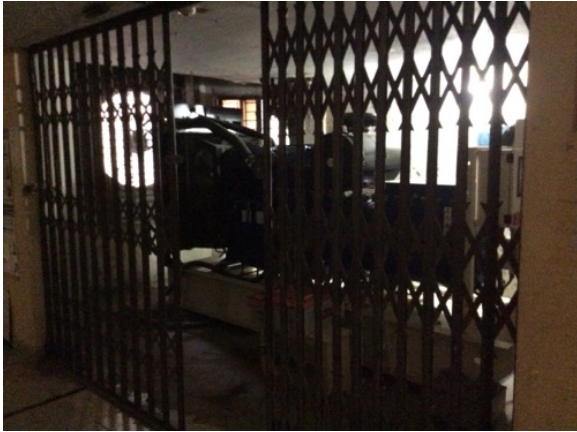
| No. | Category | Finding | Recommendation | Remediation Timeframe |
|---|---|---|---|---|
| F-1 | Fire Rated Construction | <p>The boiler / generator / transformer rooms are not separated by fire-rated construction (openings, non-rated doors, penetrations).</p> <p>On ground floor open to egress path.</p> | Separate the boiler / generator / transformer rooms by a minimum 2-hr fire-rated construction. Seal and/or protected all openings to maintain the required fire separations | Within 3 months |

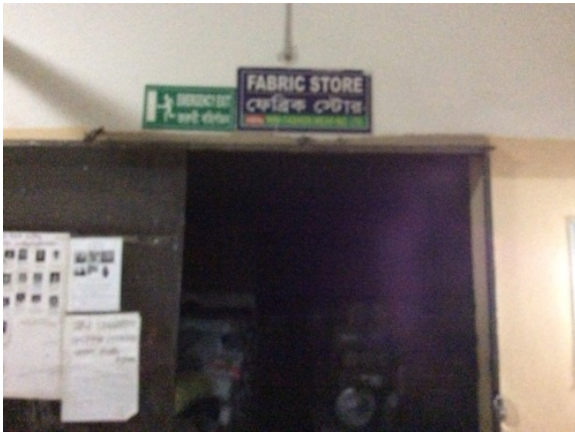
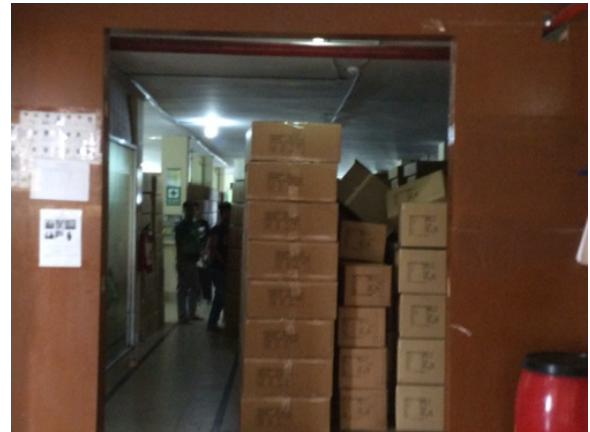
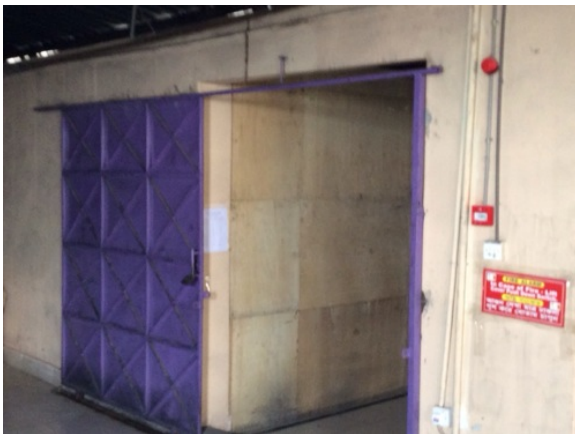
| F-2 | Fire Rated Construction | <p>Areas used for combustible storage are not separated by fire-rated construction.</p> <p>Unprotected openings at storage rooms on multiple floors.</p> | <p>Provide dedicated storage rooms separated by minimum 1-hr fire-rated construction.</p> <p>Where separate storage rooms are not feasible, provide defined storage areas and limit the storage arrangement as follows:</p> <ul style="list-style-type: none"> <li>- Maximum height of 2.4m and maximum area of 23m<sup>2</sup></li> <li>- If sprinkler protected: maximum height of 3.66m and maximum area of 93m<sup>2</sup></li> </ul> <p>Separate areas of unenclosed combustible storage by a minimum clear distance of 3m.</p> | Within 3 months |

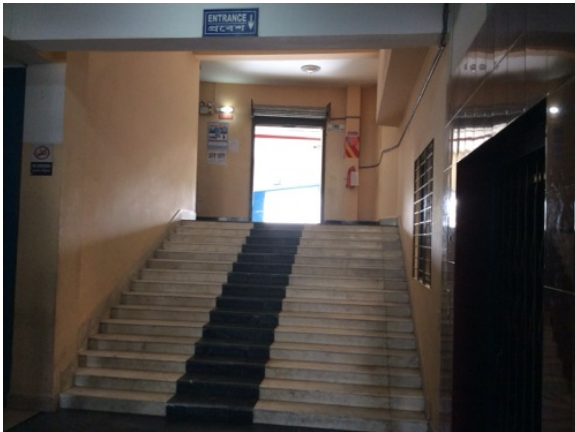
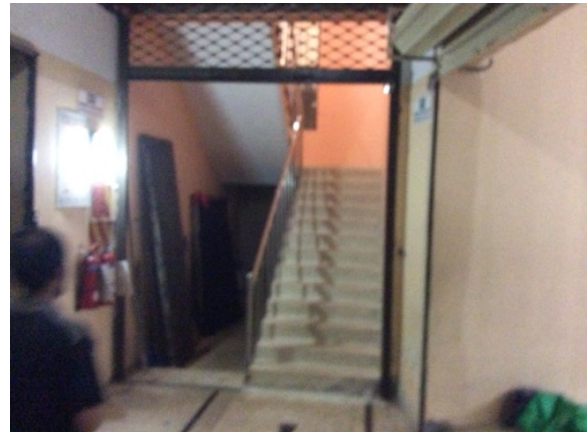
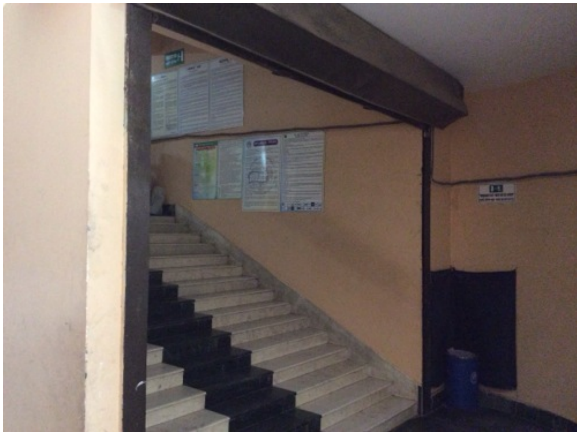
| F-3 | Fire Rated Construction | <p>The exit stairs are not separated from work areas on each floor by fire-rated construction.</p> <p>Elevator shafts open to stairs.</p> | <p>Provide minimum 1.5-hr fire rated doors and seal all unprotected openings to separate the exit stairs from work areas and other building spaces on all floor levels. Ensure that the fire doors are self-closing and positive latching and that they are provided with fire exit (panic) hardware where serving production floors.</p> <p>If fire doors are required to be held open for functional reasons, provide automatic-closing devices tied to the fire alarm system.</p> | Within 3 months |

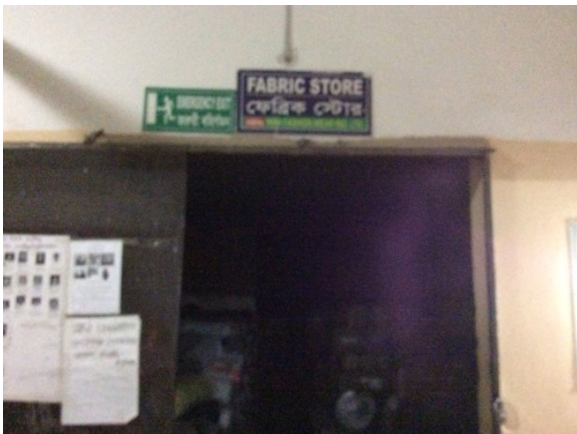
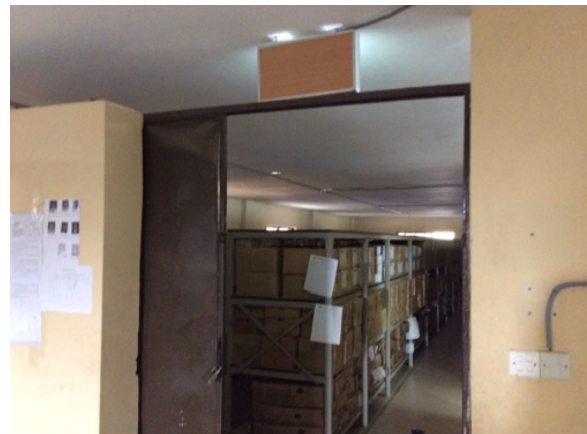
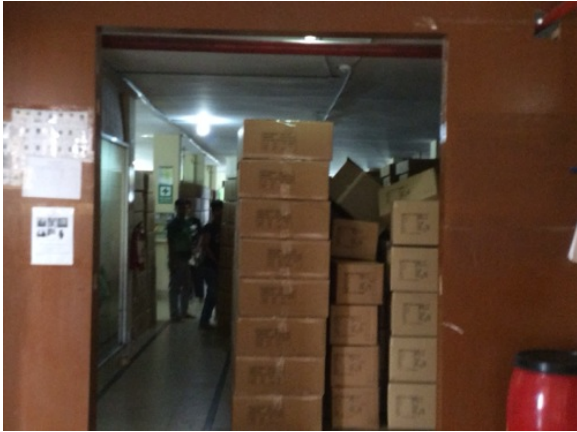
| F-4 | Egress | Storage was located in the egress path. | Keep egress paths and stairs clear of storage. | Immediate |
| | | Store rooms open to egress path on ground floor and upper floors. | | |

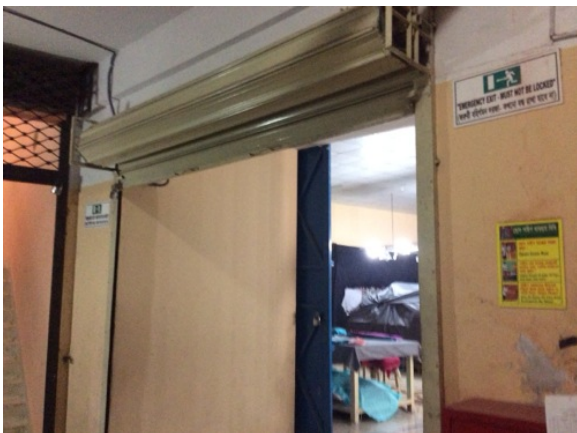
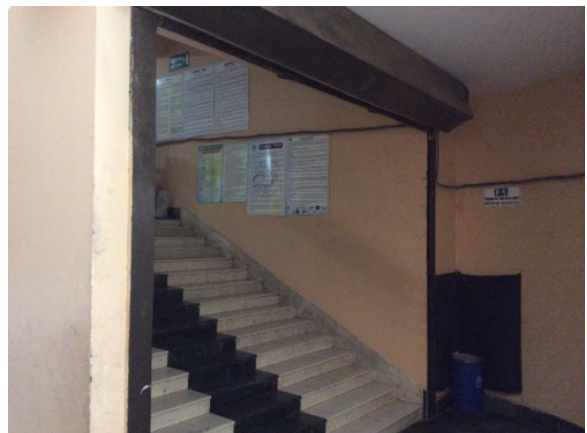
| F-5 | Egress | Collapsible gates / sliding doors are provided at building exits, and exit stairs. | Replace all gates / sliding doors along the means of egress with side-hinged, swinging egress doors. | Within 1 month |
| | | Main and secondary stair have roll down shutters at stair entrances. | If locks are required for security reasons, utilize special door locking features complying with NFPA 101. | |

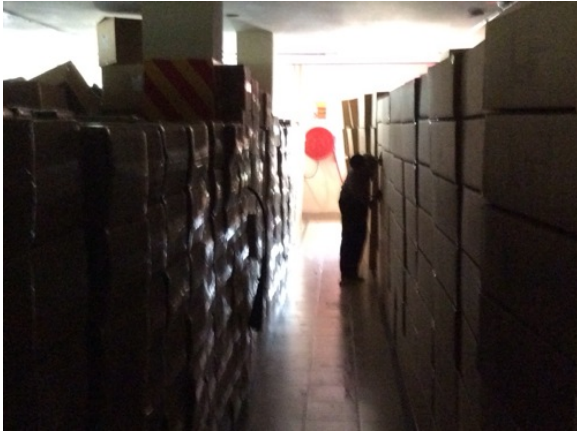
| F-6 | Egress | The width of egress aisles is less than 36-in.<br><br>5th floor store room. | Provide minimum aisle widths of 36-in. | Within 3 months |

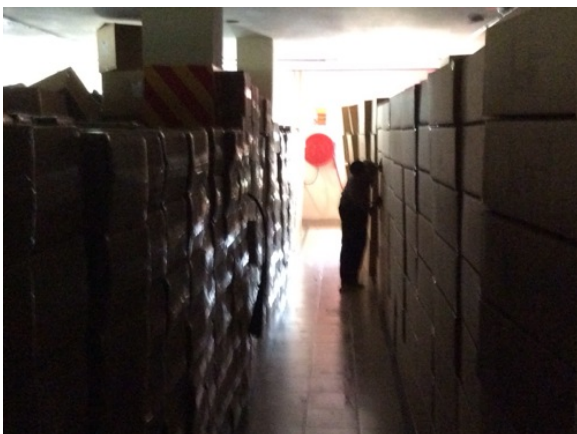
| F-7 | Egress | Common path of egress travel exceeds 30 m.<br><br>5th floor store room. | Reconfigure the egress arrangement to reduce the maximum common path of travel to not more than 30 m. | Within 3 months |

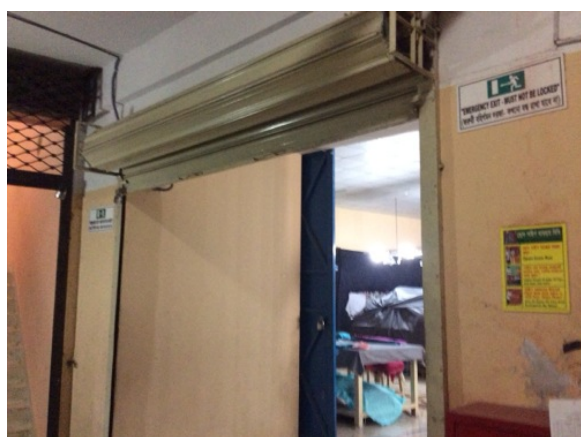
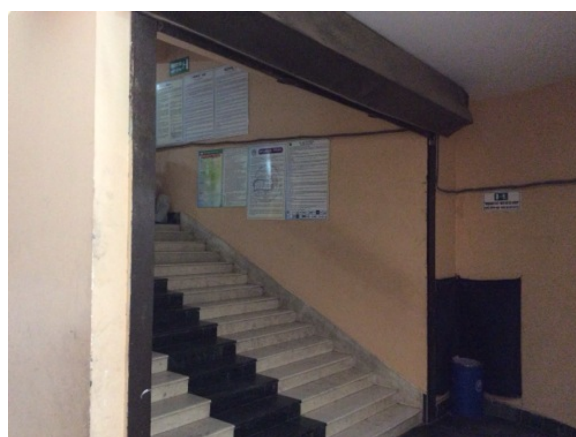
| F-8 | Egress | Exit stair door / egress door serving 50 or more occupants does not swing in the direction of egress travel.<br><br>Swinging doors only on stair between this building and adjacent factory at each floor. | Modify the egress door to swing in the direction of egress travel. | Within 3 months |

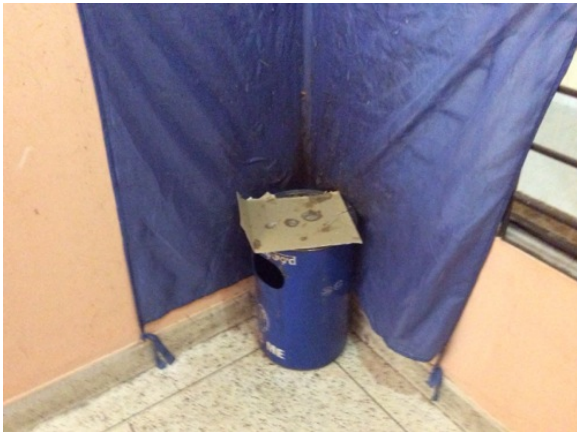
| F-9 | Egress | Storage was located in the exit stair.<br><br>Ash cans on stair landings. | Remove all storage from exit stairs and egress paths. | Within 3 months |

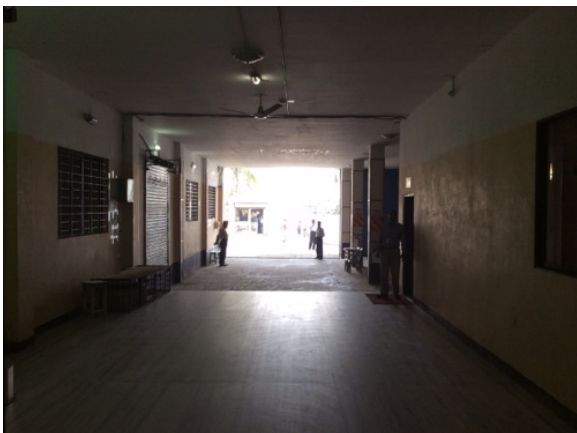
| F-10 | Egress | Exit stairs discharge inside the building.<br><br>Main stair and secondary stair discharge into hall that proceeds through the parking area/loading area, to the exterior | Provide 2-hr fire-rated exit passageway leading directly outside, vestibules to be separate from any storage areas. | Within 6 months |

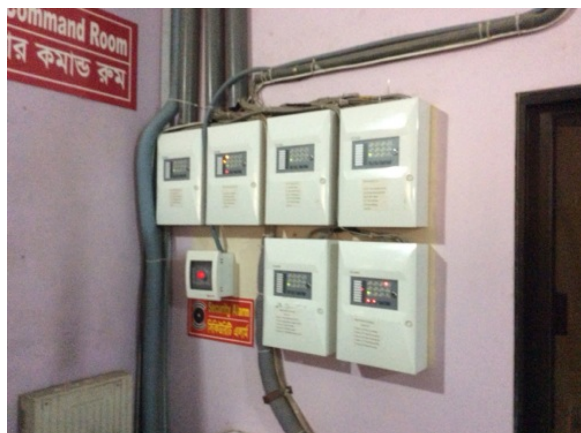
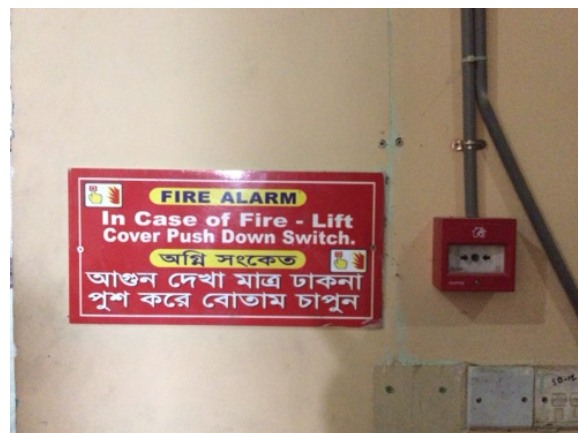
| F-11 | Fire Protection | The fire alarm system is antiquated, not a listed system, and does not provide alarm and notification features consistent with acceptable standards. | Replace the fire alarm system with a new, listed addressable fire alarm system in accordance with NFPA 72. | Design within 4 months, install within 9 months |

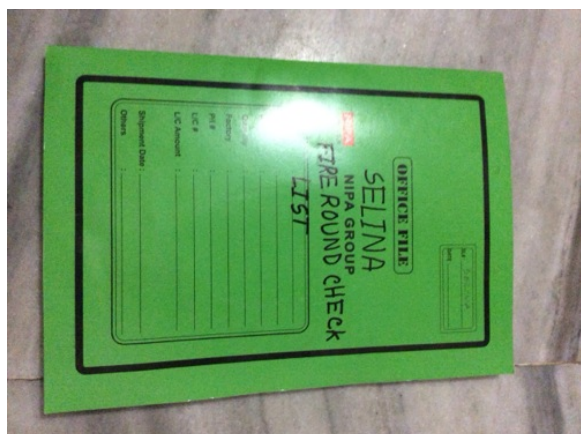
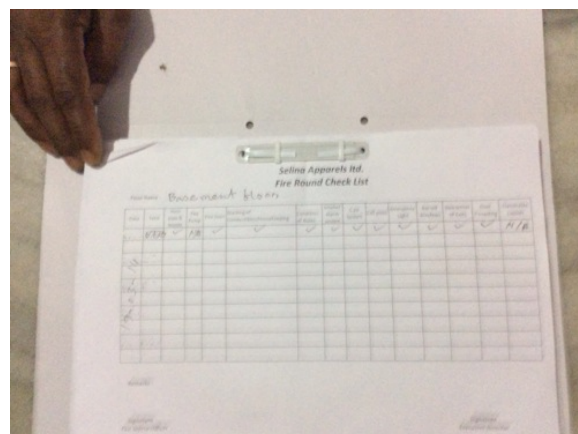
| F-12 | Fire Protection | Inspection, testing, and maintenance records for the fire alarm system were not available. | Inspect, test and maintain the fire alarm system, and keep written records on-site, in accordance with NFPA 72. | Within 3 months |
