# **FIRE SAFETY INSPECTION REPORT**

**REZA FASHIONS LTD**  
**GORAT, BAGHBARI,ASHULIA,SAVAR**

**ACCORD**  
on Fire and Building Safety in Bangladesh

March 16, 2014

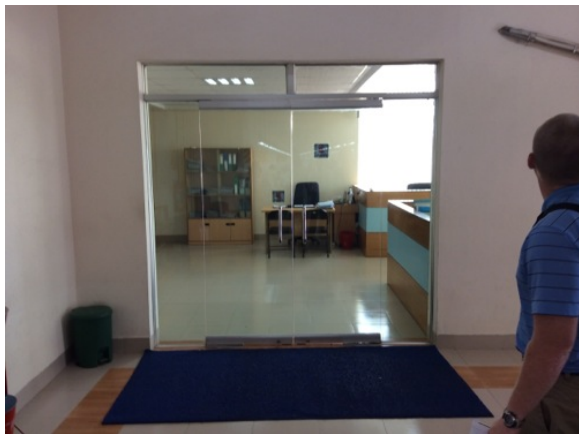
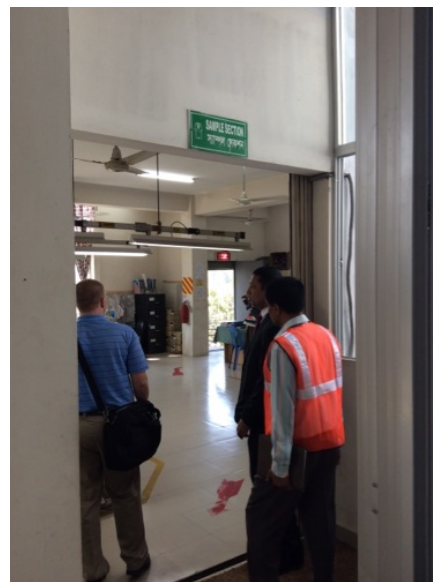
F-2	Fire Rated Construction	The exit stairs are not separated from work areas and other spaces on each floor by fire-rated construction.	Provide minimum 1.5-hr fire rated doors and seal all unprotected openings to separate the exit stairs from work areas and other building spaces on all floor levels. Ensure that the fire doors are self-closing and positive latching and that they are provided with fire exit (panic) hardware where serving production floors.  If fire doors are required to be held open for functional reasons, provide automatic-closing devices tied to the fire alarm system.	Within 3 months
-----	-------------------------	--	---	-----------------

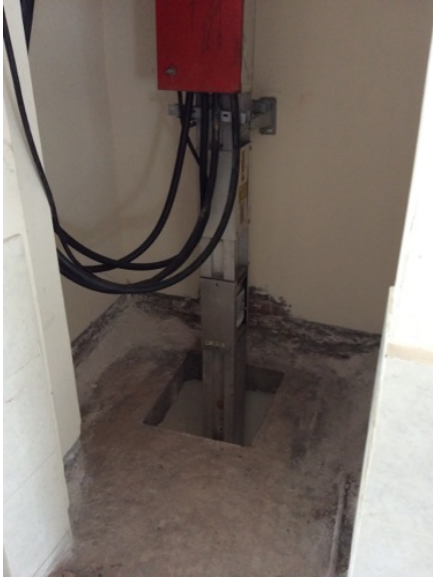
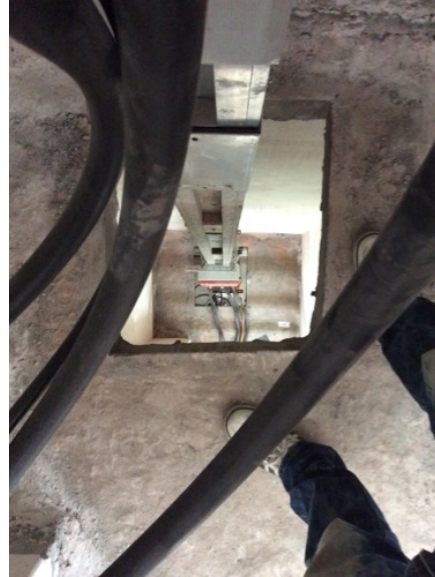
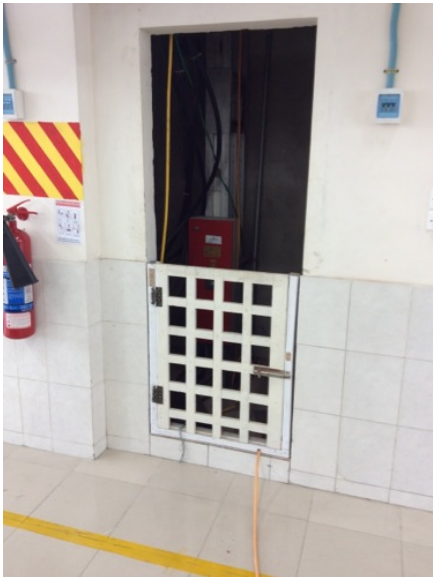
F-3	Fire Rated Construction	Unsealed penetrations and openings are located in the fire-rated floor/ceiling assemblies.	Provide a minimum 2-hr fire-rated shaft to separate the utility risers from each floor level.  Seal all penetrations and openings in floor/ceiling assemblies to maintain the fire separation.	Within 3 months
-----	-------------------------	--	--	-----------------

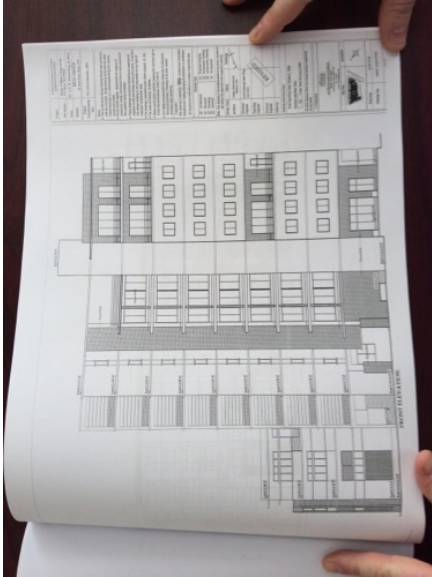
F-8	Fire Protection	The fire alarm system is antiquated, not a listed system, and does not provide alarm and notification features consistent with acceptable standards.	Replace the fire alarm system with a new, listed addressable fire alarm system in accordance with NFPA 72.	Design within 4 months, install within 9 months
F-9	Fire Protection	The high-rise building has an occupied floor greater than 23m (75 ft) and is not provided with automatic sprinkler protection. The large occupant loads, heavy fuel loading, and anticipated extended egress times warrant sprinkler protection.	Provide automatic sprinkler protection throughout the building in accordance with NFPA 13.	Design within 6 months, install within 12 months
		Height of highest occupied floor is 92' 6".

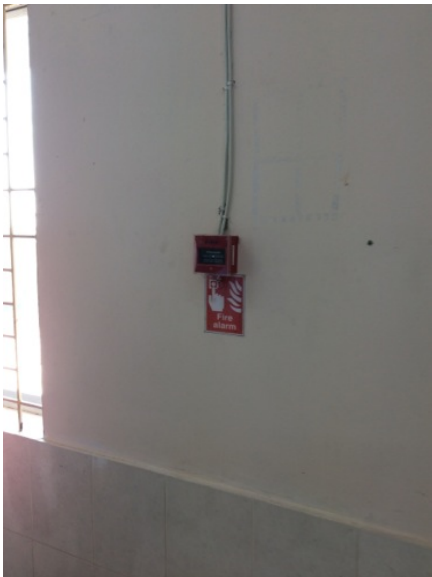
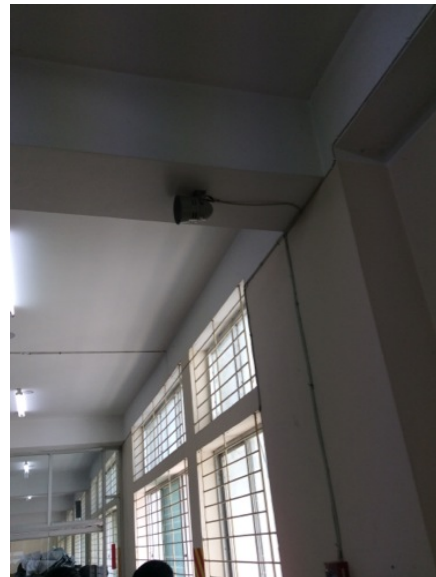
F-10	Fire Protection	Activation of the fire alarm system by a manual fire alarm station provides automatic occupant notification only on the floor of alarm and not throughout the building.	Configure the fire alarm system to initiate automatic occupant notification on all floor levels to facilitate whole-building evacuation upon any manual fire alarm station activation.	Within 1 months
------	-----------------	---	--	-----------------

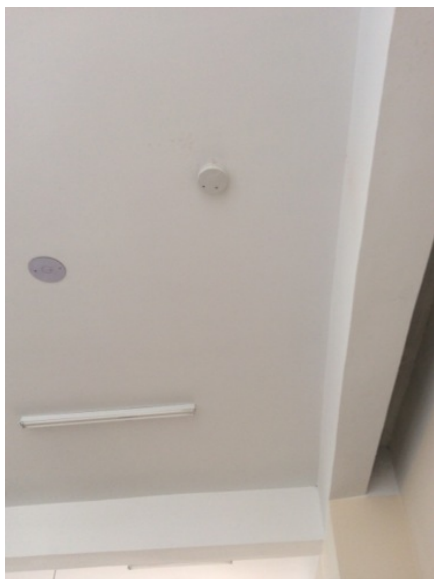
F-11	Fire Protection	Inspection, testing, and maintenance records for the fire alarm system were not available.	Inspect, test and maintain the fire alarm system, and keep written records on-site, in accordance with NFPA 72.	Within 3 months
F-12	Fire Protection	The building is equipped with single-station smoke alarms. Smoke alarm activation sounds only a local alarm and does not provide automatic fire alarm notification of occupants.	Replace the single-station smoke alarms with automatic smoke detectors tied into the fire alarm system. Configure the fire alarm system to initiate occupant notification upon activation of any two smoke detectors in addition to the manual fire alarm stations.	Within 6 months

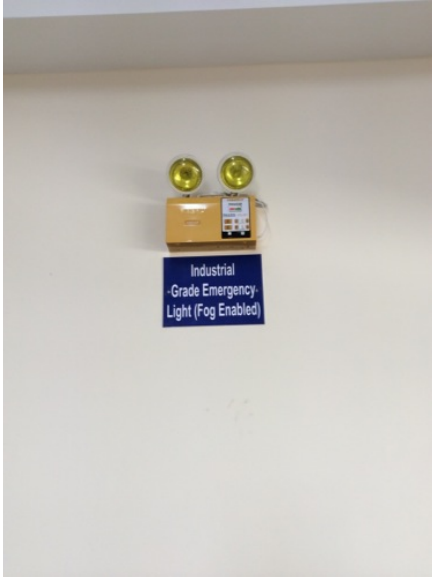
F-13	Egress Lighting	Emergency lighting did not function in test mode (burned out, broken, etc.).	Regularly test the emergency lighting system on each floor and replace/repair lights as needed.	Within 1 month
		Locations: All Locations were not working properly.
