FIRE SAFETY INSPECTION REPORT

**VISION GARMENTS LTD.
GARMENTS LTD.
B47, PURBO RAJASHAN, SAVAR**

ACCORD
on Fire and Building Safety in Bangladesh

June 1, 2014

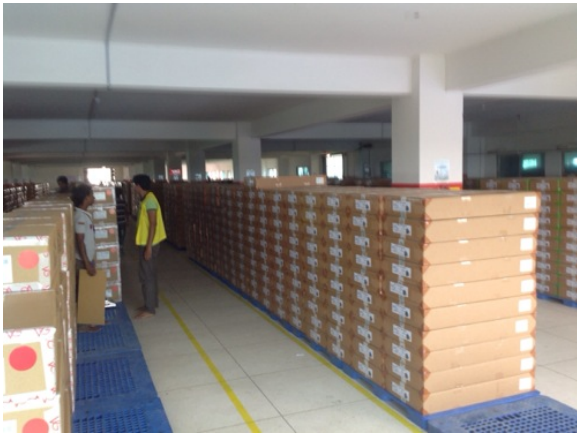
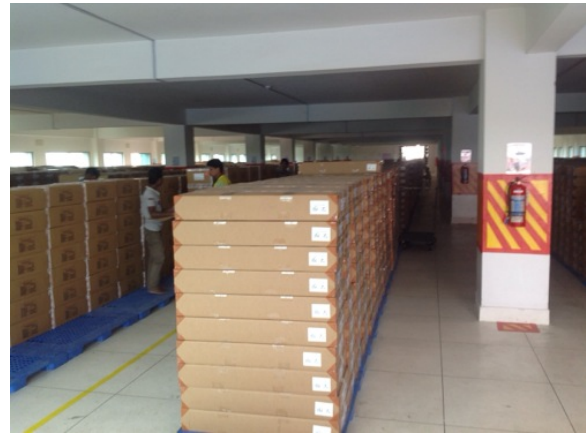
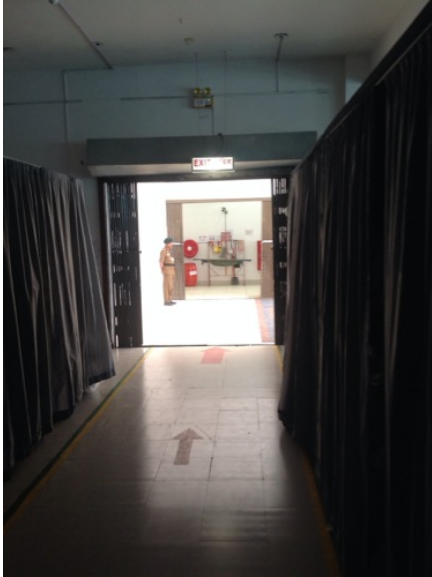
No.	Category	Finding	Recommendation	Remediation Timeframe
F-1	Fire Rated Construction	Areas used for storage on the ground, 8,6 and 5 floors are not separated by fire-rated construction.	Provide dedicated storage rooms separated by minimum 1-hr fire-rated construction.	Within 3 months

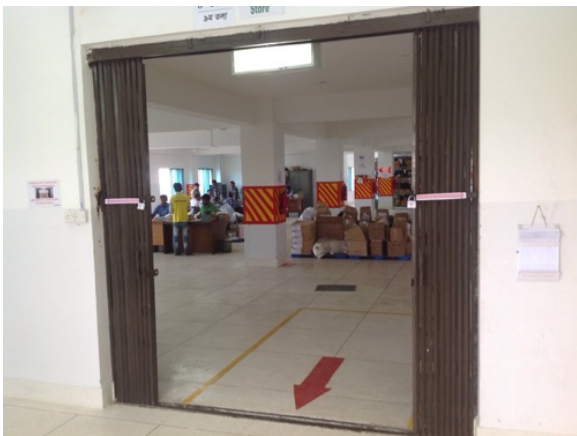
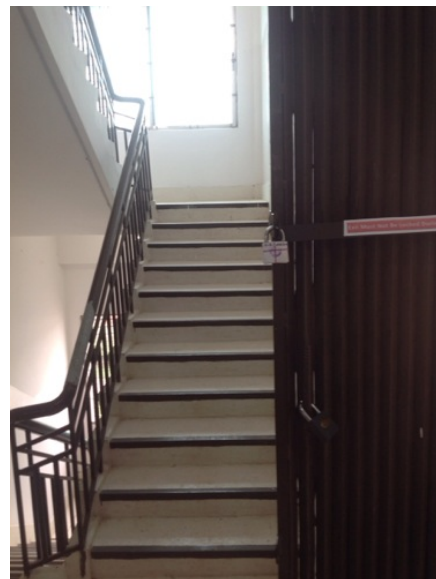
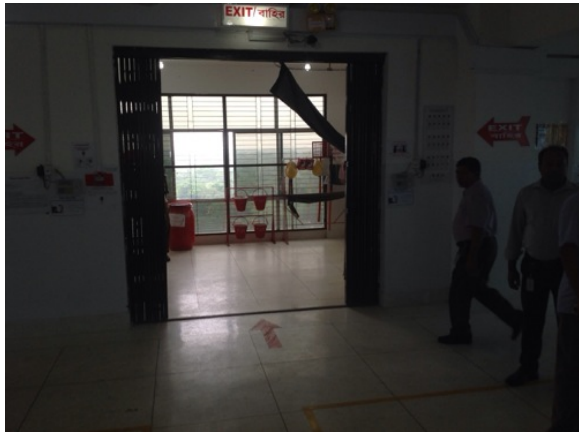
F-2	Fire Rated Construction	The exit stairs are not separated from work areas, other spaces on each floor by fire-rated construction. This applies to the north and east exit stairs.	Provide minimum 1.5-hr fire rated doors and seal all unprotected openings to separate the exit stairs from work areas and other building spaces on all floor levels. Ensure that the fire doors are self-closing and positive latching and that they are provided with fire exit (panic) hardware where serving production floors.	Within 3 months
-----	-------------------------	---	--	-----------------

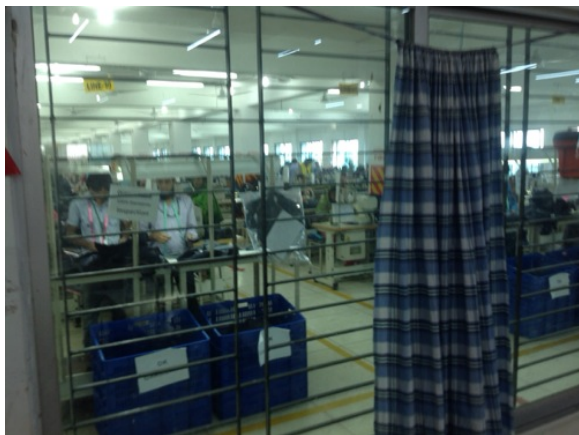
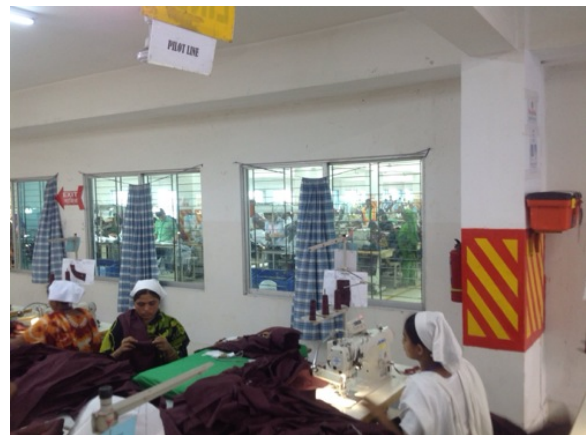
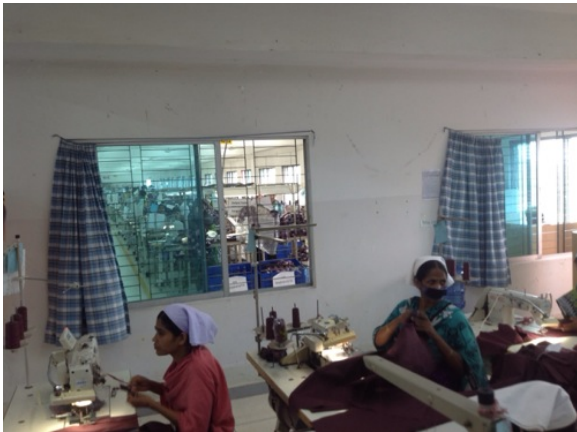
F-3	Fire Rated Construction	Unprotected openings in floors 5,4,3 and 2 east wall.	Seal openings with proper fire rated construction.	Within 6 months
-----	-------------------------	---	--	-----------------

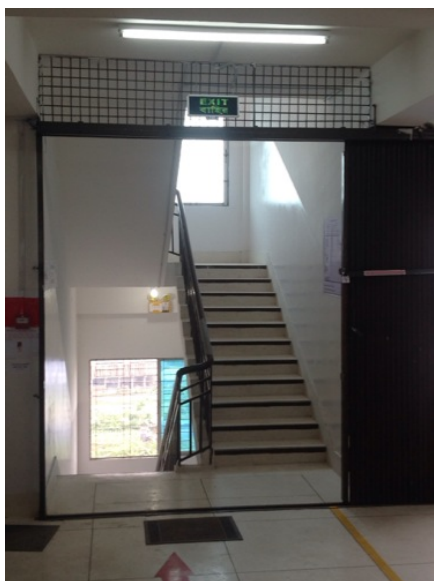
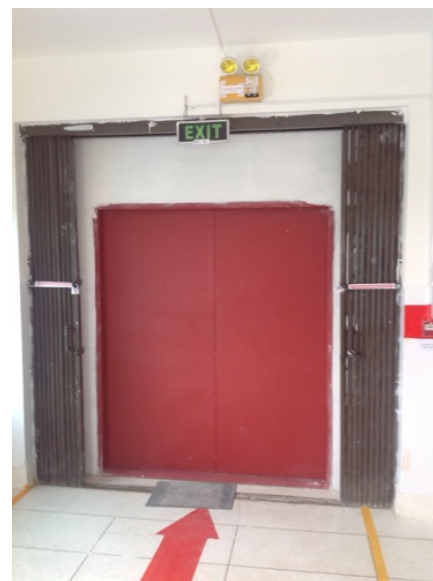
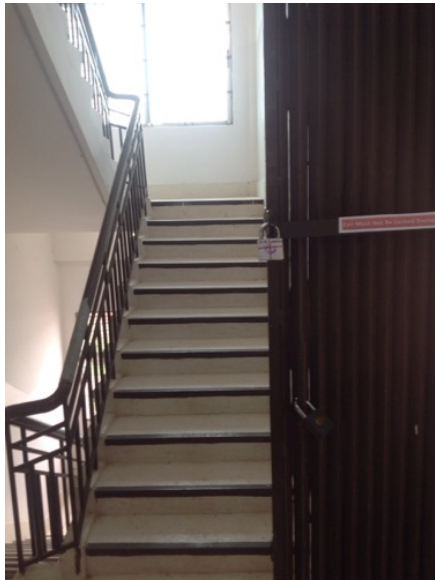
F-4 Egress

Egress doors / gates with locking features are provided at building exits, exit stairs, along egress routes, exit discharge.

These locking features can be found on all exits, on all floors throughout the factory.

Remove locking features from all egress doors / gates.

If locks are required for security reasons, utilize special door locking features complying with NFPA 101.

Immediate

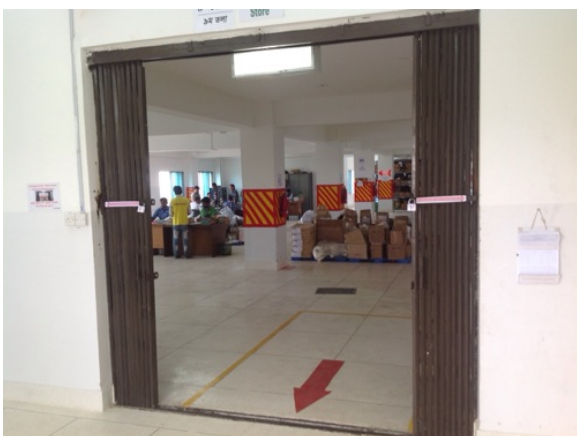
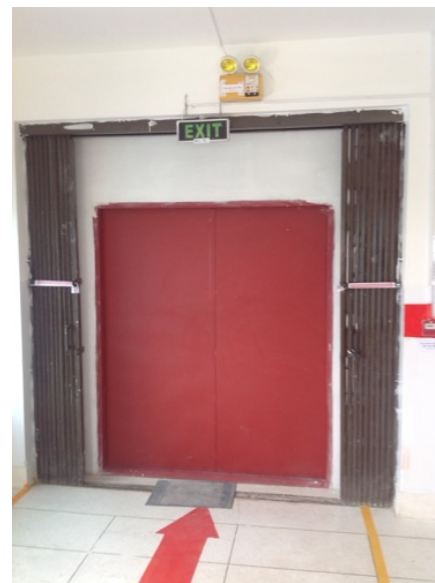
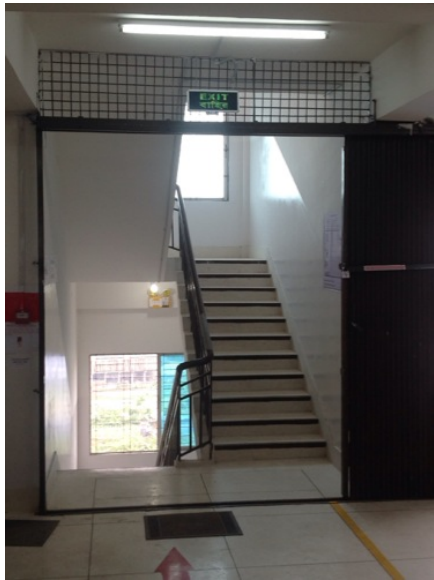
F-5 Egress

Collapsible gates are provided at building exits, exit stairs, along egress routes, exit discharge. These were at exit access on all floors for all four exit stairwells as well as all three exit discharges

Replace all gates / sliding doors along the means of egress with side-hinged, swinging egress doors.

Within 1 month

If locks are required for security reasons, utilize special door locking features complying with NFPA 101.

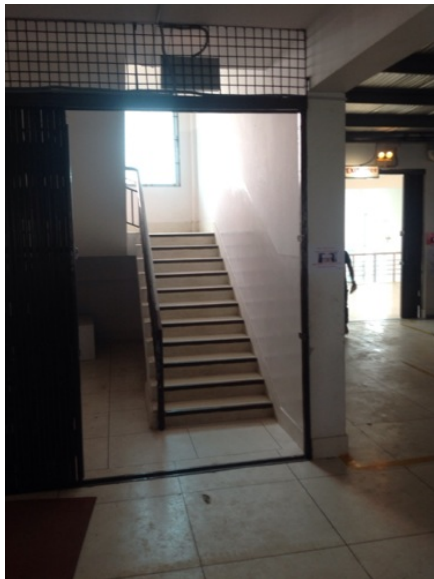
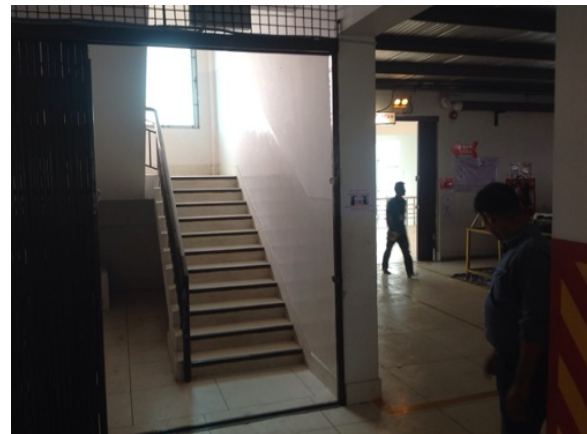
F-6	Egress	Exit stairs discharge inside the building. The east exit stairwell for floors 8 and 7 discharge onto the 6th floor.	Provide sprinkler protection for discharge floor in accordance with NFPA 13.	Within 12 Months
-----	--------	---	--	------------------

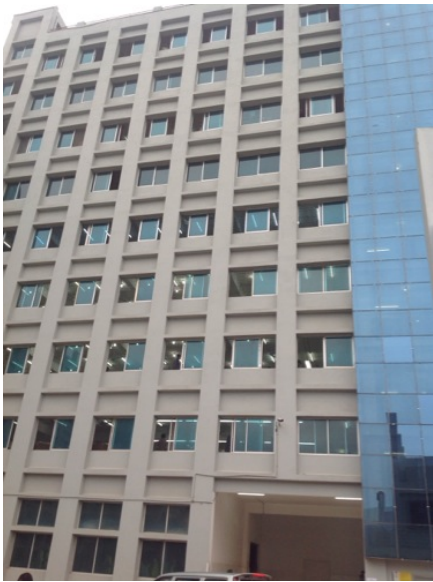
F-7	Fire Protection	The high-rise building has an occupied floor greater than 23m (75 ft) and is not provided with automatic sprinkler protection. The large occupant loads, heavy fuel loading, and anticipated extended egress times warrant sprinkler protection.	Provide automatic sprinkler protection throughout the building in accordance with NFPA 13.	Design within 6 months, install within 12 months
-----	-----------------	--	--	--
