INITIAL FIRE SAFETY INSPECTION REPORT

NAYEM KNITWEAR LTD - Extension (Previously UNION KNITTING AND DYEING LTD)

RSC ID: 25766

Date: 25-Sep-2024

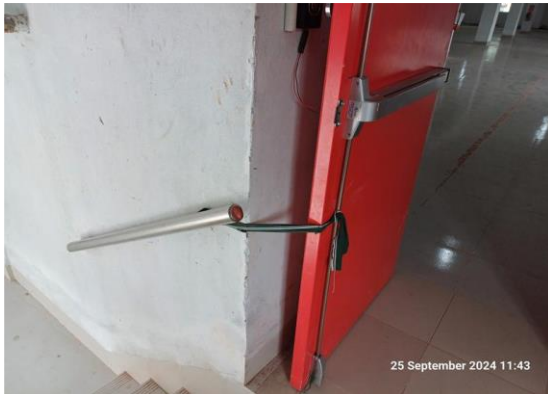
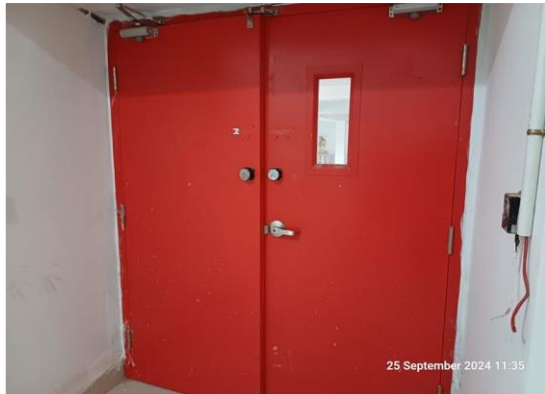
SI No.	Category	Findings	Required Action	Remediation Time Frame
1	Means of Egress	<p>The exit stairs are not separated from work areas and other spaces on each floor by fire-rated construction. During the inspection, it was noted that the fire doors were not effectively latching and door co-ordinator were not properly functional.</p> <p>Location: Factroy Building (New) and Dining Building</p>	<p>Stair shall be enclosed with a minimum 1-hr fire-rated construction. Seal all unprotected openings and provide minimum 1-hr fire rated doors to separate the exit stairs from work areas and other building spaces on all floor levels. Ensure that the fire doors are self-closing, positive latching and that they are provided with fire exit (panic) hardware where serving production floors.</p> <p>Openings from exit enclosure to storage areas shall be provided with a vestibule with fire rated construction and openings. Ensure that the fire rating of the vestibule construction matches that of the exit stair enclosure.</p> <p>Penetrations into and through an exit enclosure shall be prohibited with the exception of required exit doors, sprinkler piping, standpipes, electrical raceway for fire alarm equipment, and electrical conduit serving the exit enclosure.</p> <p>If fire doors are required to be held open for functional reasons, provide automatic-closing devices tied to the fire alarm system.</p>	Within 3 months

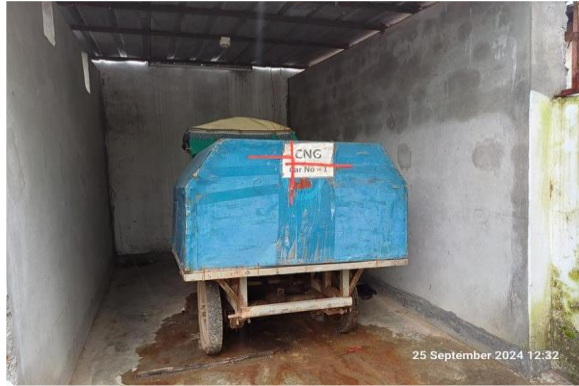
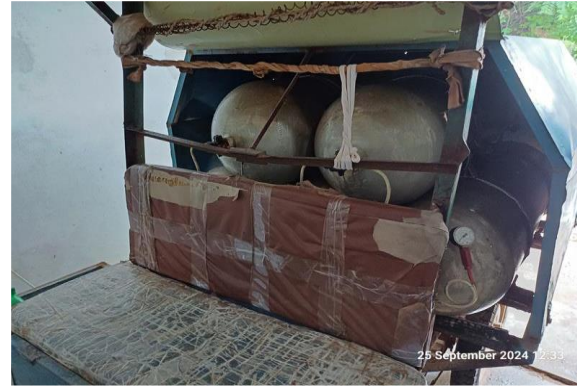
2	Fire Rated Construction	<p>Liquefied or compressed gas cylinder is used within the factory premises. Location: Beside Boiler & Compressor Building</p>	<p>LPG/CNG cylinders are permitted to be stored in a separate dedicated building on the factory premises within its boundaries if the building meets the following conditions:</p> <ol style="list-style-type: none"> 1. The storage building must be at least 3 meters away from any other building and boundaries. 2. The exterior walls of the building must have a fire resistance rating of 3 hours using noncombustible construction. 3. Doors and other openings in the exterior walls must be protected with suitable closing devices having a fire protection rating of 3 hours. 4. The building is to be used for no other purpose than the storage of LPG/CNG cylinders. 5. The building must be mechanically ventilated to control the accumulation of flammable vapors. 6. The installations must be approved and accepted by the requirements of the AHJ, Gas supply company regulations, manufacturers/supplier's instructions/guidance, Chief Inspector of Boiler (CIOB) and Chief Inspector of Explosives Bangladesh (CIEB). 	Within 3 months

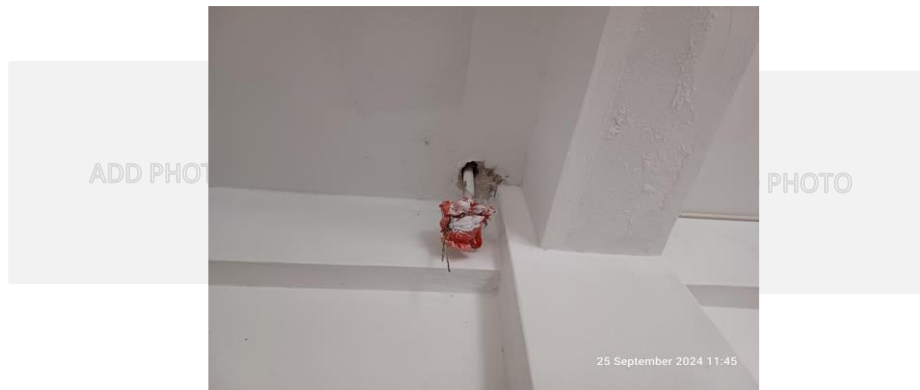
3	Fire Rated Construction	<p>Unsealed penetration is located in the fire-rated ceiling. Location: Factroy Building (New)</p>	<p>Penetrations of fire resistive rated assemblies shall be protected with listed through penetration fire stop system, Tested in Accordance with ASTM E814 and RSC standard 4.7.</p>	Within 3 months
---	-------------------------	--	---	-----------------

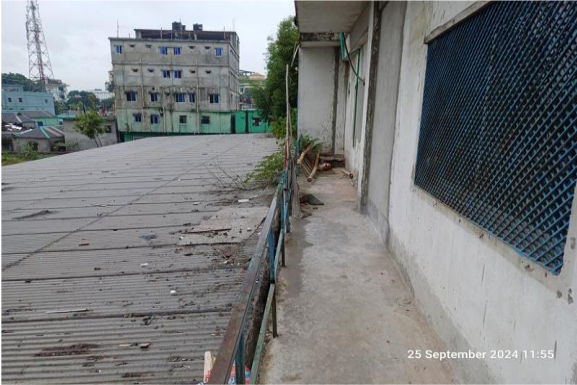
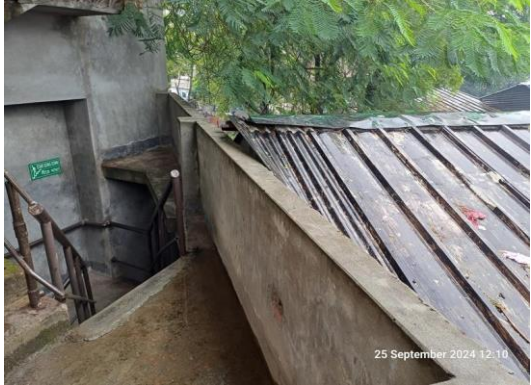
4	Fire Rated Construction	The exterior walls do not have fire resistance and opening protection as specified in BNBC 2006, Tables 3.2.2 and 3.2.3. Location: Factroy Building (New) and Dining Building	The exterior walls shall have a fire resistance and opening protection as specified in BNBC 2006, Tables 3.2.2 and 3.2.3.	Within 4 months
<div style="display: flex; justify-content: space-around;">

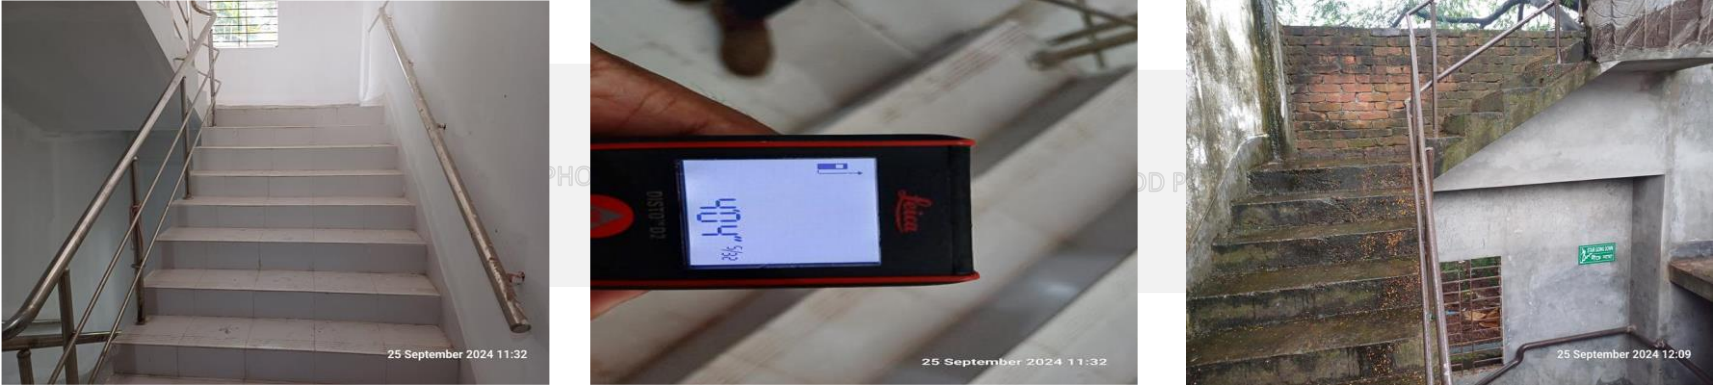
5	Means of Egress	<p>The stairs have a width less than the required minimum width. Location: Factroy Building (New) and Dining Building</p>	<p>Stairs shall have a minimum width of 1.5 m (60 in.) for all industrial occupancies and 2.0 m (79 in.) for all assembly occupancies.</p>	<p>Within 3 months</p>

<p>The first photograph shows a narrow staircase with a metal handrail. The second photograph shows a digital depth gauge held against a surface, with the screen displaying '407' and '885'. The third photograph shows an outdoor staircase with a metal handrail and a green exit sign on the wall.</p>

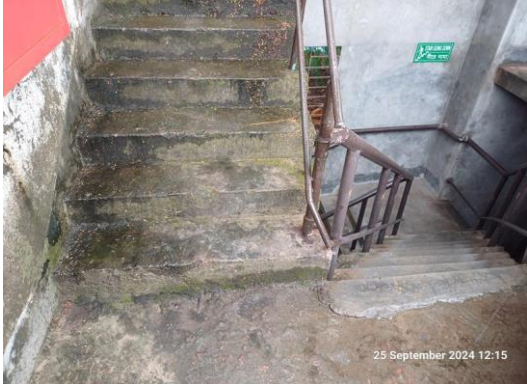
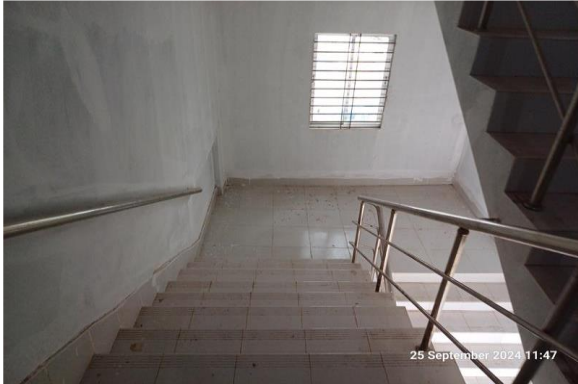
6	Means of Egress	<p>Handrails have a height of less than 865 mm (34 in.) when measured vertically from the leading edge of the tread. Location: Factroy Building (New) and Dining Building</p>	<p>Handrails shall have a minimum height of 865 mm (34 in.) and a maximum height of 965 mm (38 in.) as measured from the leading edge of the tread.</p>	Within 3 months
<div style="display: flex; justify-content: space-around;">

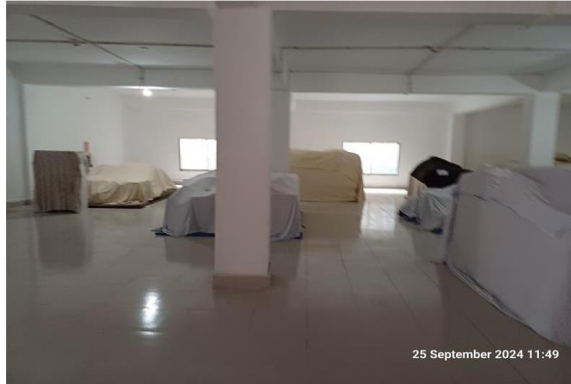
7	Means of Egress	The egress aisles are not marked. Location: Factroy Building (New)	Aisles shall be provided with a minimum unobstructed clear-width of 0.9 m (36 in.).	Within 3 months
---	-----------------	---	---	-----------------

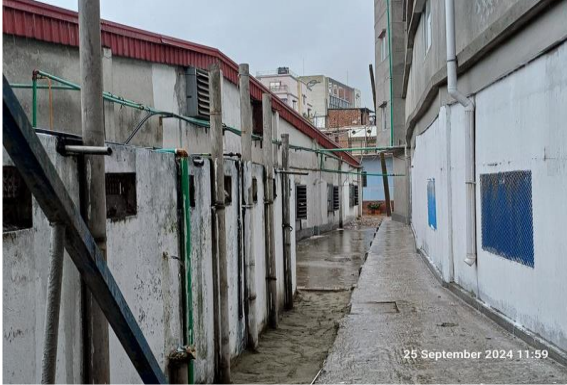
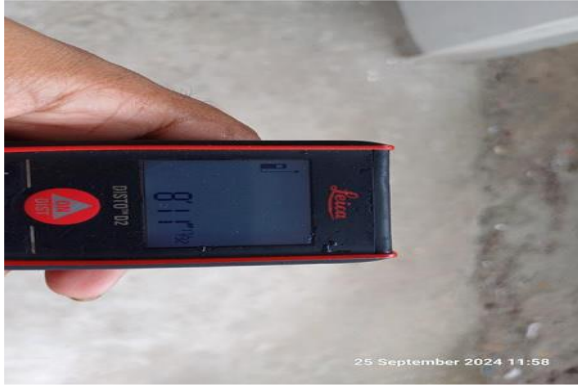
10	Means of Egress	<p>The exit discharge path [South Stair] is less than 10 ft wide and is not separated from the building interior.</p> <p>Location: Factroy Building (New)</p>	<p>Seal all penetrations and openings to the interior of the building along the discharge path, up to a height of 10 ft. to provide a minimum 1-hr fire separation.</p> <p>Alternatively, provide a second remote discharge path to the public way.</p>	Within 03 months
<div style="display: flex; justify-content: space-around;">

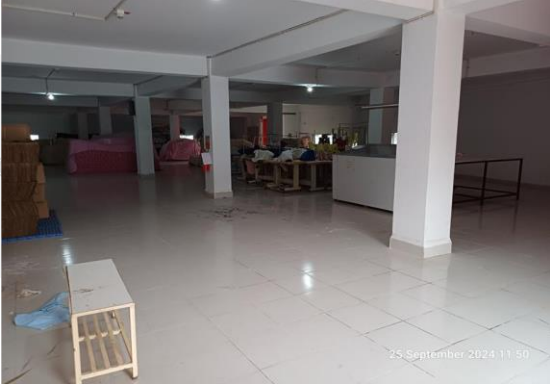
12	Means of Egress	<p>Based on the number and location of emergency lights observed, adequate illumination levels are not anticipated along egress routes. Location: Factory Building (New)</p>	<p>Test the emergency lighting system on each floor and provide additional emergency fixtures to provide adequate illumination along the means of egress. Provide a minimum illumination of 10 lux at the floor level within exit stairs and exit discharge paths and minimum 2.5 lux along exit access aisles.</p>	Within 3 months
<div style="text-align: center;">

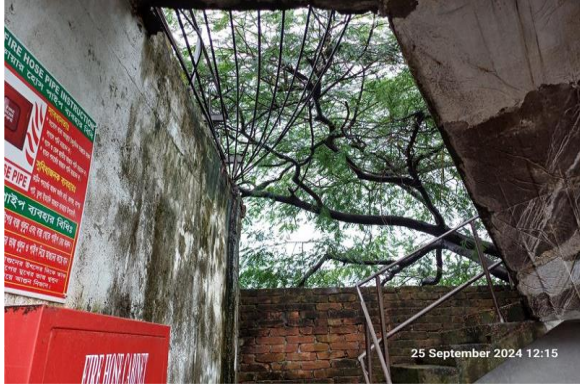
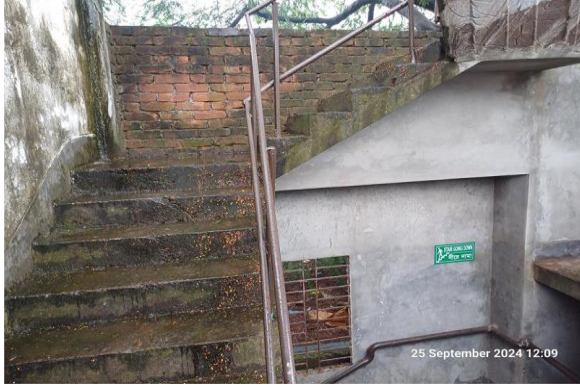
15	Means of Egress	<p>The exit stairs are not covered by a roof, leaving the top floor of the stairwell exposed to the sky. This exposure to rainwater can create slipping hazards on the stairs. Location: Dining Building</p>	<p>Walking surfaces in the means of egress shall be slip resistant under foreseeable conditions. Enclose the roof at the top of the exit stairs to prevent rainwater from making the stairs slippery.</p>	Within 1 month

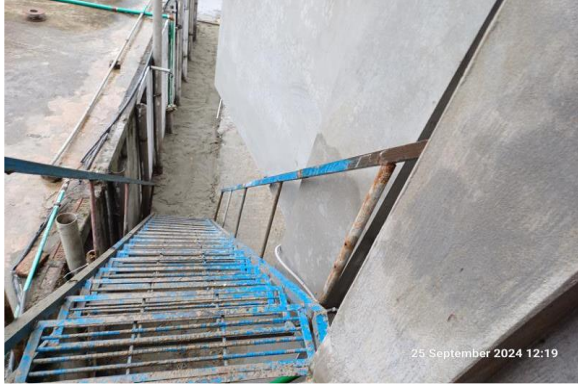
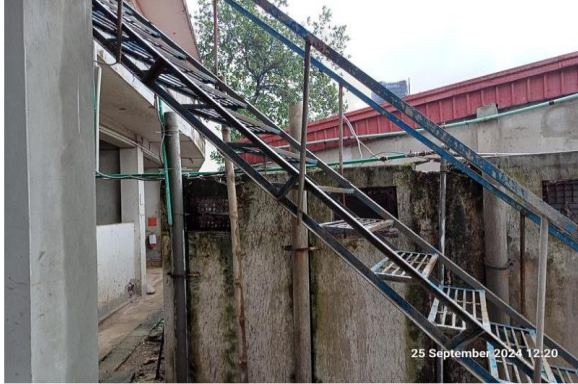
16	Means of Egress	<p>The number of risers per flight in a straight flight stair was found 18. Location: Dining Building</p>	<p>The maximum number of risers per flight in a straight flight stair shall be 15. Also, ensure that the construction of the stairs complies with BNBC 2006, Part 3, Section 1.12.5.</p>	Within 3 months
<div style="display: flex; justify-content: space-around;">

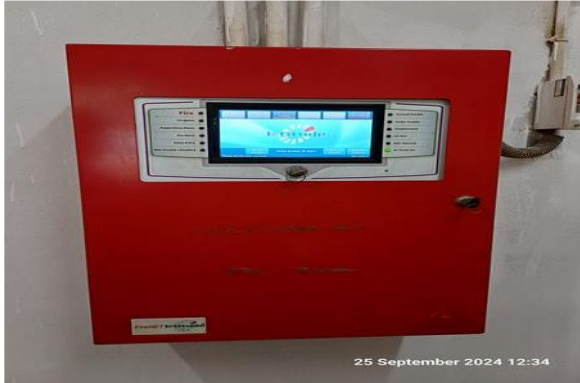
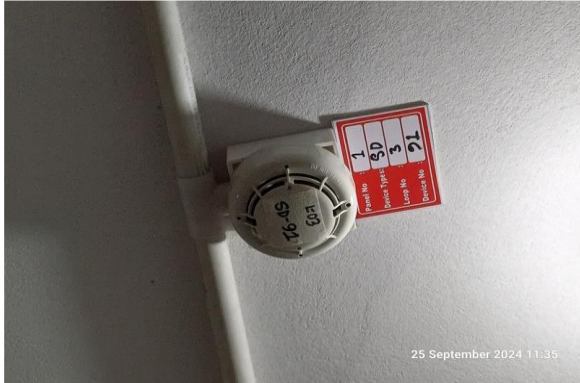
17	Fire Alarm & Detection System (FADS)	The fire alarm and detection system installation requires detailed review to confirm compliance with NFPA 72 and RSC standard. All Buildings	Submit as-built drawings, testing records, equipment certification and other relevant documentation to the RSC for review and approval/acceptance test.	Design within 02 months, installation/modification on within 04 months
<div style="display: flex; justify-content: space-around;">
