INITIAL FIRE SAFETY INSPECTION REPORT

Jin Hong Garments Ltd.

RSC ID: 25943

Date: 22-Oct-2024

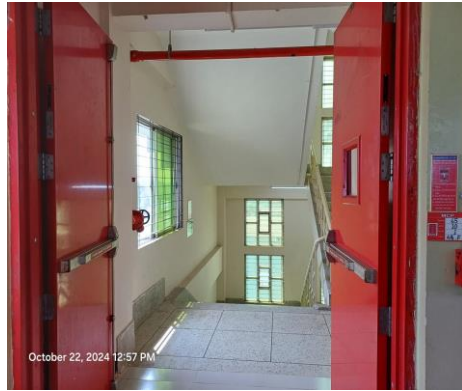
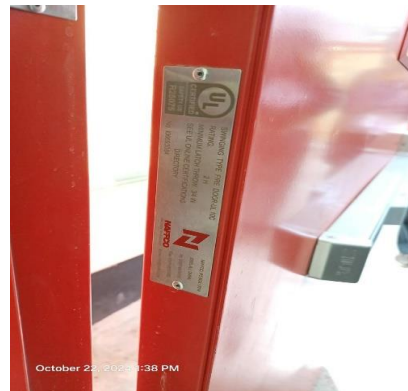
SI No.	Category	Findings	Required Action	Remediation Time Frame
F-1	Means of Egress	<p>The factory has installed fire rated doors for exit stair separation on all floors for all stairs. The datasheets & certificates of installed fire-rated doors will be verified during the next inspection.</p> <p>Location: Building-1: Production Building.</p>	<p>The factory shall provide datasheets and certificates of installed fire rated doors and their accessories to verify during the next inspection.</p> <p>If fire rated doors are required to be held open for functional reasons, provide automatic closing devices tied to the fire alarm system.</p>	Within 3 months

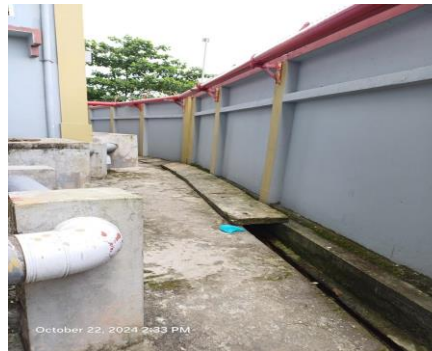
F-2	Means of Egress	<p>Uneven walking surface were found from exit discharge of Stair-4 and are not protected from slip or tripling hazard.</p> <p>Location: Building-1_North Side_Stiar-4</p>	<p>Provide an even level walking surface in exit discharge in accordance with 6.3.4 of RSC Technical Guidelines (Standard_V1.0)</p>	<p>Within 3 months</p>
-----	-----------------	---	---	------------------------

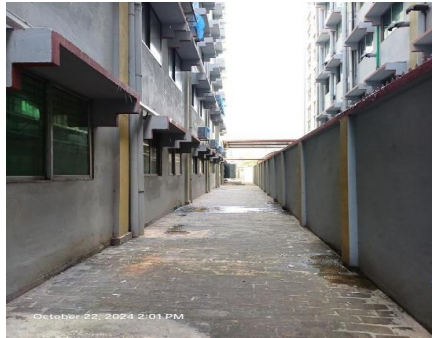
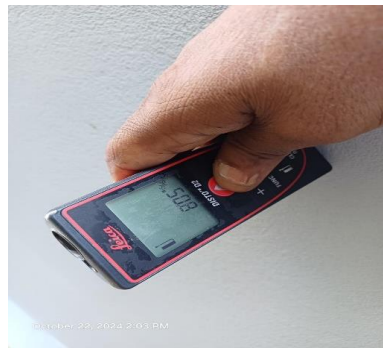
F-3	Means of egress	<p>West side exit discharge path has been found less than 10 feet and not protected from the building interior.</p> <p>Location: Building-1_West Side_Stair-2 & Stair-3</p>	<p>Seal all penetrations and openings to the interior of the building along the discharge path, up to a height of 10 ft. to provide a minimum 1-hr fire separation.</p>	Within 3 months
-----	-----------------	--	---	-----------------

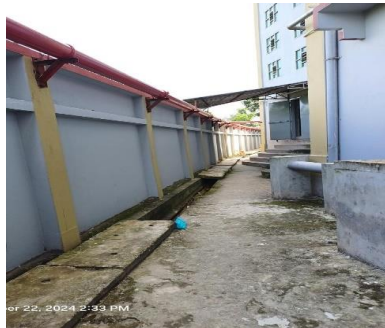
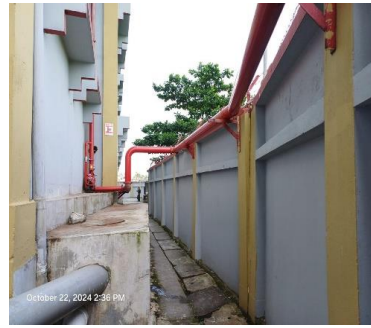
F-4	Means of egress	<p>Inadequate egress width has been found in the exit discharge path at stair-4 of the production building.</p> <p>Location: Building-1_Stair-4</p>	<p>The path of egress travel along a means of egress shall not be interrupted by any obstruction. The capacity of the means of egress shall not be reduced along the path of travel as per RSC Technical Guideline 6.5.2</p>	Within 3 months
-----	-----------------	--	--	-----------------

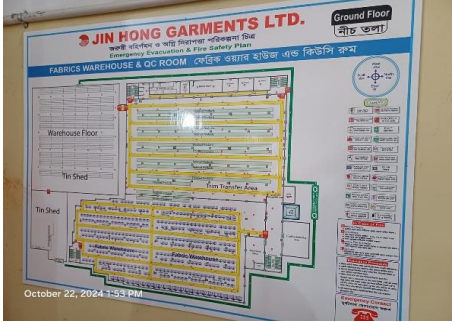
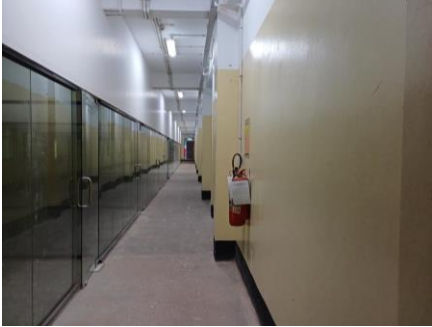
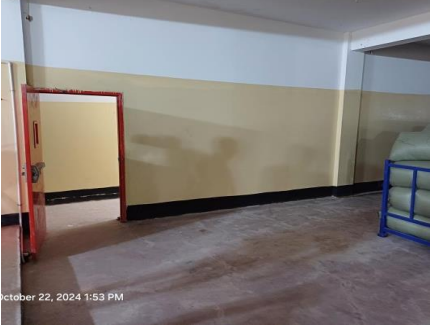
F-5	Means of Egress	<p>Secondary exit route of office room has been found through hazardous area (storage) on Ground floor.</p> <p>Location: Building-1_Ground floor.</p>	<p>Emergency egress route shall never be designed through any hazardous area. Firstly, verify the feasibility of single exit criteria following RSC Standard-6.6.2, if that fails then re-route the egress route avoiding hazardous area as store, utility etc.</p>	Within 3 months
<div style="display: flex; justify-content: space-around;">

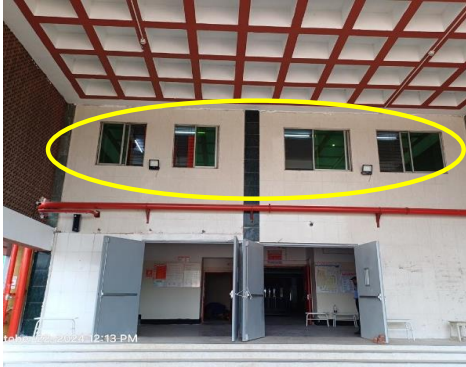
F-6	Means of Egress	<p>Unsealed penetration/opening has been found in exit discharge path of egress court.</p> <p>Location: Building-1_North Side</p>	<p>An egress court serving as a portion of the exit discharge shall be open to the sky or provided with a fire resistance rated enclosure the same as the exit enclosure. Egress courts less than 3050 mm (10 ft) in width (as measured from the building and the adjacent property line) shall be provided with walls having a 1-hr fire resistance rated construction for a distance of 3050 mm (10 ft) above the floor of the court</p>	Within 3 months

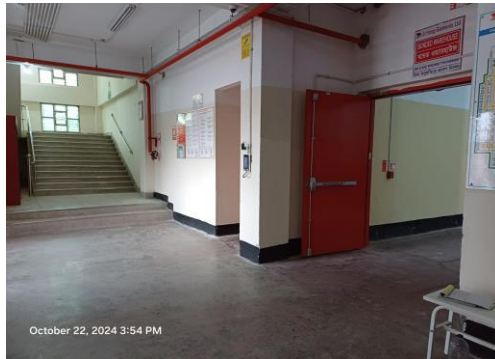
F-7	Means of Egress	<p>Storage room discharges directly into the exit stair enclosure.</p> <p>Location: Building-1_Ground Floor.</p>	<p>Openings from exit enclosure to storage spaces shall be provided with a vestibule with fire rated construction and openings. Provide a 1.5-hr. fire rated door on the exit stair side and a 1-hr. fire rated door on the storage room side as per 6.14.3-RSC Technical Guidelines Standard V1.0.</p> <p>Ensure that the fire rating of the vestibule construction matches that of the exit stair enclosure.</p>	Within 3 months
-----	-----------------	---	--	-----------------

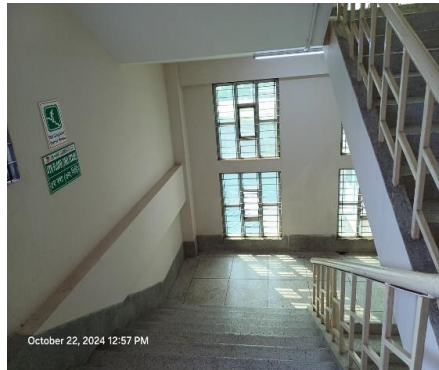
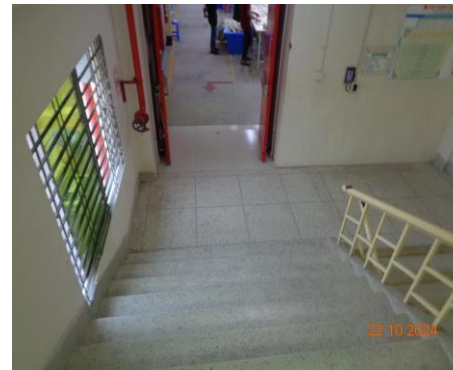
F-9	Means of Egress	<p>Handrails were not provided on both sides of the exit stairs.</p> <p>Location: Building-1.</p>	<p>Provide handrails on both sides of the exit stair. Intermediate handrails shall be provided when the stair width exceeds 2.2 m (87 in.). Existing handrails that are less than 760 mm (30 in.) or greater than 1100 mm (44 in.) as measured from the leading edge of the tread, shall be replaced with handrails meeting the RSC requirements of 6.12.1.1</p>	Within 3 months
-----	-----------------	--	--	-----------------

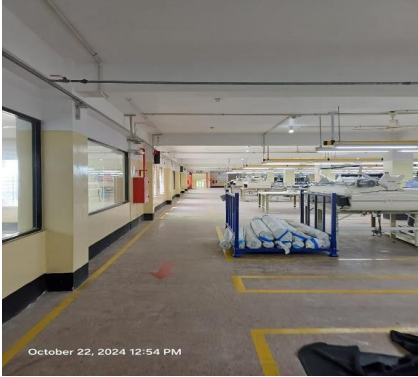
F-10	Means of Egress	<p>Directional Exit signage was not provided along the path of egress where there is a change in the direction for the path of travel and the direction to an exit is not obvious.</p> <p>Location: Building-1, Shed-1</p>	<p>Provide directional exit signs above all building exits to the exterior, all doors to the exit stairs and along all paths of travel where a change of direction is not obvious. Lighted directional signs shall be provided with either battery backup or uninterruptable power supply systems and shall be continuously illuminated.</p>	Within 1 month

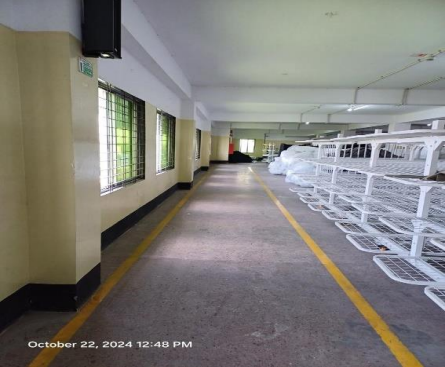
F-11	Egress Lighting	<p>Based on the number and location of emergency lights observed, adequate illumination levels are not anticipated along egress routes.</p> <p>Location: Building-1</p>	<p>Test the emergency lighting system on each floor and provide additional emergency fixtures to provide adequate illumination along the means of egress. Provide a minimum illumination of 10 lux at the floor level within exit stairs and exit discharge paths and minimum 2.5 lux along exit access aisles.</p>	Within 3 months

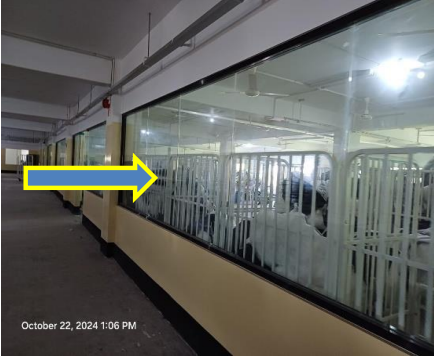
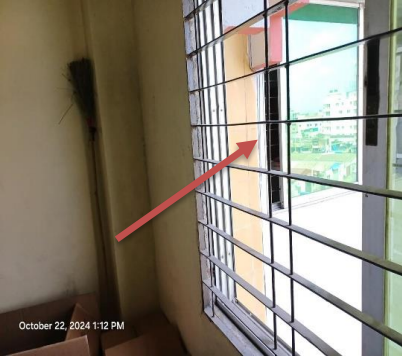
F-12	Fire Rated Construction	<p>Room used for combustible storage has not been separated properly by fire rated construction from production and office area of the building.</p> <p>Location: Building-1_Ground, 2nd-5th floor.</p>	<p>Separate the dedicated storage rooms by minimum 1-hr fire-rated construction. Provide 0.75 hr. fire rated door and seal all penetrations and openings by 0.75 hr. (45 Minutes) fire rated fire rated barrier construction.</p>	Within 3 months
<div style="display: flex; justify-content: space-around;">

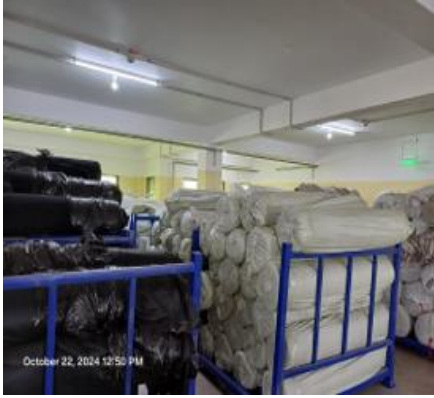
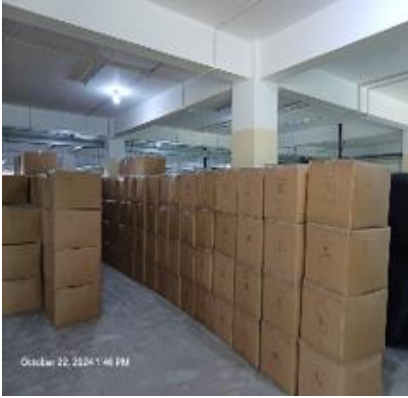
</div>				
F-13	Fire Rated Construction	<p>Areas used for combustible storage open to the factory are not separated by fire rated construction.</p> <p>Location: Building-1_1st & 5th Floor.</p>	<p>Separate the dedicated storage rooms by minimum 1-hr fire-rated construction. Provide 0.75 hr. fire rated door and seal all penetrations and openings by 1 hr. fire rated fire rated barrier construction.</p> <p>Where separate storage rooms are not feasible, provide defined storage areas and limit the storage arrangement as follows: - Maximum height of 2.45m (8ft.) , maximum area of 23m2 (250 ft2) and 3m (10ft.) clear distance from adjacent another unenclosed combustible storage. - If the building/floor is sprinkler protected: maximum height of 3.66m (12ft.) and maximum area of 93m2 (1000 ft2) and 3m (10ft.) clear distance from adjacent another unenclosed combustible storage.</p>	Within 3 months

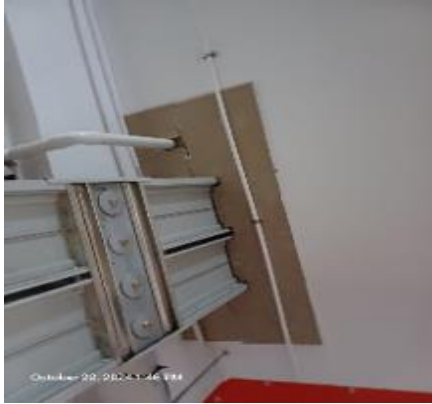
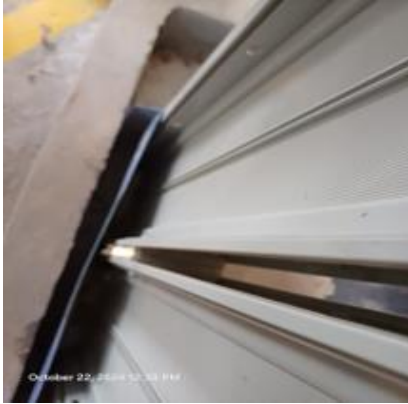
F-14	Fire Rated Construction	<p>Unsealed penetrations and openings has been found due to Bass Bar are located in the fire rated floor/ceiling assemblies</p> <p>Location: Building-1.</p>	<p>Provide a minimum 2-hr fire-rated shaft to separate the bass bar from each floor level</p> <p>or</p> <p>seal all penetrations and openings in floors/ceiling assemblies by 3-hr fire rated listed/certified materials. The installation of such fire-rated materials shall be following certified design. Factory shall ensure that, all the design, datasheet, certificate, and proposed drawing of installation has been reviewed from the RSC prior to install the passive fire protection system (If required).</p>	Within 3 months

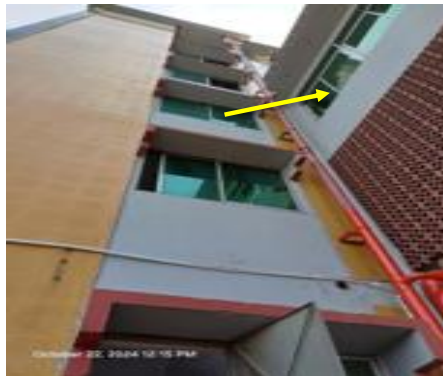
F-15	Means of Egress	<p>The exit stairs are not separated from [work areas, other spaces] on each floor by fire rated construction due to unsealed opening and penetration has been observed within 10 feet in the exit stair enclosure.</p> <p>Location: Building-1_North Side.</p>	<p>The exit stair enclosure shall be provided with a minimum 1-hr fire resistance rating for buildings with 3 or fewer stories and a minimum of 2- hr. fire resistance rating for buildings 4 or more stories. Provide 0.75 hr. fire rated door and seal all penetrations and openings by 1 hr. fire rated fire rated barrier construction for building with 3 or fewer stories. Provide 1.5 hr. fire rated door and seal all penetrations and openings by 2 hr. fire rated fire rated barrier construction for building with 4 or more stories.</p> <p>Provide a fire-resistive rated assembly between the exterior exit stairs and the building up to 10 ft. beyond the end of the stair to achieve the required separation. The rated assembly shall be approved and/or designed by a qualified fire protection engineer.</p> <p>Ensure that the fire doors are self-closing and positive latching and that they are provided with fire exit (panic) hardware where serving production floors. If fire doors are required to be held open for functional reasons, provide automatic closing devices tied to the fire alarm system.</p>	Within 3 months

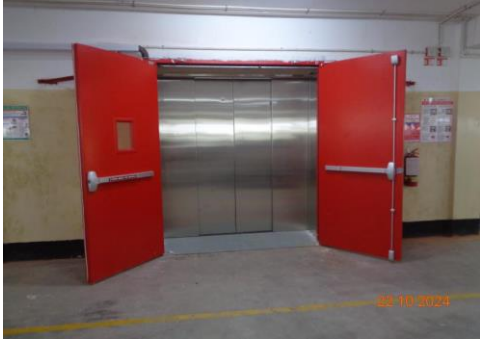
F-16	Fire Rated Construction	<p>The factory has installed fire rated doors for elevator/lift open in factory floor on 1st to 5th floors. The datasheets & certificates of installed fire-rated doors will be verified during the next inspection.</p> <p>Location: Building-1: Production Building.</p>	<p>The factory shall provide datasheets and certificates of installed fire rated doors and their accessories to verify during the next inspection.</p> <p>If fire rated doors are required to be held open for functional reasons, provide automatic closing devices tied to the fire alarm system.</p>	Within 3 months

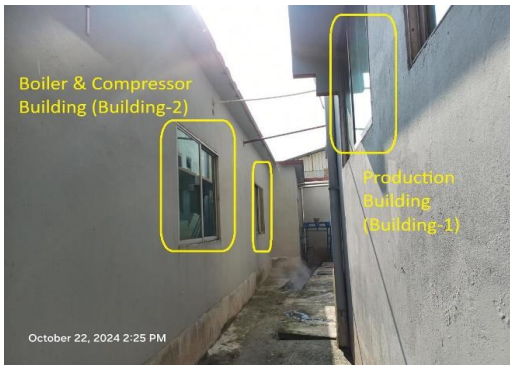
F-18	Fire Rated Construction	<p>The boiler and compressor building (Building-2) has not been separated by fire rated construction. Unprotected opening has been found within 10 feet from the Production Building (Building-1).</p> <p>Location: Building-2.</p>	<p>Separate the boiler and compressor rooms by a minimum 1-hr fire-rated construction for non-high rise, and 2-hr fire rated construction for high rise. Seal and/or protect all openings to maintain the required fire separations. When located to the exterior of a building 3m (10 ft.) spatial distance shall be maintained around the boiler/compressor. Ensure proper ventilation for the boiler/compressor room.</p>	Within 3 months
------	-------------------------	--	--	-----------------

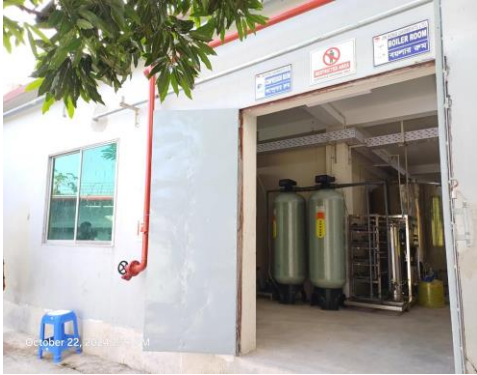
F-19	Means of Egress	<p>Single exit has been provided in the Boiler & Compressor Building (Building-2) where travel distance has been found more than 75 feet.</p> <p>Location: Building-2.</p>	<p>The number of means of egress from any floor, story or portion thereof shall not be less than 2 except where a single exit is permitted by 6.6.2, a single means of egress is permitted by 6.6.5 or where a greater number is required by 6.6.3 of RSC Technical Guidelines Standard.</p> <p>Provide Additional exit in the Boiler & Compressor Building.</p>	Within 3 months

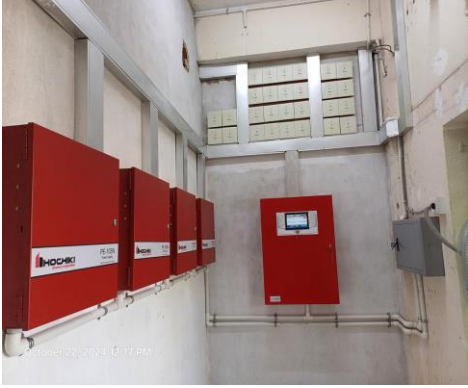
F-21	Fire Alarm & Detection System (FADS)	Automatic fire alarm & detection system installation requires detailed review to confirm compliance with NFPA 72 and RSC standards.	Design & Installation of Fire Alarm & Detection system shall be in accordance with RSC standard and NFPA 72. Submit as-built design, documents and calculations to RSC for review prior installation/modification. After installation/modification, the owner shall contact the RSC for witness of conducting the final acceptance testing of the fire detection & alarm system installation. Also inspect, test and maintain the fire alarm system, and keep written records on-site, in accordance with NFPA 72.	Design Review within 2 months and installation within 4 months.

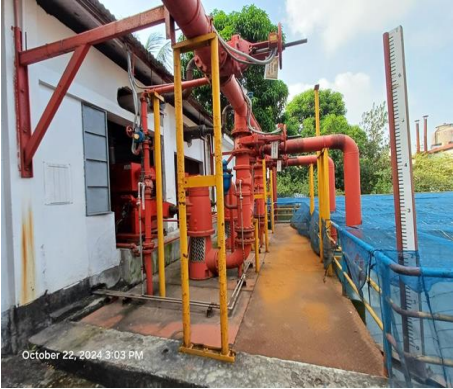
F-23	Fire Protection System(Standpipe System)	The existing building has an occupied floor greater than 10 meter (33 feet), therefore, standpipe system is required. Installation requires detailed review to confirm compliance with NFPA 14 and RSC standards.	Submit the standpipe system drawing to RSC for review. Once the design is reviewed, install and modify the standpipe system throughout the building in accordance with review comment, RSC Standard and NFPA 14, 20, 22 and 24. After installation the owner shall conduct internal testing and commissioning and then contact the RSC for witness of final acceptance testing.	Design Review within 2 months and installation within 4 months.
