INITIAL FIRE SAFETY INSPECTION REPORT

APPARELS JB21 LTD.

RSC ID: 25953

Date: 31-Oct-2024

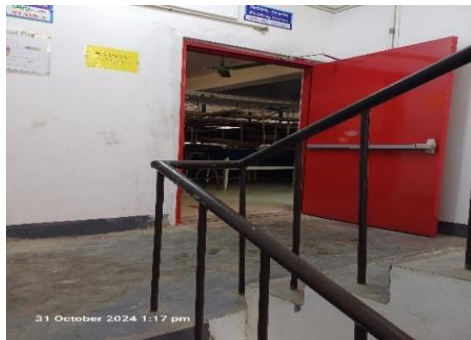
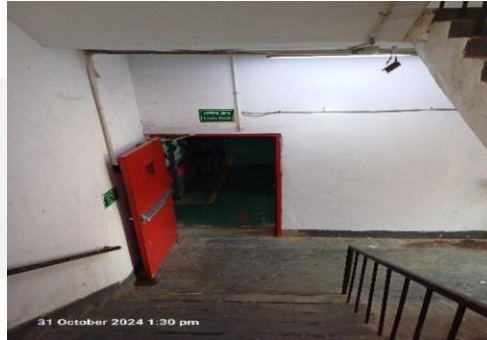
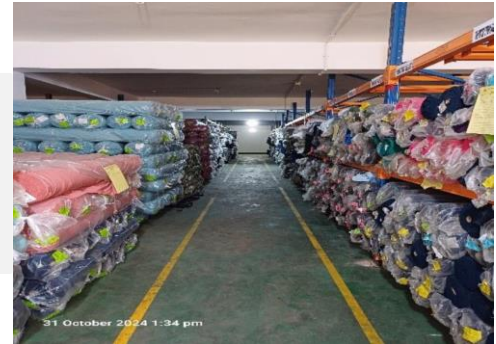
F-02	Fire Rated Construction	Storage room/areas discharges directly into the exit stair enclosure at ground floor and 1st floor Location: main Building	<p>Openings from exit enclosure to storage room, generator and transformer spaces shall be provided with a vestibule with fire rated construction and openings.</p> <p>The minimum width of a vestibule shall not be less than 1.1 m nor less than the width of the corridor leading to the vestibule. The minimum length of a vestibule in the direction of escape travel shall be 1.8 m.</p>	Within 3 months
------	-------------------------	--	--	-----------------

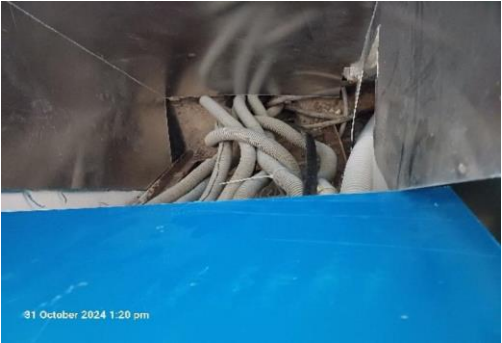
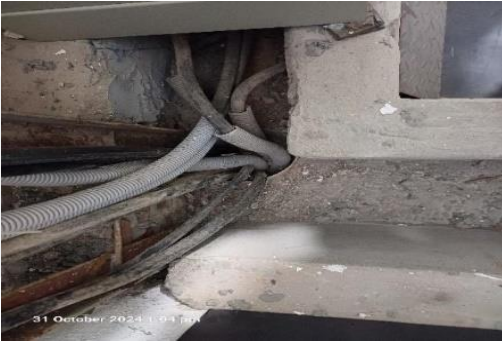
F-03	Fire Rated Construction	Penetrations through floor/ceiling assemblies due to electric cable are found unsealed. Location: Main Building	<p>Seal all penetrations and openings in floor/ceiling assemblies by a listed through-penetration fire stop system tested in accordance with ASTM E814 or approved alternative standard to maintain minimum 3-hr. fire resistance rating. Installation shall be as per manufacturer published installation guideline and the certification authority's design criteria to ensure the required fire-rating.</p> <p>or,</p> <p>Provide a minimum 2-hr fire rated shaft to separate the penetration from each floor if required.</p> <p>or,</p> <p>If the aggregate area for busbar penetration through the floor/wall does not exceed 144 in², the factory can seal the busbar penetration using concrete, grout, or mortar installed to the full thickness of the floor/wall to maintain the fire-resistance rating.</p>	Within 3 months

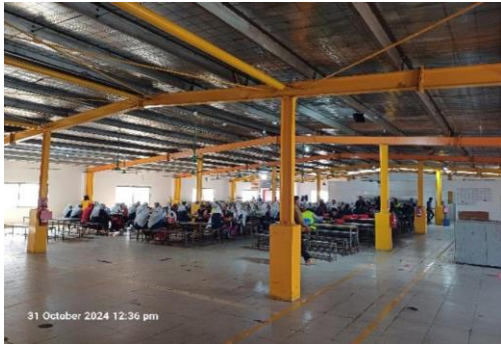
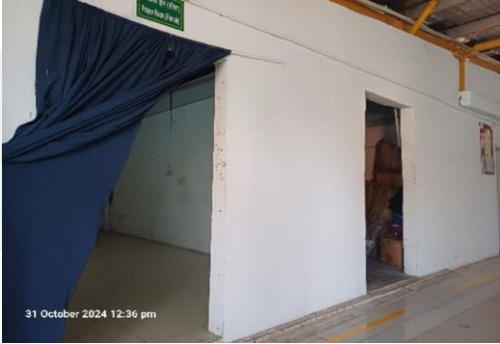
F-04	Fire Rated Construction	<p>Combustible storage was not separated from the Dining capacity at 4th for (reported more than 300 occupant) and the female prayer room with fire-rated construction.</p>	<p>To classify the occupancy as E4, it's necessary to limit the occupant load to 300 or below.</p> <p>Afterward, ensure a three-hour fire separation from other occupancies or remove the storage from the dining.</p> <p>Openings within such fire barriers shall be protected by opening protectives having a fire protection rating of not less than 3 hr.</p> <p>Additionally, ensure that there are required direct exits available for the dining facilities, or consider relocating them to a dedicated building. .</p>	Within 3 months

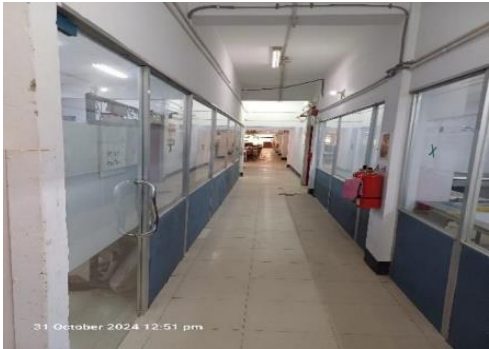
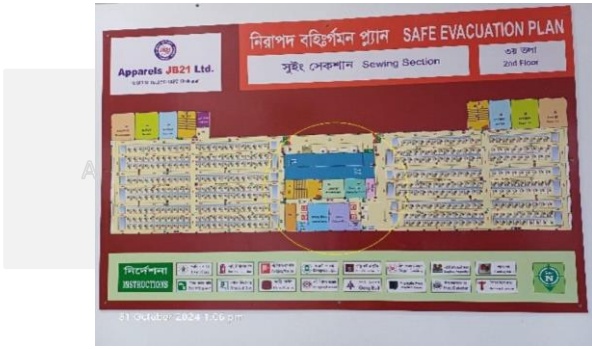
F-05	Fire Rated Construction	Office area (F1) was not separated from the Production area(G2) due to non rated door at main building.	Ensure the office area(F1) is fire separated by minimum 3-hr fire rated construction barrier with the production area(G2) as per table 3.2.1 of BNBC-2006.	Within 3 months

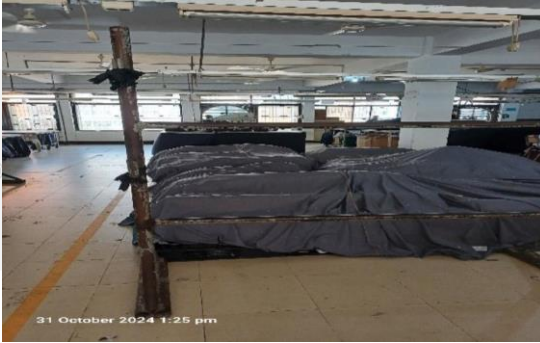
F-06	Fire Rated Construction	Areas used for in-process storage of combustible materials are open to the surrounding occupancy. Location: Production Building	<p>Provide defined storage areas and limit the storage arrangement as follows:</p> <p>Maximum height of 2.45 m and maximum area of 23 m² and is separated by a minimum 3.0 m (10ft) from other storage areas and they do not exceed 10 percent of the building area of the story in which they occur.</p> <p>or,</p> <p>If sprinkler protected, Maximum height 12 ft (3.66 m) and maximum area of 1000 ft² (93 m²) and separated by a at least 25 ft (7.62 m) and does not constitute more than 10 percent of the building area or 4000 ft² (372 m²) of the sprinklered area, whichever is greater.</p> <p>or,</p> <p>Enclose the storage area from the surrounding occupancy with a minimum 1 hour construction.</p>	Within 3 months
------	-------------------------	---	--	-----------------

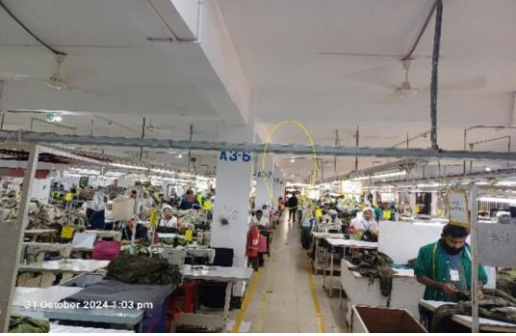
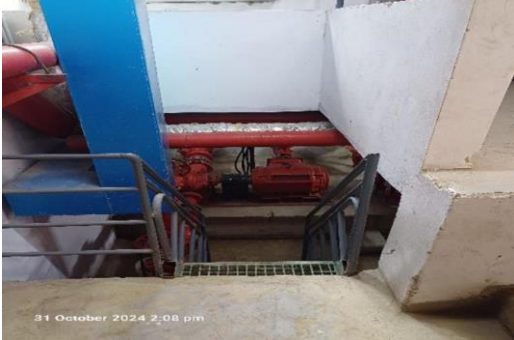
F-07	Means of Egress	Headroom clearance was found less than 6 feet 8 inches in the sewing area egress path due to the presence of the electrical channel, and main exit gate, and fire pump room	Ensure minimum headroom 6ft 8 inch or re-route the egress way to avoid the critical path.	Within 1 month
<div style="display: flex; justify-content: space-around;">

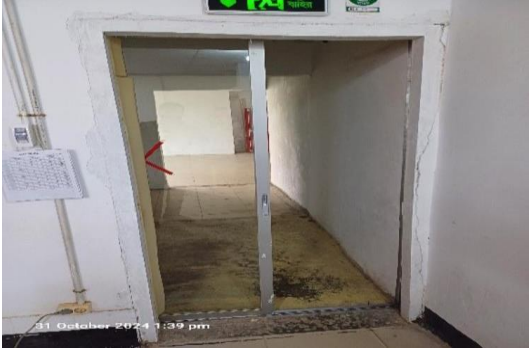
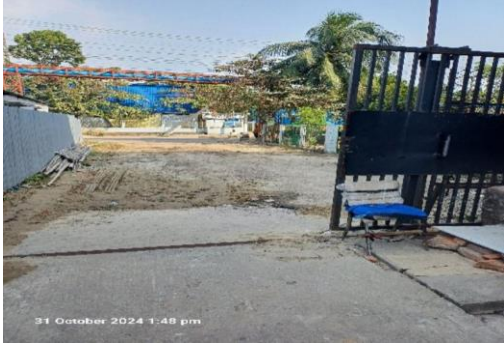
F-08	Means of Egress	Sliding type doors have provided along means of egress. Location: Inspection room and north east side main gate exit.	All doors in a means of egress shall be of the side---hinged swinging type. Roll-down and sliding gates and shutters shall not be allowed. Doors serving an occupant load of more than 50 shall swing in the direction of egress travel.	Within 1 month

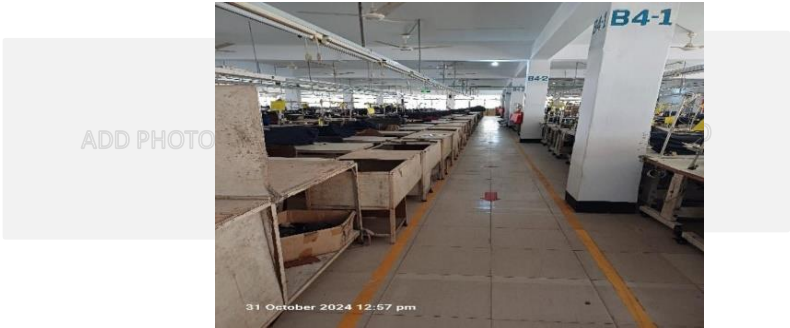
F-09	Means of Egress	The egress aisles available clear width were found less than 36 inch. Location: Accessories store main building.	Aisles shall be provided with a minimum unobstructed clear-width of 0.9 m (36 in.). The path of egress travel along a means of egress shall not be interrupted by any obstruction.	Immediately

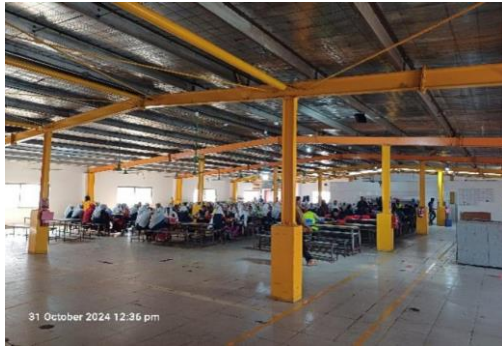
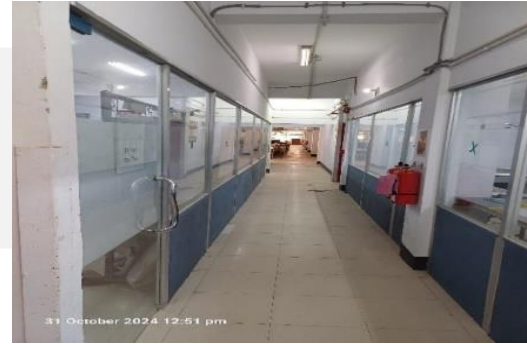
F-12	Egress Lighting	Directional signs are not provided where direction of the path of travel to an exit has changed. Location: Production Building	Illuminated directional signs shall be provided where there is a change in the direction for the path of travel and the direction to an exit is not obvious.	Within 2 months

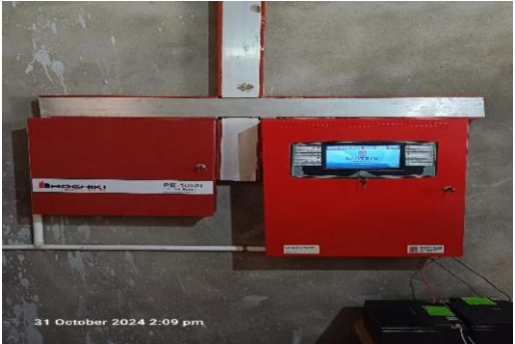
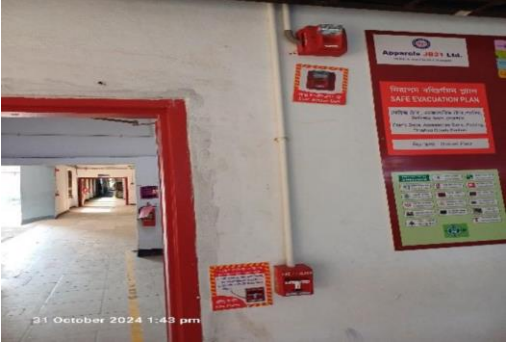
F-15	Fire Alarm & Detection System (FADS)	The buildings are not provided with compliant fire alarm and detection systems. The installation of the fire and detection system (FADS) has been completed . Locations: All Buildings	<p>Addressable fire alarm and detection systems shall be installed throughout all buildings and structures (When complete sprinkler protection is provided throughout a floor with water flow devices designed to initiate the alarm notification, smoke and fire detection devices can be eliminated throughout that floor).</p> <p>Submit the proposed fire alarm system design to RSC for review. Once the design is reviewed, install the fire detection and alarm system throughout the building in accordance with review comment, RSC Technical Guidelines (Standard) and NFPA 72.</p> <p>After installation the owner shall conduct internal testing and commissioning and then contact the RSC for witness of final acceptance testing.</p>	Design within 2 month and modification/ installation with 4 months

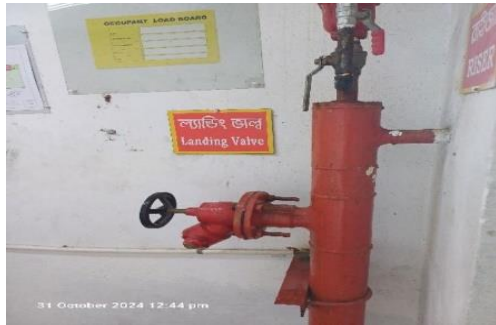
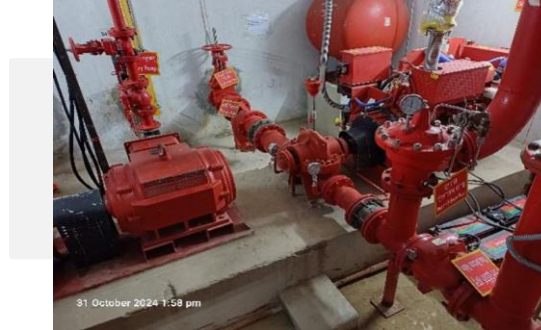
F-17	Fire Suppression System (SUPS)	<p>The highest occupied floor of the main building is over 33 feet above grade, mandating a class III standpipe system.</p> <p>. Location: Main Building</p>	<p>A class III standpipe system (both a 40 mm connection with attached hose and a 65 mm connection) shall be installed throughout the production building (Where the building is protected throughout with automatic sprinklers a Class I standpipe (65 mm connections without attached hose) shall be permitted. The installation of Occupant Use (Class II 40 mm connections) shall not be required). Location: Production Building.</p> <p>Submit proposed fire Suppression System (fire pump, standpipe and sprinkler) design to RSC for review.</p> <p>Once the design is reviewed, install and modify the fire Suppression System throughout the building in accordance with review comment, RSC Technical Guidelines (Standard) and NFPA 13, 14, 20, 22 and 24.</p> <p>After installation the owner shall conduct internal testing and commissioning and then contact the RSC for witness of final acceptance testing.</p>	<p>Design within 2 month and modification/ installation with 4 months</p>
