# INITIAL FIRE SAFETY INSPECTION REPORT

## Nippon Garment Industries Ltd (Extension)

RSC ID: 25889

# Fire Safety Inspection Report

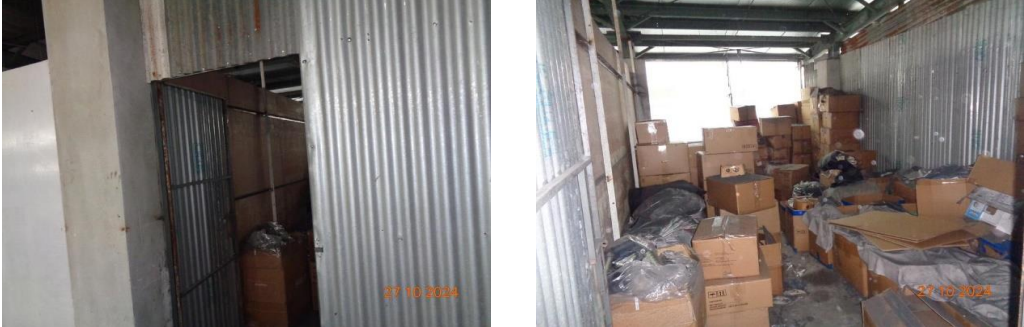
| SI No. | Category | Findings | Required Action | Remediation Time Frame |
|---|---|---|---|---|
| F-1 | Fire Rated Construction | Dining area(E3) is not separated from storage area by fire-rated construction.<br><b>Location: 1st floor at Warehouse-1</b> | Separate the dining(E3) from other Storage(H2) by 3-hr fire rated construction having two direct access to exit stair/outside of the building. Seal and/or protected all openings maintain the required fire separations. | Within 2 months |

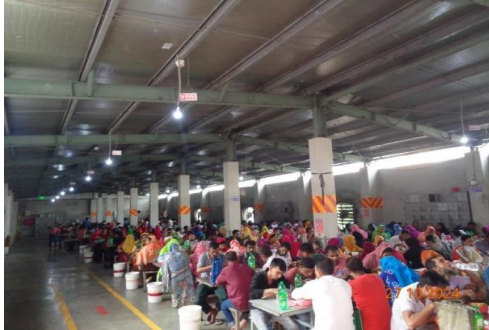
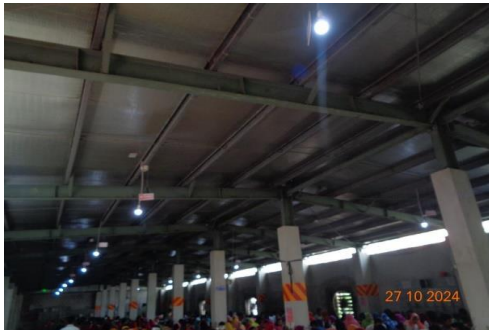
| F-2 | Fire Rated Construction | <p>The main structural element of the building is constructed by steel which is non-rated and were found in exposed condition without any fire protection.</p> <p><b>Location: Warehouse-1</b></p> | <p>For interm construction, the building shall be Group 1 or Group 2 construction as required in BNBC 2020 Part 3 Table 3.2.4. So, provide required rating for the structural elements of the building following BNBC 2020-Table 3.2.4, 3.1.7 and 3.3.1</p> <p>Factory shall ensure that, all the design, datasheet, certificate, and the design-philosophy has been reviewed from the RSC prior to install the structural fire protection system.</p> | Within 6 months |

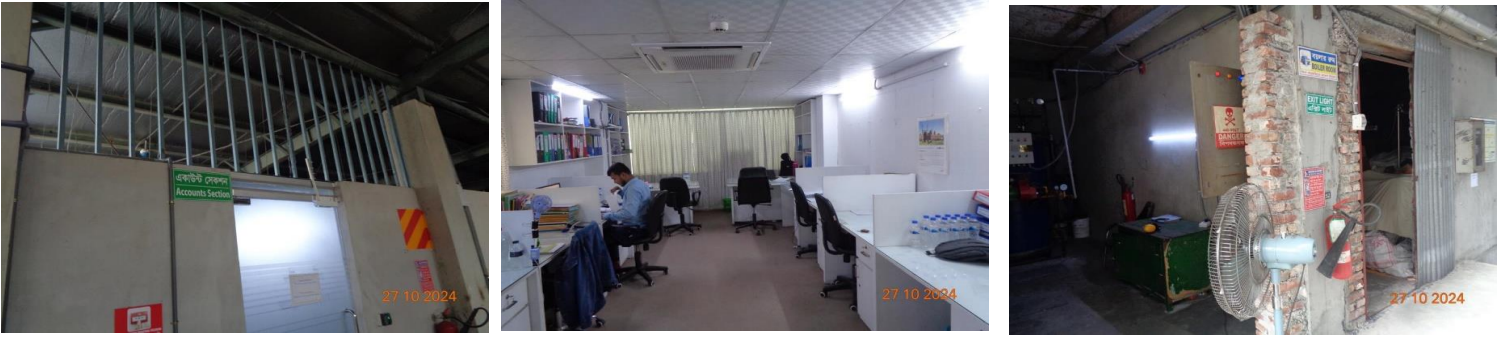
| F-3 | Fire Rated Construction | <p>Rooms used for combustible storage are not separated by fire-rated construction from Boiler room, Office room and Parking shed.</p> <p><b>Location: Ground and 1st floor at Warehouse-1, Parking shed</b></p> | <p>Separate the dedicated storage rooms by minimum 1-hr fire-rated construction. Provide 0.75 hr. fire rated door and seal all penetrations and openings by 0.75 hr. fire rated fire rated construction.</p> | Within 2 months |

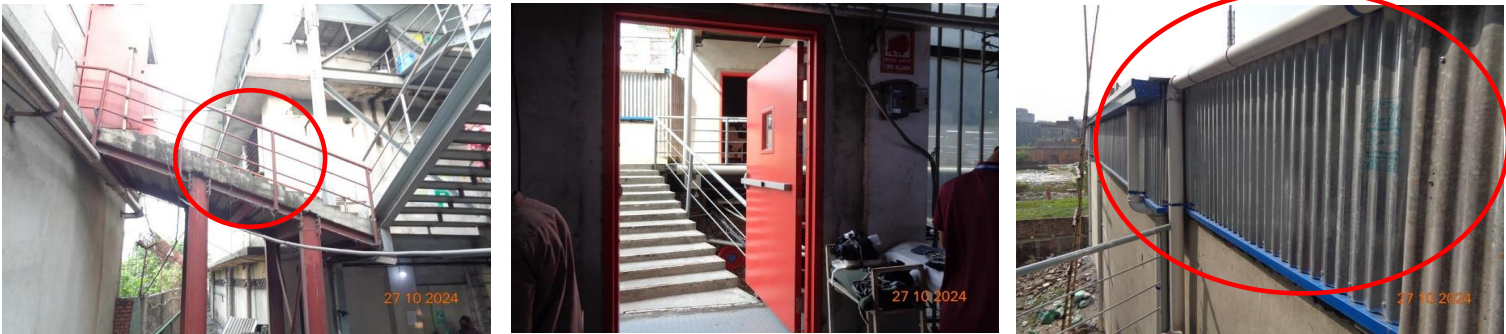
| F-4 | Means of egress | <p>The exterior exit stair is not separated from the building by fire rated construction.</p> <p><b>Location: Warehouse-1</b></p> | <p>Exterior exit stairs shall be separated by minimum 1-hr fire-rated construction and The rating of the exterior wall shall extend 3.05 m (10 ft.) beyond the ends of the stair structure. Provide minimum 1-hr fire rated separation in exit enclosures with minimum 1-hr fire rated doors and seal all unprotected openings and penetration to separate the exit stairs from work areas and other building spaces on all floor levels with similar rating of fire door. Ensure that the fire doors are self-closing and positive latching and that they are provided with fire exit (panic) hardware where serving production floors. If fire doors are required to be held open for functional reasons, provide automatic closing devices tied to the fire alarm system. Fire doors assemblies shall conform to NFPA 252, BS 476 Part 22, EN 1634-1, GB 12955-2008, or IS 3614 Part II.</p> | Within 3 months |

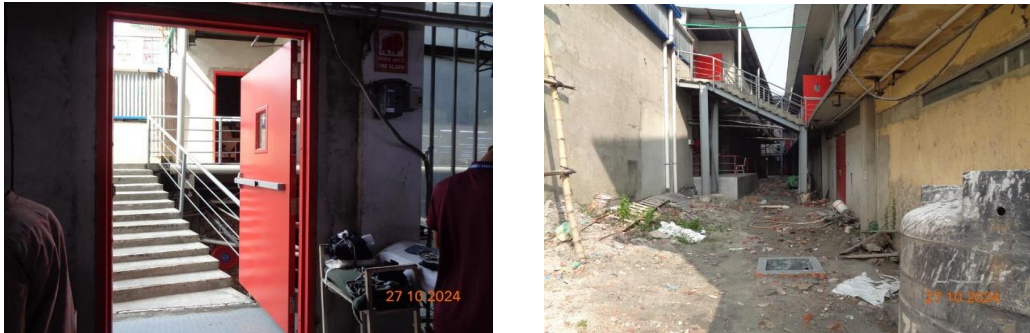
| F-6 | Means of Egress | The Exit stair-2(South East side) did not discharge directly to the outside of the building.<br><b>Location: Warehouse-1</b> | Provide 2-hr fire-rated exit passageway leading directly outside. Or, Provide sprinkler protection for discharge floor in accordance with NFPA 13 and RSC standard 6.17.3. | Within 2 Months |

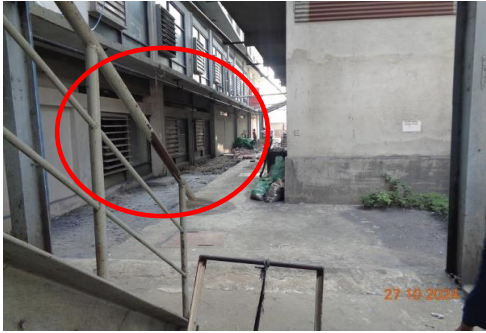
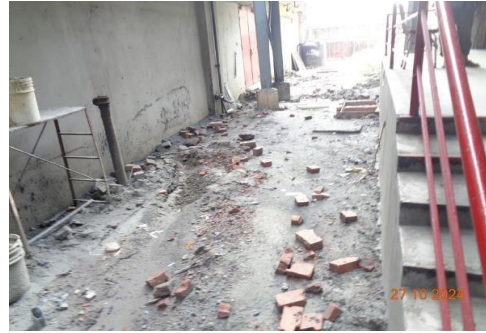
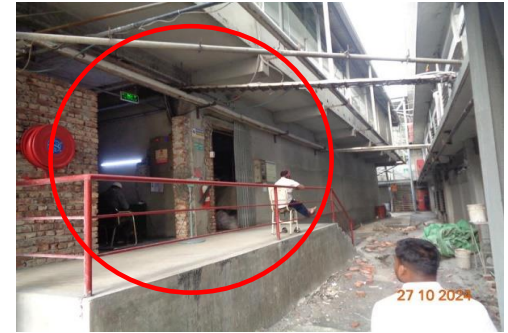
| F-9 | Means of Egress | The exit discharge path was not separated from the building interior due to unprotected openings from Warehouse-1 [due to Boiler and Storage] and Main building(RSC ID: 12009) [due to window opening].<br><b>Location: South side of Warehouse-1</b> | Seal all penetrations and openings to the interior of the building along the discharge path, up to a height of 10 ft. with minimum 2-hr fire rated materials. Seal and/or protected all openings to maintain the required fire separations. Provide vestibules to separate storage areas and Boiler room. | Within 3 months |

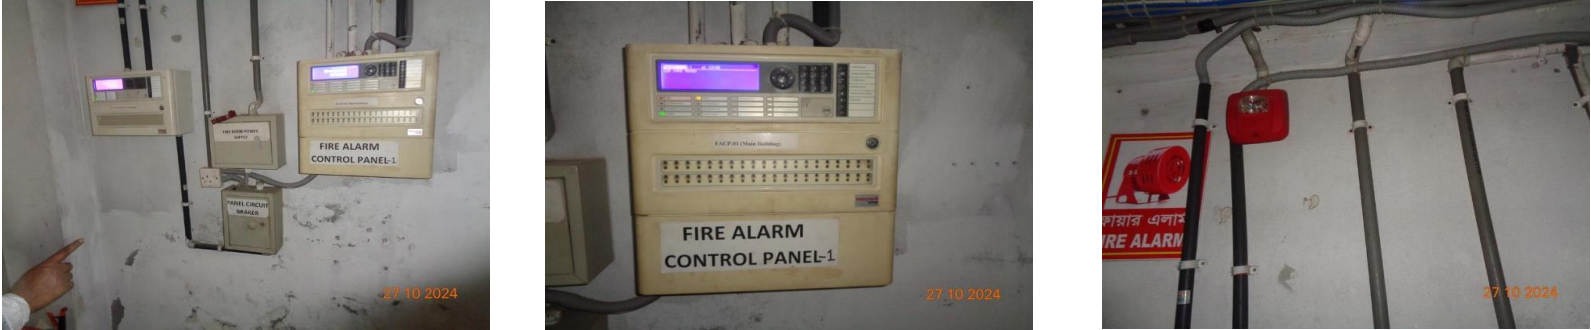
| F-12 | Fire Alarm & Detection system | Automatic fire alarm and detection system is being installed which requires detailed review to confirm compliance with NFPA 72 and The RSC Technical Guidelines (Standard). | Submit the fire alarm system design to RSC for review. Once the design is reviewed, install and modify the fire detection and alarm system throughout the buildings in accordance with review comment, RSC Technical Guidelines (Standard) and NFPA 72. After installation the owner shall conduct internal testing and commissioning and then contact the RSC for witness of final acceptance testing. | Design Review within 2 months and installation/modification within 4 months |
