# INITIAL FIRE SAFETY INSPECTION REPORT

**Columbia Apparels Ltd - Extension**

**RSC ID: 25893**

**ADDRESS: 228/1 Tin Sharak, Joydevpur**

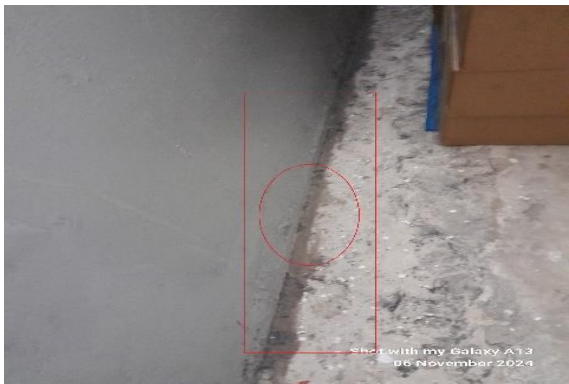
| Sl No. | Category | Findings | Required Action | Remediation Time Frame |
|---|---|---|---|---|
| F-1 | Fire rated Construction | The factory has claimed that Building expansion joint are sealed by fire rated materials but certificate, design & technical datasheet is missing which requires to be verified.<br>Location: 5-Storied Factory Building (Extended Portion) | Collect the certificate, design & other documents for fire stop materials & keep on site . Seal the building expansion joint opening by 3 hr. listed fire rated sealant/material to maintain required floor to floor separation. The used sealer shall be 3rd party certified and installation shall be as per manufacturer's datasheet. | Within 3 months |

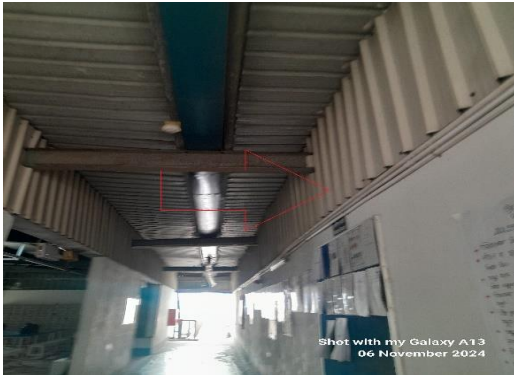
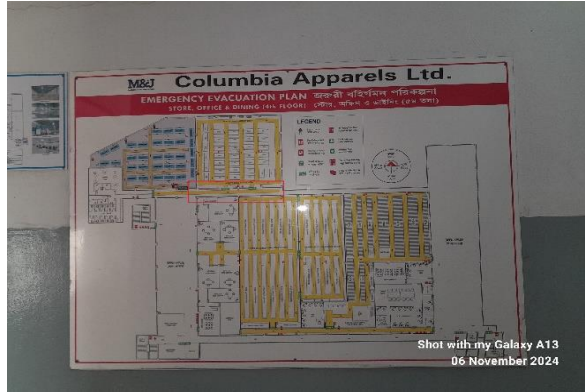
| F-2 | Fire rated construction | <p>The Dining area is not separated by fire rated construction with the adjacent occupancies.</p> <p>Location: 4th floor of the 5-Storeyed Factory building(Extended portion)</p> | <p>Separate the dining area from other occupancies(office , store) by minimum 3-hr fire rated construction. Provide rated exit passageways leading directly to the exit stairs of the same resistance rating.</p> | Within 3 months |

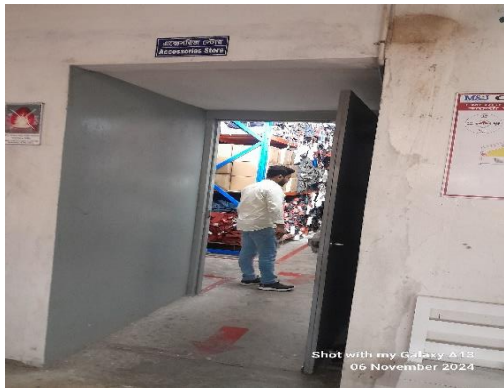
| F-3 | Fire Rated Construction | <p>Dedicated store room is not separated properly due to installed fire doors listing label missing at several floors</p> <p>Location: 5-Storeyed Factory building(Extended portion)</p> | <p>Collect the 3rd party listed certificate &amp; technical datasheet &amp; keep on site. Proper label on door leaf's, frame and accessories is required to ensure as per requirement of certification authority and manufacturer declaration. Provide dedicated storage rooms separated by minimum 1 hr. fire rated construction. Ensure that the fire doors are self-closing and positive latching and that they are provided with fire exit (panic) hardware where serving production floors. If fire doors are required to be held open for functional reasons, provide automatic closing devices tied to the fire alarm system.</p> | Within 3 months |

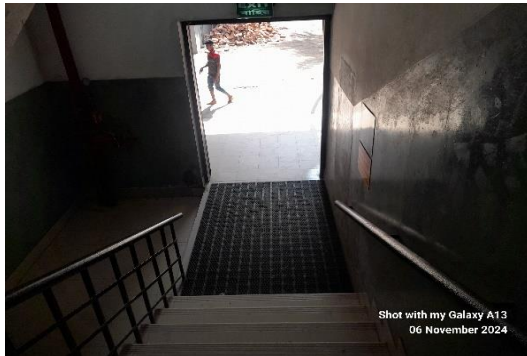
| F-4 | Mean of Egress | <p>Width of exit stairs are less than 1.5 m (60 in.).</p> <p>Location: West side Stair-4(56 inch)</p> | Provide exit stair minimum clear and unobstructed width of 1.5 m (60 in.) for all industrial occupancies in accordance with RSC standard 6.5.6.2.1 | Within 3 months |

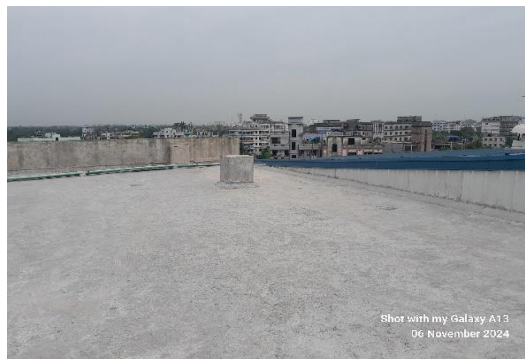
| F-5 | Mean of Egress | <p>Parapets or guards are not provided in occupied roof .</p> <p>Location: 5-Storeied main building(extended portion)</p> | Provide parapets or guards with a minimum height of 1067mm (42 inch.). | Within 3 months |

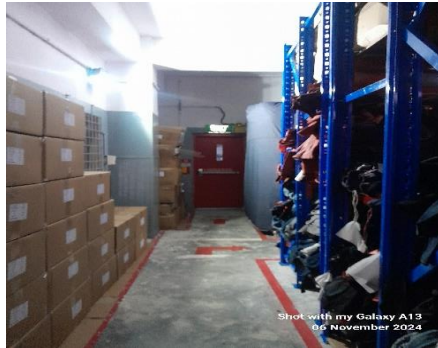
| F-8 | Means of egress | The door width found 29 inches of second exit from first to 3rd floors of 5-storied building (extended part) which is not as per standard.<br>Location: 5-Storied Factory Building (Extended Portion) | Doors in a means of egress shall have a minimum width of 1 m (39in) as per RSC Technical guideline standard V1-6.5.6.1.2 . | Within 2 months |

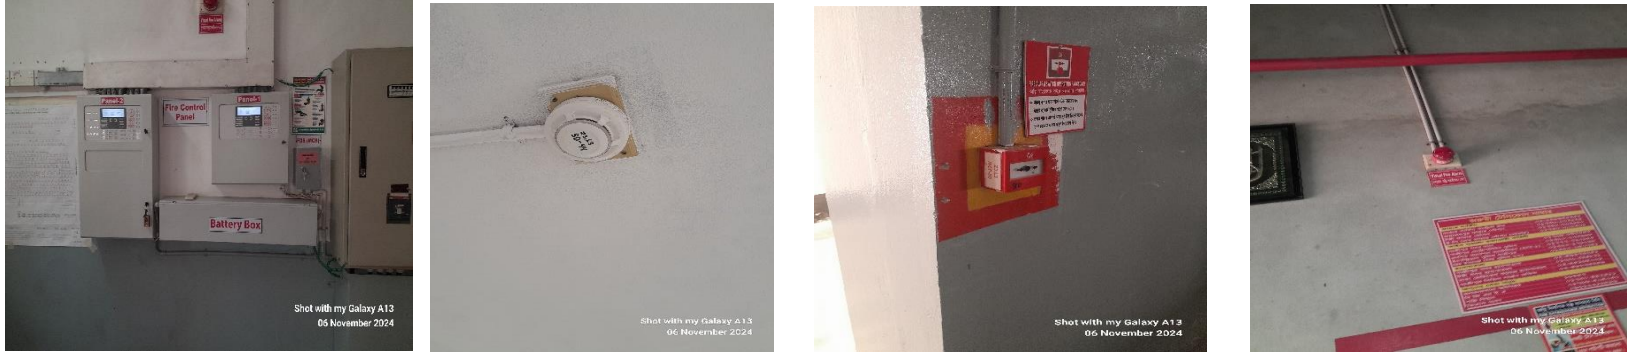
| F-11 | Fire Alarm & Detection System (FADS) | <p>The factory has been installed an addressable fire alarm &amp; detection system (NITTAN (Model: evo+5400, evo+5800) all structure such as 5-storied Main Factory Building (Extended Portion) , two Fabric Warehouse , STP building in this ID-25893 and Pre-T&amp;CVI has been conducted combined both (ID-25893 &amp; ID-9572) on date 19-May-2024 &amp; Status is Pre-T&amp;C closure verification inspection required. So Pre-T&amp;CVI closure verification &amp; T&amp;C will be conducted combinedly for both ID.</p> <p>Location: 5-Storied store building, Two storied fabric warehouse &amp; STP.</p> | <p>After complete modification work as per Pre-T&amp;CVI report, the owner shall contact the RSC for witness of conducting the final acceptance testing of the fire detection &amp; alarm system installation for combined both ID together.</p> <p>Also inspect, test and maintain the fire alarm system, and keep written records on-site, in accordance with NFPA 72.</p> | Modification within 1 months (If require). |
| <p>The row contains four photographs documenting the fire alarm system installation. From left to right: 1. A fire alarm control panel with a 'Battery Box' label. 2. A circular ceiling-mounted smoke detector. 3. A red fire alarm bell mounted on a wall. 4. A red fire alarm pull station with a label. Each photo has a small caption at the bottom right: 'Shot with my Galaxy A13 06 November 2024'.</p> | | | | |

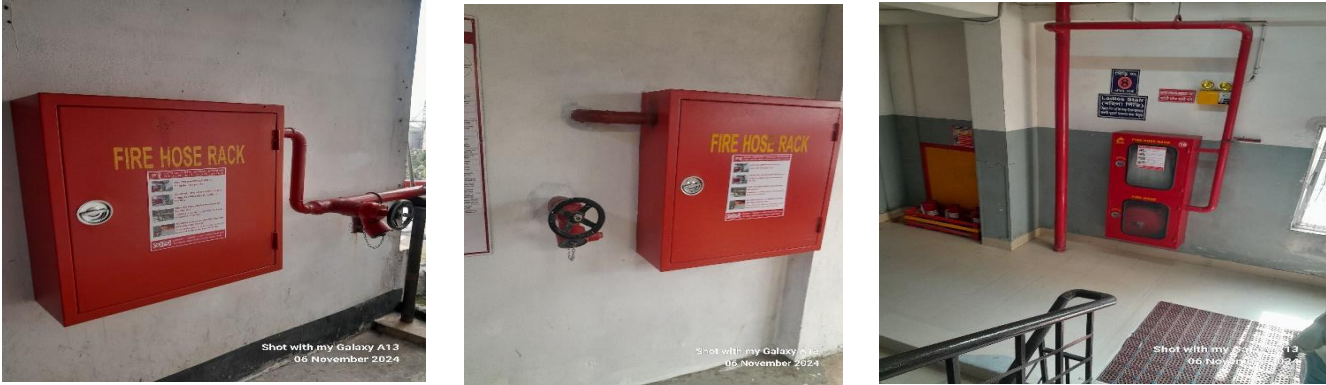
| F-13 | Fire Protection System(Standpipe) | <p>5-Storeyed Factory Building (Extended Portion)(ID-25893) is architecturally connected to 5-Storeyed main factory building(ID-9572).So, both Building are considering single fire compartments.</p> <p>Standpipe system installation requires detailed initial review for combined both ID to confirm compliance with NFPA- 14 , 20 ,22 &amp; 24 or as per RSC standard.</p> | <p>Submit the standpipe system drawing to RSC for review.</p> <p>Once the design is reviewed, install and modify the standpipe system throughout the building in accordance with review comment, RSC Standard and NFPA- 14,20,22 and 24.</p> <p>After installation the owner shall conduct internal testing and commissioning and then contact the RSC for witness of final acceptance testing.</p> | Design Review within 1 month and modification within 3 months (If require). |

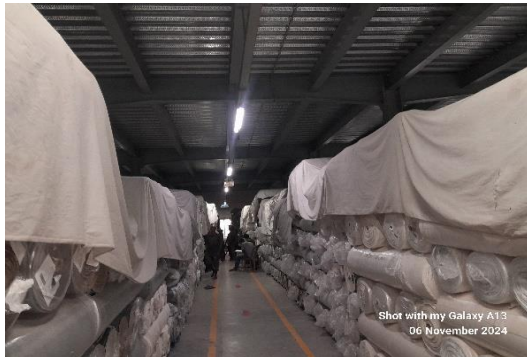
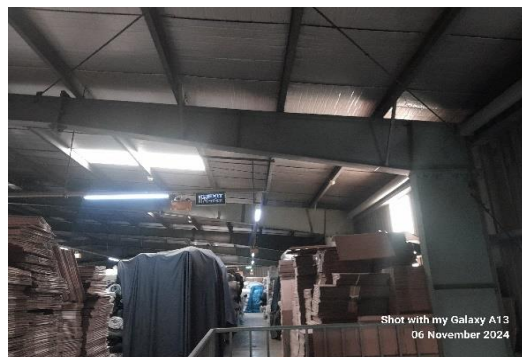
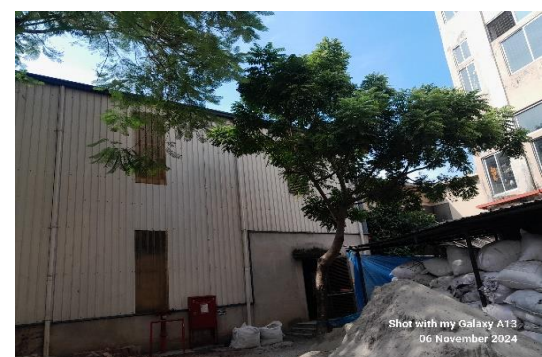
| SI No. | Category | Findings | Required Action | Remediation Time Frame |
|---|---|---|---|---|
| F-17 | Fire rated Construction | <p>The main structural elements of factory buildings (G and/ or H2) are constructed by steel which is non-rated structure and were found in exposed condition without any fire protection. Building peak height appr. 9.527 Meter. As per RSC Technical Guidelines (Standard) V1 1.5.5 this building is defined as an interim building &amp; have lack of front space as per standard. so, fire protection shall be provided for the structural elements of the building following section 3.5.2 of RSC Technical Guidelines (Standard) V1.0</p> <p>Location: Two storied fabric warehouse</p> | <p>The building shall be Group 1 or Group 2 construction as required in BNBC 2020 Part 3 Table 3.2.4. So, provide require rating for the structural elements of the building following BNBC 2020- Table 3.2.4, 3.1.7 and 3.3.1</p> <p>Factory shall ensure that, all the design, datasheet, certificate, and the design-philosophy has been reviewed from the RSC prior to install the passive fire protection system.</p> | Within 6 months |

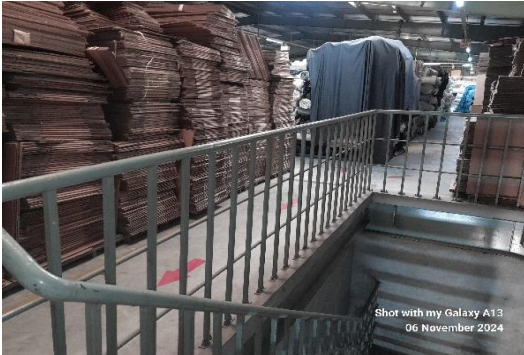
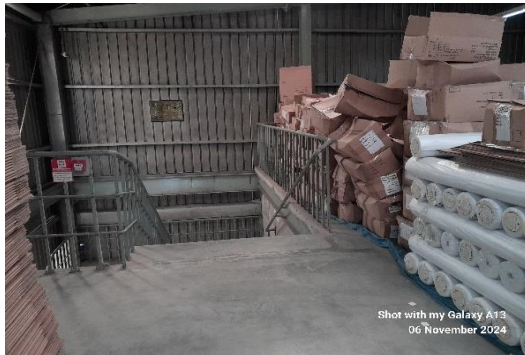
| F-18 | Mean of Egress | <p>Exit stairs are not separated from work areas &amp; other spaces on each floor by fire-rated construction.</p> <p>Location: Two fabric warehouse</p> | <p>The exit stair enclosure shall be provided with a minimum 1-hr fire resistance rating with 1- hr. fire rated door and seal all penetrations and openings by 1 hr. fire rated materials.</p> <p>Ensure that the fire doors are self-closing and positive latching and that they are provided with fire exit (panic) hardware where serving production floors. If fire doors are required to be held open for functional reasons, provide automatic closing devices tied to the fire alarm system.</p> | Within 3 months |

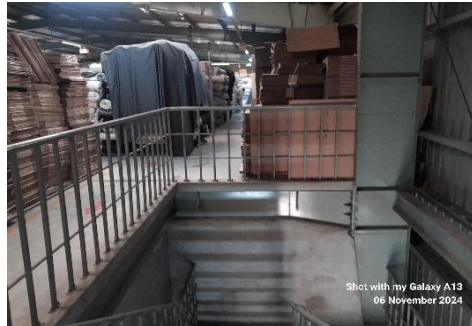
| F-20 | Means of Egress | <p>Width of exit stairs (3feet 7 inch) are less than 1.5 m (60 in.).</p> <p>Location: West side exit stair-2(width 43 inch)</p> | Provide exit stair minimum clear and unobstructed width of 1.5 m (60 in.) for all industrial occupancies in accordance with RSC standard 6.5.6.2.1 | Within 1 month |

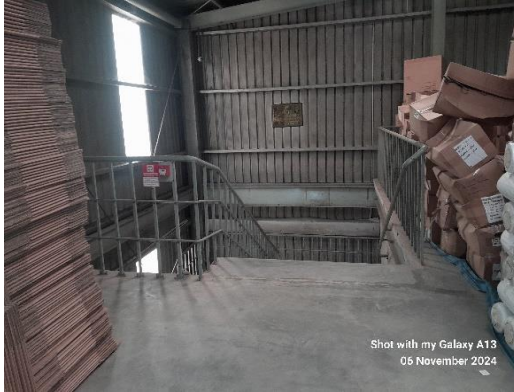
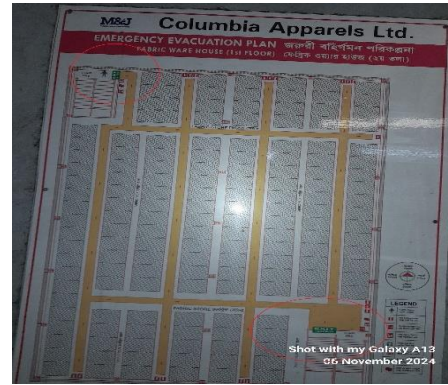
| F-22 | Means of egress | Store room directly open into exit stair enclosure without vestibule.<br>Location: Two storied fabric warehouse building. | Openings from exit enclosure to storage shall be provided with a vestibule with fire rated construction and openings as per RSC Technical Guideline (Standard) V1-6.14.3 .<br><br>Provide a 2 hr. fire rated door on the exit stair side and a 1- hr. fire rated door on the storage side. The minimum width for vestibules shall not be less than 1.1m and length 1.8m as per BNBC, Part-4, Chapter-3, section 3.13.3.<br><br>Ensure that the fire rating of the vestibule construction matches that of the exit stair enclosure. | Within 3 months |
