# ELECTRICAL SAFETY INSPECTION REPORT

**Mawna Fashions Ltd (Extension)**

**Tepirbari, Sreepur, Gazipur**

**Inspected on:** 18-Dec-2024

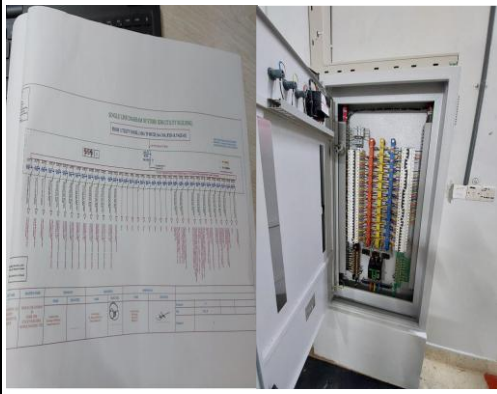
| Item No | Inspection Observation | Inspection Action Plan<br>(Recommendation) | Priority | Inspection Time line<br>(given in report) | Pictorial Evidence |
|---|---|---|---|---|---|
| 1 | Field information has no/less reflection in existing SLD. | As-built Electrical Single Line Diagram (SLD) must be prepared by a qualified engineer, including all essential details of the electrical system. This diagram must be reviewed and approved by the RSC. The accepted SLD needs to be implemented at the factory. All cables, all circuits, all terminals, all equipment are required to be identified as per the accepted Single line diagram. | P2 | 3 Months | |
