# INITIAL FIRE SAFETY INSPECTION REPORT

## MAWNA FASHIONS LTD (EXTENSION)

**RSC ID: 25871**

**ADDRESS: Tepirbari, Sreepur, Gazipur-1740, Bangladesh.**

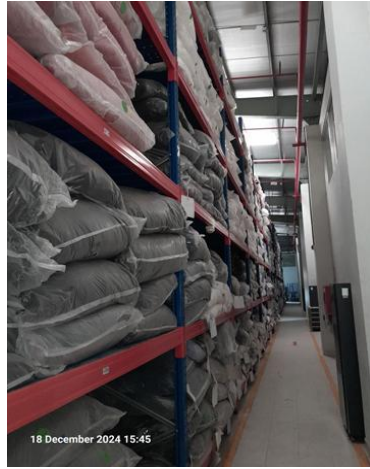
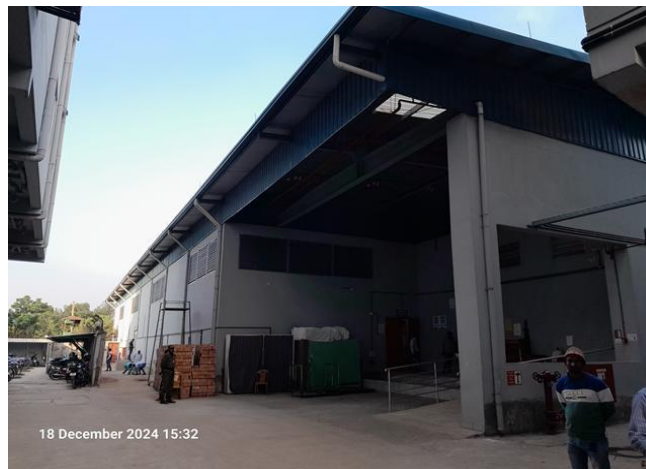
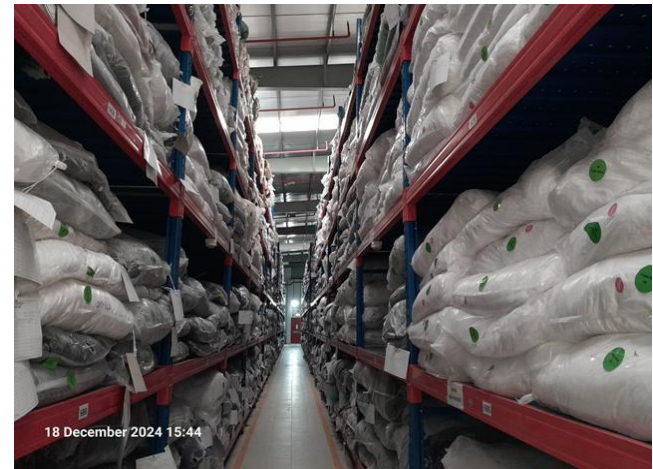
| SI No. | Category | Findings | Required Action | Remediation Time Frame |
|---|---|---|---|---|
| F-1 | Fire Rated Construction | <p><b>Single Storied Pre-fab Fabric Store Shed (G):</b></p> <p>The main structural elements of factory buildings (H2) are constructed by steel which is non-rated structure and were found in exposed condition without any fire protection. As per the RSC Technical Guidelines (Standard) 1.5.4 this building is defined as new building, so fire protection shall be provided for the structural elements of the building following section 3.5.2 of the RSC Technical Guidelines (Standard) V1.0.</p> | <p>For new construction, the building shall be Group 1 or Group 2 construction as required in BNBC 2020 Part 3 Table 3.2.4. So, provide require rating for the structural elements of the building following BNBC 2020-Table 3.2.4, 3.1.7 and 3.3.1</p> <p>Factory shall ensure that, all the design, datasheet, certificate (if applicable), and the design-philosophy has been reviewed from the RSC prior to install the passive fire protection system.</p> | Within 6 months |

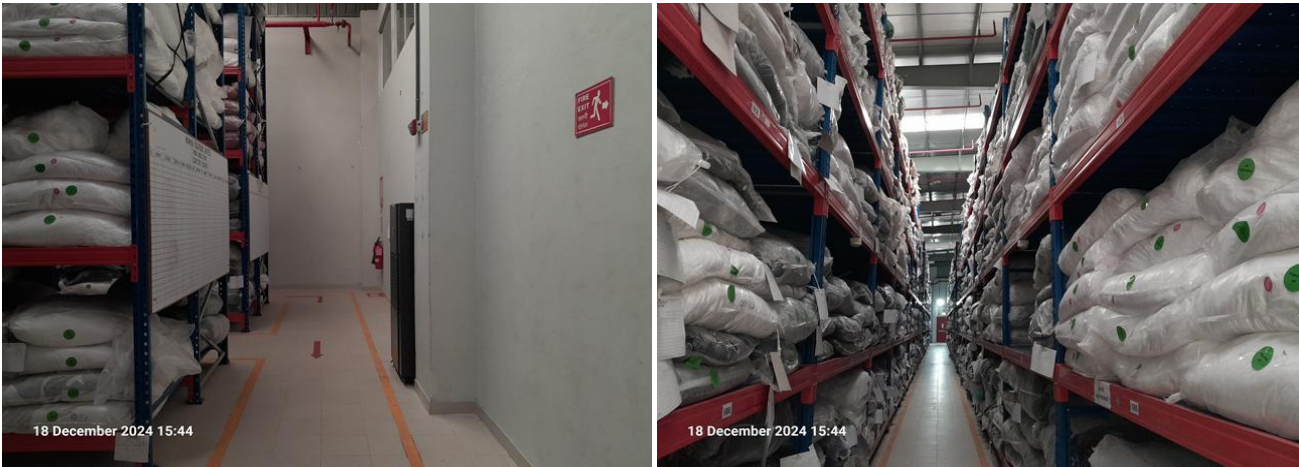
| F-4 | Egress Lighting | <p><b>Single Storied Pre-fab Fabric Store Shed (G):</b></p> <p>The directional signs are not provided where there is a change in direction and where the continuation of the egress path is not obvious.</p> <p>Location: On ground floor of fabric store shed.</p> | <p>Install illuminated directional signs shall be provided where there is a change in the direction for the path of travel and the direction to an exit is not obvious.</p> | <p>Within 1 month</p> |

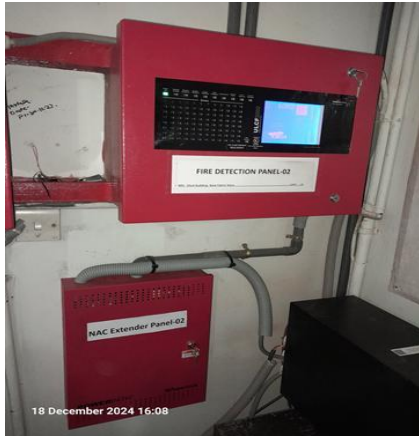
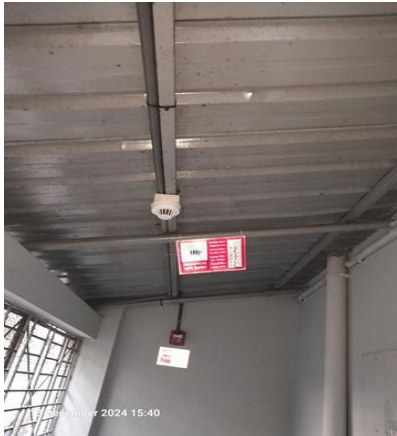
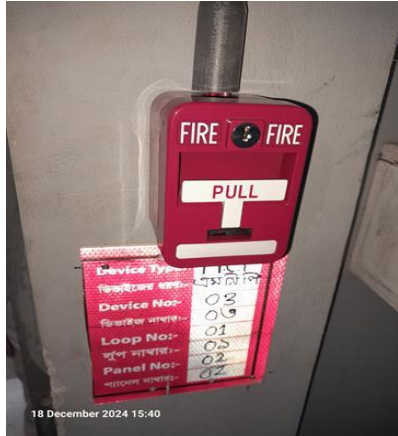
| F-6 | Fire Alarm & Detection system | <p><b>Single Storied Pre-fab Fabric Store Shed (G) with adjacent chemical room:</b></p> <p>Automatic fire alarm and detection system installation complete which requires detailed review to confirm compliance with NFPA 72 and The RSC Technical Guidelines (Standard).</p> | <p>Submit the fire alarm system design to the RSC for review. Once the design is reviewed, install and modify the fire detection and alarm system throughout the buildings in accordance with review comment, the RSC Technical Guidelines (Standard) and NFPA 72.</p> <p>After installation the owner shall conduct internal testing and commissioning and then contact the RSC for witness of final acceptance testing. Also inspect, test and maintain the fire alarm system, and keep written records on-site, in accordance with Table-14.3.1 of NFPA 72.</p> | <p>Design Review within 2 months and installation within 4 months</p> |
