# INITIAL FIRE SAFETY INSPECTION REPORT

## Aliza fashion Ltd. (Extension)

RSC ID: 25925

Date: 19-Dec-2024

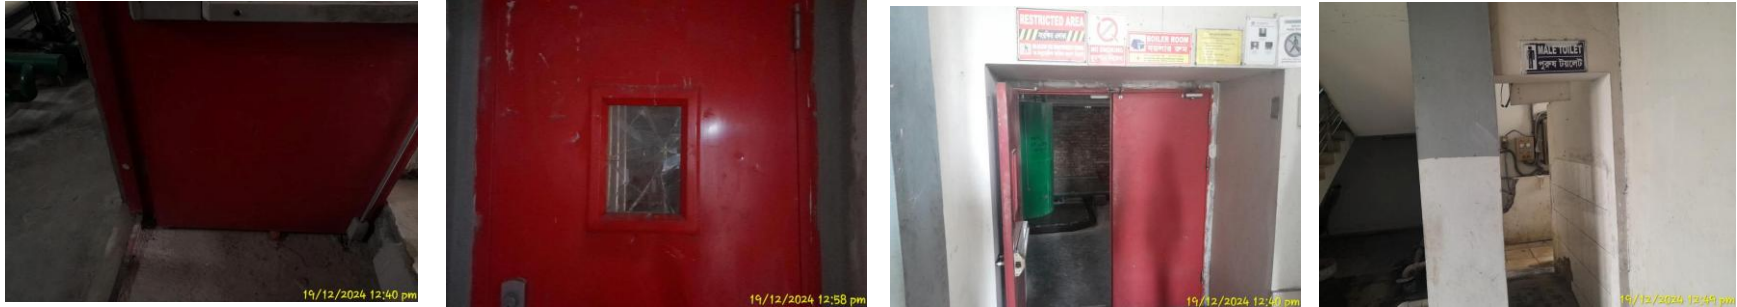
| SI No. | Category | Findings | Required Action | Remediation Time Frame |
|---|---|---|---|---|
| F-1 | Mean of Egress | <p>Exit stairs are not separated from work areas &amp; other spaces on each floor by fire-rated construction due to toilet in the stair enclosure, fire door non-functionality (door closer, door coordinator), forceful opening with external objects, interfacing with the FACP not ensured &amp; broken vision panel.</p> <p><b>Location: All floor, Building-1</b></p> | <p>Separate the exit stairs from work areas and other building spaces on all floor levels by minimum 2- hr. fire-rated construction.</p> <p>Provide a minimum 1.5- hr. fire-rated doors and seal all unprotected openings and penetrations to maintain the fire separation.</p> <p>Ensure that all fire doors are self-closing and positive latching, and are provided with fire exit (panic) hardware where serving production floors or assembly occupancies.</p> <p>If fire doors are required to be held open for functional reasons, provide automatic closing devices tied to the fire alarm system.</p> | Within 3 months |

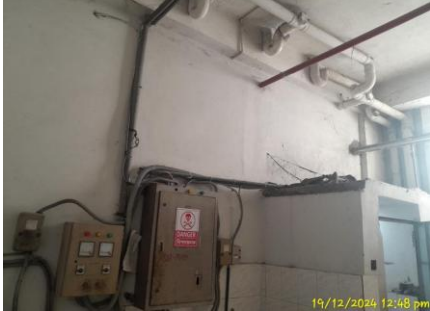
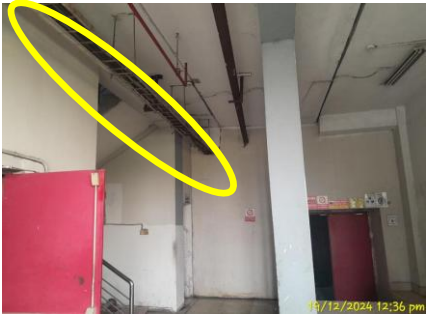
| SI No. | Category | Findings | Required Action | Remediation Time Frame |
|---|---|---|---|---|
| F-2 | Mean of Egress | <p>Electrical cable raceway &amp; DB was located in the exit stair enclosure.</p> <p><b>Location: Ground floor, Building-1.</b></p> | <p>Remove or relocated the electrical cable raceway.</p> <p>As per <b>RSC Technical Guidelines (Standard) 6.14.4</b>, Penetrations into and through an exit enclosure shall be prohibited with the exception of required exit doors, sprinkler piping, standpipes, electrical raceway for fire alarm equipment, and electrical conduit serving the exit enclosure.</p> | Within 3 months |

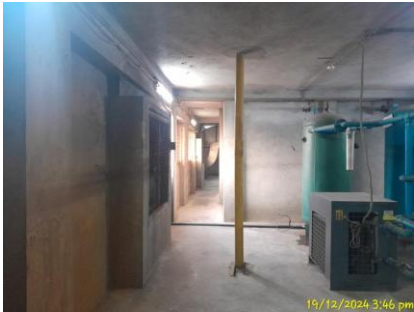
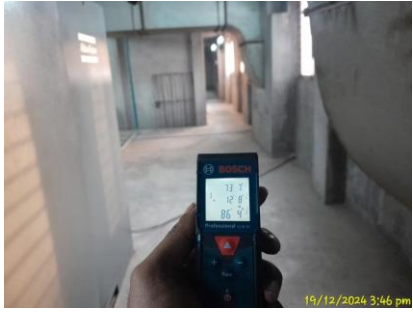
| <b>F-4</b> | Means of Egress | <p>Common path of travel exceeds 75 feet (available 86 feet) in the compressor room.</p> <p><b>Location: 2nd floor, Building-1.</b></p> | Provide additional exit. | Within 3 months |

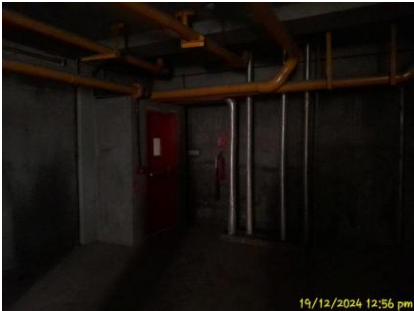
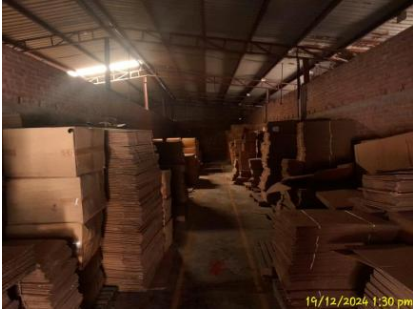
| F-6 | Means of Egress | <p>Based on the number and location of emergency lights observed, adequate illumination levels are not anticipated along egress routes.</p> <p><b>Locations: All Buildings.</b></p> | <p>Test the emergency lighting system on each floor and provide additional emergency fixtures to provide adequate illumination along the means of egress. Provide a minimum illumination of 10 lux at the floor level within exit stairs and exit discharge paths and minimum 2.5 lux along exit access aisles.</p> | Within 3 months |

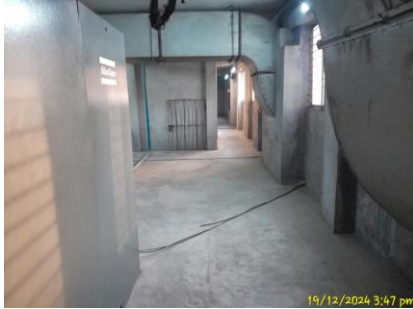
| F-7 | Means of Egress | <p>Directional Exit signage was not provided along the path of egress where there is a change in the direction for the path of travel and the direction to an exit is not obvious.</p> <p><b>Locations: 1st &amp; 2nd floor, Building-1.</b></p> | <p>Provide directional exit signs above all building exits to the exterior, all doors to the exit stairs and along all paths of travel where a change of direction is not obvious. Lighted directional signs shall be provided with either battery backup or uninterruptable power supply systems and shall be continuously illuminated.</p> | Within 1 month |

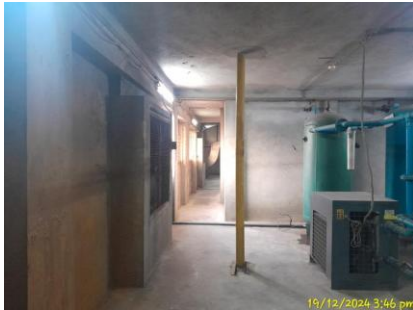
| F-8 | Means of Egress | <p>Aisle marking has not been marked properly.</p> <p><b>Location: Building-1.</b></p> | <p>Aisles mark shall be provided at required places with a minimum unobstructed clear-width of 0.9 m (36 in.).</p> | Within 1 month |

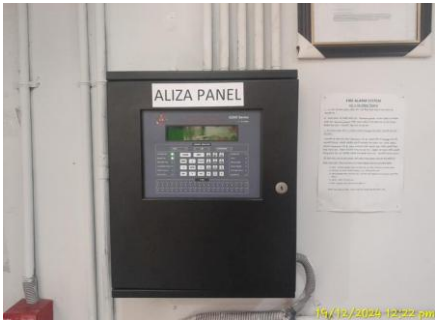
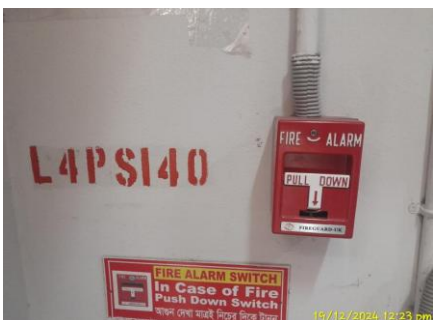
| F-9 | Fire Alarm & Detection System (FADS) | <p>Automatic fire alarm &amp; detection system installation requires detailed review to confirm compliance with NFPA 72 and RSC standards.</p> <p><b>Location: All Buildings.</b></p> | <p>Design &amp; Installation of Fire Alarm &amp; Detection system shall be in accordance with RSC standard and NFPA 72. Submit as-built design, documents and calculations to RSC for review prior installation/modification.</p> <p>After installation/modification, the owner shall contact the RSC for witness of conducting the final acceptance testing of the fire detection &amp; alarm system installation.</p> <p>Also inspect, test and maintain the fire alarm system, and keep written records on-site, in accordance with NFPA 72.</p> | Design Review within 2 months and installation within 4 months. |

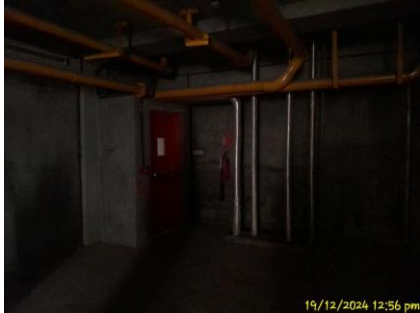
| <b>F-11</b> | Means of Egress | Exit signage not illuminated (burned out, broken, missing etc.) on several locations.<br><br><b>Locations: All Building.</b> | Regularly inspect all exit signage and replace/install lights as needed to illuminate signs | Within 1 month |

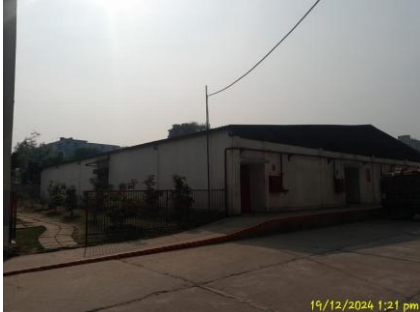
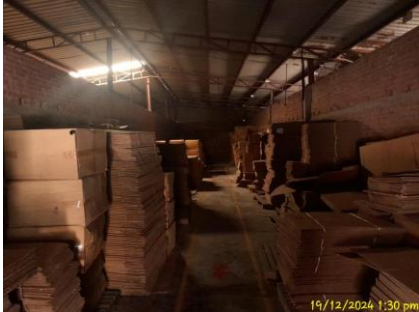
| F-12 | Fire Rated Construction | <p>The Jute &amp; Empty Carton Shed is unprotected steel construction (<b>Constructed Start: Jan 2014, Construction End: Jun 2014; Date of first Operation: Jun 2014</b>) Interim Structure. As per RSC Technical Guideline and BNBC 2006, The Fire rating of the structure requires to be confirmed as per BNBC 2006. The "Ministry of Housing and Public Works" has issued a resolution based on the recommendations from the House Building Research Institute (HBRI) and the Public Works Department (PWD) to assess structural fire protection requirements of steel buildings (unprotected non-combustible construction type) according to BNBC 2020.</p> <p><b>Locations: Jute &amp; Empty Carton Shed.</b></p> | <p>The construction type shall be confirmed to be in accordance with BNBC 2020 Part-3, Table 3.1.7. Ensure fire resistive rated construction following Table 3.3.1 (a) Part 3 Section-3, Table 3.2.2 and Table 3.2.3 Part 3 Section 2 and Table 4.1.1 from BNBC 2020 Part 4 Section 1. Provide design philosophy to determine the construction type as per BNBC 2020. If any construction rating is required, Consult a qualified fire protection engineer to achieve the required fire rating.</p> | Within 6 months |
