# INITIAL FIRE SAFETY INSPECTION REPORT

## Unimas Sportswear (Extension 2)

**RSC ID: 25870**

**Date: 14-Nov-2024**

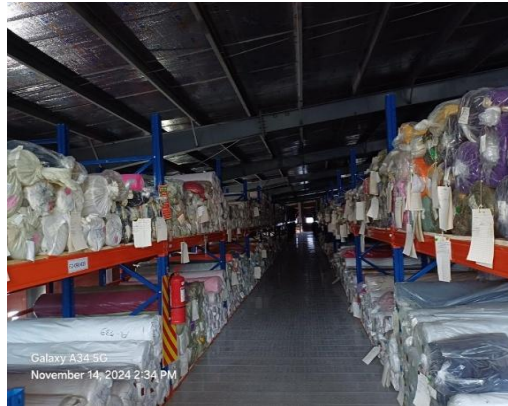
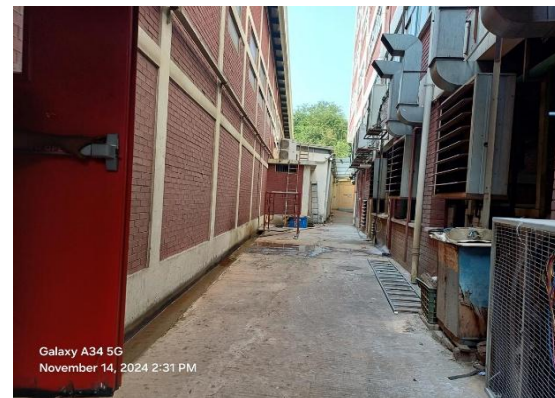
| Sl No. | Category | Findings | Required Action | Remediation Time Frame |
|---|---|---|---|---|
| F-1 | Fire Rated Construction | The Warehouse Shed-1 was constructed at 2022-23. The construction type is unprotected steel construction. Fire Resistance Ratings of Exterior Walls is not maintaining considering the Fire Separation Distance. | The construction type shall confirm to be in accordance with BNBC 2020 Part-3, Table 3.1.7. Ensure fire resistive rated construction following Table 3.3.1 (a) Part 3 Section-3, Table 3.2.2 and Table 3.2.3 Part 3 Section 2 and Table 4.1.1 from BNBC 2020 Part 4 Section 1. Provide design philosophy to determine the construction type as per BNBC 2020. If any construction rating requires, Consult a qualified fire protection engineer to achieve the require fire rating. | Within 6 months |

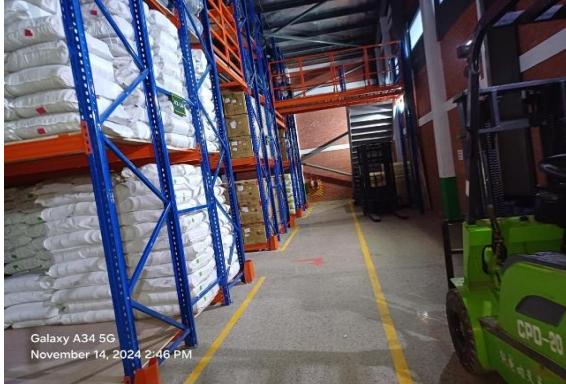
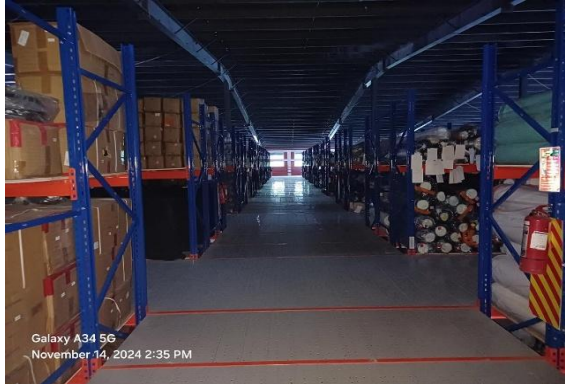
| F-2 | Fire Rated Construction | <p>Catwalk has been constructed on High rack storage and the area of the the intermediate deck creates a full floor where the size of the deck is more than 33% of the total floor area and requires fire rated separation.</p> <p><b>Location:</b> Warehouse Shed-1</p> | <p>Remove the catwalk of the intermediate deck.</p> <p>Or ,</p> <p>The floor must adhere to the RSC building standards and BNBC 2020 regulations regarding fire rated construction and egress features.</p> | Within 6 Months |

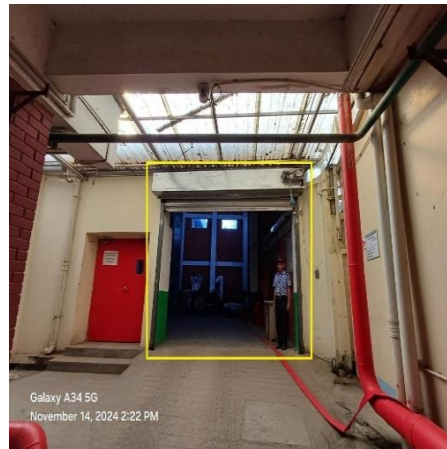
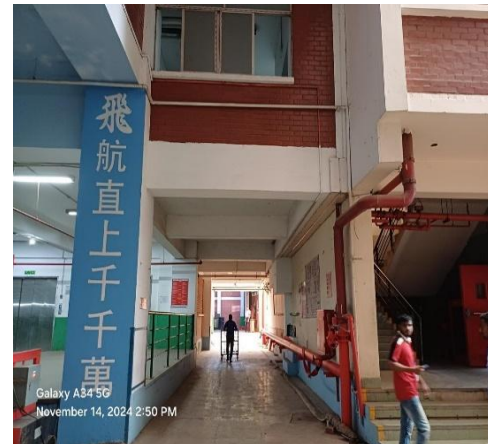
| F-3 | Fire Rated Construction | <p>The east exit discharge path was not fire separated with New Expansion building. The egress court was not properly fire rated. The egress court has unprotected openings within 10 ft height.</p> <p>Location: Warehouse Shed-1</p> | <p>An egress court serving as a portion of the exit discharge shall be open to the sky or provided with a fire resistance rated enclosure the same as the exit enclosure. Egress courts less than 3050 mm (10 ft) in width (as measured from the building and the adjacent property line) shall be provided with walls having a 1-hr fire resistance rated construction for a distance of 3050 mm (10 ft) above the floor of the court.</p> | Within 3 months |

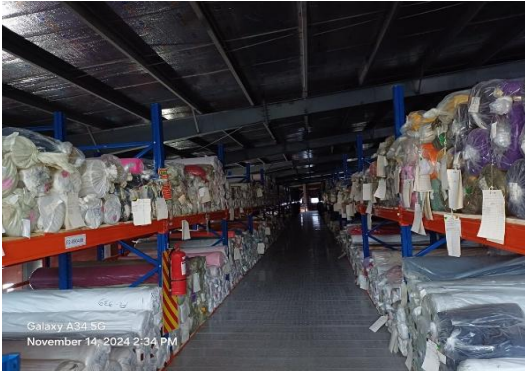
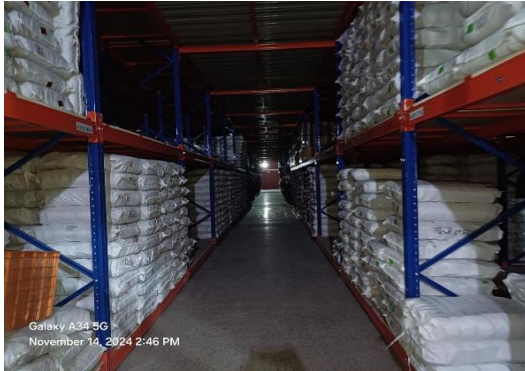
| F-4 | Emergency Lighting | <p>Based on the number and location of emergency lights observed, adequate illumination levels are not anticipated along egress routes.</p> <p><b>Location:</b> Warehouse Shed-1</p> | <p>Test the emergency lighting system on each floor and provide additional emergency fixtures to supply adequate illumination along the means of egress. Provide a minimum illumination of 10 lux at the floor level within exit stairs and along exit discharge paths and a minimum 2.5 lux along exit access aisles.</p> | Within 1 Month |

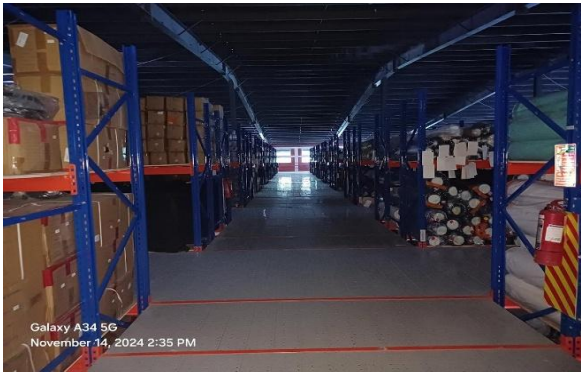
| F-5 | Means of Egress | <p>Directional exit sign was not provided along a path of egress.</p> <p><b>Location:</b> Warehouse Shed-1</p> | <p>Provide exit signs above all building exits to the exterior, all doors to the exit stairs and along all paths of travel where a change of direction is not obvious. Lighted exit signs shall be provided with either battery backup or uninterruptable power supply systems and shall be continuously illuminated.</p> | Within 1 month |

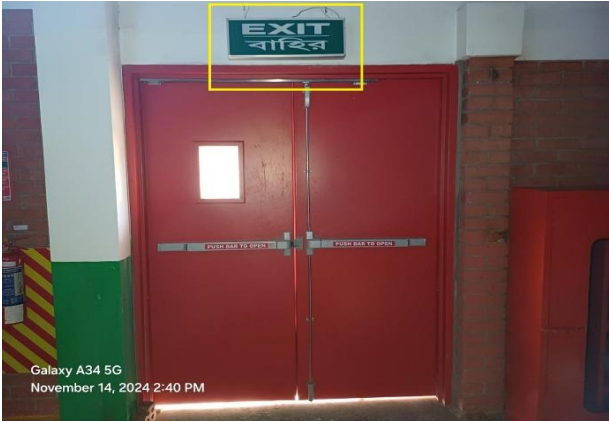
| F-6 | Emergency Lighting | Exit signage was not illuminated.<br><b>Location:</b> Warehouse Shed-1 | Regularly inspect all exit signage and replace/install lights as needed to illuminate signs. | Within 1 month |

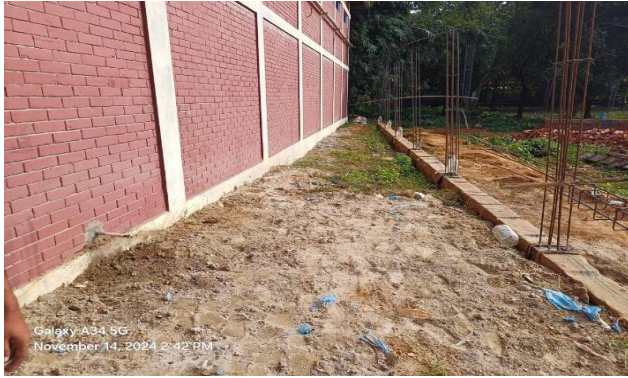
| F-7 | Means of Egress | West side exit discharge path was uneven.<br><b>Locations:</b> Warehouse Shed-1. | Remove unnecessary items and level exit path to the public way. | Within 1 month |

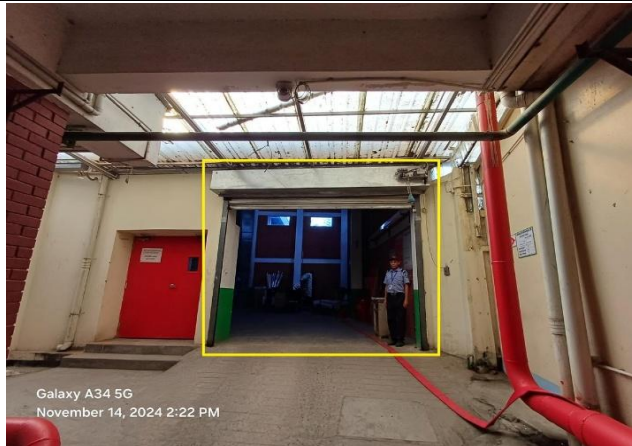
| F-8 | Means of Egress | Shutter type door is provided at east exit.<br><b>Location:</b> Warehouse Shed-1 | Replace the shutter gate along the means of egress with side-hinged, swinging egress doors in accordance with RSC standard 6.8.1. | Within 1 month. |

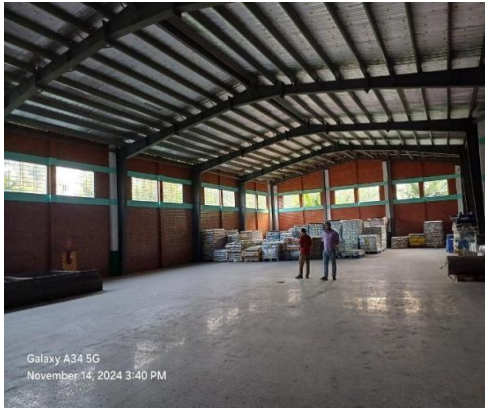
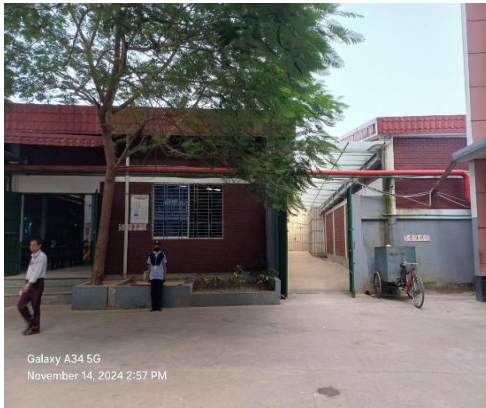
| Sl No. | Category | Findings | Required Action | Remediation Time Frame |
|---|---|---|---|---|
| F-1 | Fire Rated Construction | The Warehouse Shed-2 was constructed at 2023-24. The construction type is unprotected steel construction. Fire Resistance Ratings of Exterior Walls is not maintaining considering the Fire Separation Distance. | The construction type shall confirm to be in accordance with BNBC 2020 Part-3, Table 3.1.7. Ensure fire resistive rated construction following Table 3.3.1 (a) Part 3 Section-3, Table 3.2.2 and Table 3.2.3 Part 3 Section 2 and Table 4.1.1 from BNBC 2020 Part 4 Section 1. Provide design philosophy to determine the construction type as per BNBC 2020. If any construction rating requires, Consult a qualified fire protection engineer to achieve the require fire rating. | Within 6 months |

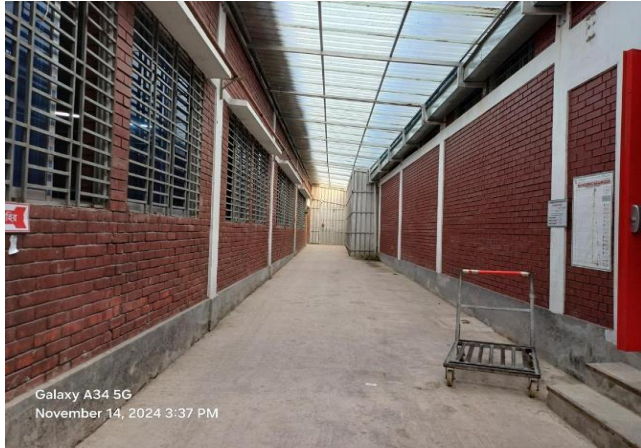
| F-2 | Fire Rated Construction | <p>The north exit discharge path was not fire separated with Dining &amp; store shed. The egress court was not properly fire rated. The egress court has unprotected openings within 10 ft height were available with Dining &amp; store shed.</p> | <p>An egress court serving as a portion of the exit discharge shall be open to the sky or provided with a fire resistance rated enclosure the same as the exit enclosure. Egress courts less than 3050 mm (10 ft) in width (as measured from the building and the adjacent property line) shall be provided with walls having a 1-hr fire resistance rated construction for a distance of 3050 mm (10 ft) above the floor of the court.</p> | Within 3 months |

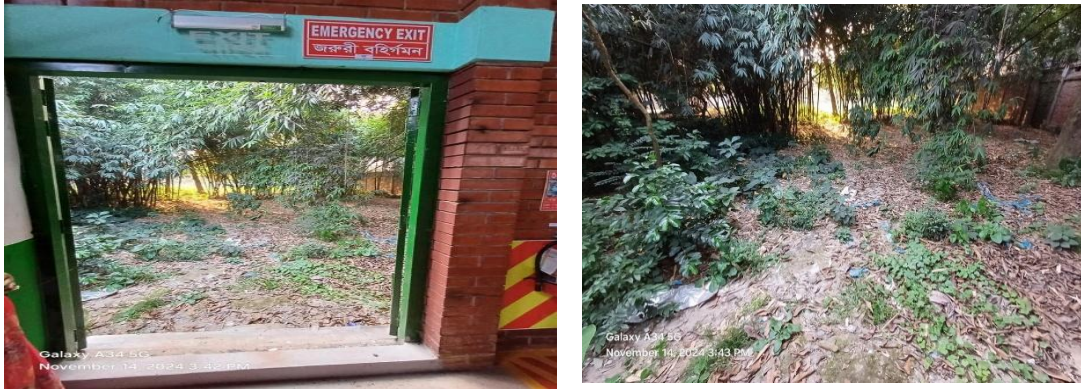
| F-3 | Means of Egress | West side exit discharge path was uneven.<br><b>Locations:</b> Warehouse Shed-2. | Remove unnecessary items and level exit path to the public way. | Within 1 month |

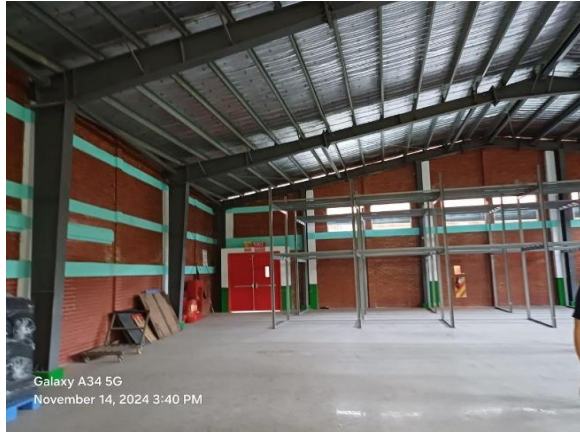
| F-4 | Means of Egress | Aisle marking is not provided.<br><b>Location:</b> Warehouse Shed-2. | Provide minimum aisle widths of 36-inch. All the aisles shall be marked properly and free from any kind of obstruction. | Within 1 Month |

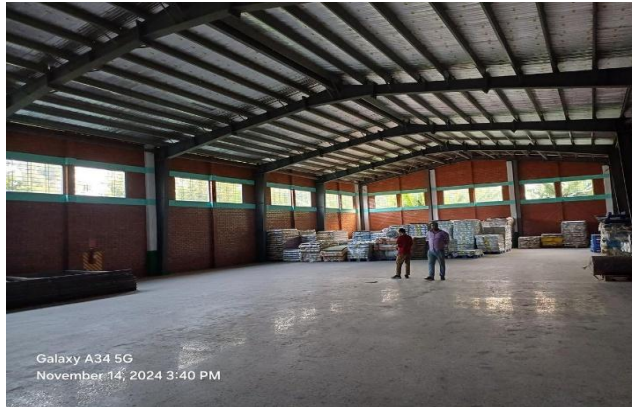
| F-5 | Emergency Lighting | <p>Based on the number and location of emergency lights observed, adequate illumination levels are not anticipated along egress routes.</p> <p><b>Location:</b> Warehouse Shed-2.</p> | <p>Test the emergency lighting system on each floor and provide additional emergency fixtures to supply adequate illumination along the means of egress. Provide a minimum illumination of 10 lux at the floor level within exit stairs and along exit discharge paths and a minimum 2.5 lux along exit access aisles.</p> | Within 1 Month |

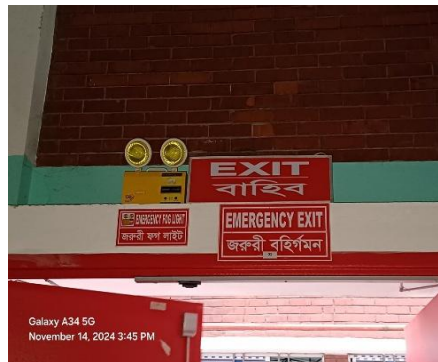
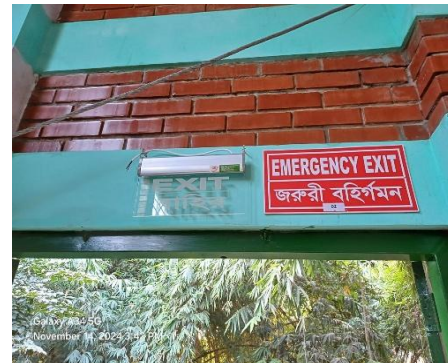
| F-6 | Emergency Lighting | Exit signage was not illuminated.<br><b>Location:</b> Warehouse Shed-2 | Regularly inspect all exit signage and replace/install lights as needed to illuminate signs. | Within 1 month |

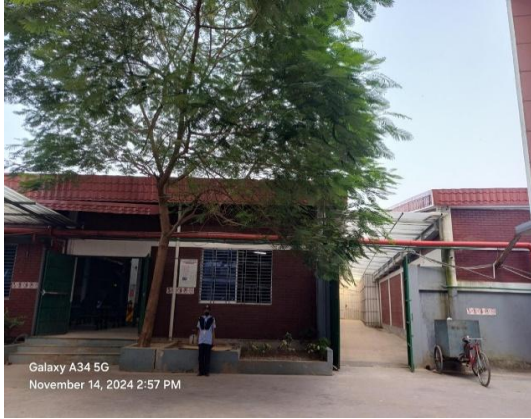
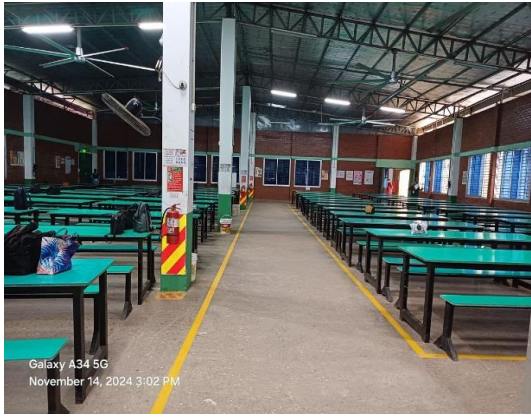
| Sl No. | Category | Findings | Required Action | Remediation Time Frame |
|---|---|---|---|---|
| F-1 | Fire Rated Construction | The Dining & Store Shed was constructed at 2022. The construction type is unprotected steel construction. Fire Resistance Ratings of Exterior Walls is not maintaining considering the Fire Separation Distance. | The construction type shall confirm to be in accordance with BNBC 2020 Part-3, Table 3.1.7. Ensure fire resistive rated construction following Table 3.3.1 (a) Part 3 Section-3, Table 3.2.2 and Table 3.2.3 Part 3 Section 2 and Table 4.1.1 from BNBC 2020 Part 4 Section 1. Provide design philosophy to determine the construction type as per BNBC 2020. If any construction rating requires, Consult a qualified fire protection engineer to achieve the require fire rating. | Within 6 months |

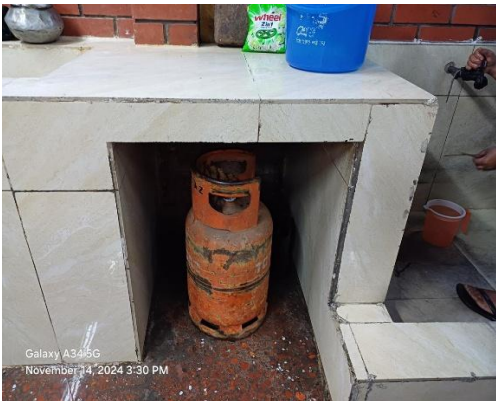
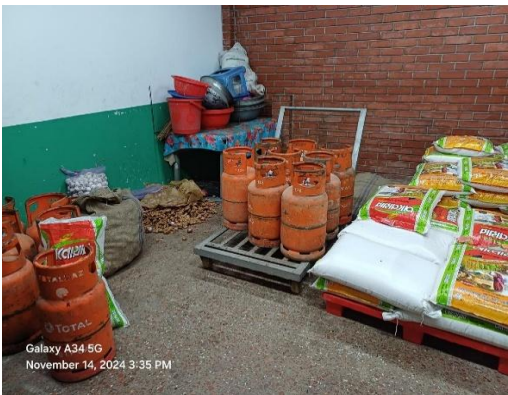
| F-2 | Fire Rated Construction | <p>Liquefied or compressed gas cylinders were located within the factory (kitchen &amp; kitchen store) without adequate fire separation.</p> <p><b>Location:</b> Dining &amp; Store Shed</p> | <p>Remove the liquefied or compressed flammable gas cylinders. The storage or use of liquefied or compressed flammable gas (LPG/CNG) cylinders within the factory building as per section 3.4.2.1.11 of RSC Technical Guidelines (Standard)<sup>1</sup> V1.0.</p> <p>Or,</p> <p>Factory shall follow the requirements RSC Published "SUPPLEMENTARY PAPER ON TECHNICAL GUIDANCE NOTE FOR USE OF LIQUIFIED OR COMPRESSED FLAMMABLE GAS IN FACTORY PREMISES" to use or store liquefied or compressed flammable gas cylinders in the factory premises.</p> | Within 3 Months |

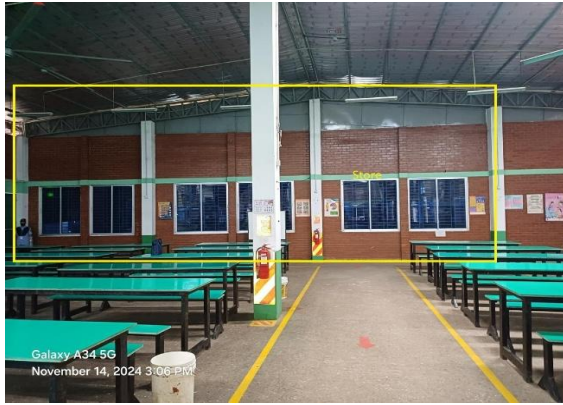
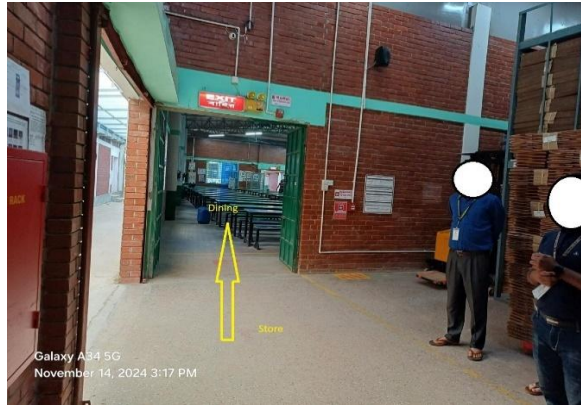
| F-3 | Fire Rated Construction | <p>Dining area (I3) was not separated by fire rated construction with adjacent store room (H2).</p> <p><b>Location:</b> Dining &amp; Store Shed</p> | <p>The dining area (I3) is not permitted with storage area (H2) following table 3.2.1 of BNBC-2020.</p> <p>Required number of exits for entire dining arrangement shall lead directly to safe discharge path without passing through another occupancies.</p> | Within 3 months |

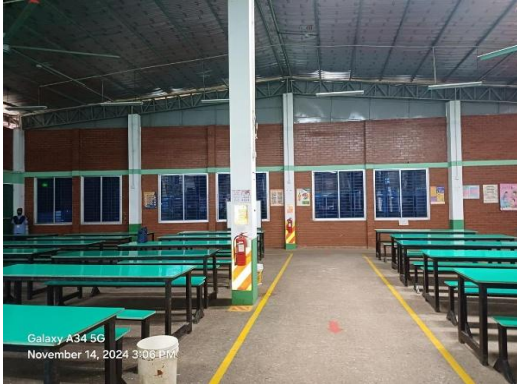
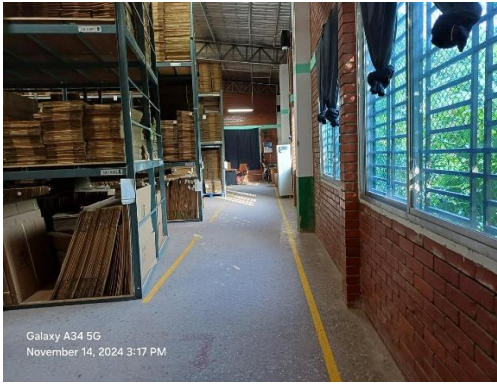
| F-4 | Emergency Lighting | <p>Based on the number and location of emergency lights observed, adequate illumination levels are not anticipated along egress routes and at exit stairs on all floors.</p> <p><b>Location:</b> Dining &amp; Store Shed</p> | <p>Test the emergency lighting system on each floor and provide additional emergency fixtures to supply adequate illumination along the means of egress. Provide a minimum illumination of 10 lux at the floor level within exit stairs and along exit discharge paths and a minimum 2.5 lux along exit access aisles.</p> | Within 1 Month |

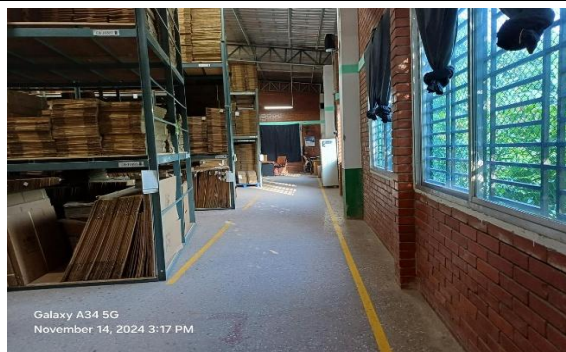
| F-5 | Emergency Lighting | <p>Directional exit sign was not provided along a path of egress.</p> <p><b>Location:</b> Dining &amp; Store Shed</p> | <p>Provide exit signs above all building exits to the exterior, all doors to the exit stairs and along all paths of travel where a change of direction is not obvious. Lighted exit signs shall be provided with either battery backup or uninterruptable power supply systems and shall be continuously illuminated.</p> | Within 1 month |

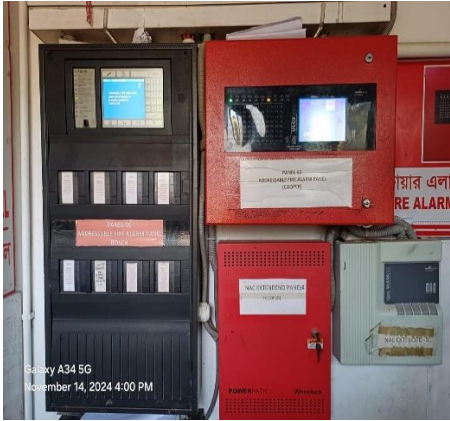
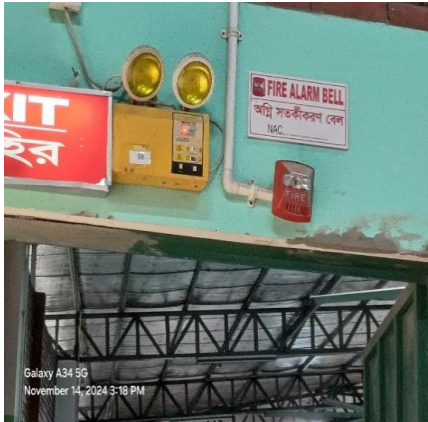
| F-9 | Fire Alarm & Detection System (FADS) | <p>The installation of fire alarm and detection system is on going which requires a detailed review to confirm compliance with NFPA 72 and RSC Technical Guidelines (Standard).</p> <p><b>Location:</b> All sheds.</p> | <p>Submit the fire alarm and detection system design to RSC for review.</p> <p>Once the design is reviewed, install and modify the fire detection and alarm system throughout the building in accordance with review comment, RSC Technical Guidelines (Standard) and NFPA 72.</p> <p>After installation the owner shall conduct internal testing and commissioning and then contact the RSC for witness of final acceptance testing.</p> | Design Review within 2 months and installation/modification within 4 months. |
