# LCB INTERNATIONAL (BD) LTD.

Plot 48, Sector 7, CEPZ, Chattogram  
(22.299803, 91.776259)

11 February 2025

## 1. Building Information:

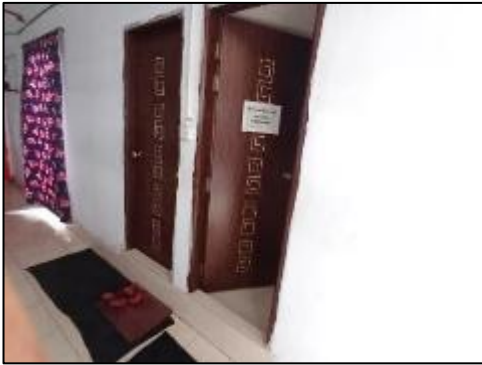
200 mm build-up at 3rd-floor toilet

**Description:** During the inspection, undocumented 200 mm build-up at the 3rd-floor toilet and 100 mm false slab at typical floor toilets were observed. Roof bracing was missing, and truss mismatches were observed at the RO plant shed.

The building engineer is required to survey the whole structure and update as-built drawings as per site conditions.

| Item No. | Observation | Action Plan | Timeline |
|---|--|---|---|
| 6 | Discrepancies in as built drawings (Production Building) | The building engineer is required to survey the whole structure and update the as-built drawings. | within 6 weeks |

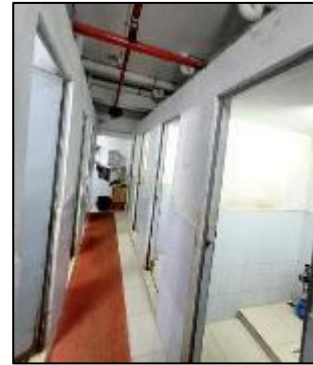
100 mm false slab at typical floor toilet area

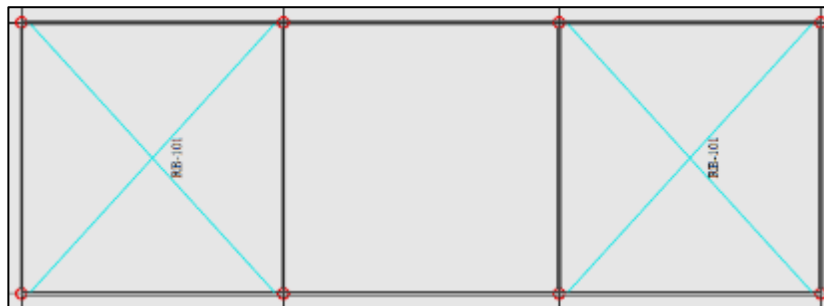
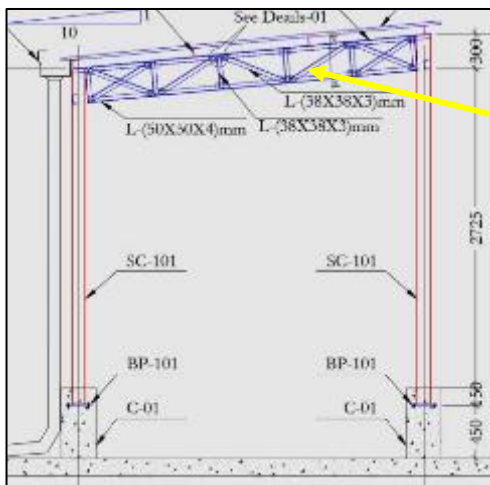
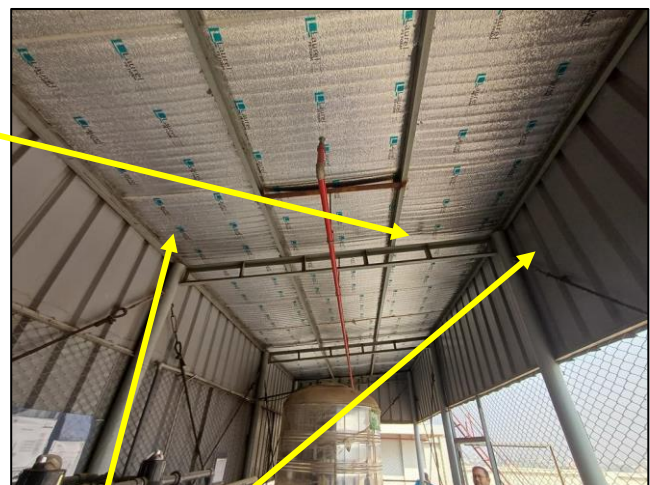
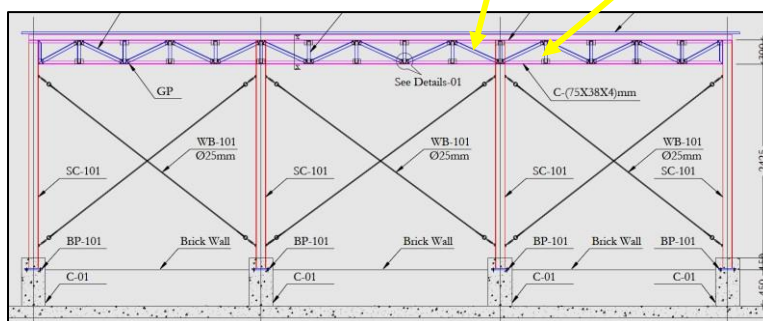
Roof bracing layout (RO plant)

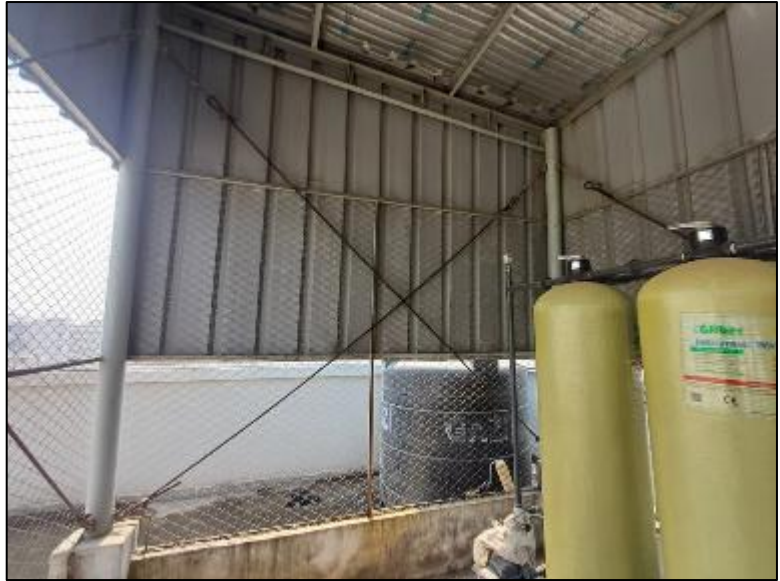
**Observation-4:** Loose cable bracing in RO plant shed (Production Building).

**Description:** During the inspection, cable bracings were found in loose condition. The factory is required to tighten all loose bracings.

| Item No. | Observation | Action Plan | Timeline |
|---|--|---|---|
| 7 | Loose cable bracing in RO plant shed (Production Building) | The factory is required to tighten all loose bracings. | within 6 weeks |

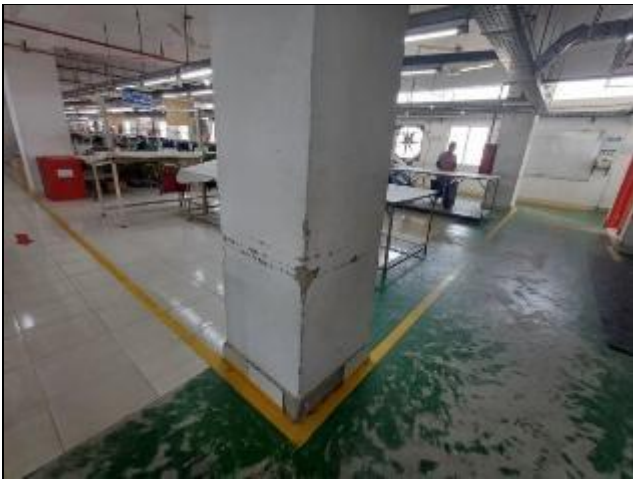
Trolley impact on typical floor column

**Description:** During the inspection, column edges of several floors were found affected due to trolley impact and several columns at ground floor loading/unloading area are susceptible to vehicle impact. The factory is required to provide safety barriers to protect the columns from trolley/vehicle impact.

| Item No. | Observation | Action Plan | Timeline |
|---|--|---|---|
| 8 | Column susceptible to trolley/vehicle impact (Production Building) | The factory is required to provide a safety barrier to protect the columns from trolley/vehicle impact. | within 6 weeks |

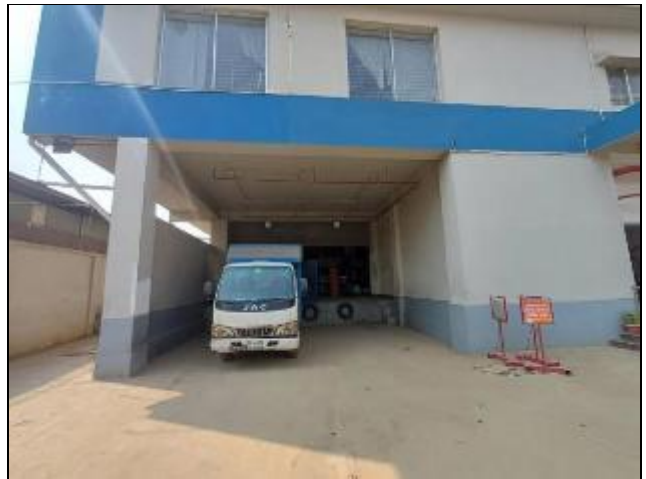
Susceptible to vehicle impact

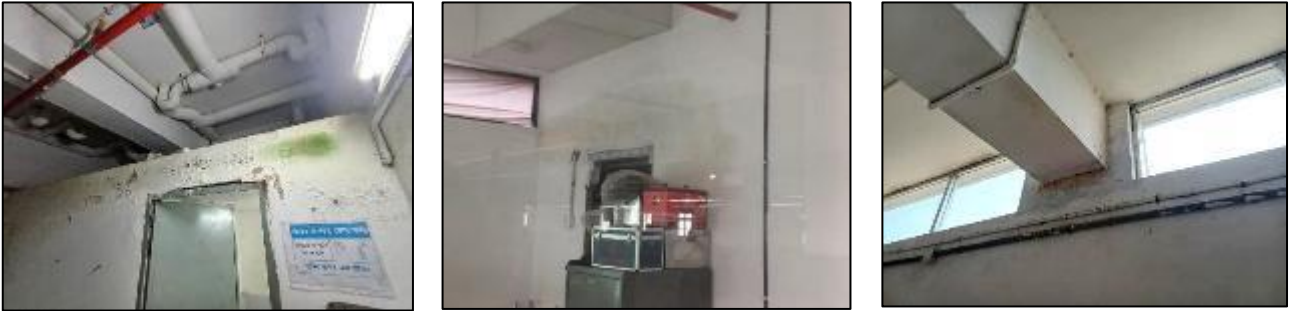
**Observation-6:** Dampness on brick wall (Production Building).

**Description:** During the inspection, dampness on brick walls was observed at several locations. The factory is required to repair the dampness with suitable methods.

| Item No. | Observation | Action Plan | Timeline |
|---|--|---|---|
| 9 | Dampness on brick wall (Production Building) | The factory is required to repair the dampness with suitable methods. | within 6 weeks |

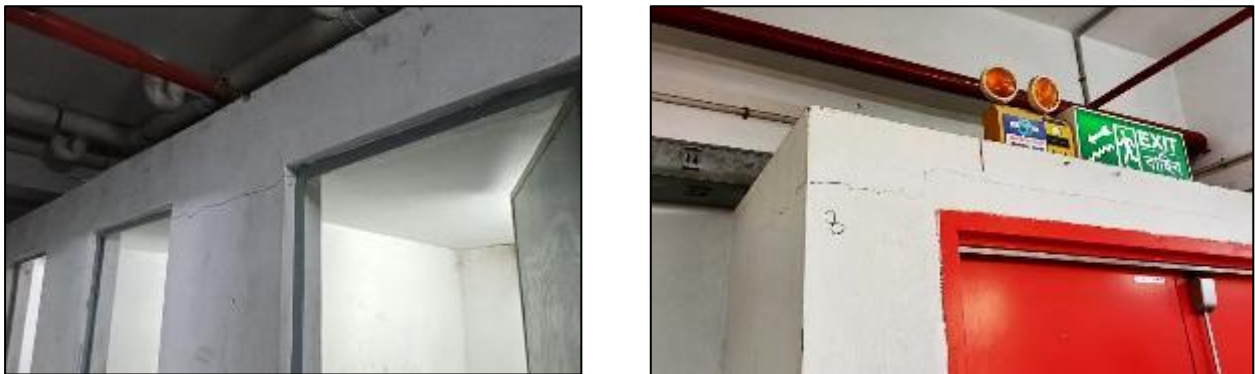
**Observation-7:** Crack in brick wall (Production Building).

**Description:** During the inspection, cracks in brick walls were observed at several locations. The factory is required to repair the crack with suitable methods.

| Item No. | Observation | Action Plan | Timeline |
|---|--|---|---|
| 10 | Crack in brick wall (Production Building) | The factory is required to repair the crack with suitable methods. | within 6 weeks |

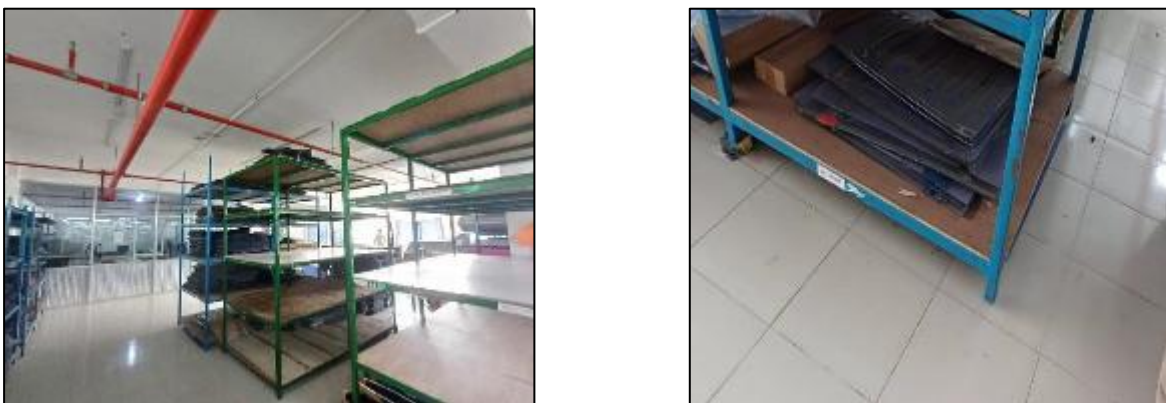
Unbraced/unanchored racks on 3rd floor

**Description:** Unbraced and unanchored steel storage racks were found on the 3rd floor. The factory is required to brace/anchor all non-structural elements (storage racks) to prevent falling during seismic.

| Item No. | Observation | Action Plan | Timeline |
|---|--|---|---|
| 11 | Non-structural elements found unbraced/not anchored (Production Building) | The factory is required to brace/anchor all non-structural elements (storage racks) to prevent falling during Seismic. | within 6 weeks |

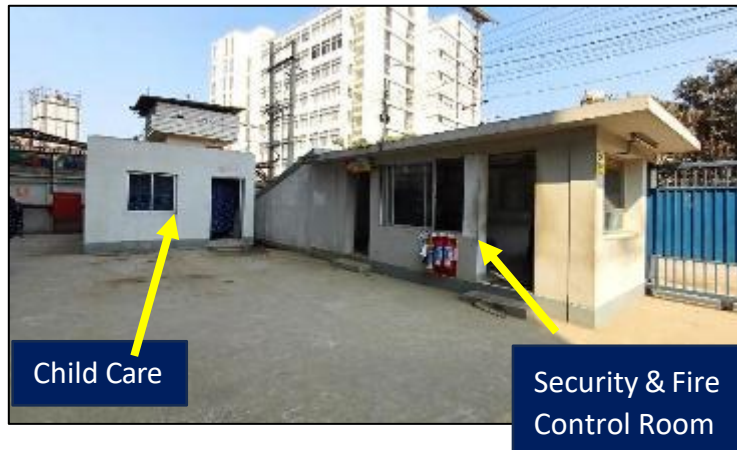
Isometric View

**Description:** A separate as-built drawing was available for the childcare and Security room. However, the structures are structurally connected by underground water tanks. The building engineer is required to survey the field condition and update the as-built drawings.

| Item No. | Observation | Action Plan | Timeline |
|---|--|---|---|
| 12 | Inconsistencies in as-built drawings (Security, Child Care and Fire Pump Room) | The building engineer is required to survey the whole structure and update the as-built drawings. | within 6 weeks |

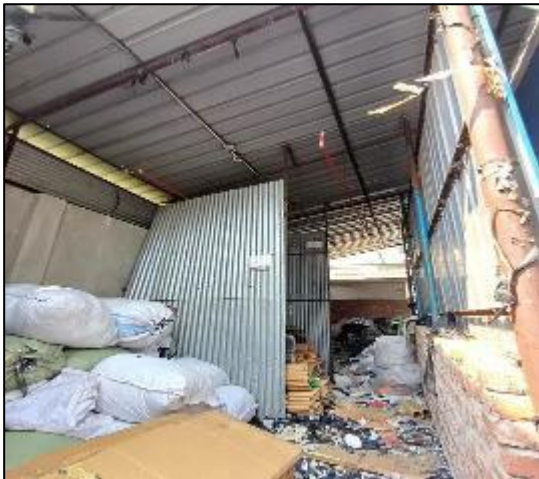
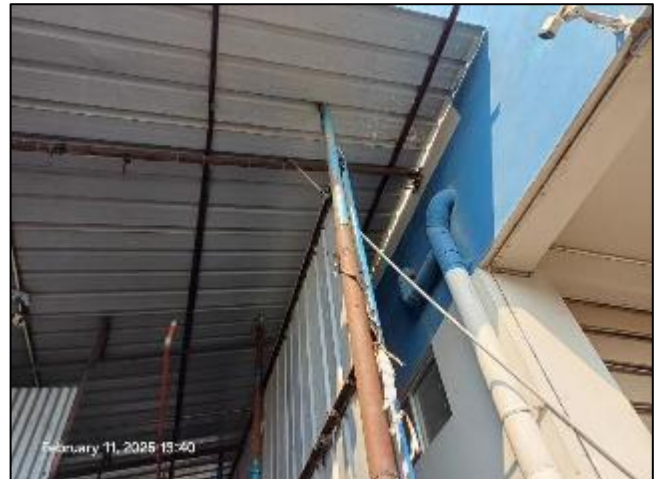
**Observation-10:** Non-engineered shed (Wastage Shed)

**Description:** Non-engineered framing and connection was observed. The building engineer is required to provide the necessary alternatives to make the structure stable. Otherwise, replace it with an engineered one.

| Item No. | Observation | Action Plan | Timeline |
|---|--|---|---|
| 13 | Non-engineered shed (Wastage Shed) | The building engineer is required to provide the necessary alternatives to make the structure stable. Otherwise, replace it with an engineered one. | within 6 weeks |

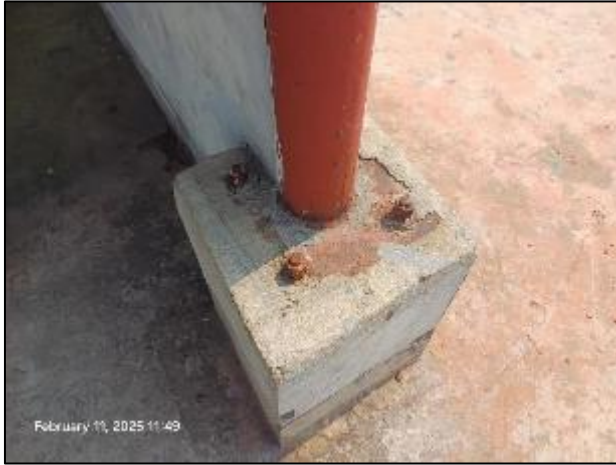
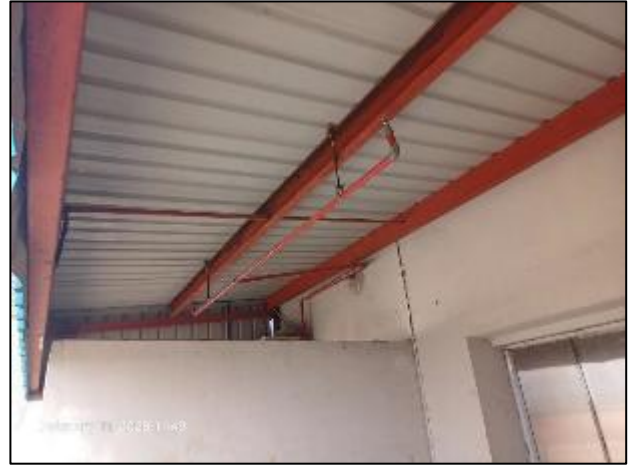
Lift canopy at roof of Production Building

**Description:** During the inspection, corrosion was observed on several steel members. The factory is required to remove rust and apply anti-corrosive paint on steel members.

| Item No. | Observation | Action Plan | Timeline |
|---|--|---|---|
| 14 | Corrosion on steel member (Lift canopy at roof of Production Building) | The factory is required to remove rust and apply anti-corrosive paint on steel members. | within 6 weeks |

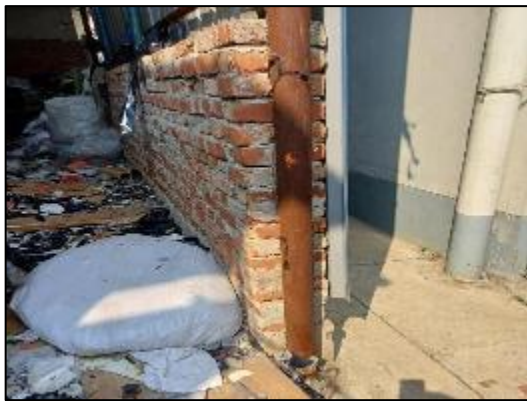
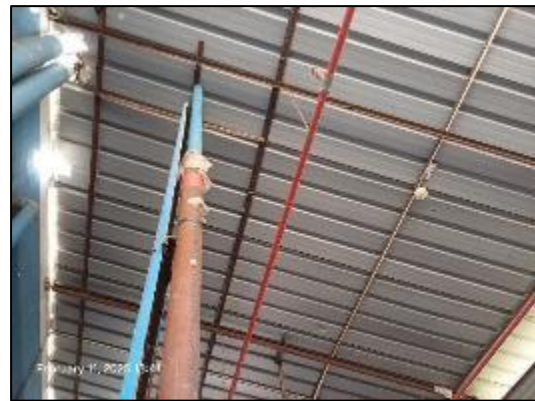
Wastage Shed

| Item No. | Observation | Action Plan | Timeline |
|---|--|---|---|
| 15 | Corrosion on steel member (Wastage Shed) | The factory is required to remove rust and apply anti-corrosive paint on steel members. | within 6 weeks |
