# Brandix Apparel Bangladesh Ltd. (Extension)

## Structural Inspection Report

FG warehouse & Finishing Building 3-storied (G+2) RC building.

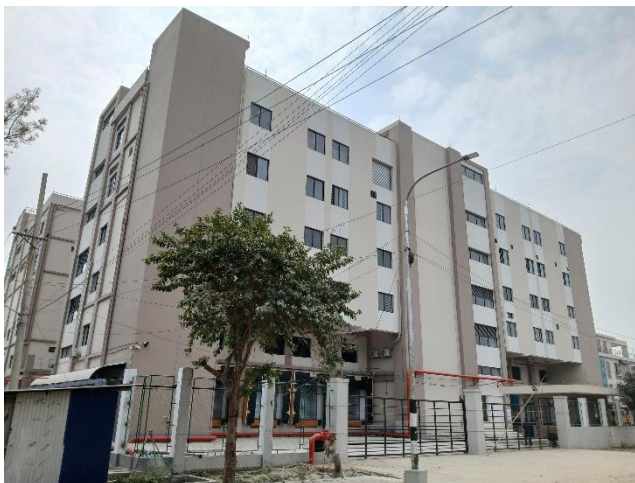
**Observation-1:** Prepared design report needs to be reviewed against lateral forces (FG Warehouse & Finishing Building).

**Description:** A design report has been prepared for the three storied FG Warehouse & Finishing Building. The prepared design report needs to be reviewed against lateral forces. Submit the design report to the RSC for detailed review.

| SL | Observation | Action Plan | Timeline |
|---|---|---|---|
| 1. | Design report needs to be reviewed against lateral forces (Main Factory Building). | The building engineer is required to submit the prepared design report to RSC for review against lateral forces. | within 6 weeks |
| 2. | | Carry out remedial work and implement loan management plan. | within 6 months |

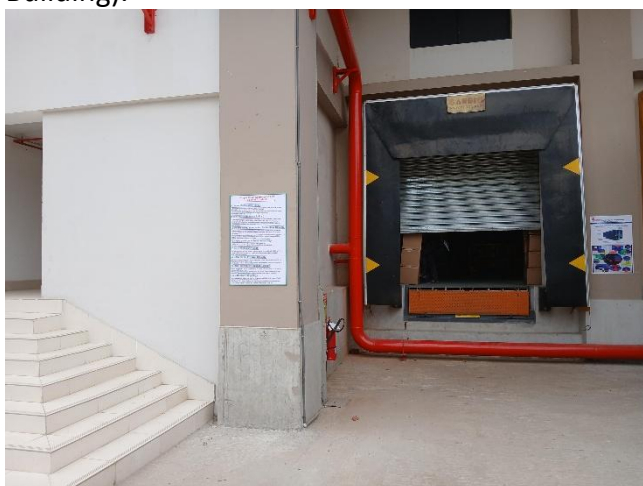
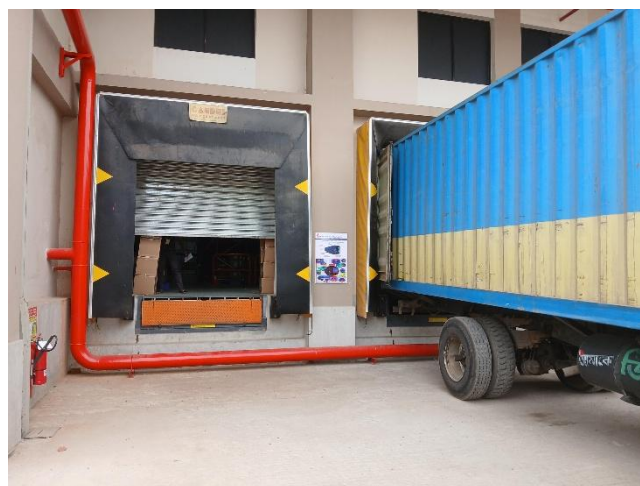
**Observation 2:** Possible vehicle impact on ground floor columns (FG Warehouse & Finishing Building).

Possible vehicle impact on ground floor columns

**Description:** Ground floor columns were found susceptible to vehicle impact. The building engineer is required to provide barrier around the columns to protect from vehicle impact.

| SL | Observation | Action Plan | Timeline |
|---|---|---|---|
| 3. | Possible vehicle impact on ground floor columns (FG Warehouse & Finishing Building). | The building engineer is required to provide separate barrier around the columns to protect from vehicle impact. | within 6 months |
