# INITIAL FIRE SAFETY INSPECTION REPORT

**Adury Fashion & Print Ltd.**

**RSC ID: 26472**

# Fire Safety Inspection Report

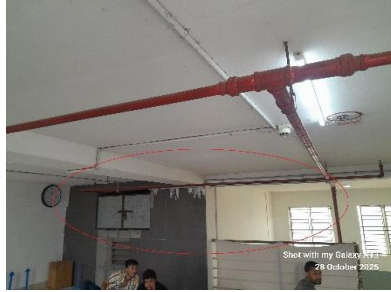
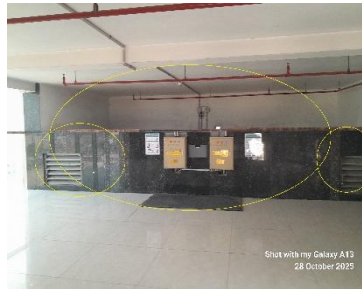
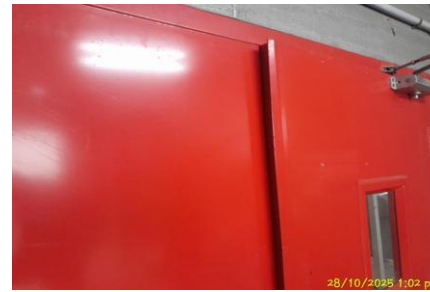
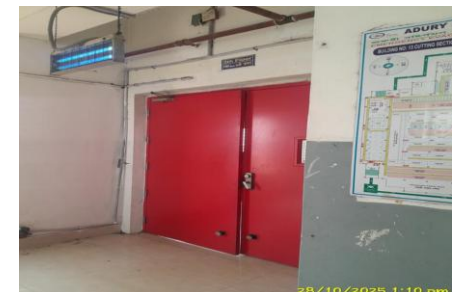
| SI No. | Category | Findings | Required Action | Remediation Time Frame |
|---|---|---|---|---|
| F-1 | Means of Egress | <p>The exit stair enclosures are not separated from work areas and other spaces on each floor by fire-rated construction.</p> <p><b>Location(s): Roof, Building-13.</b></p> <p><b>Non-compliance: Unprotected opening from the lift machine room, fire door non-functionality, etc.</b></p> | <p>The exit stair enclosure shall be provided with a minimum of 2-hr. fire resistance rating for buildings 4 or more stories. Provide 1.5 hr. fire rated door and seal all penetrations and openings by 2 hr. fire rated fire rated barrier construction for building with 4 or more stories in accordance with section 6.3.1.2 of RSC Technical Guidelines (Standard)<sup>1</sup> V1.0.</p> <p>Provide a fire-resistive rated assembly between the exterior exit stairs and the building up to 10 ft. beyond the end of the stair to achieve the required separation. The rated assembly shall be approved and/or designed by a qualified fire protection engineer.</p> <p>Ensure that the fire doors are self-closing and positive latching and that they are provided with fire exit (panic) hardware where serving production floors. If fire doors are required to be held open for functional reasons, provide automatic closing devices tied to the fire alarm system.</p> | Within 3 Months |

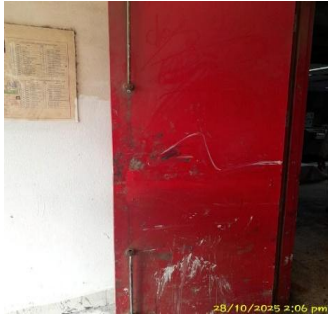
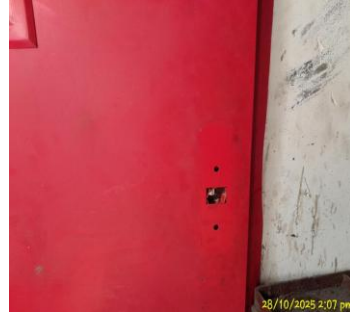
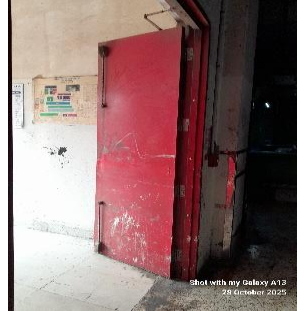
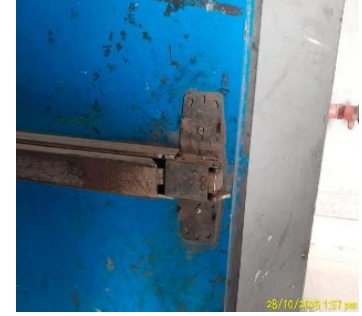
| F-2 | Means of Egress | <p>Proper certification was not available for fire rated doors and door accessories installed in the factory and most of the fire doors and accessories were in damaged condition.</p> <p><b>Location(s): All floors, Building-13.</b></p> | <p>Keep proper datasheet &amp; certifications for installed fire doors &amp; accessories on-site for verification.</p> <p>Replace/install the non-functional/missing fire door accessories and properly inspect, test &amp; maintain fire door as per NFPA 80.</p> <p>In cases of a field modification, the laboratory with which the product or component being modified is listed shall be contacted through the manufacturer and a written or graphic description of the modifications shall be presented to that laboratory.</p> <p>A written authorization from that laboratory is required. Field modification shall conduct as per NFPA 80.</p> | Within 1 Month |

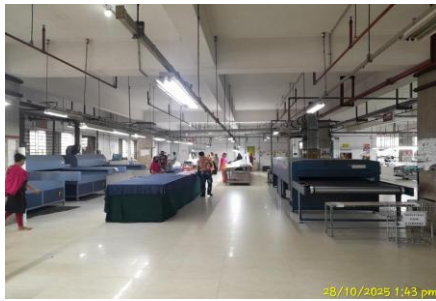
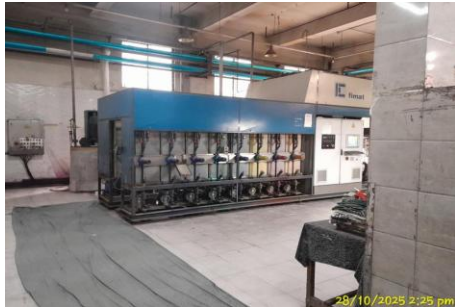
| F-4 | Means of Egress | <p>Aisles were found missing in several locations.</p> <p><b>Location(s): GF (Auto colour room), 2nd floor (Printing area), etc. (Building-13)</b></p> | <p>Provide minimum aisle widths of 36-in. Aisles mark shall be clearly visible.</p> | <p>Within 1 Month</p> |

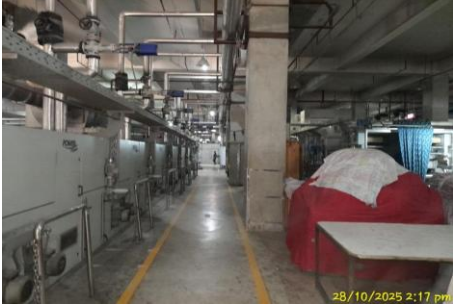
| F-5 | Means of Egress | <p>Directional signs are not provided where direction of the path of travel to an exit has changed.</p> <p><b>Location(s): Building-13.</b></p> | <p>Illuminated directional signs shall be provided where there is a change in the direction for the path of travel and the direction to an exit is not obvious in accordance with RSC Technical Guidelines (Standard)<sup>1</sup> V1.0 Section 6.11.3.</p> | Within 1 Month |

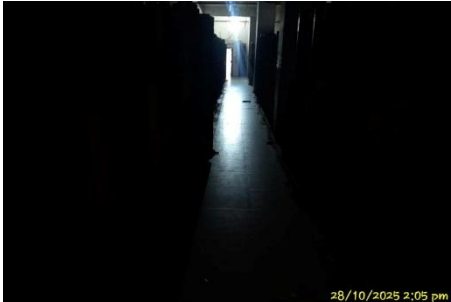
| F-6 | Means of Egress | <p>Based on the number and location of emergency lights observed, adequate illumination levels are not anticipated along egress routes.</p> <p><b>Location(s): All floors, Building-13.</b></p> | <p>Test the emergency lighting system on each floor and provide additional emergency fixtures to provide adequate illumination along the means of egress. Provide a minimum illumination of 10 lux at the floor level within exit stairs and exit discharge paths and minimum 2.5 lux along exit access aisles. Illumination on means of egress shall meet in accordance with RSC Technical Guidelines (Standard)<sup>1</sup> V1.0 Section 10.12.2.</p> | Within 3 Months |

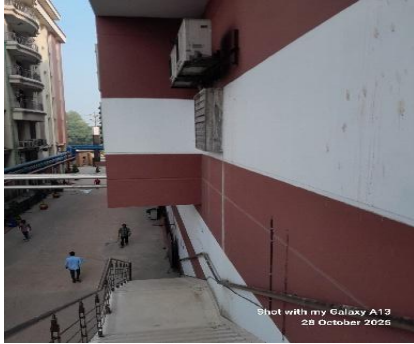
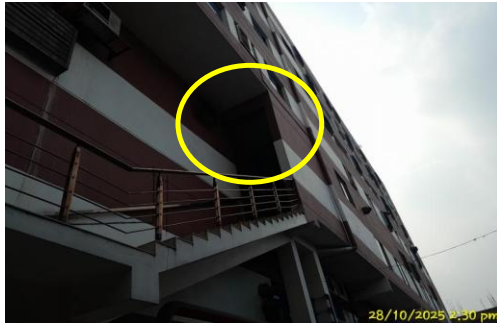
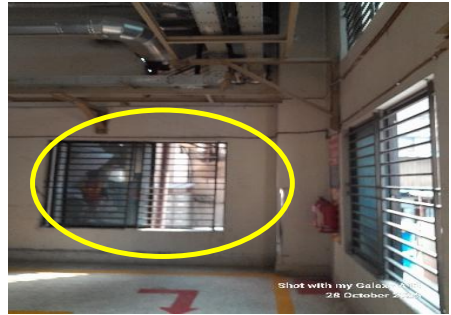
| F-8 | Means of Egress | <p>The exterior exit stair is not separated from the building interior within 10 feet of the exit stair.</p> <p><b>Location(s): North-Mid Stair, 1st floor, &amp; south-west stair on GF, Building-13.</b></p> | <p>Nonrated walls or unprotected openings enclose the exterior of the stairway and the walls or openings are exposed by other parts of the building at an angle of less than 180 degrees (3.14 rad), the building exterior walls within 3050 mm (10 ft) horizontally of a nonrated wall or unprotected opening shall have a fire-resistance rating of not less than 2 hr. in accordance with section 6.3.1.3 of RSC Technical Guidelines (Standard)<sup>1</sup> V1.0.</p> | Within 3 Months |

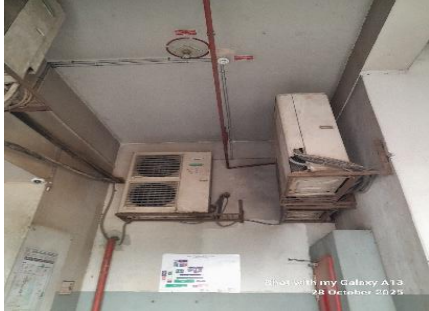
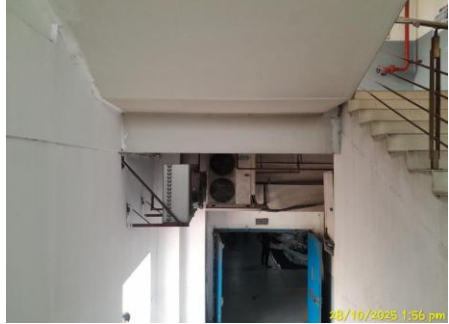
| <b>F-10</b> | Means of Egress | <p>Outdoor AC &amp; DB board were located in the exit stair enclosure.</p> <p><b>Location: South-East stair on GF &amp; 1st floor, Building-13.</b></p> | <p>Remove and re-locate all AC Outdoors from exit stair enclosures.</p> <p>Or,</p> <p>Provide fire separation with stair enclosure in accordance with section 6.3.1 of RSC Technical Guidelines (Standard)<sup>1</sup> V1.0.</p> | Within 3 Months |

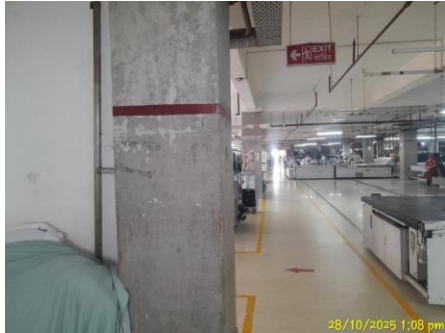
| <b>F-11</b> | Means of Egress | <p>Manual on-off switch is provided for exit signage units.</p> <p><b>Location: All floors of the Building-13.</b></p> | Remove manual on/off switches from emergency lighting / exit signage units to prevent them from being switched off. | Within 1 Month |

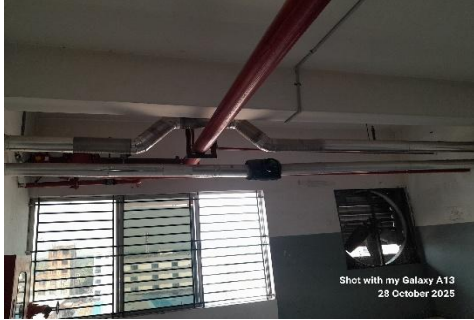
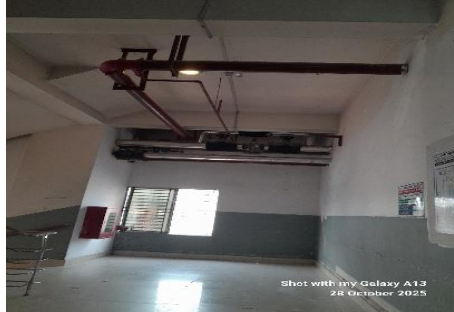
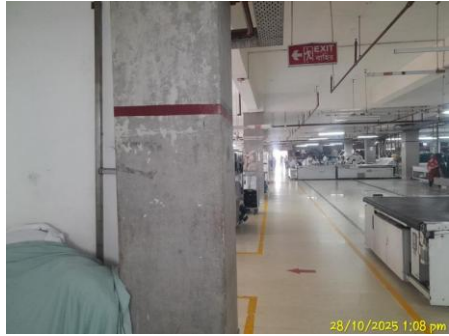
| F-12 | Means of Egress | <p>Unsealed penetrations and openings are located in exit stair enclosures.</p> <p>Stream lines &amp; power cable passing through the exit enclosure.</p> <p><b>Location(s): West-North side on all floor of the Building-13.</b></p> | <p>No other penetration into and through the exit enclosure except for fire alarm equipment electrical raceway, required exit doors, sprinkler piping, standpipes, and electrical conduit serving the exit enclosure is permitted in accordance with section 6.14.4 of RSC Technical Guidelines (Standard)<sup>1</sup> V1.0. So, relocate the electrical wires/raceways to somewhere else avoiding the exit enclosure, and seal the created unprotected openings with a minimum of 1.5 hours listed/certified fire-rated materials. Installation shall be as per manufacturer published installation guideline and the certification authority guideline to ensure the fire-rating. Or seal the penetration by 2-hr masonry construction.</p> | Within 3 Months |

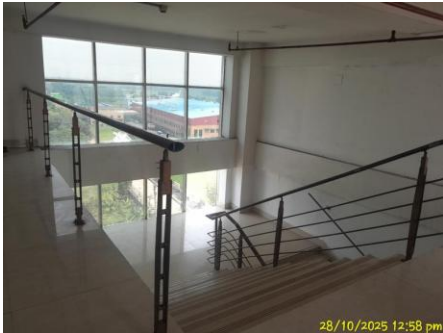
| F-13 | Means of Egress | <p>The guards have gaps that are too large, allowing a sphere 200 mm (8 in.) in diameter to pass through.</p> <p><b>Location: All Handrail of Building-13.</b></p> | <p>Open guards shall have intermediate rails or pattern such that a sphere 200 mm (8 in.) in diameter cannot pass through any opening up to a height of 865 mm (34 in.).</p> | Within 3 Months |

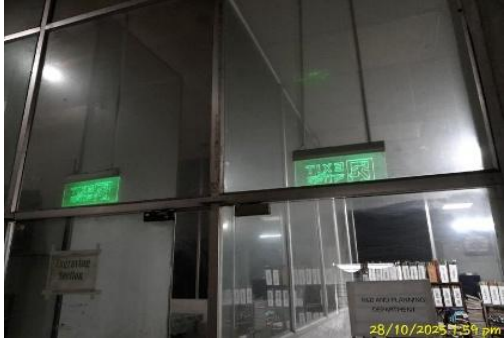
| F-14 | Means of Egress | <p>Some lighted exit signs were two-sided, so that they indicated an exit where there were none.</p> <p><b>Location(s): 1st floor, Building-13.</b></p> | <p>Ensure that lighted exit signs are only visible from the side that directs people toward an exit path.</p> | <p>Within 1 Month</p> |

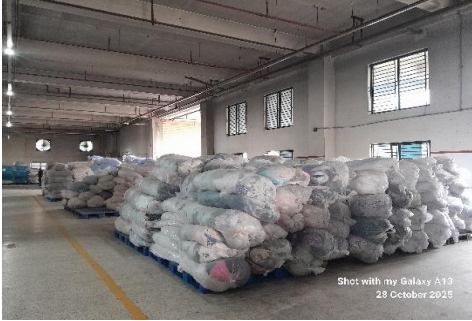
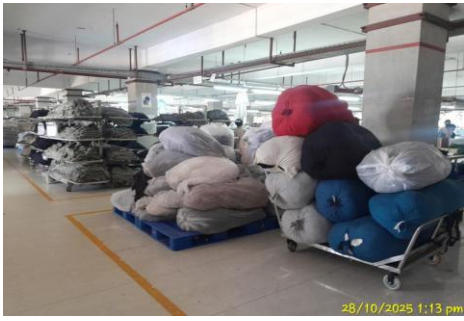
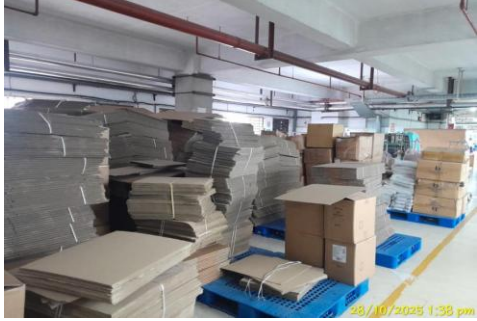
| F-15 | Fire rated construction | <p>Areas used for in-process storage of combustible materials are open to the surrounding occupancy.</p> <p><b>Location(s): Ground, first, 4th &amp; 5th floors of the Building-13.</b></p> | <p>Provide defined storage areas and limit the storage arrangement as follows:</p> <p>Maximum height of 2.45 m and maximum area of 23 m<sup>2</sup> and is separated by a minimum 3.0 m (10ft) from other storage areas and they do not exceed 10 percent of the building area of the story in which they occur.</p> <p>or,</p> <p>If sprinkler protected, Maximum height 12 ft (3.66 m) and maximum area of 1000 ft<sup>2</sup> (93 m<sup>2</sup>) and separated by at least 25 ft (7.62 m) and does not constitute more than 10 percent of the building area or 4000 ft<sup>2</sup> (372 m<sup>2</sup>) of the sprinklered area, whichever is greater.</p> <p>or,</p> <p>Enclose the storage area from the surrounding occupancy with a minimum 1 hour construction.</p> | Within 3 Months |

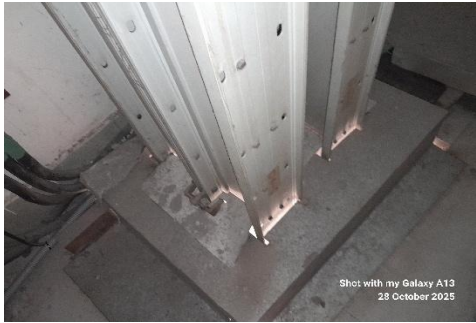
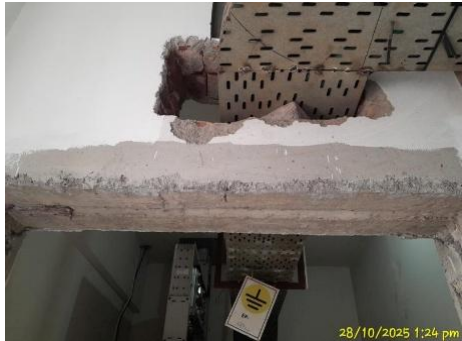
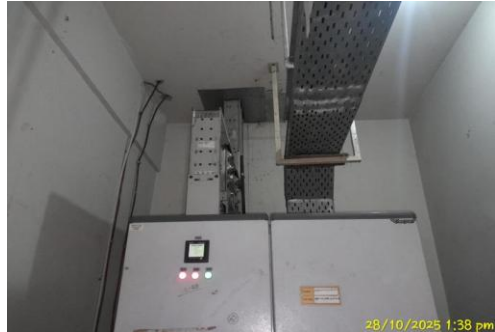
| F-17 | Fire Rated Construction | <p>Penetrations through floor/ceiling assemblies are found unsealed.</p> <p><b>Location(s): Building-13.</b></p> <p><b>Non-compliance reason: Unsealed Penetration through BBT.</b></p> | <p>Seal all penetrations and openings in floor/ceiling assemblies by a listed through-penetration fire stop system tested in accordance with ASTM E814 or approved alternative standard to maintain minimum 3-hr./ 2-hr. fire resistance rating. Installation shall be as per manufacturer published installation guideline and the certification authority guideline to ensure the fire-rating in accordance with section 4.7 of RSC Technical Guideline (Standard)</p> <p>Or,</p> <p>Provide a minimum 2-hr fire rated shaft to separate the penetration from each floor if required.</p> | Within 3 Months |

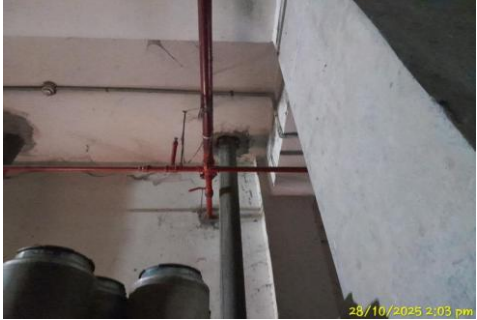
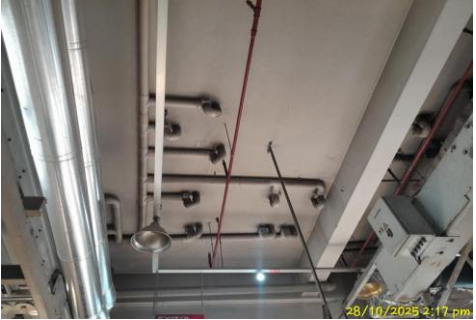
| F-18 | Fire Rated Construction | <p>Penetrations through floor/ceiling assemblies are found unsealed.</p> <p><b>Location(s): Building-13.</b></p> <p><b>Non-compliance reason: Unsealed Penetration through Plastic Plumbing Pipe, Steam Pipe, etc.</b></p> | <p>Seal all penetrations and openings in floor/ceiling assemblies by a listed through-penetration fire stop system tested in accordance with ASTM E814 or approved alternative standard to maintain minimum 3-hr. fire resistance rating. Installation shall be as per the manufacturer's published installation guidelines and the certification authority guideline to ensure the fire-rating in accordance with section 4.7 of RSC Technical Guideline (Standard)</p> <p>Or,</p> <p>Provide a minimum 2-hr fire rated shaft to separate the penetration from each floor if required.</p> | Within 3 Months |

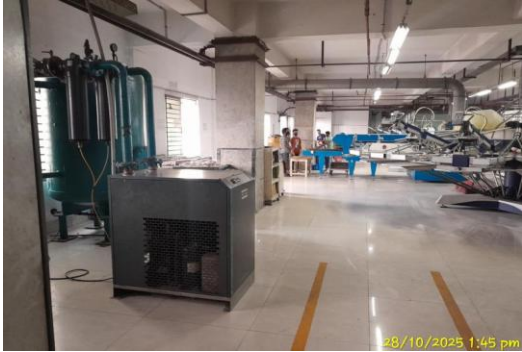
| F-19 | Fire Rated Construction | <p>Compressor is not separated by fire-rated construction from other Occupancies (production area).</p> <p><b>Location(s): 2nd floor, Building-13.</b></p> | <p>Boilers/compressor or other heat producing equipment shall be separated from other occupancies by a minimum 1-hr fire rated construction (wall, floor, slab etc.). Seal all penetrations and openings (door, window etc.) should be protected by 0.75-hr (45 min) fire rated materials to maintain the fire separation if required. All exhaust systems shall discharge to the exterior of the building in a safe location.</p> <p>Or</p> <p>Relocate it to exterior of the building and maintain a minimum 3m (10 ft.) spatial separation distance from the building. Boiler room separation shall meet section 3.4.2.1.2 of RSC Technical Guideline (Standard) .</p> | Within 3 Months |

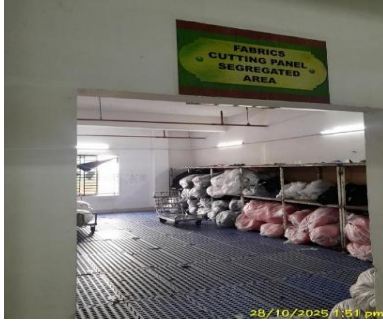
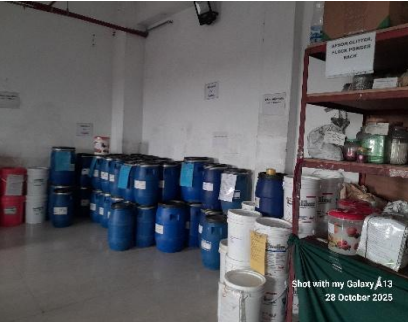
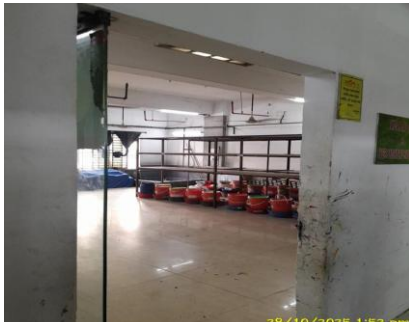
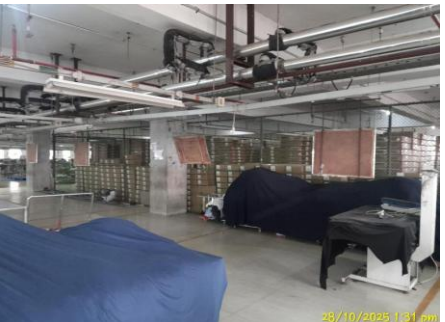
| F-20 | Fire Rated Construction | <p>Rooms used for storage and printing material storage are not separated from the surrounding occupancy (Production).</p> <p><b>Location(s): 1st, 2nd, 4th floors, etc. Building-13.</b></p> <p><b>Non-Compliance: 1. Unprotected opening at Printing material storage on the Ground Floor &amp; 2nd Floor.</b><br/> <b>2. Unprotected opening for store on 1st Floor, 2nd, 4th Floors, etc..</b></p> | <p>Rooms used for storage of combustible materials shall be separated from the surrounding occupancy with a minimum 1 hour construction in accordance with section 3.4.2.1.5 of RSC Technical Guideline (Standard).</p> | Within 3 Months |

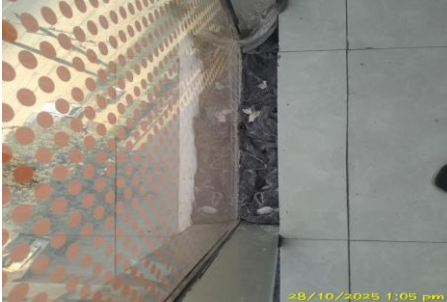
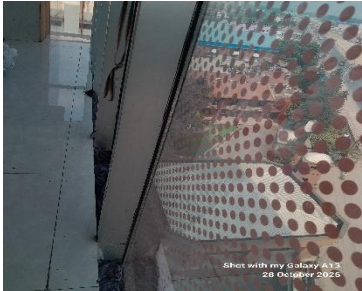
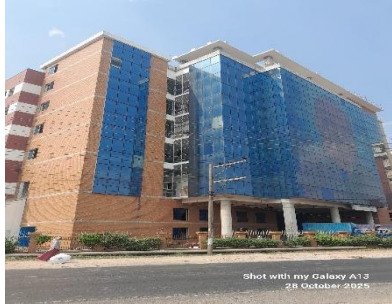
| <b>F-21</b> | Fire Rated Construction | <p>Unprotected openings in the exterior wall in two consecutive floors lying within 1.5 m and vertical spread of fire is not restricted.</p> <p><b>Location(s): East side, South &amp; West side of the Building-13.</b></p> | <p>Provide flame barriers as similar as sunshades or cornices or projected wall at least 750 mm from the external face of the exterior wall. BNBC 2006 Part III chapter 3 clause 3.1.7.2.</p> | Within 6 Months |

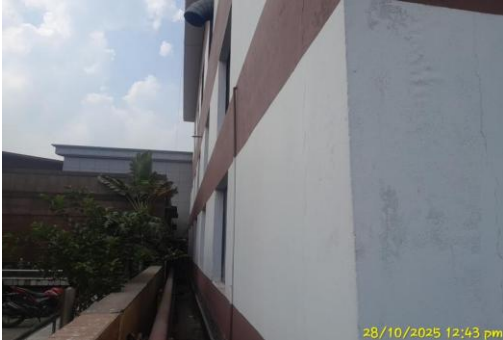
| F-22 | Fire Rated Construction | <p>The required fire separation distance for the main production building does not comply with the requirements of BNBC 2006.</p> <p><b>Location(s): South side of the Building-13.</b></p> | <p>The exterior walls shall have a fire resistance and opening protection as specified in BNBC 2006, Tables 3.2.2 and Part 3 Section 2.4.1.3.</p> | Within 6 Months |

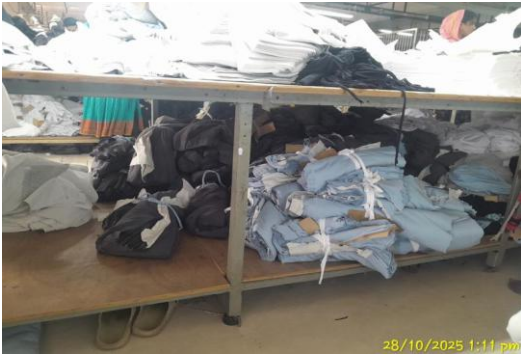
| F-23 | Fire Rated Construction | <p>Storages were found underneath the cutting tables.</p> <p><b>Location(s): 5th floor, Building-13.</b></p> | <p>Storage underneath the cutting tables shall be kept clear of combustibles at all time, except as provided for miscellaneous storage in accordance with 3.4.2.1.6 or ,</p> <p>Where an automatic sprinkler system is installed sprinklers are required to be installed beneath cutting tables greater than 4 ft in width that are used for storage of combustibles.</p> | Within 3 Months |

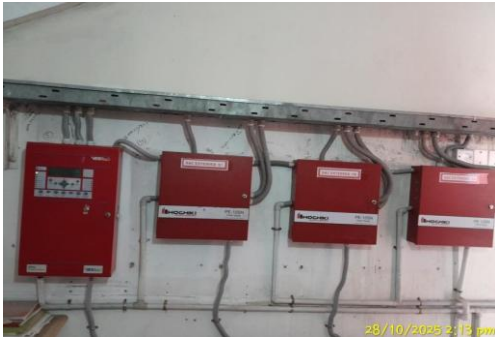
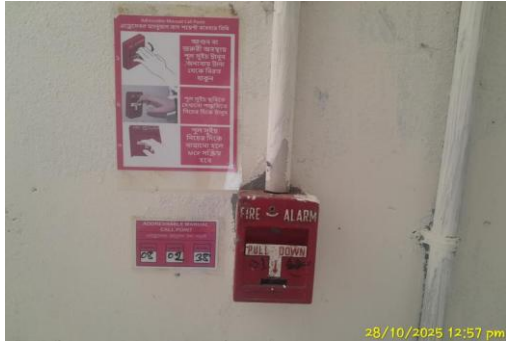
| <b>F-24</b> | Fire Alarm & Detection System (FADS) | <p>The factory has installed a fire alarm and detection system that requires a detailed review to confirm compliance with NFPA 72 and RSC Technical Guidelines (Standard).</p> <p><b>Location(s): Building-13.</b></p> | <p>Submit the fire alarm and detection system design to RSC for review.</p> <p>Once the design is reviewed, install and modify the fire detection and alarm system throughout the building in accordance with review comment, RSC Technical Guidelines (Standard) and NFPA 72.</p> <p>After installation the owner shall conduct internal testing and commissioning and then contact the RSC for witness of final acceptance testing.</p> | Design within 2 Month and modification/ installation with 4 Months |

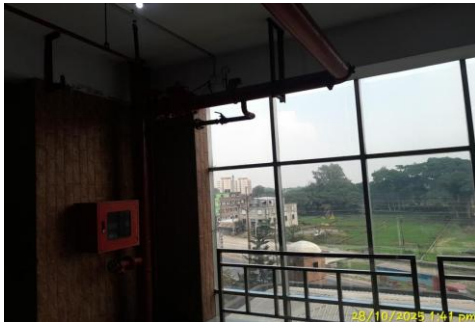
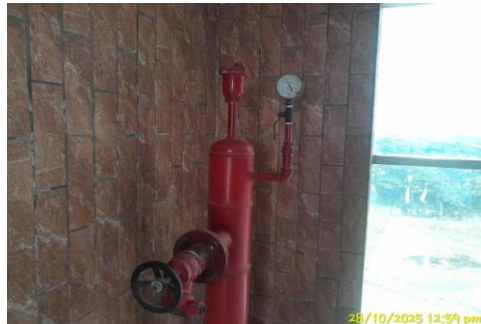
| F-26 | Fire Suppression System (SUPS) | <p>The highest occupied floor of the main building is over 75 feet above grade, mandating a sprinkler system along with a class I standpipe. The factory has installed a sprinkler system with a class III standpipe, requiring a detailed review to ensure compliance with NFPA 13, 14, 20, 22, and 24 and RSC Technical Guidelines (Standard).</p> <p><b>Location(s): Building-13.</b></p> | <p>Submit the fire Suppression System (standpipe and sprinkler) design to RSC for review.</p> <p>Once the design is reviewed, install and modify the fire Suppression System throughout the building in accordance with review comments, RSC Technical Guidelines (Standard), and NFPA 13, 14, 20, 22 and 24.</p> <p>After installation, the owner shall conduct internal testing and commissioning, and then contact the RSC for witness of final acceptance testing.</p> | <p>Design within 2 Months and modification/ installation with 4 Months</p> |

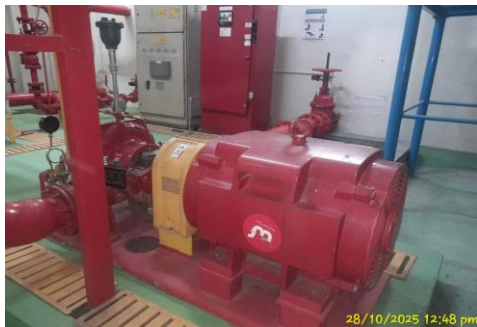
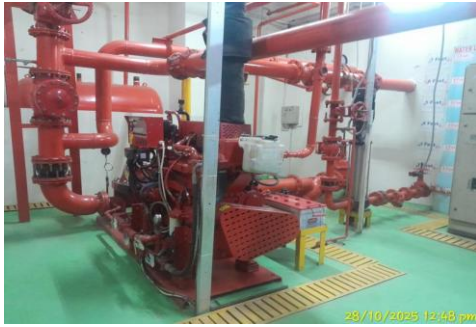
| F-27 | Fire Suppression System (SUPS) | <p>Fire pump installation requires detailed review to confirm compliance with NFPA 20 and RSC Technical Guidelines (Standard)<sup>1</sup> V1.0.</p> <p><b>Location(s): Building-13.</b></p> | <p>Submit as-built drawings, testing records, equipment certification and other relevant documentation to the RSC for review and approval.</p> <p>Submit the standpipe system drawing to RSC for review. Once reviewed, install or modify the standpipe system throughout the building in accordance with RSC Technical Guidelines (Standard)<sup>1</sup> V1.0. and NFPA 14 and 20. The factory management shall contact RSC to conduct the final acceptance testing after the installation, testing &amp; commissioning.</p> | <p>Design within 2 Months and modification/ installation with 4 Months</p> |
