BOILER SAFETY REPORT

Ayesha Fashion Limited

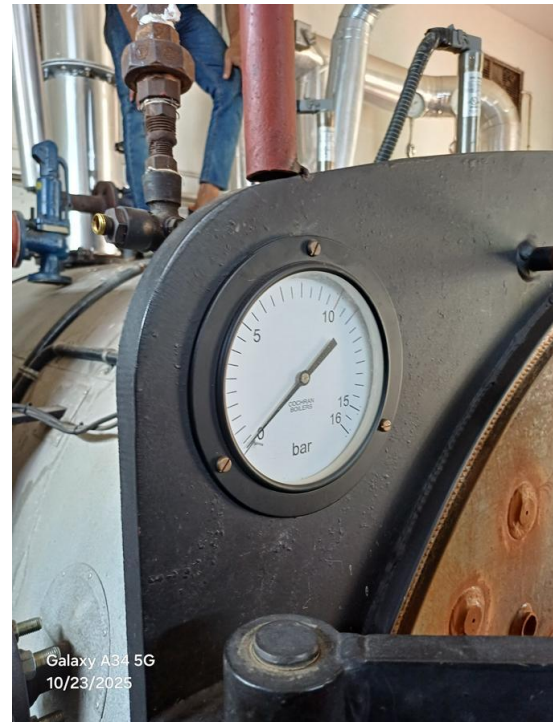
2. INTERNAL INSPECTION & HYDROSTATIC PRESSURE TEST INSPECTION
