# BOILER SAFETY REPORT

**Divine Design Ltd**

**Factory ID: 9542**

**Boiler Numbers** : Non BBR-9542-1  
Non BBR-9542-2  
Non BBR-9542-3

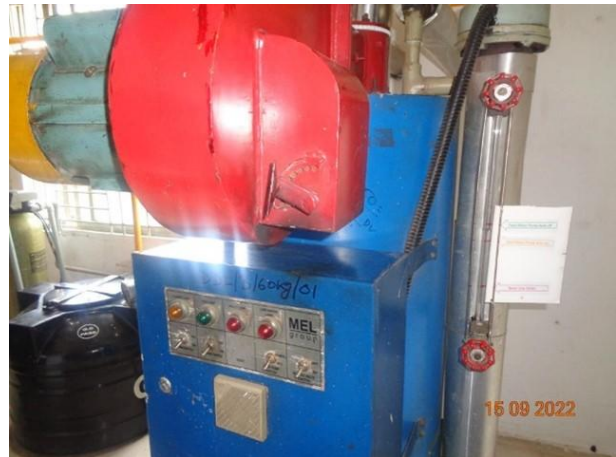
| <b>FINDING NO:</b> | B-3 |

| <b>FINDING:</b><br><br>The boiler manufacturer's nameplate was not available on the boiler. | |

| <b>RECOMMENDATION:</b><br><br>The boiler manufacturer's nameplate shall be available on the boiler with accurate technical information and boiler manufacturer's name in standard language. | |

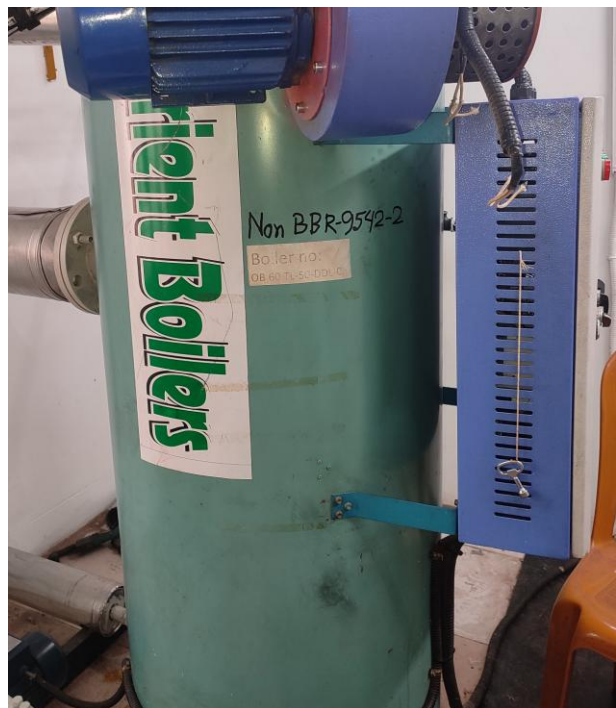
| <b>FINDING NO:</b> | B-4 |

| <b>FINDING:</b><br><br>The boiler manufacturer's nameplate was not available on the boiler. | |

| <b>RECOMMENDATION:</b><br><br>The boiler manufacturer's nameplate shall be available on the boiler with accurate technical information and boiler manufacturer's name in standard language. | |

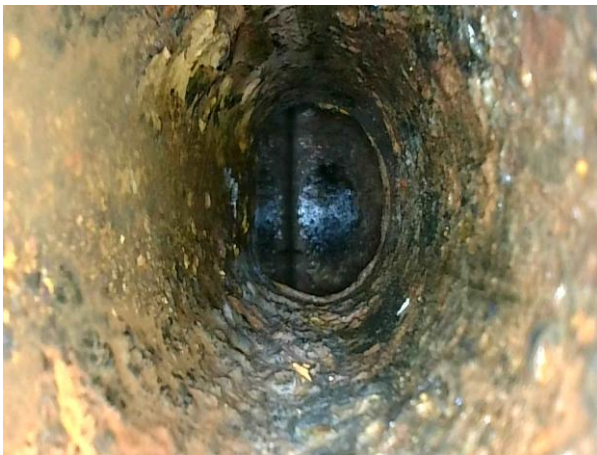
| <b>FINDING NO:</b> | B-7 | |

| <b>FINDING:</b><br><br>Salt and thin scale (3 mm) formation was observed on the waterside. | | |

| <b>RECOMMENDATION:</b><br><br>Cleaning is required. A water treatment station is to be used. Feed and boiler water quality and conditioning should be verified and monitored. The boiler operator should operate the boiler with proper blowdown. | | |
