# INITIAL FIRE SAFETY INSPECTION REPORT

**Habitus Fashion Ltd. (Extension 2)**

**RSC ID: 26547**

**Date: 24-December-2025**

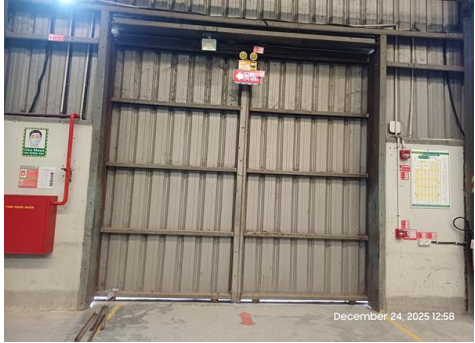
| SI No. | Category | Findings | Required Action | Remediation Time Frame |
|---|---|---|---|---|
| F-01 | Means of Egress | Sliding type doors has been provided along means of egress [building exit].<br><br><b>Location: North Exit of Warehouse Shed.</b> | Replace all sliding type doors & gates by the side-hinged swinging type doors in accordance with section 6.8.1 of RSC Technical Guidelines (Standard) <sup>1</sup> V1.0.<br><br>All doors in a means of egress shall be of the side-hinged swinging type.<br>Roll--down and sliding gates and shutters shall not be allowed.<br>Doors serving an occupant load of more than 50 shall swing in the direction of egress travel. | Within 1 Month |

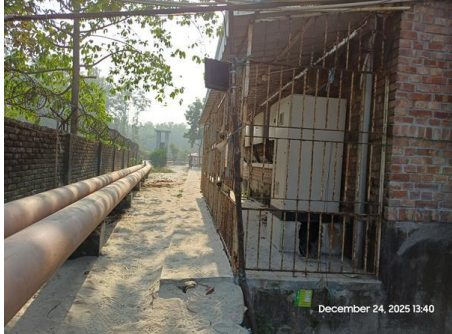
| F-02 | Means of Egress | <p>The egress court [serving east exits] was less than 10 ft wide and was not separated from the building interior and adjacent electrical panels which is not in accordance with section 6.17.2 of RSC Technical Guidelines (Standard)<sup>1</sup> V1.0.</p> <p><b>Location: East side of Warehouse Shed.</b></p> | <p>Egress courts less than 3050 mm (10 ft) in width (as measured from the building and the adjacent property line) shall be provided with walls having a 1-hr fire resistance rated construction for a distance of 3050 mm (10 ft) above the floor of the court.</p> <p>Seal all penetrations and openings to the interior of the building along the discharge path, up to a height of 10 ft. to provide a minimum 1-hr fire separation.</p> <p>Alternatively, provide a second remote discharge path to the public way.</p> | Within 3 Months |

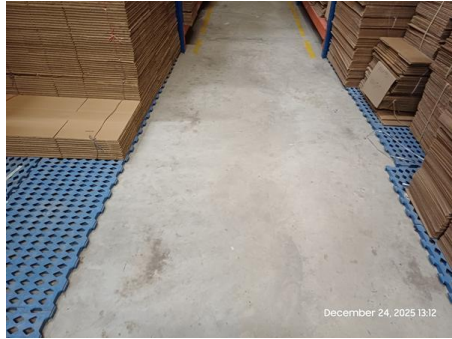
| F-03 | Means of Egress | <p>Aisles were found missing / not marked on several locations throughout the building.</p> <p><b>Location: Warehouse Shed.</b></p> | Provide minimum aisle widths of 36-in. Aisles mark shall be clearly visible. | Within 1 Month |

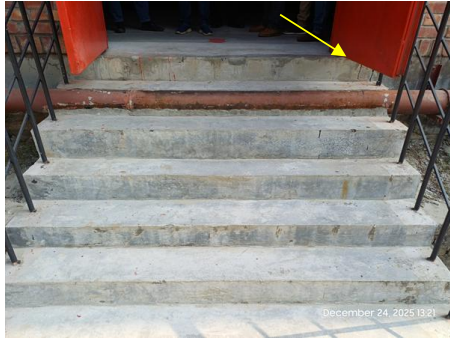
| F-04 | Means of Egress | <p>The door swings outward directly over the stair without an adequate landing, creating a potential fall hazard during egress.</p> <p><b>Location: South-west (S-W) and North-west (N-W) Exits of Warehouse Shed.</b></p> | <p>A landing shall be provided on both sides of doors used in the means of egress to facilitate uninterrupted egress of occupants. Door shall not swing out over stairs. Landings with same width as the stair clear width shall be provided at each level and at intermediate landings.</p> | Within 3 Months |

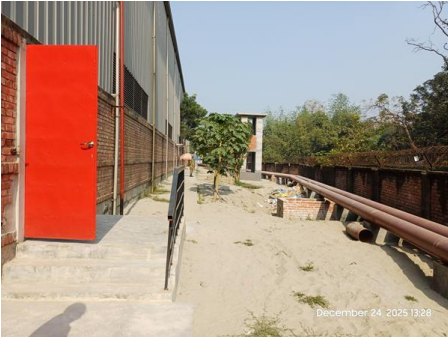
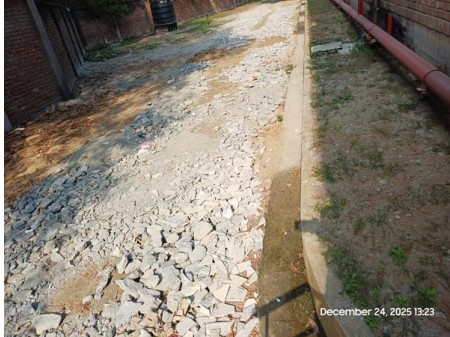
| F-05 | Means of Egress | <p>Walking surface were found uneven.</p> <p><b>Location: East &amp; West sides of Warehouse Shed.</b></p> | <p>Walking surfaces shall be mostly level; however, shall not exceed a slope of 1 in 20 in the direction of travel unless meeting the requirements for ramps in 6.10 shall meet the requirements for RSC Technical Guidelines (Standard)<sup>1</sup> V1.0 Section 6.3.4.2.</p> | Within 3 Months |

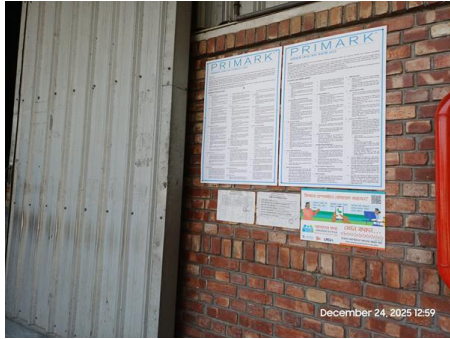
| F-06 | Means of Egress | <p>Building did not have occupant load signs at all required locations.</p> <p><b>Location: All buildings and sheds.</b></p> | <p>Post the occupant load for every assembly and production floor in a facility in a conspicuous space near the main exit or exit access doorway for the space in accordance with RSC Technical Guidelines (Standard)<sup>1</sup> V1.0 Section 6.4.4 .</p> | Within 1 Month |

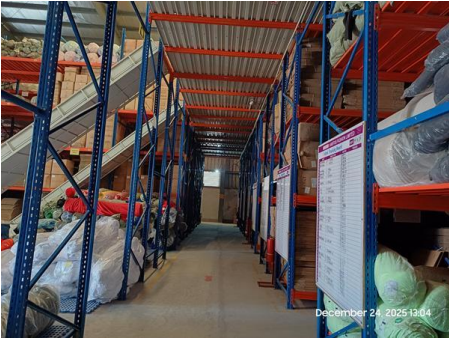
| F-07 | Means of Egress | <p>Directional signs were not provided where direction of the path of travel to an exit has changed.</p> <p><b>Location: Warehouse Shed.</b></p> | <p>Illuminated directional signs shall be provided where there is a change in the direction for the path of travel and the direction to an exit is not obvious in accordance with RSC Technical Guidelines (Standard)<sup>1</sup> V1.0 Section 6.11.3.</p> | Within 1 Month |

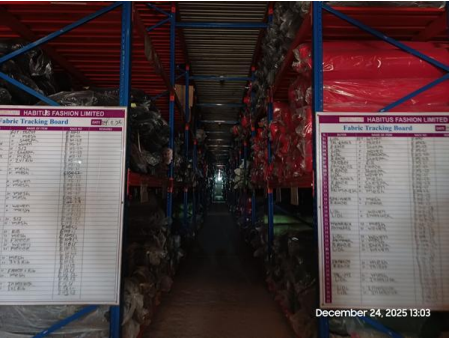
| F-08 | Means of Egress | <p>Based on the number and location of emergency lights observed, adequate illumination levels were not anticipated along egress routes.</p> <p><b>Location: All buildings and sheds.</b></p> | <p>Test the emergency lighting system on each floor and provide additional emergency fixtures to provide adequate illumination along the means of egress. Provide a minimum illumination of 10 lux at the floor level within exit stairs and exit discharge paths and minimum 2.5 lux along exit access aisles. Illumination on means of egress shall meet in accordance with RSC Technical Guidelines (Standard)<sup>1</sup> V1.0 Section 10.12.2.</p> | Within 3 Months |

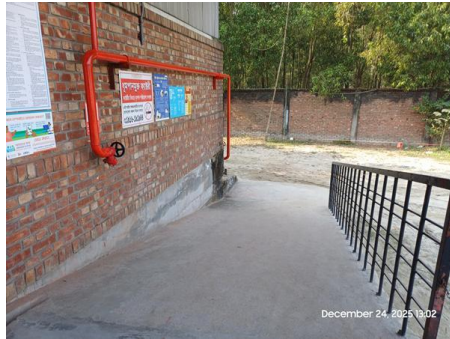
| F-09 | Means of Egress | <p>The means of egress includes a ramp; however, it's slope did not comply with the applicable standards. Additionally, Both side guard rail were not provided at exit ramp.</p> <p><b>Location: North Exit of Warehouse Shed.</b></p> | <p>Ramps used in a means of egress shall not reduce the overall means of egress width. The minimum width shall be 1.1 m (44 in.).</p> <p><b>New ramps shall not have a running slope greater than 1 in 12 (8 percent).</b></p> <p><b>Existing ramps shall not have a running slope greater than 1 in 8 (12.5 percent).</b></p> <p>Ramps shall be provided with handrails on both sides of the ramp.</p> <p>RSC Technical Guidelines (Standard) V1.0, Section: 6.10</p> | Within 3 Months |

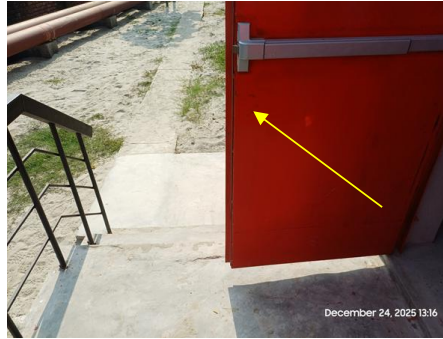
| F-10 | Means of Egress | <p>The egress path (landing) along means of egress has obstructed by door leaf.</p> <p><b>Location: South-Easr Exit.</b></p> | <p>Modify the door swing/exit arrangement as required. Keep egress paths clear of obstruction in accordance with section 6.3.9 of RSC Technical Guidelines (Standard)<sup>1</sup> V1.0.</p> <p>Means of egress shall be maintained continuously free and clear of all obstructions or impediments to full instant use in the case of fire or other emergency. No furnishings, decorations, or other objects shall obstruct exits and access to exits. Nothing shall obstruct or impede visibility to exits.</p> | Within 1 Month |

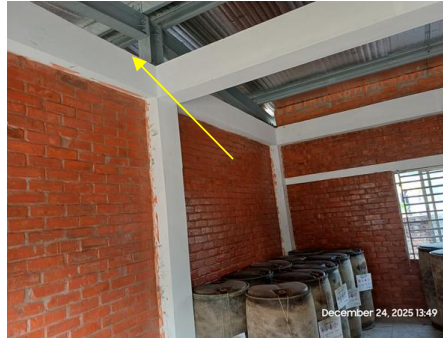
| F-11 | Fire Rated Construction | <p>Diesel fuel storage were located inside the diesel &amp; wastage store shed without proper fire separation from storage occupancy.</p> <p><b>Location: Diesel &amp; wastage store shed.</b></p> | <p>Provide a 4-hour fire-rated construction barrier to separate the diesel fuel storage from the surrounding occupancies / areas. The 4-hour fire-resistive separation shall have no openings / no unprotected openings therein and shall provide a fire resistance for at least four hour.</p> <p>Diesel fuel storage shall comply with BNBC 2006, Part 3, Section 2.13.</p> <p>or,</p> <p>Ensure exempt amounts of flammable liquid/chemical as per Table 3.2.7 (BNBC 2006) with nearly resemble occupancy group.</p> <p>Provide fire separation if required.</p> <p>Additionally, a license must be obtained in accordance with the Petroleum Act for all storage of Class II petroleum greater than 1000 L (264 gal) individually and 2000 L (528 gal) aggregate and storing criteria shall be followed as per the license provided by the Department of Explosives Bangladesh.</p> | Within 3 Months |

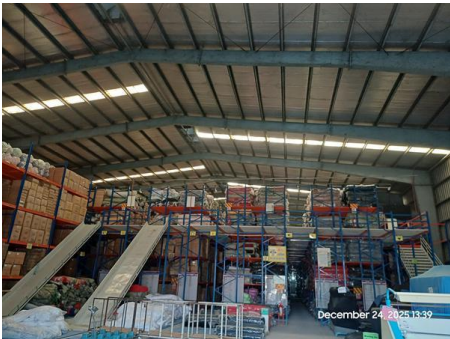
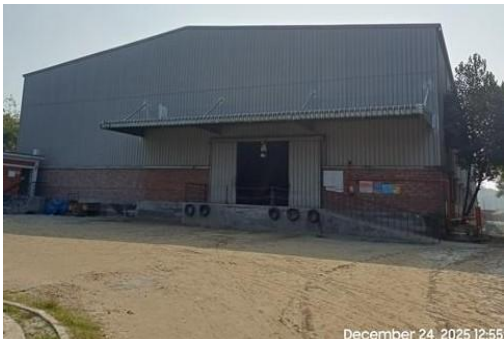
| F-12 | Fire Rated Construction | <p>The main structural element of the interim building is constructed by steel which is non-rated and were found in exposed condition without any fire protection.</p> <p>Note: Warehouse Shed height: Peak= 14.33 m, Edge height= 11.59 m; Average Height=12.96 m</p> <p><b>Location: Warehouse Shed.</b></p> | <p>The construction type is unprotected steel construction. As per RSC Technical Guideline and BNBC 2006, The Fire rating of the structure requires to be confirmed as per BNBC 2006. The "Ministry of Housing and Public Works" has issued a resolution based on the recommendations from the House Building Research Institute (HBRI) and the Public Works Department (PWD) to assess structural fire protection requirements of steel buildings (unprotected non-combustible construction type) according to BNBC 2020. The construction type shall confirm to be in accordance with BNBC 2020 Part-3, Table 3.1.7. Ensure fire resistive rated construction following Table 3.3.1 (a) Part 3 Section-3, Table 3.2.2 and Table 3.2.3 Part 3 Section 2 and Table 4.1.1 from BNBC 2020 Part 4 Section 1. Provide design philosophy to determine the construction type as per BNBC 2020. If any construction rating requires, Consult a qualified fire protection engineer to achieve the require fire rating.</p> <p>Submit the design philosophy along with the required documents to the RSC for review the required construction type.</p> <p>Once the design philosophy is reviewed, provide fire ratings of structural members.</p> | Within 6 Months |

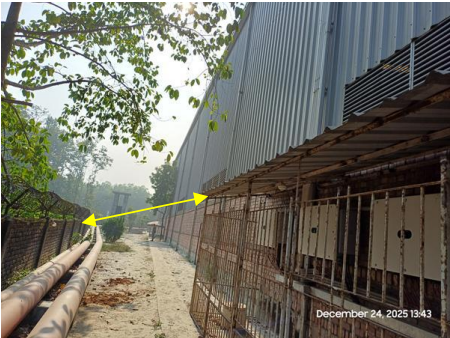
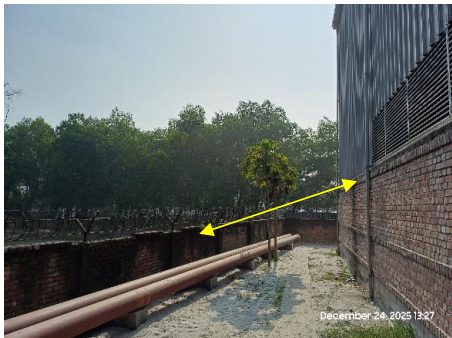
| F-13 | Fire Rated Construction | <p>The required fire separation distance did not comply with the requirements of BNBC 2006.</p> <p><b>Location: Warehouse Shed.</b></p> | <p>The exterior walls shall have a fire resistance and opening protection as specified in BNBC 2006, Tables 3.2.2 and Part 3 Section 2.4.1.3.</p> | Within 6 Months |

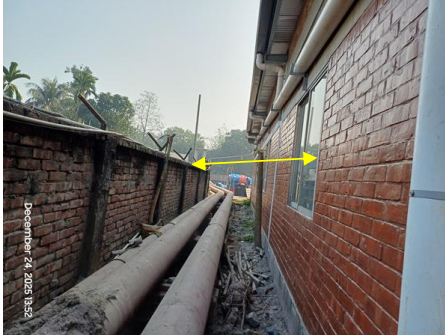
| F-14 | Fire Rated Construction | <p>The required fire separation distance did not comply with the requirements of BNBC 2006.</p> <p><b>Location: Diesel &amp; Wastage store shed.</b></p> | <p>The exterior walls shall have a fire resistance and opening protection as specified in BNBC 2006, Tables 3.2.2 and Part 3 Section 2.4.1.3.</p> | Within 6 Months |

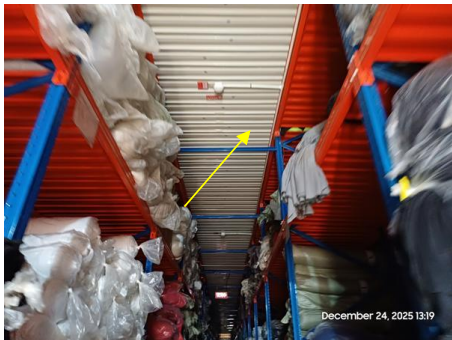
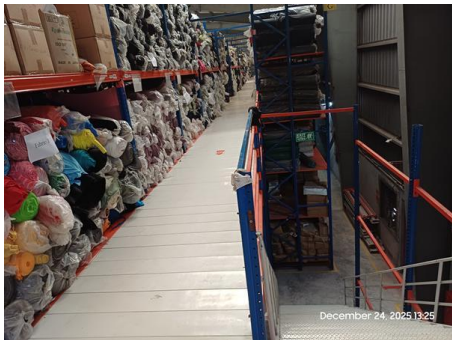
| F-15 | Fire Rated Construction | <p>A catwalk (deck) has been constructed on the high-rack storage, and the area of the intermediate deck creates a separate floor, as the size of the deck exceeds 33% of the total floor area, requiring fire-rated separation.</p> <p><b>Location: Warehouse Shed.</b></p> | <p>Remove the catwalk of the intermediate deck.</p> <p>Or ,</p> <p>The floor must adhere to the RSC building standards and BNBC 2006 regulations regarding fire rated construction and egress features.</p> | Within 6 Months |

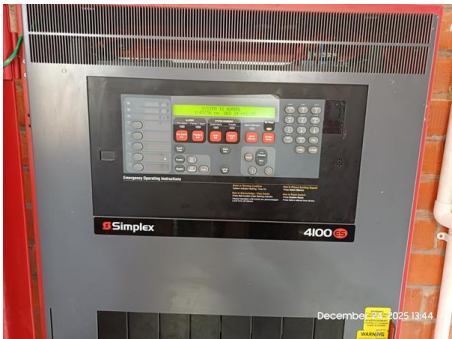
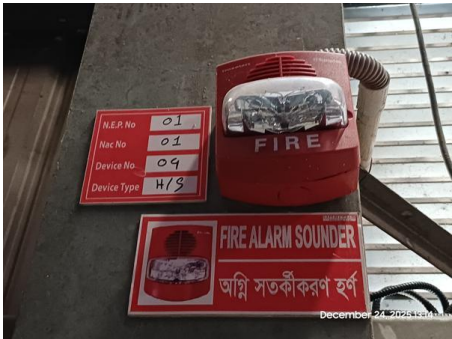
| F-16 | Fire Alarm & Detection System (FADS) | <p>The factory has installed a fire alarm and detection system that requires a detailed review to confirm compliance with NFPA 72 and RSC Technical Guidelines (Standard).</p> <p><b>Location: All buildings and sheds.</b></p> | <p>Submit the fire alarm and detection system design to the RSC for review.</p> <p>Once the design is reviewed, install and modify the fire detection and alarm system throughout the building in accordance with review comment, RSC Technical Guidelines (Standard) and NFPA 72.</p> <p>After installation the owner shall conduct internal testing and commissioning and then contact the RSC for witness of final acceptance testing.</p> | <p>Design within 2 months and modification/ installation within 4 months</p> |
