# **FIRE SAFETY INSPECTION REPORT**

**EUROTEX KNITWEAR LTD**  
**NAYAMATI, KUTUBPUR, FATULLAH, NARAYANGONG**

**ACCORD**  
on Fire and Building Safety in Bangladesh

March 31, 2014

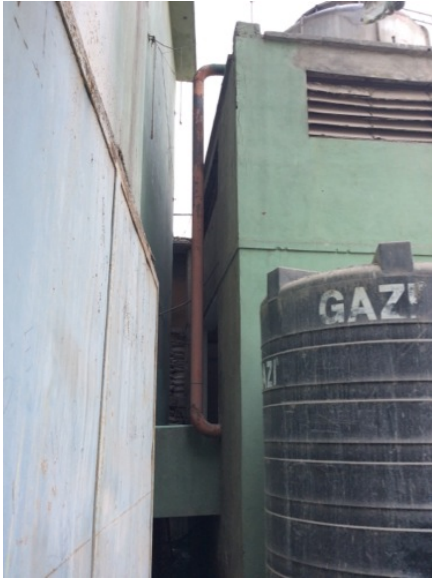
| No. | Category | Finding | Recommendation | Remediation Timeframe |
|---|---|---|---|---|
| F-1 | Fire Rated Construction | The generator building has unprotected openings in close proximity to the factory building. | Seal and/or protect all generator building openings to maintain a 2-hr fire rated separation. | Within 3 months |

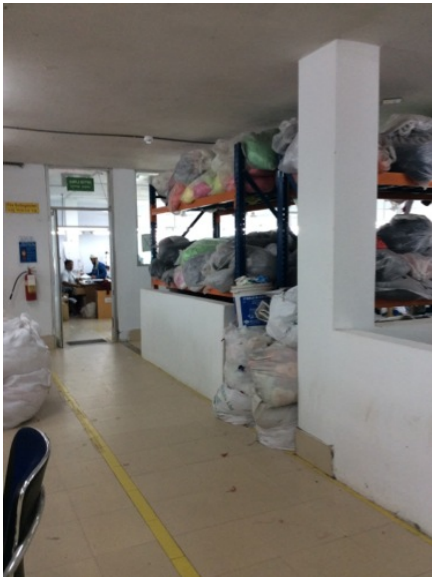
| F-2 | Fire Rated Construction | Areas on Floors 1, 2, and 3 used for combustible storage are not separated by fire-rated construction. | <p>Provide dedicated storage rooms separated by minimum 1-hr fire-rated construction.</p> <p>Where separate storage rooms are not feasible, provide defined storage areas and limit the storage arrangement as follows:</p> <ul style="list-style-type: none"><li>- Maximum height of 2.4m and maximum area of 23m<sup>2</sup></li></ul> <p>Separate areas of unenclosed combustible storage by a minimum clear distance of 3m.</p> | Within 3 months |

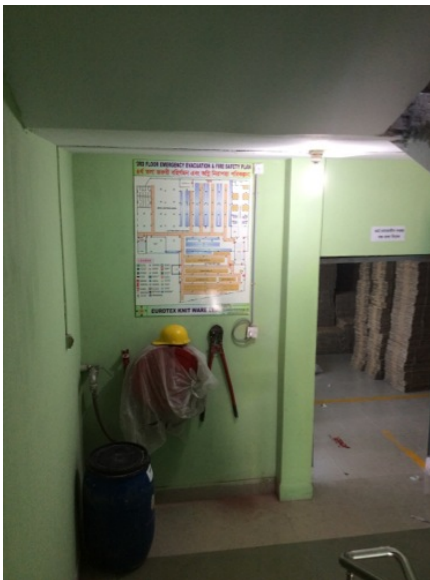
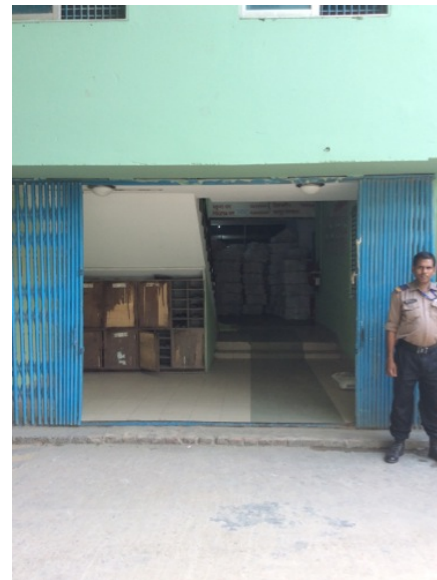
| F-3 | Fire Rated Construction | The exit stairs are not separated from adjacent spaces on each floor by fire-rated construction. | Provide minimum 1.5-hr fire rated doors and seal all unprotected openings to separate the exit stairs from work areas and other building spaces on all floor levels. Ensure that the fire doors are self-closing and positive latching and that they are provided with fire exit (panic) hardware where serving production floors. | Within 3 months |

| | | | If fire doors are required to be held open for functional reasons, provide automatic-closing devices tied to the fire alarm system. | |

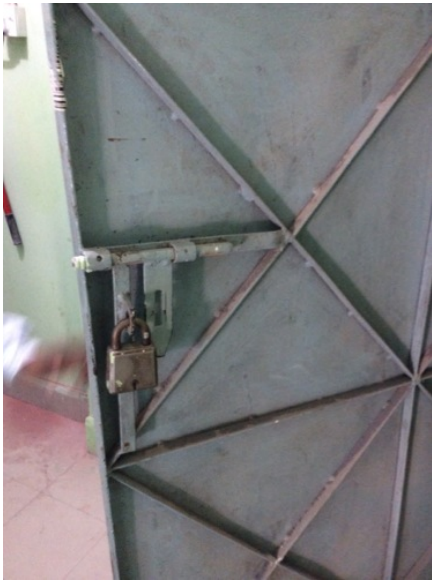
| F-4 | Egress | Egress doors / gates with locking features are provided along egress routes. | Remove locking features from all egress doors / gates. | Immediate |
| | | Gates/doors were open and unlocked during the inspection. | If locks are required for security reasons, utilize special door locking features complying with NFPA 101. | |

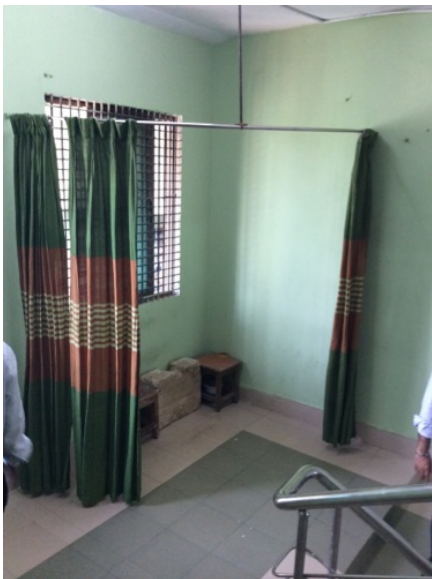
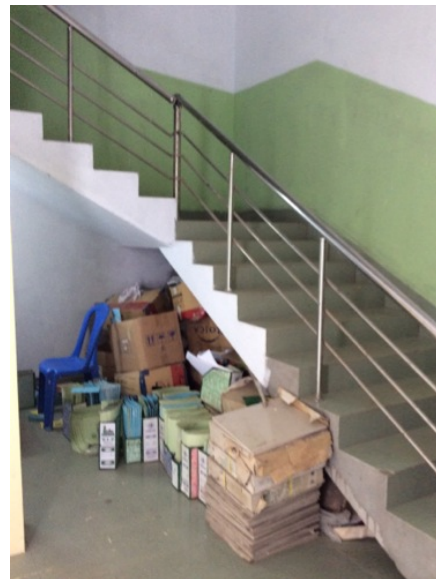
| F-5 | Egress | Storage was located in the exit stairs. | Remove all storage from exit stairs and egress paths. | Immediate |

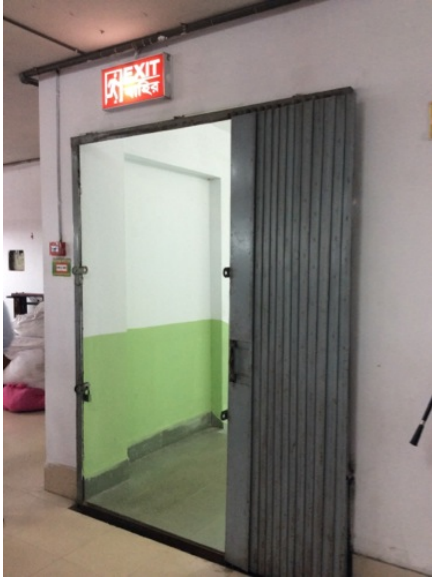
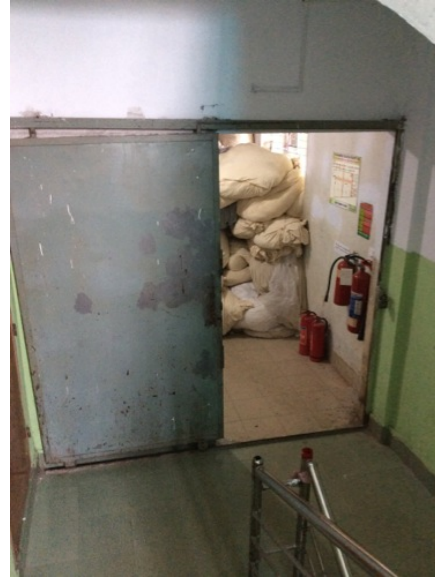
| F-6 | Egress | Collapsible gates / sliding doors are provided at building exits, exit stairs, and along egress routes. | Replace all gates / sliding doors along the means of egress with side-hinged, swinging egress doors.<br><br>If locks are required for security reasons, utilize special door locking features complying with NFPA 101. | Within 1 month |

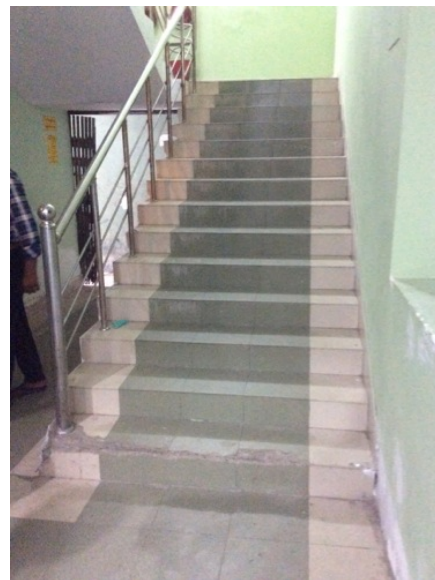
| F-8 | Egress | The main exit stair discharges inside the building main entrance. | Provide 2-hr fire-rated exit passageway leading directly outside. | Within 6 months |

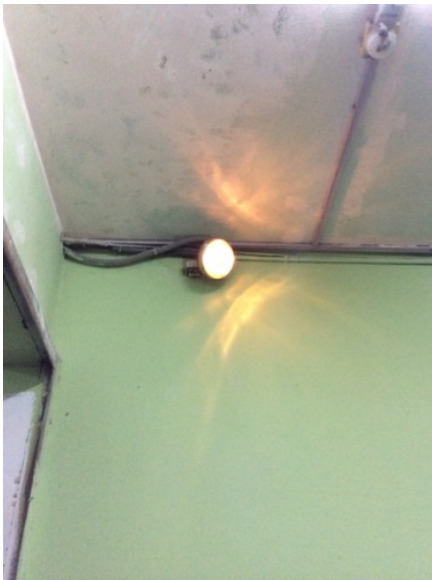
| F-12 | Egress Lighting | Battery powered 'fog lights' are provided in the exit stairwells. It does not appear that the lights would provide adequate illumination. | Test the emergency lighting system on each floor and provide additional emergency fixtures to provide adequate illumination along the means of egress. Provide a minimum illumination of 10 lux at the floor level within exit stairs and exit discharge paths and minimum 2.5 lux along exit access aisles. | Within 3 months |
