# Knit Plus Ltd (Extension - 2)

PLOT NO-2036, MOUCHACK, KALIAKOIR, GAZIPUR, BANGLADESH

## 1. Building Information

1. 10 Storied Green Building: Ten-storied (B+G+9) RC building with a basement

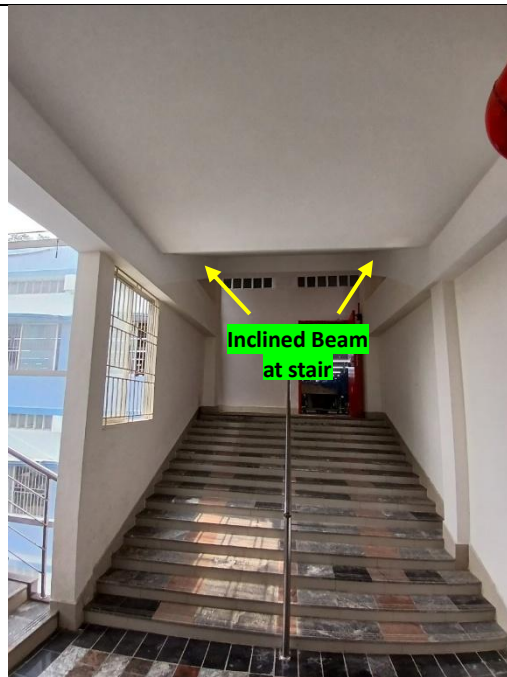
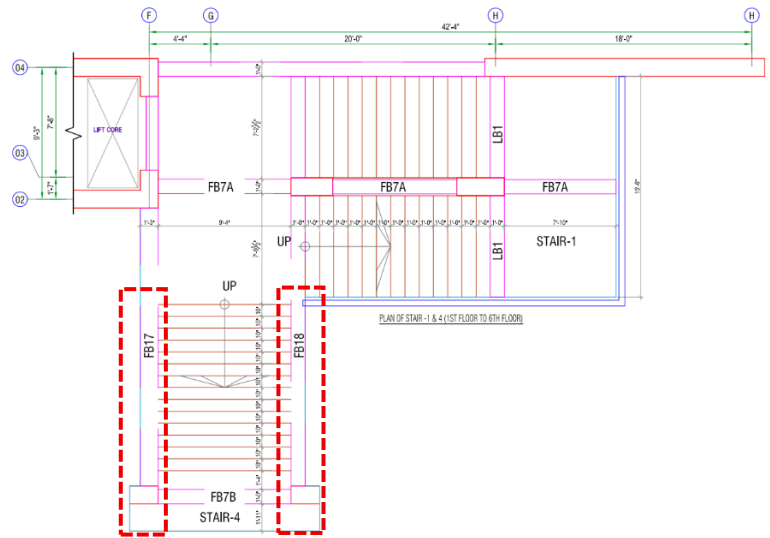
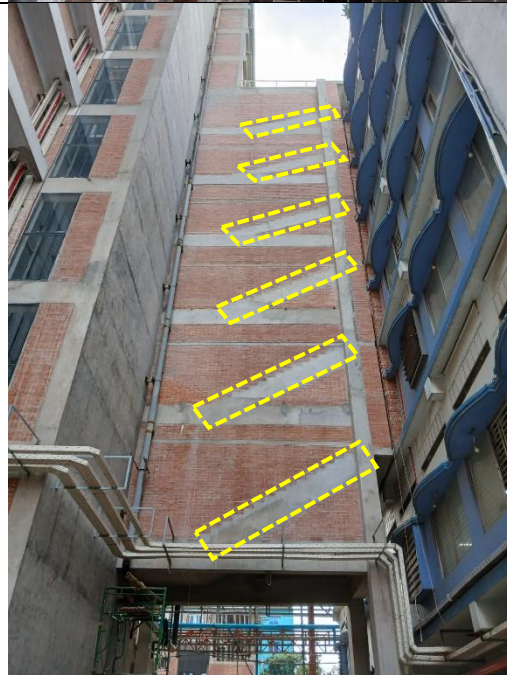
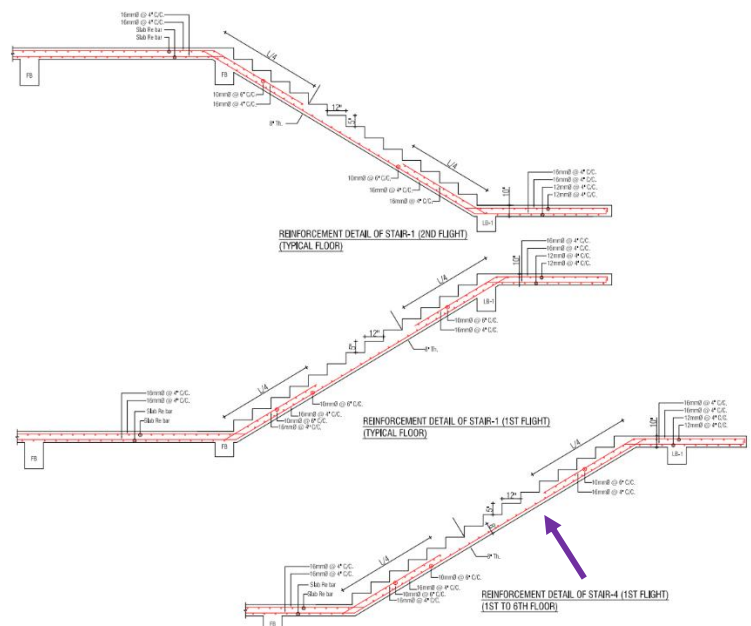
## Observation-02: Lack of information in as-built drawing (10 Storied Green Building)

**Description:** Inclined beam was provided below the waist slab of Stair-4. The inclined beam was not found in the provided drawings. The building engineer is required to survey the whole structure and update the drawings to reflect the actual on-site conditions.

| Item No | Observations | Action Plan | Timeline |
|---|---|---|---|
| 4. | Lack of information in as-built drawing (10 Storied Green Building) | The building engineer is required to survey the whole structure and update the drawings to reflect the actual on-site conditions. | within 6 weeks |

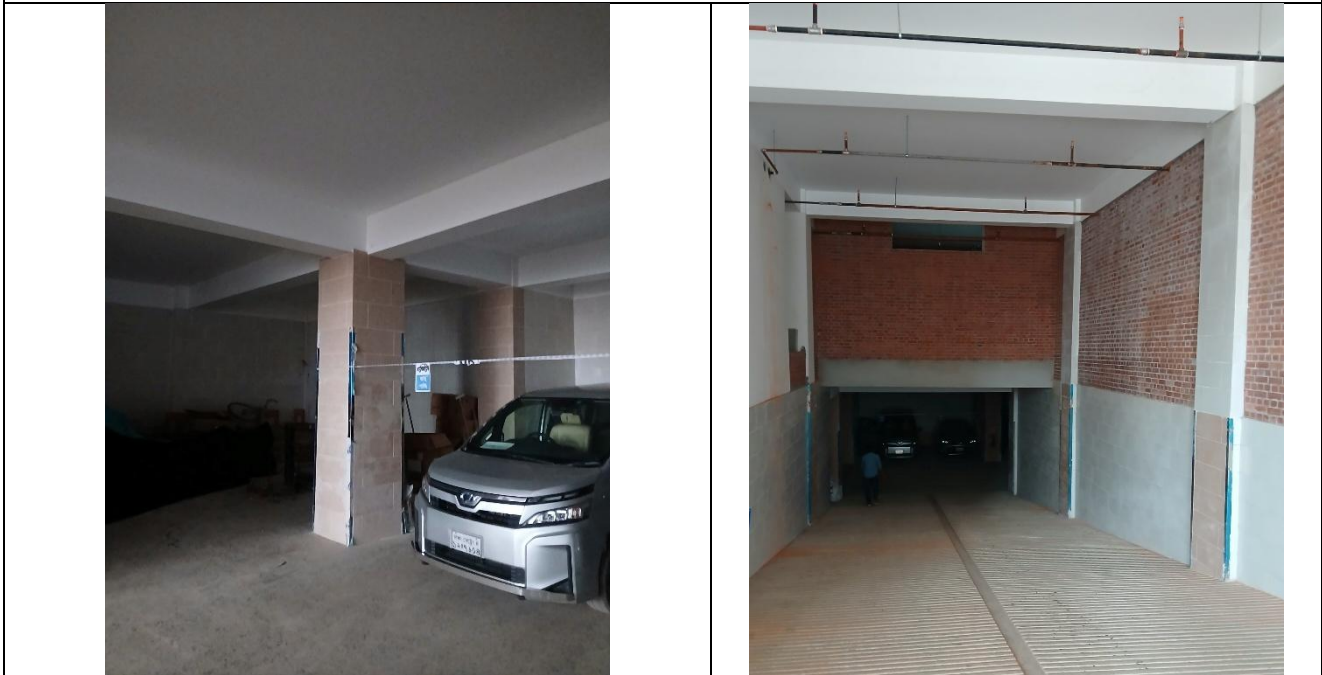
**Observation-03:** Column susceptible to vehicle impact (10 Storied Green Building)

**Description:** Columns in the basement and ramp areas are susceptible to vehicle impact. The building engineer is required to provide separate protective guards around the columns to avoid potential vehicle impact.

| Item No | Observations | Action Plan | Timeline |
|---|---|---|---|
| 5. | Column susceptible to vehicle impact (10 Storied Green Building) | The building engineer is required to provide separate protective guards around the columns to avoid potential vehicle impact. | within 6 weeks |

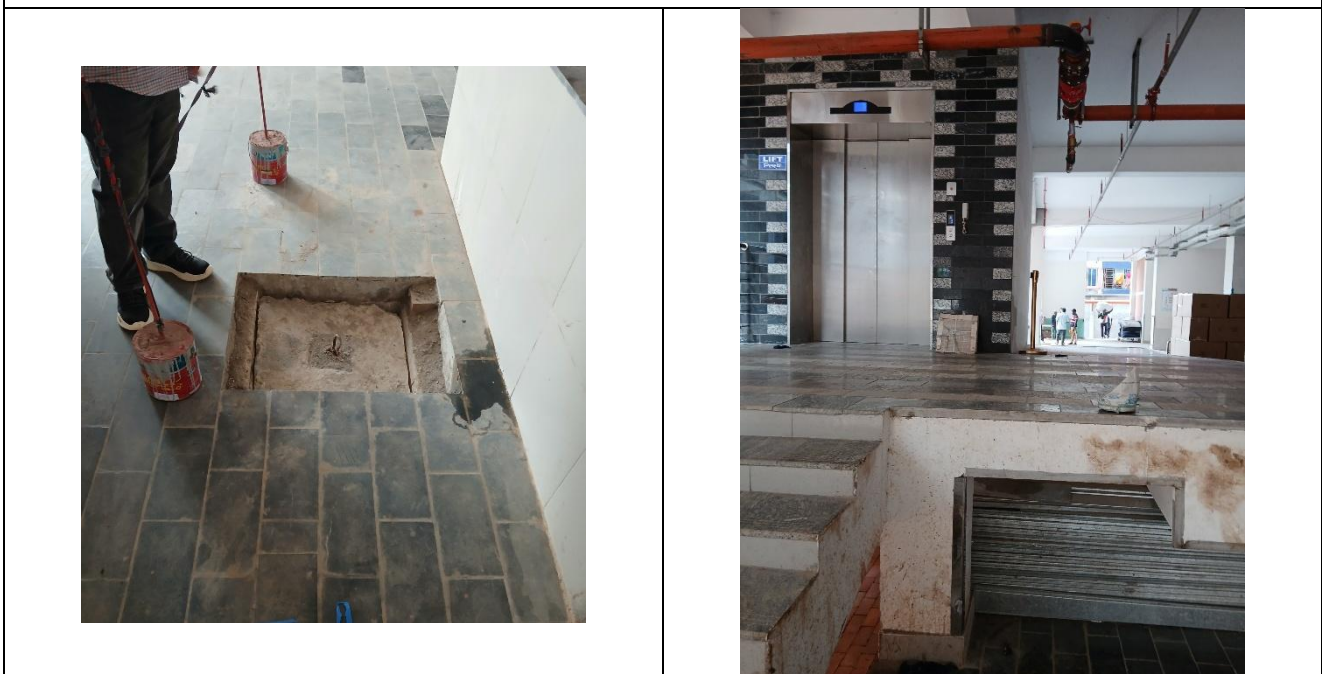
**Observation-04:** Possible falling hazard at ground floor (10 Storied Green Building)

**Description:** No railing was found at the elevated area of the ground floor, and the manhole cover was found to be improperly placed. The building engineer is required to provide edge protection and ensure proper covering of the manhole to mitigate falling hazards.

| Item No | Observations | Action Plan | Timeline |
|---|---|---|---|
| 6. | Possible falling hazard at ground floor (10 Storied Green Building) | The building engineer is required to provide edge protection and ensure proper covering of the manhole to mitigate falling hazards. | within 6 weeks |

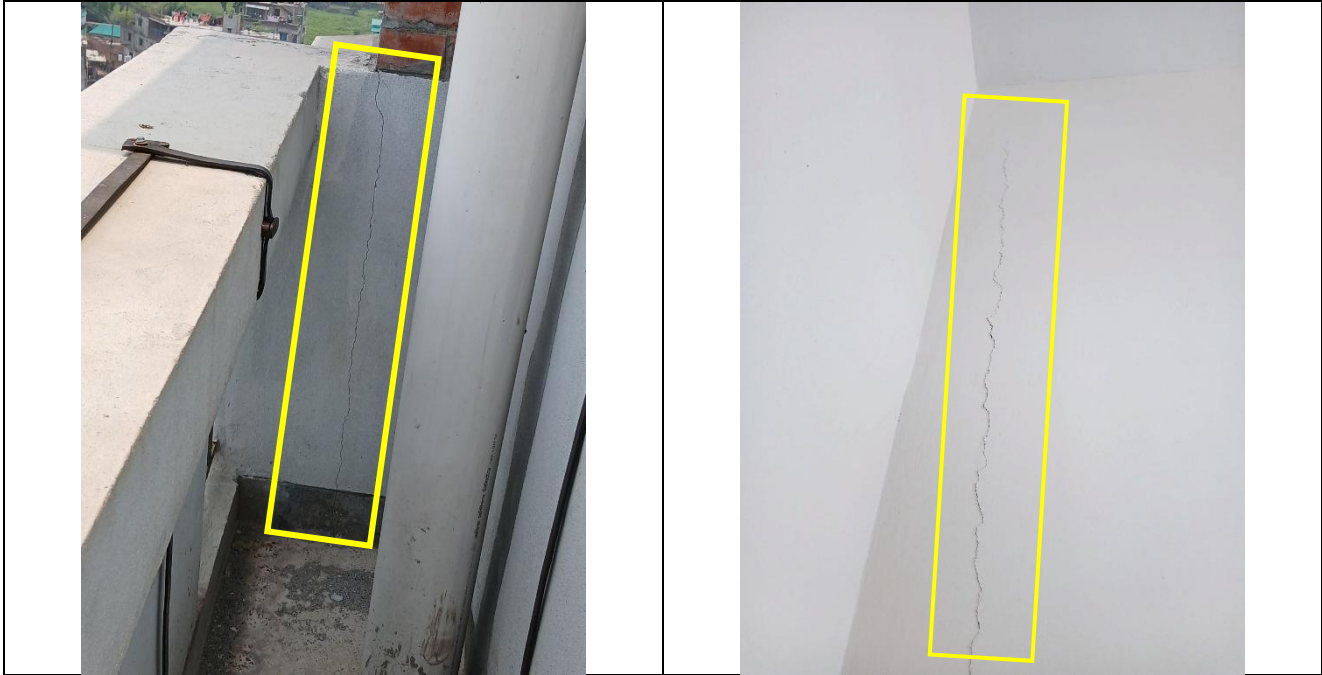
**Observation-05: Cracks in brick wall joints (10 Storied Green Building)**

**Description:** Cracks were observed in the brick wall joints. The building engineer is required to investigate the cause and extent of the cracks and repair them using a suitable method.

| Item No | Observations | Action Plan | Timeline |
|---|---|---|---|
| 7. | Cracks in brick wall joints (10 Storied Green Building) | The building engineer is required to investigate the cause and extent of the cracks and repair them using a suitable method. | within 6 weeks |

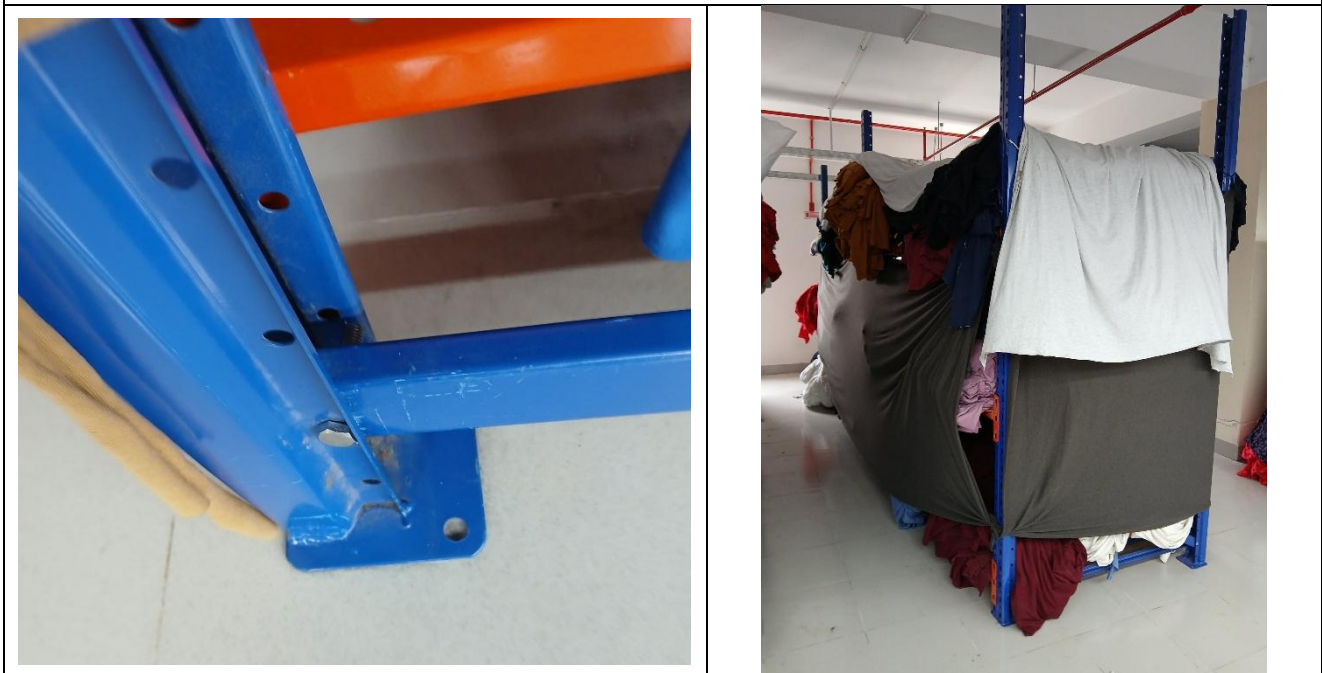
**Observation-06: Lack of anchorage in non-structural elements (10 Storied Green Building)**

**Description:** Unanchored racks observed on the production and storage floors. The building engineer is required to anchor/brace all non-structural elements within the building including the storage racks.

| Item No | Observations | Action Plan | Timeline |
|---|---|---|---|
| 8. | Lack of anchorage in non-structural elements (10 Storied Green Building) | The building engineer is required to anchor/brace all non-structural elements within the building including the storage racks. | within 6 weeks |
