# **FIRE SAFETY INSPECTION REPORT**

**NEWTEX KNIT FASHION LTD**  
**GORAI, INDUSTRIAL AREA, MIRZAPUR**

**ACCORD**  
on Fire and Building Safety in Bangladesh

June 11, 2014

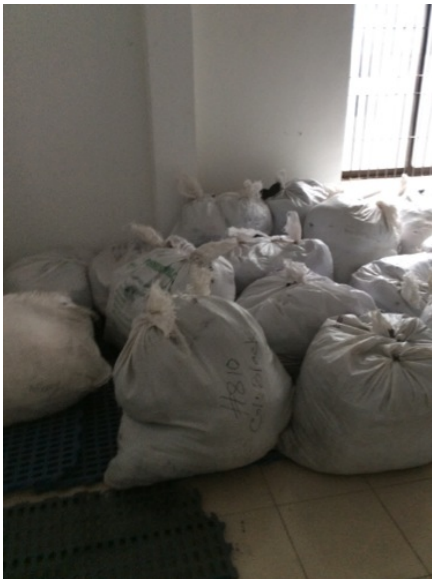
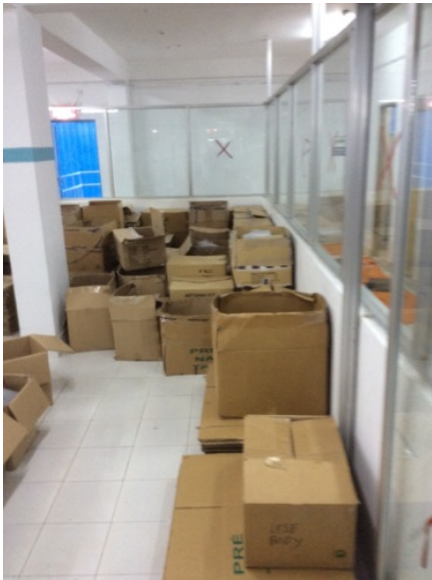
| No. | Category | Finding | Recommendation | Remediation Timeframe |
|---|---|---|---|---|
| F-1 | Fire Rated Construction | Areas used for combustible storage are not separated by fire-rated construction.<br>First and second floors. | Provide dedicated storage rooms separated by minimum 1-hr fire-rated construction.<br><br>Where separate storage rooms are not feasible, provide defined storage areas and limit the storage arrangement as follows:<br>Maximum height of 2.4m and maximum area of 23m <sup>2</sup><br>Separate areas of unenclosed combustible storage by a minimum clear distance of 3m. | Within 3 months |

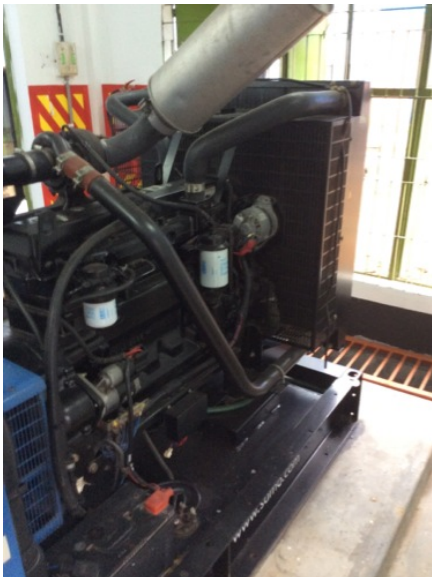
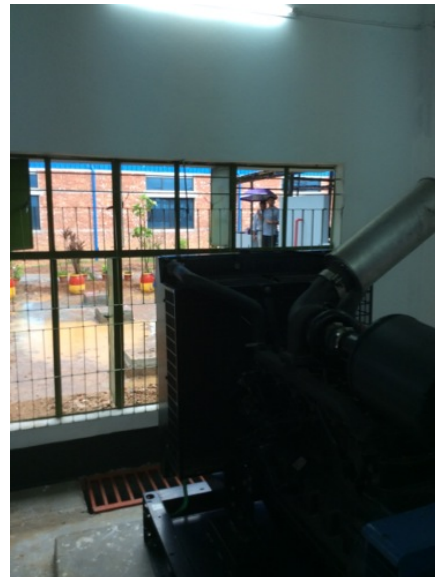
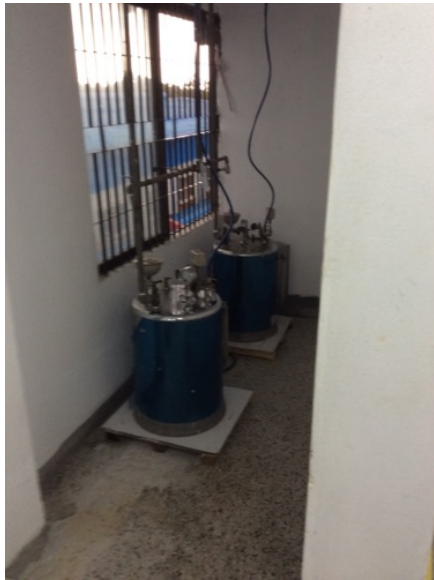
| F-2 | Fire Rated Construction | The boiler and generator rooms is not separated by fire-rated construction (openings, non-rated doors, penetrations).<br>Location: Second floor boilers and ground floor generator. | Separate the boiler and generator rooms by a minimum 2-hr fire-rated construction. Seal and/or protected all openings to maintain the required fire separations | Within 3 months |

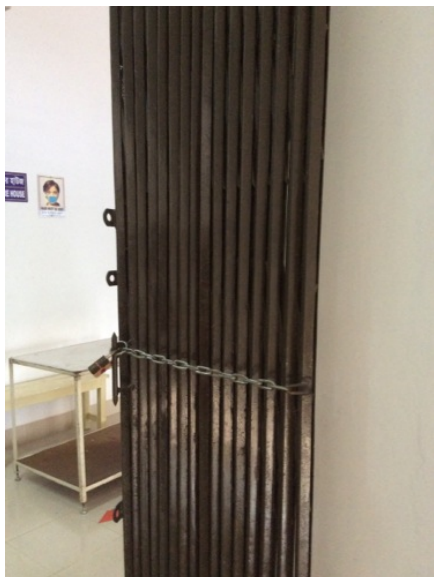
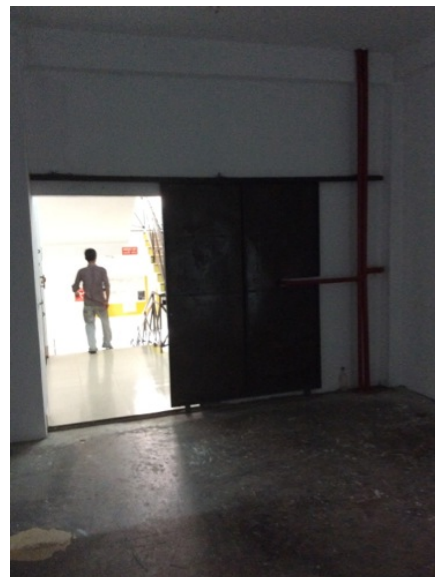
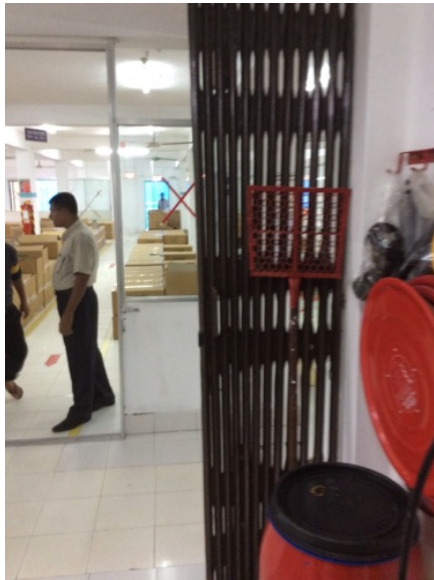
| F-3 | Egress | Egress doors / gates with locking features are provided at building exits, exit stairs, along egress routes and exit discharge.<br>Location: On all floors gates/doors were open and unlocked during the inspection. | Remove locking features from all egress doors / gates.<br><br>If locks are required for security reasons, utilize special door locking features complying with NFPA 101. | Immediate |

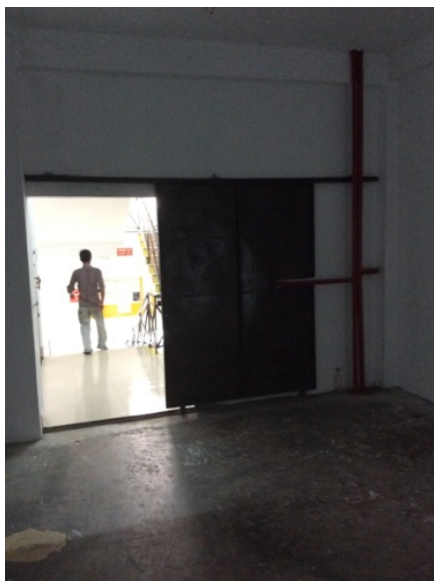
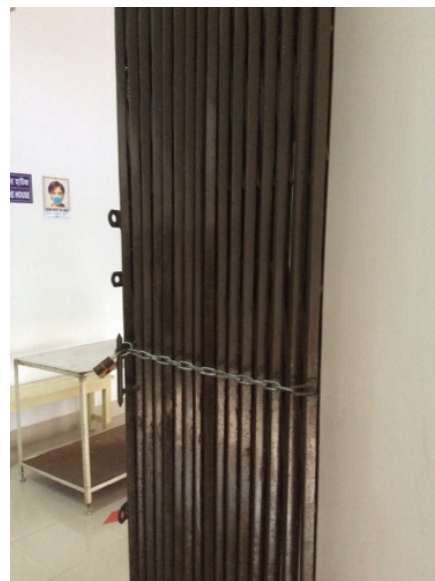
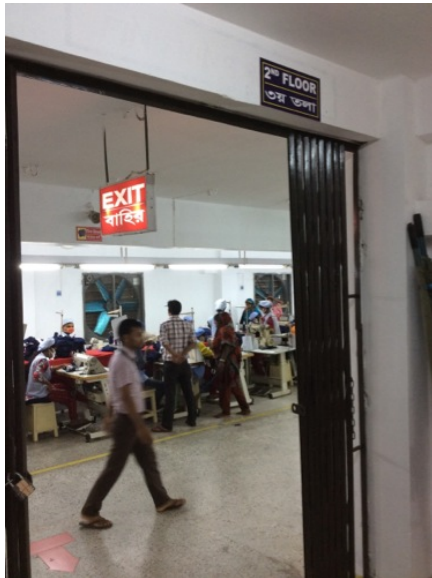
| F-4 | Egress | Collapsible gates / sliding doors are provided at building exits, exit stairs, along egress routes and exit discharge.<br>Location: On all floors. | Replace all gates / sliding doors along the means of egress with side-hinged, swinging egress doors.<br><br>If locks are required for security reasons, utilize special door locking features complying with NFPA 101. | Within 1 month |

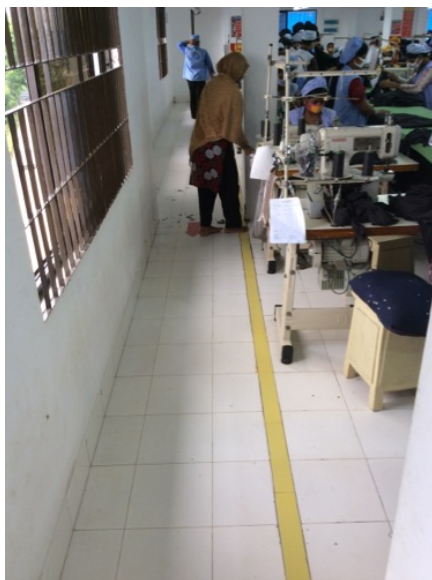
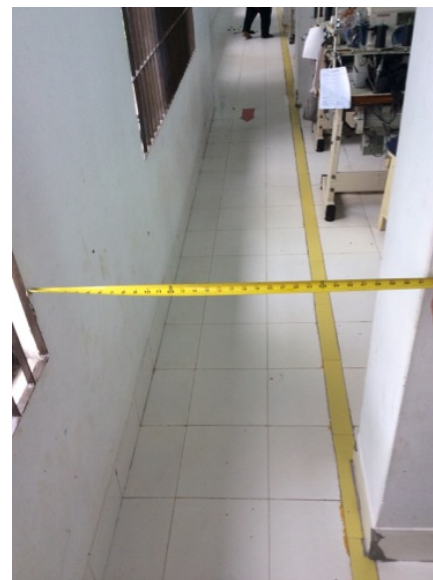
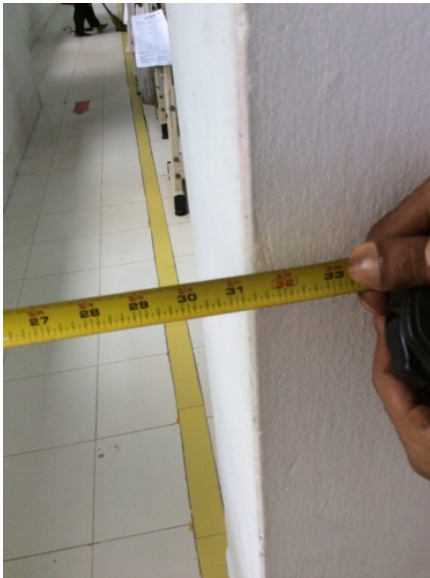
| F-5 | Egress | The width of egress aisles is less than 36-in. Location: Third floor sewing section egress aisles is reduced to 31-in | Provide minimum aisle widths of 36-in. | Within 3 months |

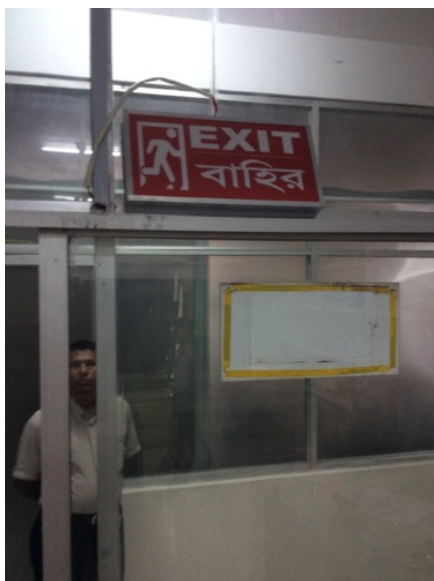
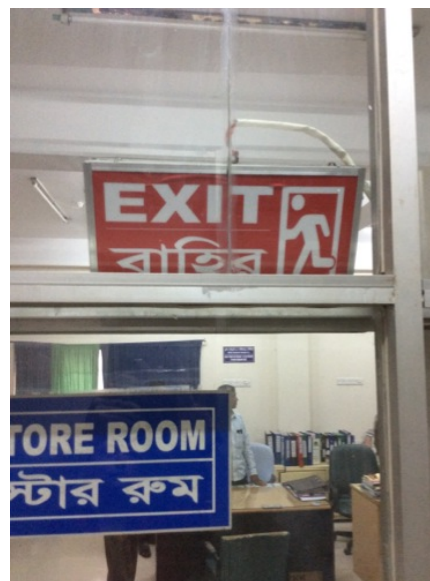
| F-10 | Egress Lighting | Exit signage not illuminated (burned out, broken, etc.).<br>Location: Ground floor at store exit sign not working. | Regularly inspect all exit signage and replace/install lights as needed to illuminate signs. | Within 1 month |

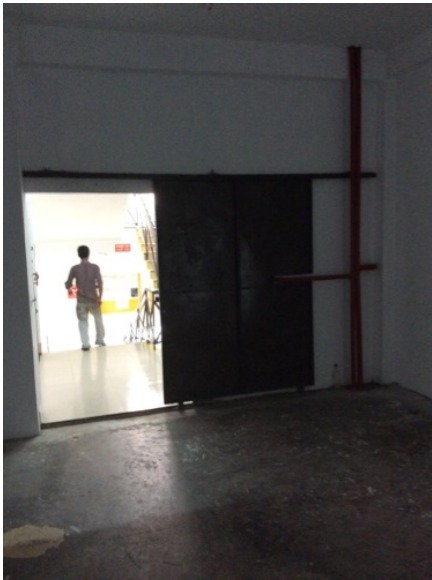
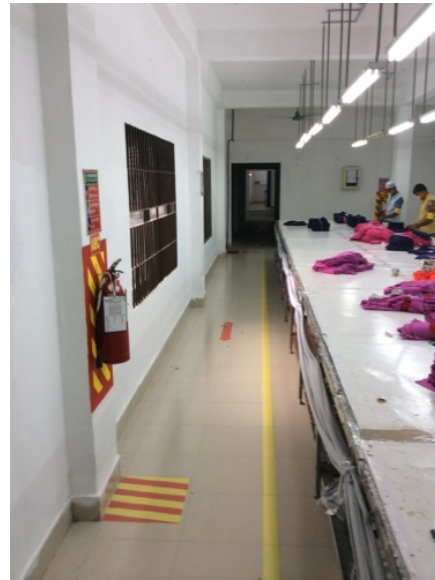
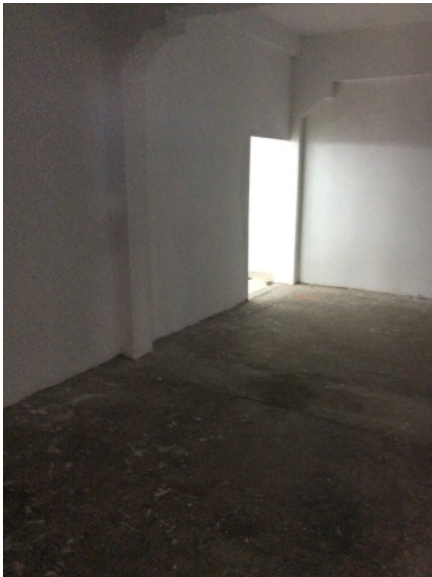
| F-11 | Egress Lighting | Exit sign not provided at exit.<br>Location: first floor next to cutting and bonded wear house. | Provide exit signs above all exits to the exterior and all doors to the exit stairs. | Within 1 month |
