# **FIRE SAFETY INSPECTION REPORT**

**SAKURA DYEING + GARMENTS LTD**  
**KUTUBAIL, FATULLAH, NARYANGONJ**

**ACCORD**  
on Fire and Building Safety in Bangladesh

June 10, 2014

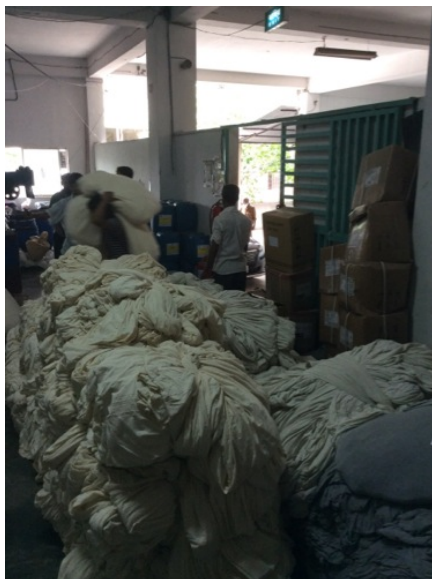
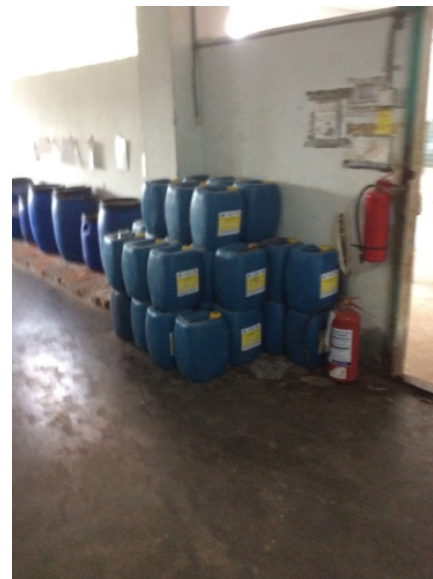
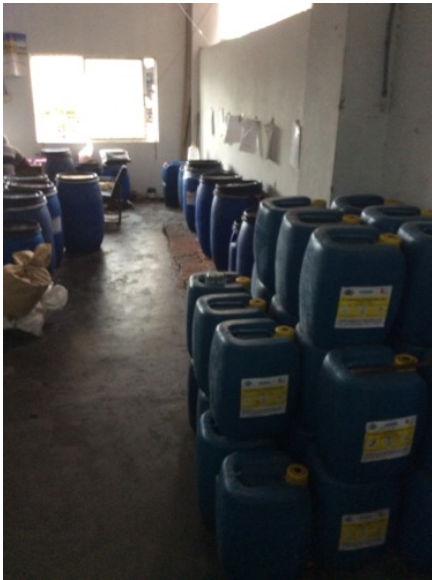
| No. | Category | Finding | Recommendation | Remediation Timeframe |
|---|---|---|---|---|
| F-1 | Fire Rated Construction | Hazardous materials storage area is not separated by fire-rated construction (openings, non-rated doors, penetrations).<br>Location: Ground floor next to batch section their is hazardous storage area with no fire rated separation between these areas. | Separate the hazardous materials storage room by a minimum 2-hr fire-rated construction. Seal and/or protected all openings to maintain the required fire separations. | Within 3 months |

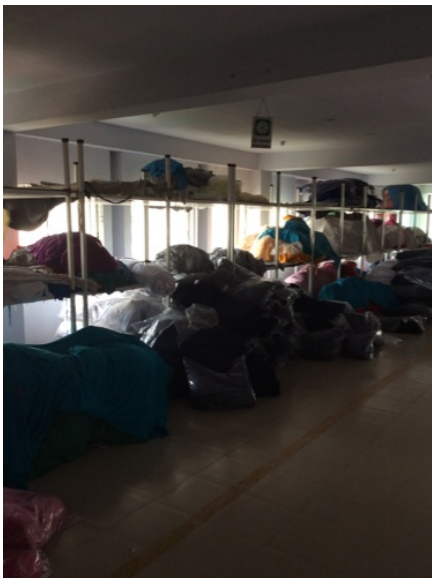
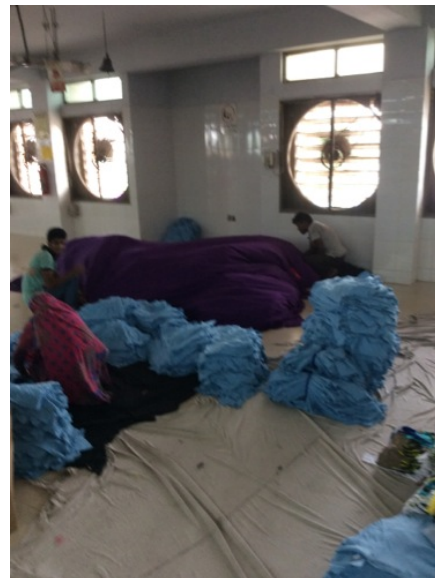
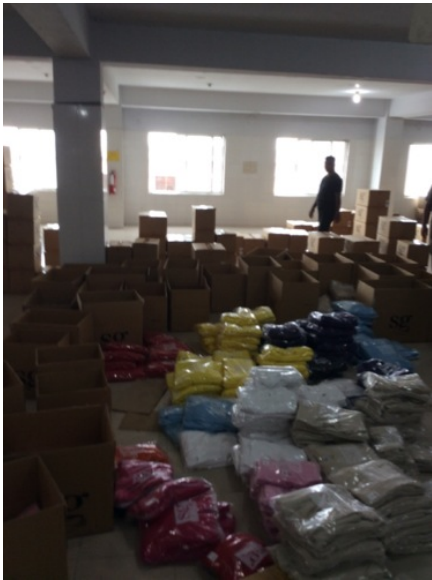
| F-2 | Fire Rated Construction | Areas used for combustible storage are not separated by fire-rated construction.<br>Location: Ground, first, second, third, and fifth floors. | Provide dedicated storage rooms separated by minimum 1-hr fire-rated construction. | Within 3 months |

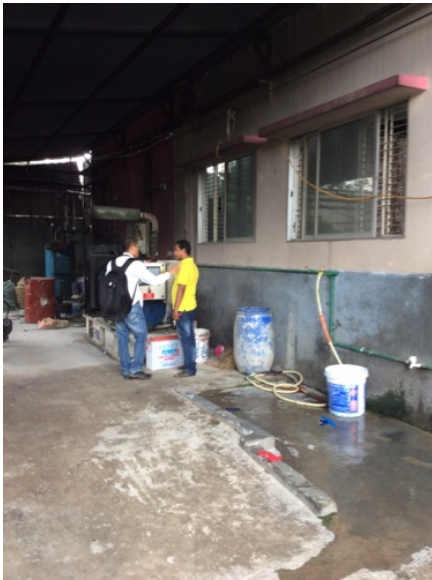
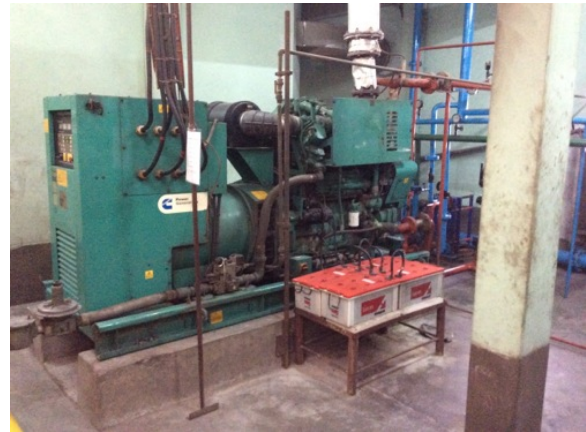
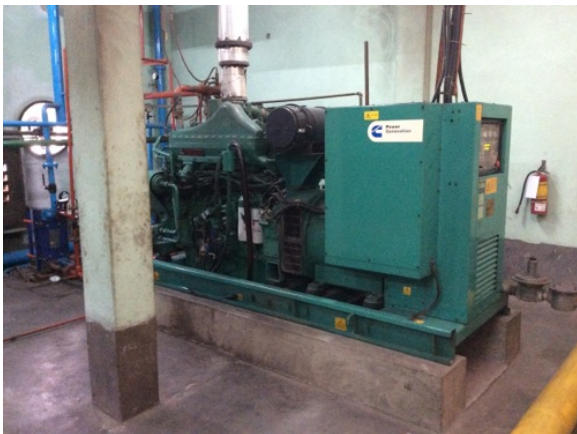
| F-3 | Fire Rated Construction | <p>The generator rooms and not separated by fire-rated construction (openings, non-rated doors, penetrations).<br/>Location: One generator is located in the south of the building in a shed attached to building the other two generators are located on the second floor of the two story building.</p> | <p>Separate the generator rooms by a minimum 2-hr fire-rated construction. Seal and/or protected all openings to maintain the required fire separations</p> | <p>Within 3 months</p> |

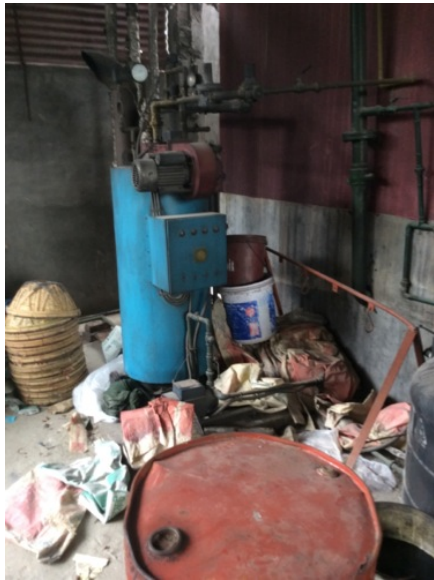
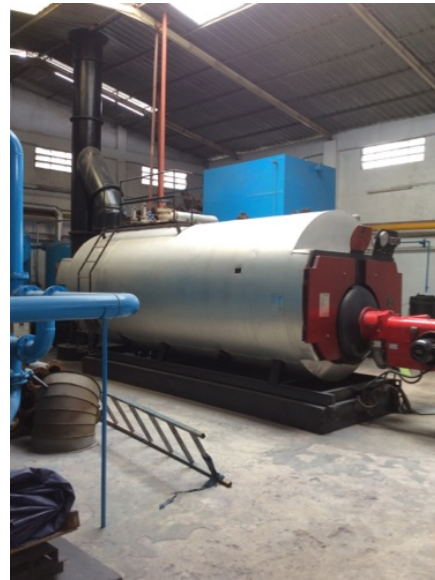
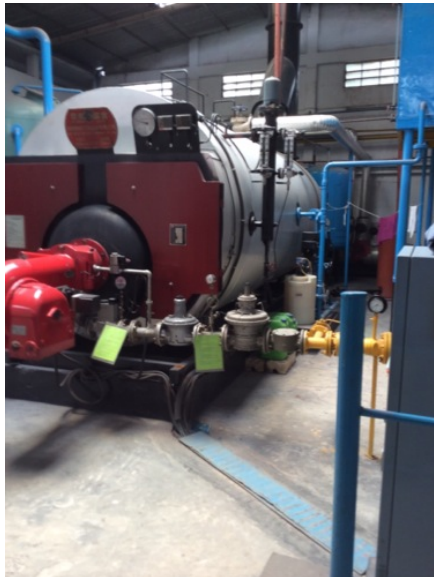
| F-4 | Fire Rated Construction | <p>The boiler rooms is not separated by fire-rated construction (openings, non-rated doors, penetrations).</p> <p>Location: In two separate locations one smaller boiler in shed next to generator the other is a larger boiler in shed by it's self.</p> | <p>Separate the boiler rooms by a minimum 2-hr fire-rated construction. Seal and/or protected all openings to maintain the required fire separations</p> | <p>Within 3 months</p> |

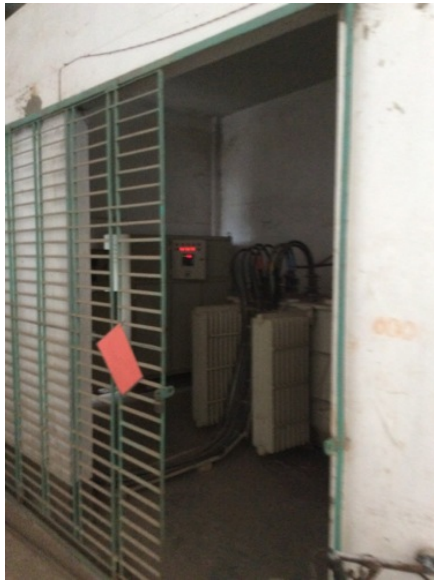
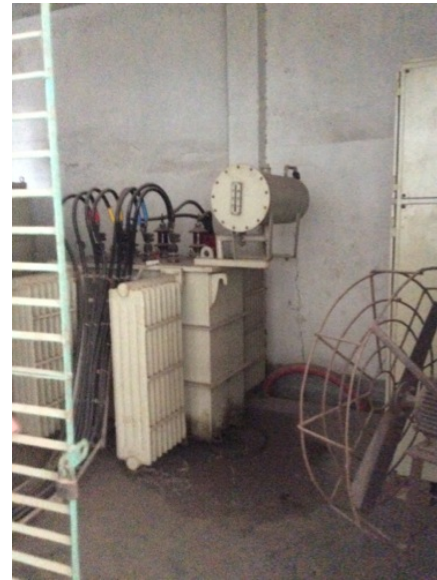
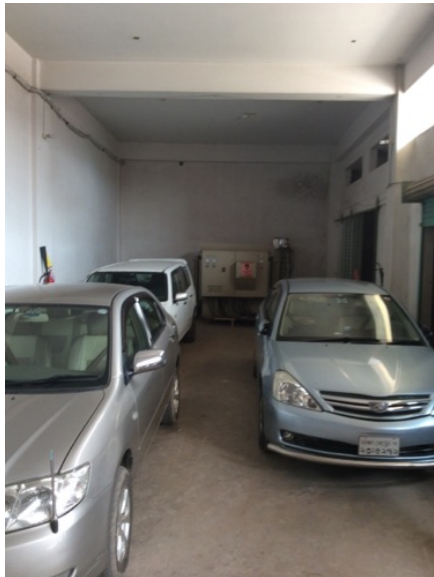
| F-5 | Fire Rated Construction | The transformer room is not separated by fire-rated construction (openings, non-rated doors, penetrations). Location: Ground floor north side of building. | Separate the transformer room by a minimum 2-hr fire-rated construction. Seal and/or protected all openings to maintain the required fire separations | Within 3 months |

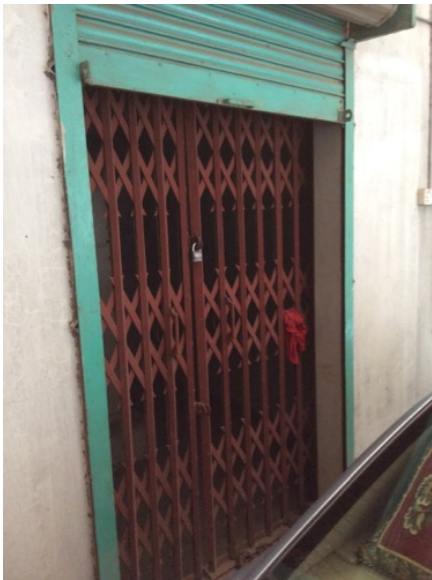
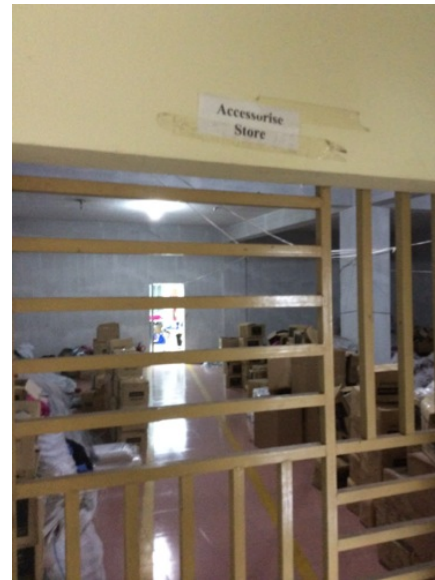
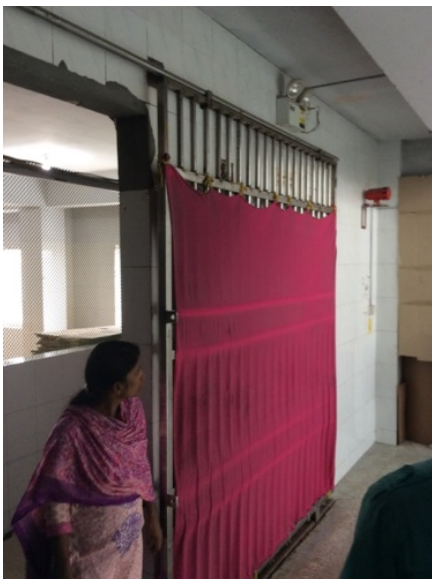
| F-7 | Egress | <p>Egress doors / gates with locking features are provided at building exits, exit stairs, along egress routes and exit discharge.</p> <p>Location: On all floors all gates/doors were open and unlocked during the inspection.</p> | <p>Remove locking features from all egress doors / gates.</p> <p>If locks are required for security reasons, utilize special door locking features complying with NFPA 101.</p> | Immediate |

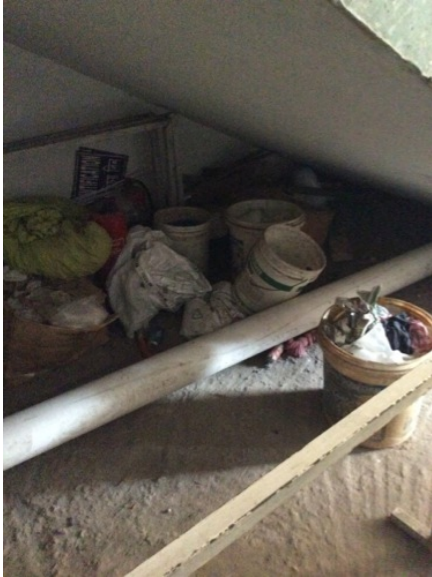
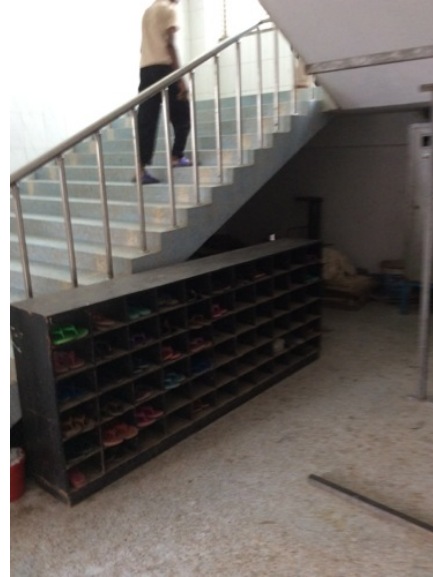
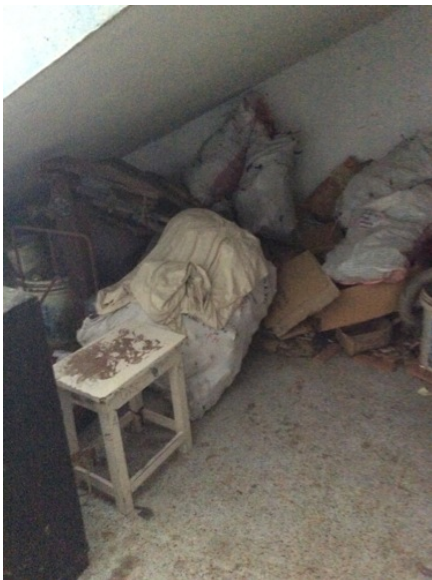
| F-8 | Egress | Storage was located in the exit stair.<br>Location: Under both stairs had storage. | Remove all storage from exit stairs and egress paths. | Immediate |

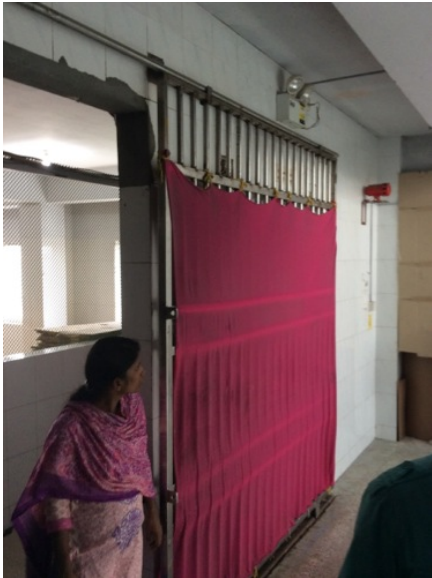
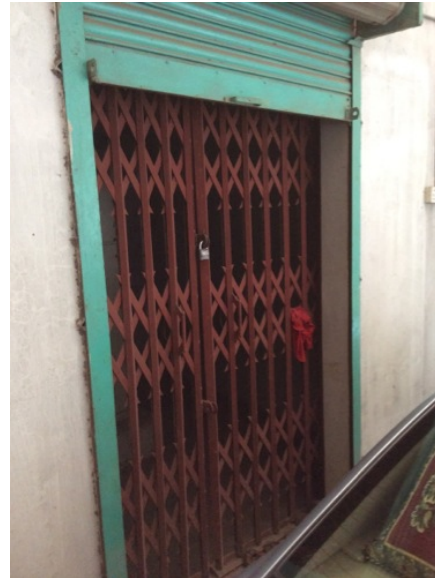
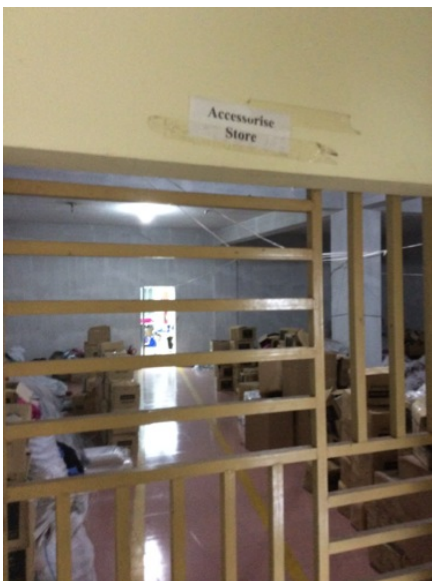
| F-9 | Egress | Collapsible gates / sliding doors are provided at building exits, exit stairs, along egress routes and exit discharge.<br>Location: On all floors. | Replace all gates / sliding doors along the means of egress with side-hinged, swinging egress doors.<br><br>If locks are required for security reasons, utilize special door locking features complying with NFPA 101. | Within 1 month |

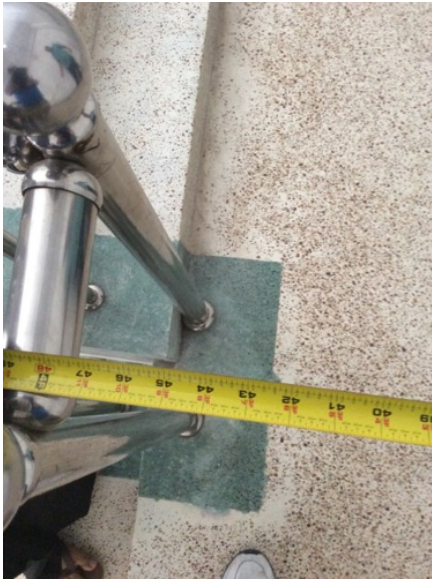
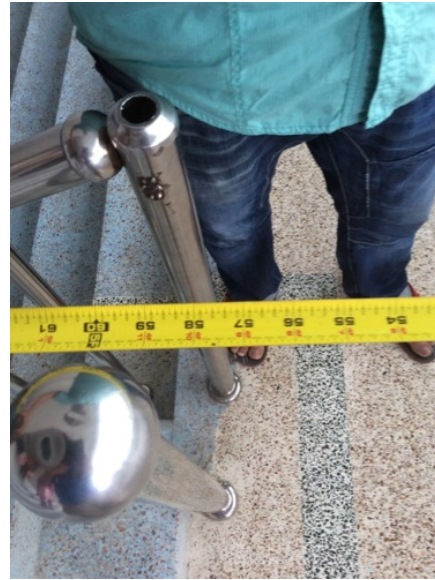
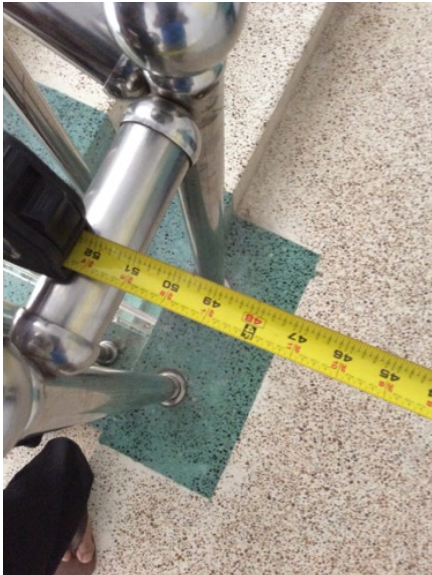
| F-10 | Egress | Exit capacity is not adequate for the occupant load.<br>Location: On the third floor available capacity is 326 but the occupant load was 430. | Reduce occupant load to not more than available exit capacity (326) and provide additional exits in the future to increase occupant load. | Within 3 months |

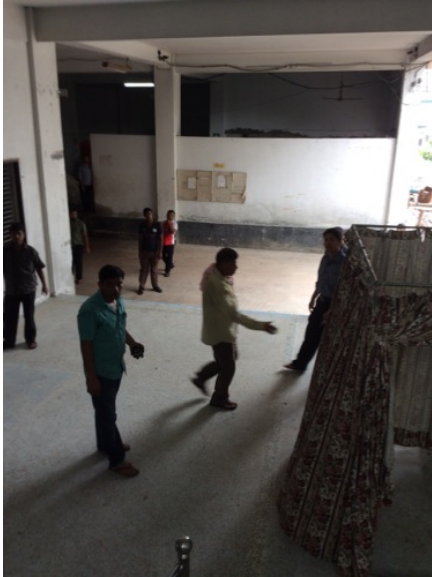
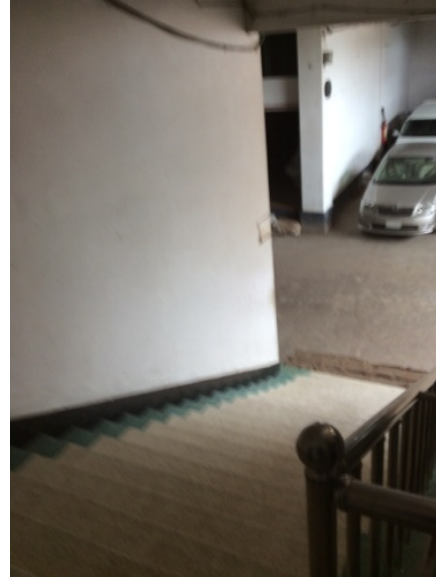
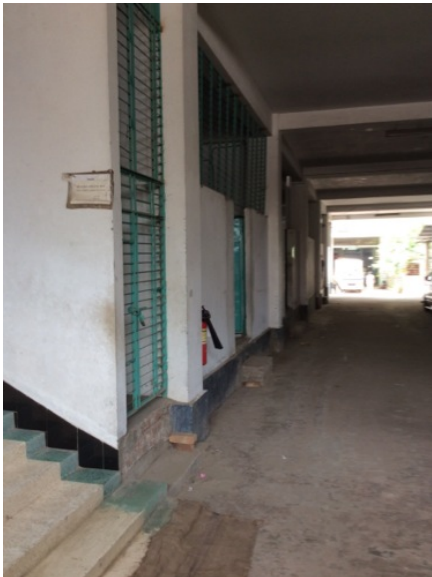
| F-12 | Egress | Exit stairs discharge inside the building. Location: North and south stairwells discharge to ground floor into storage area then to outside. | Provide 2-hr fire-rated exit passageway leading directly outside (vestibules to separate any storage areas).<br>or<br>Provide sprinkler protection for discharge floor in accordance with NFPA 13. | Within 6 months |

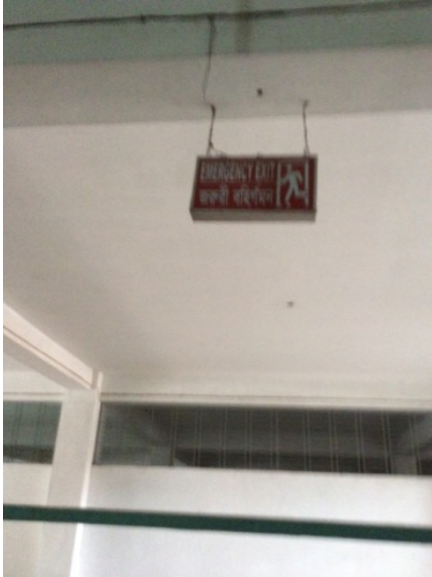
| F-17 | Egress Lighting | Exit signage not illuminated (burned out, broken, etc.).<br>Location: Ground, floor in batch section. | Regularly inspect all exit signage and replace/install lights as needed to illuminate signs. | Within 1 month |

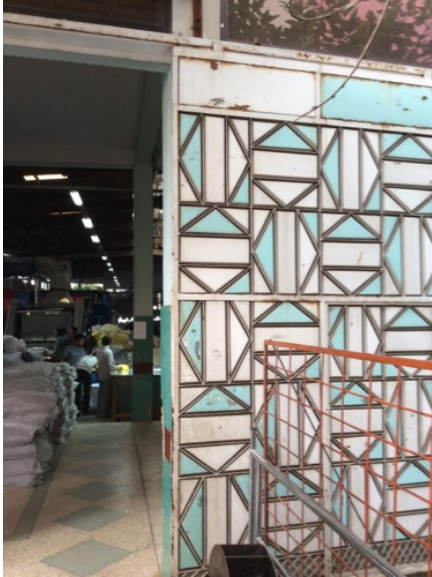
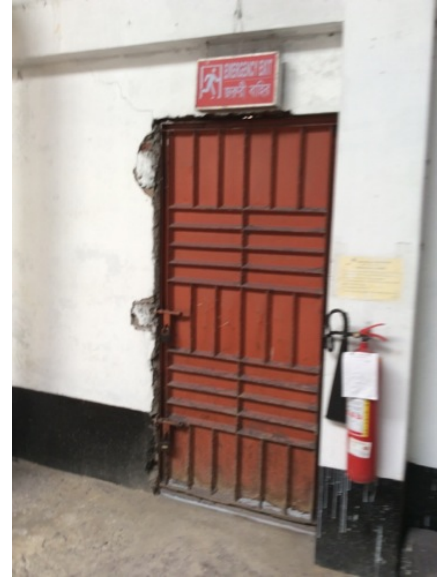
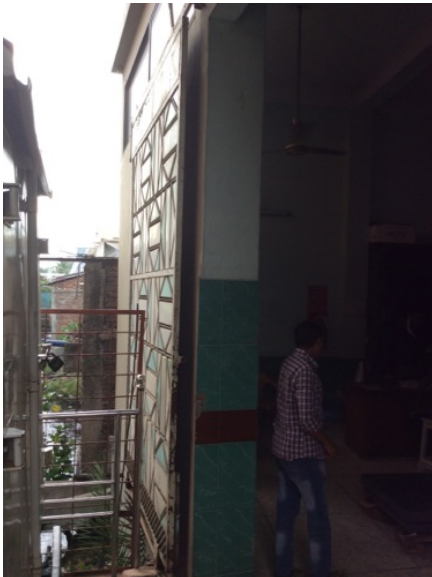
| No. | Category | Finding | Recommendation | Remediation Timeframe |
|---|---|---|---|---|
| F-2 | Egress | Egress doors / gates with locking features are provided at building exits, exit stairs, along egress routes, exit discharge.<br>Located: On all floors all gates/doors were open and unlocked during the inspection. | Remove locking features from all egress doors / gates.<br><br>If locks are required for security reasons, utilize special door locking features complying with NFPA 101. | Immediate |

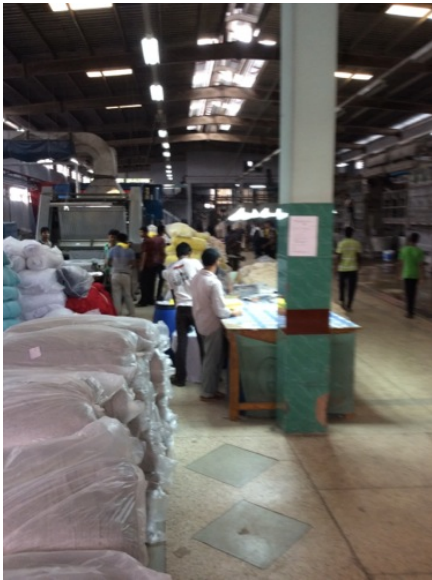
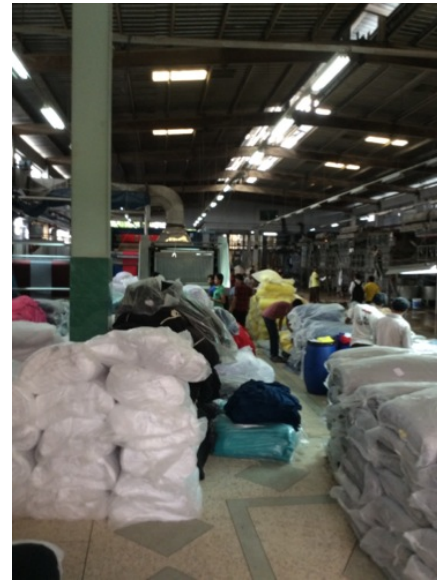
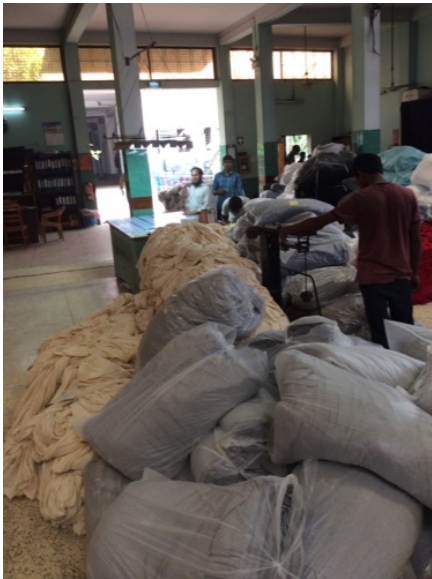
| F-3 | Egress | Storage was located in the egress path.<br>Location: Ground floor. | Keep egress paths and stairs clear of storage. | Immediate |

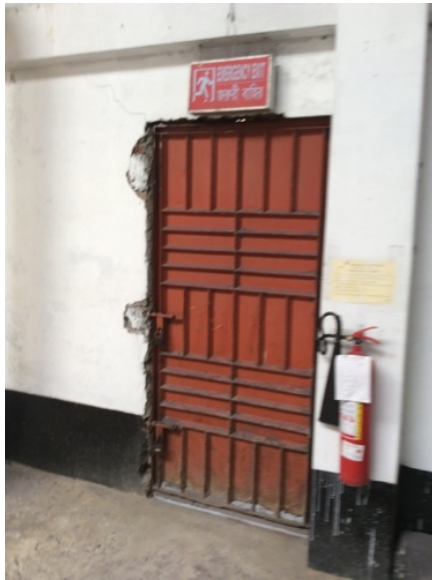
| F-9 | Egress Lighting | Exit signage not illuminated (burned out, broken, etc.).<br>Location: Large boiler exit light not working. | Regularly inspect all exit signage and replace/install lights as needed to illuminate signs. | Within 1 month |
