# FIRE SAFETY INSPECTION REPORT

**Factory Name: Shad Fashion Limited.**

**ACCORD ID: 12429**

**Date: 18 May 2016**

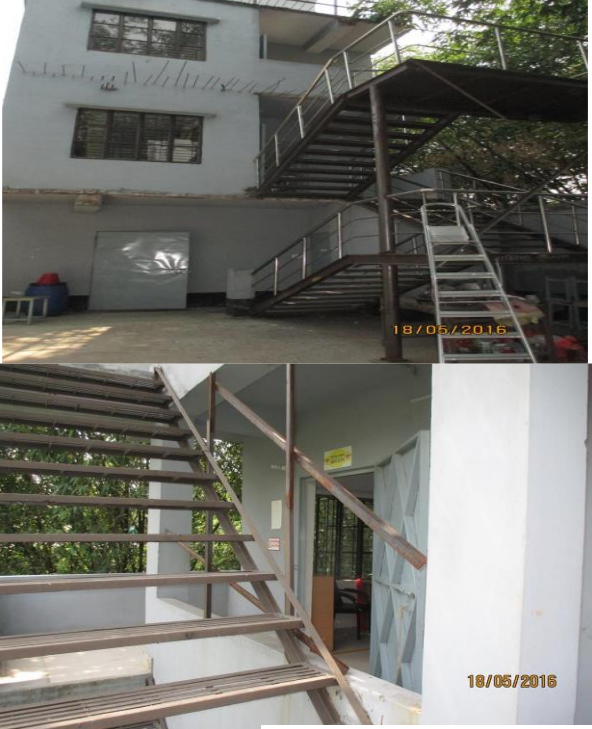
SI No.	Category	Findings	Required Action	Remediation Time Frame	Pictorial Evidence
1	Fire Rated Construction	The exterior exit stair is not separated from the building. Location: Building B (Sample Building).	Provide minimum 1.5-hr fire rated doors and seal all unprotected openings to separate the exit stairs from work areas and other building spaces on all floor levels. Ensure that the fire doors are self-closing and positive latching and that they are provided with fire exit (panic) hardware where serving production floors. If fire doors are required to be held open for functional reasons, provide automatic closing devices tied to the fire alarm system.	Within 3 months

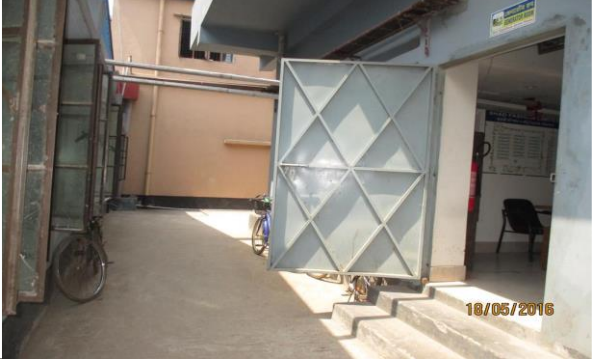
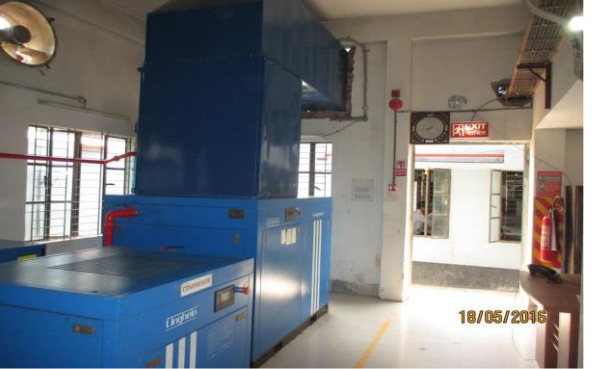
SI No.	Category	Findings	Required Action	Remediation Time Frame	Pictorial Evidence
2	Fire Rated Construction	Generator/ transformer/Boiler/Compressor room is not properly separated by fire rated construction from the stair which is used for going to the prayer room at south-east corner of the factory premises.	<p>Generator/ transformer room shall be separated from the stair by a minimum 2-hr fire rated construction (wall, floor, slab etc.). Seal all penetrations and openings (door, window etc.) shall be protected by 1.5-hr fire rated materials to maintain the fire separation if required. All exhaust systems shall discharge to the exterior of the building in a safe location.</p> <p>Or, relocate the prayer room in a safe place.</p>	Within 3 months

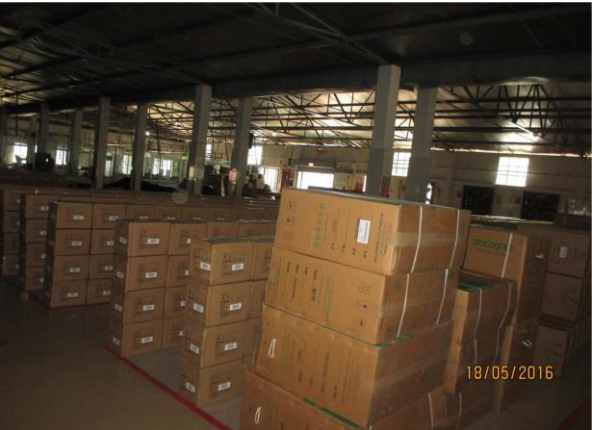
3	Fire Rated Construction	Areas used for in-process storage (Inspection Goods) of combustible materials are open to the surrounding occupancy. Location: Building A	Provide defined storage areas and limit the storage arrangement as: Maximum height of 2.4m and maximum area of 23m2. Separate areas of unenclosed combustible storage by a minimum clear distance of 3m	Within 2 months

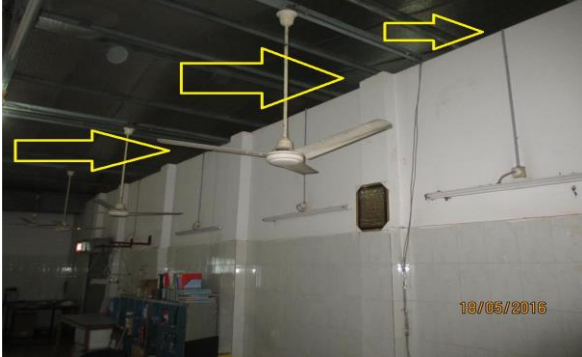
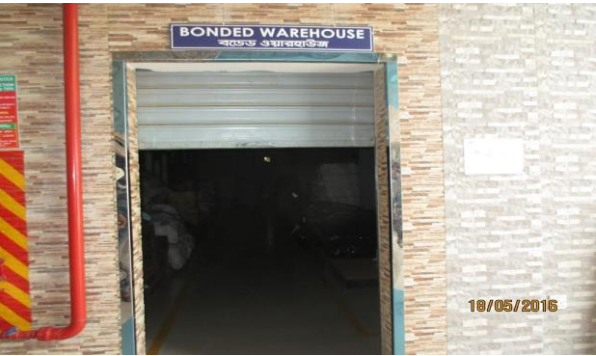
SI No.	Category	Findings	Required Action	Remediation Time Frame	Pictorial Evidence
4	Fire Rated Construction	Room used for storage of combustible materials (Accessories store & Bonded Ware House) is not separated from the surrounding occupancy (sewing section). Location: Building A.	Rooms used for storage of combustible materials shall be separated from the surrounding occupancy with a minimum 1 hour construction.	Within 3 months

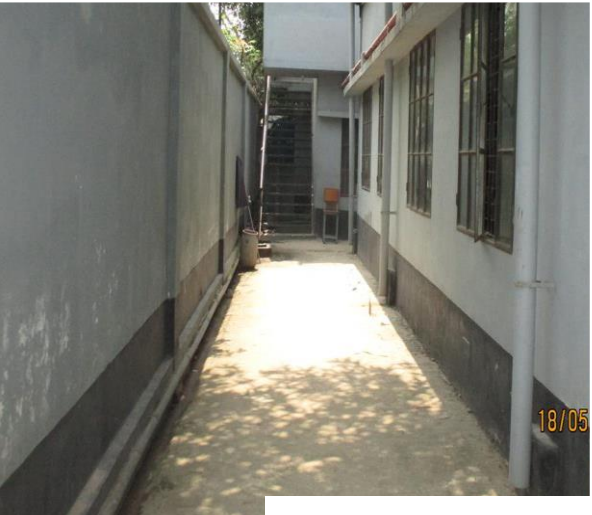
5	Fire Rated Construction	The exit discharge path [serving South East Exit & North East Exit] is less than 10 ft. wide and is not separated from the building interior. Location: Building B.	Seal all penetrations and openings to the interior of the building along the discharge path, up to a height of 10 ft. to provide a minimum 1-hr fire separation.  Alternatively, provide a second remote discharge path to the public way (only include this if feasible).	Within 2 month

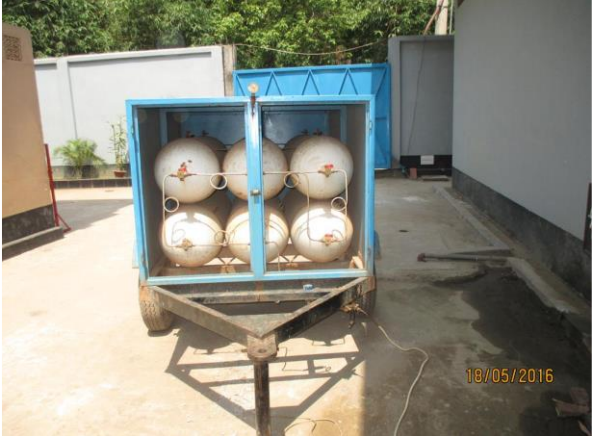
SI No.	Category	Findings	Required Action	Remediation Time Frame	Pictorial Evidence
6	Fire Rated Construction	The factory is using/ storing liquefied gas cylinder without any separation.	Remove them from the factory building. Or, Provide 2-hr rated room for using/ storing liquefied gas cylinder and ensure proper verification of that room. Source of fire such as electrical connection is prohibited.	Immediate

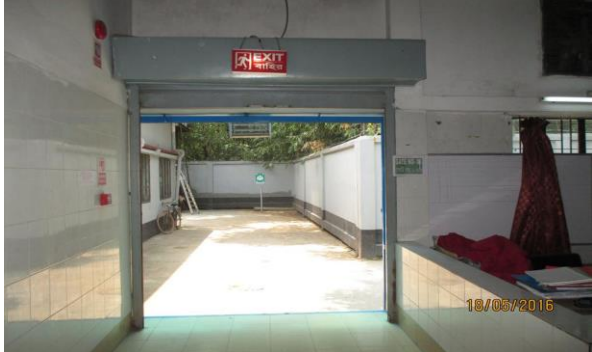
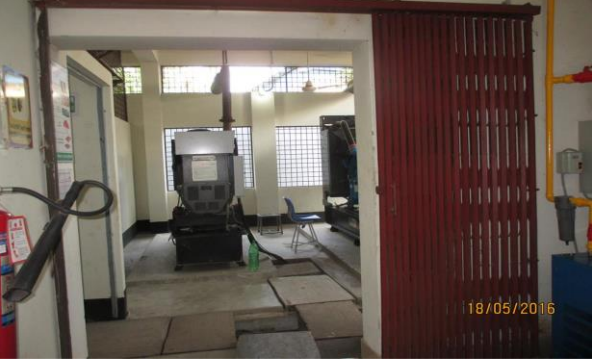
7	Egress	Collapsible/ sliding type doors have been provided along means of egress (building exits, along egress routes, exit discharge).	Replace all collapsible/ sliding type doors & gates by the side-hinged swinging type doors.  If locks are required for security reasons, utilize special door locking features complying with NFPA 101.	Immediate

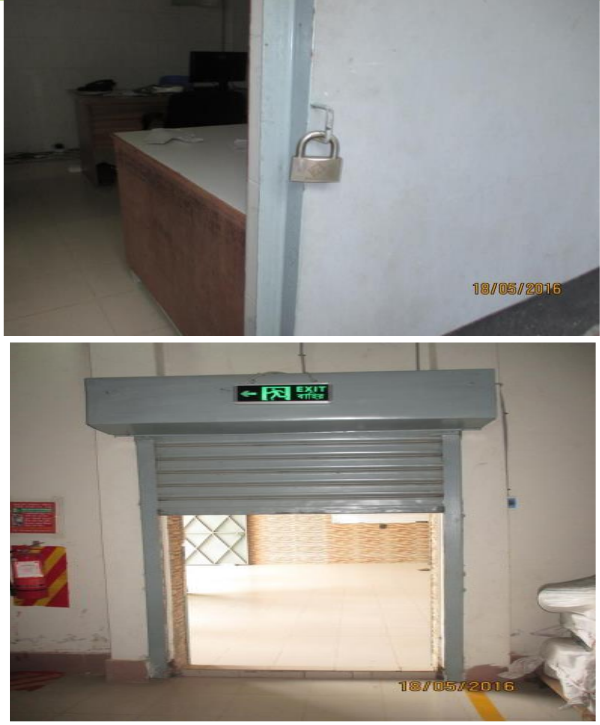
SI No.	Category	Findings	Required Action	Remediation Time Frame	Pictorial Evidence
8	Egress	Doors along means of egress are provided with non compliant locking system	<ol style="list-style-type: none"> <li>1. Remove all non compliant locking features from egress doors.</li> <li>2. If locks are required for security reasons, utilize special door locking features complying with NFPA 101.</li> </ol>	Immediate

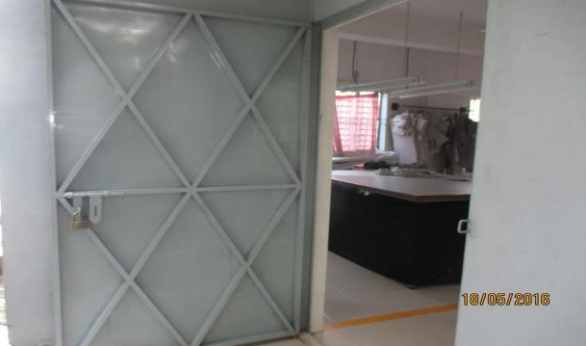
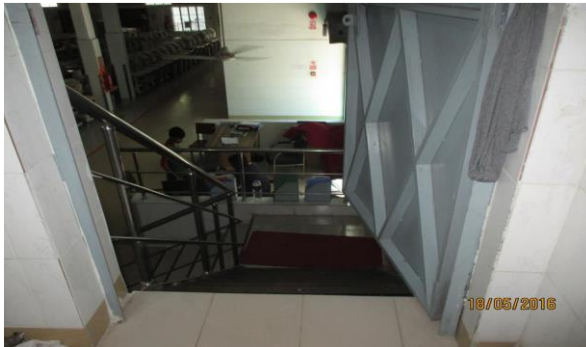
SI No.	Category	Findings	Required Action	Remediation Time Frame	Pictorial Evidence
9	Egress	Landings are not provided on both sides of doors used along the path of egress. Doors do not swing out over stairs. Location: Building B, Mezzanine Floor of Building A.	Provide minimum 36 inch landing on both sides of doors used along the path of egress.	Within 1 month

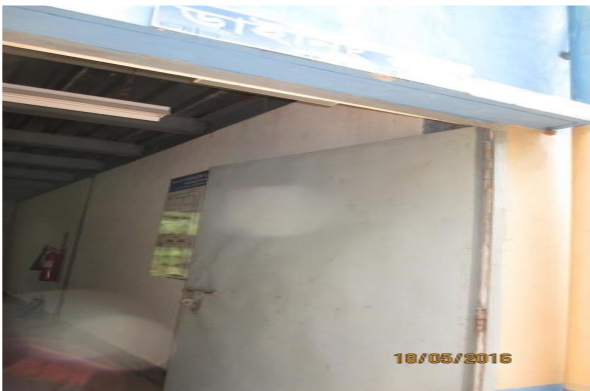
10	Egress	Egress door serving 50 or more occupants but does not swing in the direction of egress travel. Location: Dinning Area.	Modify swing direction of egress doors to the direction of egress travel. Doors serving an occupant load of more than 50 shall swing in the direction (out-ward) of egress travel .	Within 1 month

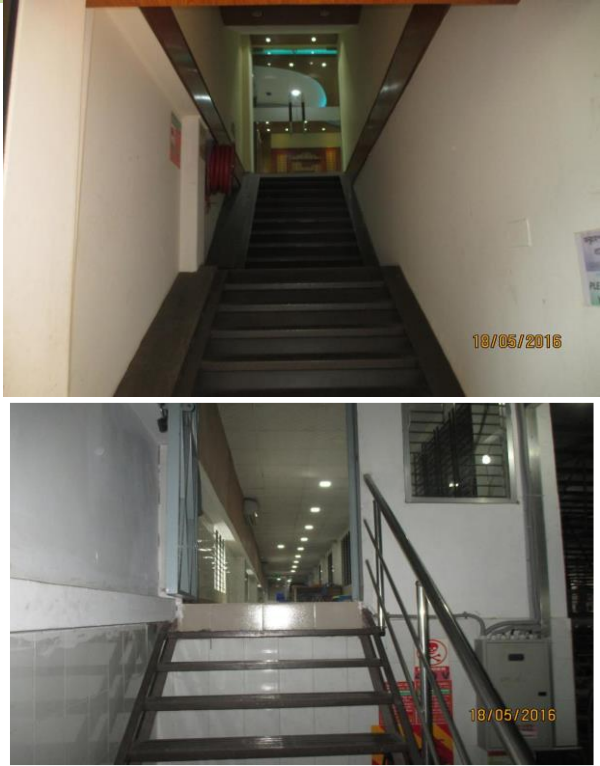
SI No.	Category	Findings	Required Action	Remediation Time Frame	Pictorial Evidence
13	Egress	Handrails are not provided in the exit stair. Location: Building D, Mezzanine Floor in Building A.	Provide handrails on both side of exit stair having a minimum height 34 in.	Within 1 month

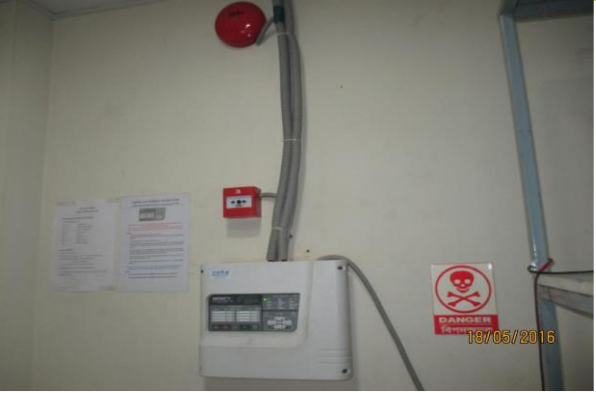
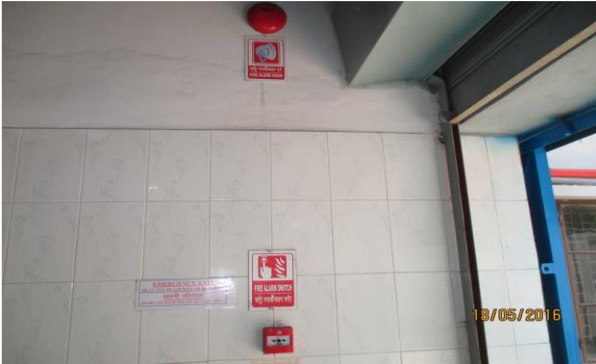
SI No.	Category	Findings	Required Action	Remediation Time Frame	Pictorial Evidence
14	Fire Alarm System	The Required Fire Alarm system is not installed in accordance with the ACCORD standard Or NFPA-72.	Design of Fire Alarm system should be in accordance with ACCORD standard and NFPA 72.	Design Submission 2 months and Installation 4 months.

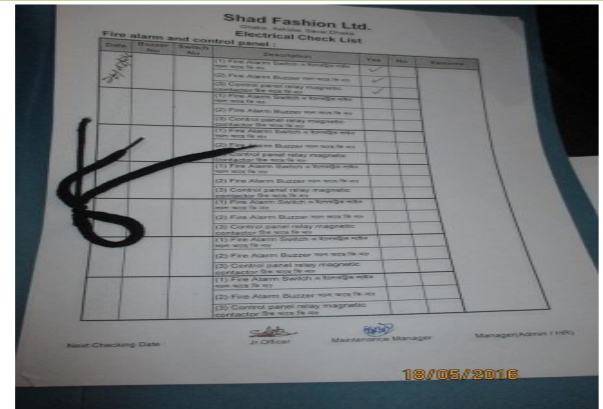
16	Fire Alarm System	Inspection, testing, and maintenance for the fire alarm system is not in accordance with NFPA 72 or as per Accord standard.	Inspect, test and maintain the fire alarm system, and keep written records on-site, in accordance with NFPA 72 or as per Accord standard.	Within 3 months	
----	-------------------	---	---	-----------------	--

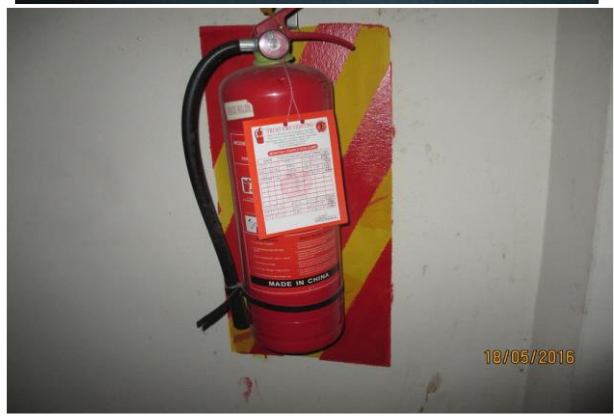
17	Fire Protection	Inspection, testing and maintenance of portable fire extinguishers is not in accordance with NFPA 10.	Inspect, test and maintain the portable fire extinguishers and keep written records on-site, in accordance with NFPA 10 and ACCORD standards.	Within 3 months	
----	-----------------	---	---	-----------------	--

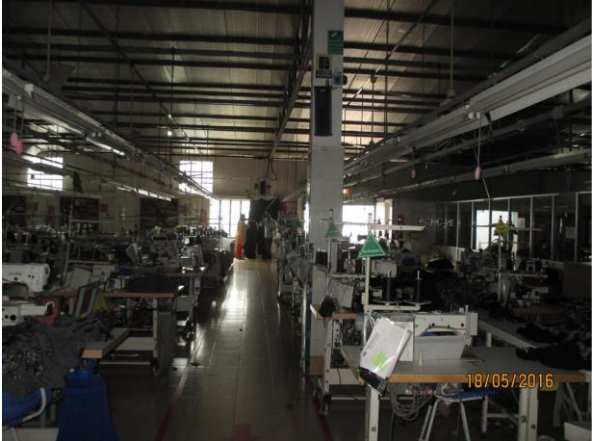
SI No.	Category	Findings	Required Action	Remediation Time Frame	Pictorial Evidence
18	Emergency Egress Lighting	Based on the number and location of emergency lights observed, adequate illumination levels are not anticipated along egress routes.	Test the emergency lighting system on each floor and provide additional emergency fixtures to provide adequate illumination along the means of egress. Provide a minimum illumination of 10 lux at the floor level within exit stairs and exit discharge paths and minimum 2.5 lux along exit access aisles.	Within 3 months

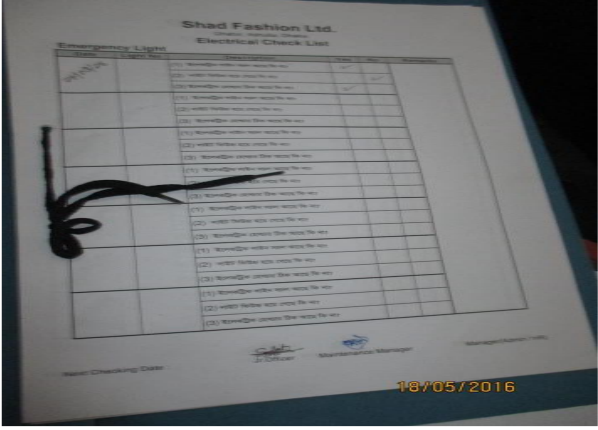
19	Inspection, testing and maintenance	Inspection, testing, and maintenance for the exit sign and emergency lighting system was not in accordance with The ACCORD standard.	Inspect, test and maintain the exit sign and emergency lighting system in the accordance with The ACCORD standard. Keep written records on-site.	Within 3 months

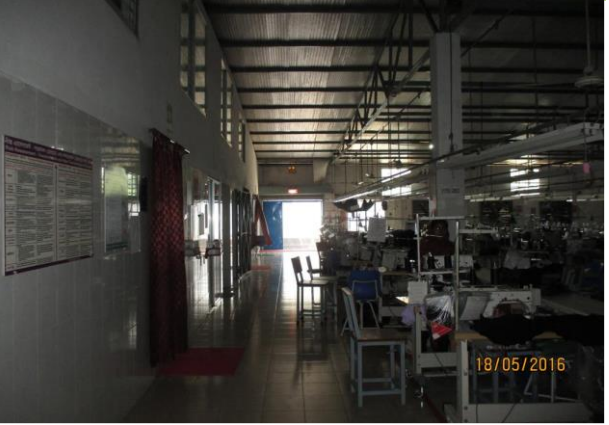
Sl No.	Category	Findings	Required Action	Remediation Time Frame	Pictorial Evidence
20	Directional Sign	Directional signs are not provided where direction of the path of travel to an exit has changed. Location: Main Production Building A.	Illuminated directional signs shall be provided where there is a change in the direction for the path of travel and the direction to an exit is not obvious.	Within 1 months

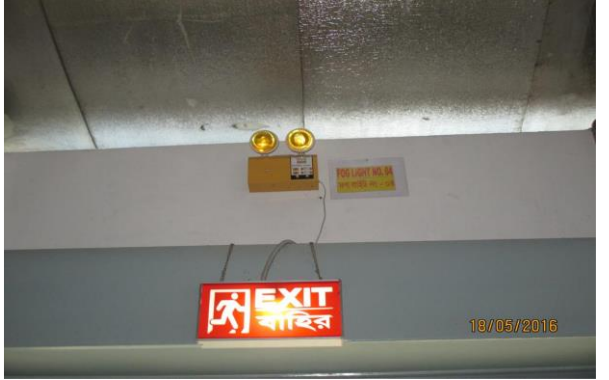
21	Manual On/Off Switch	Manual on-off switch is provided for [emergency lighting / exit signage] units.	Remove manual on/off switches from emergency lighting / exit signage units to prevent them from being switched off.	Within 3 months
