# Summer Dress Ltd Elegance Orientale Ltd

Jangaliapara, Vawal Mirzapur, Gazipur Sadar, Gazipur, Bangladesh  
(24.092165N; 90.384487E)

23 April 2015

## Structural Inspection Report

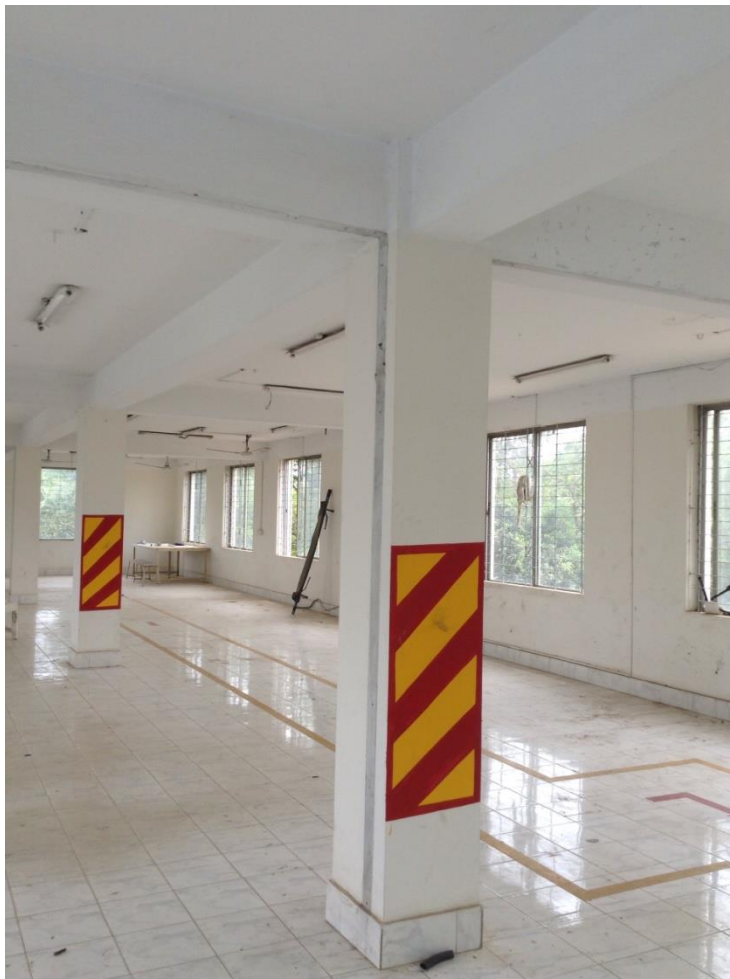
**Typical Floor**

- RC beams with two-way spanning slabs.
- Lateral stability is assumed to be provided by moment frame system.
- **Columns:** 375mm x 375mm RC (Typical internal)  
250mm x 500mm RC (Typical corner & edge)
- **Grid:** 6.9m x 4.44m maximum observed
- **Beams:** 285mm wide x 350 mm downstand (with plaster)
- **Floor Slab:** 125 mm thick (avg. excluding floor finishes)
- **Floor to Ceiling:** 3.0m(1<sup>st</sup> & 2<sup>nd</sup> ) and 4.55m (Ground Floor)
- **Foundation:** Pad Foundation assumed (and as shown in permit drawing)

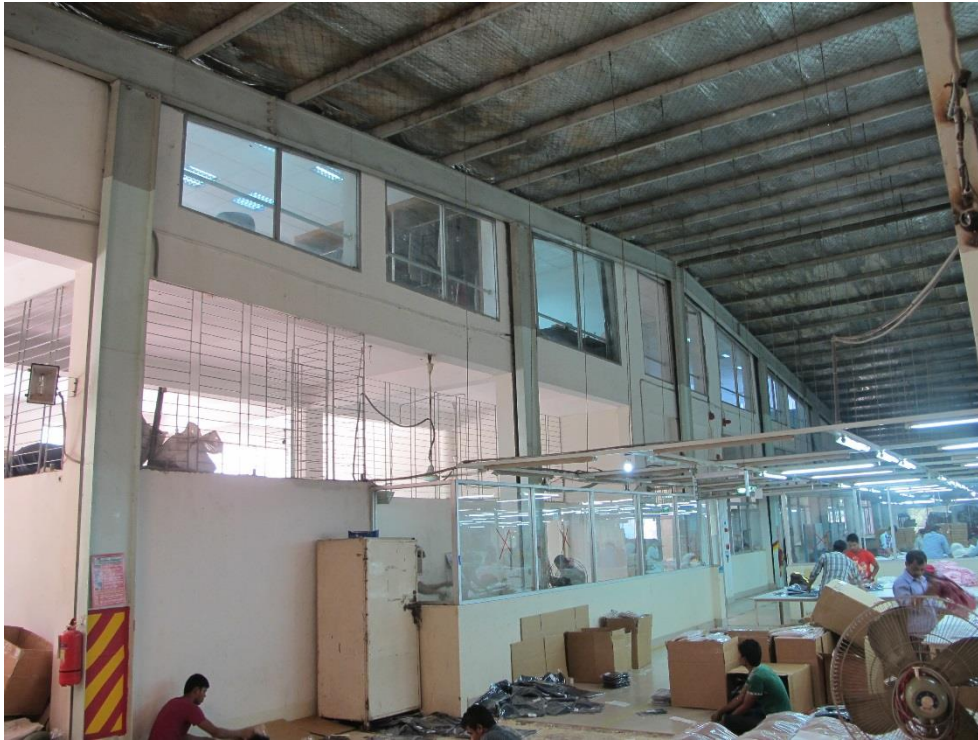
**4.55m high floor to ceiling height at Ground level**

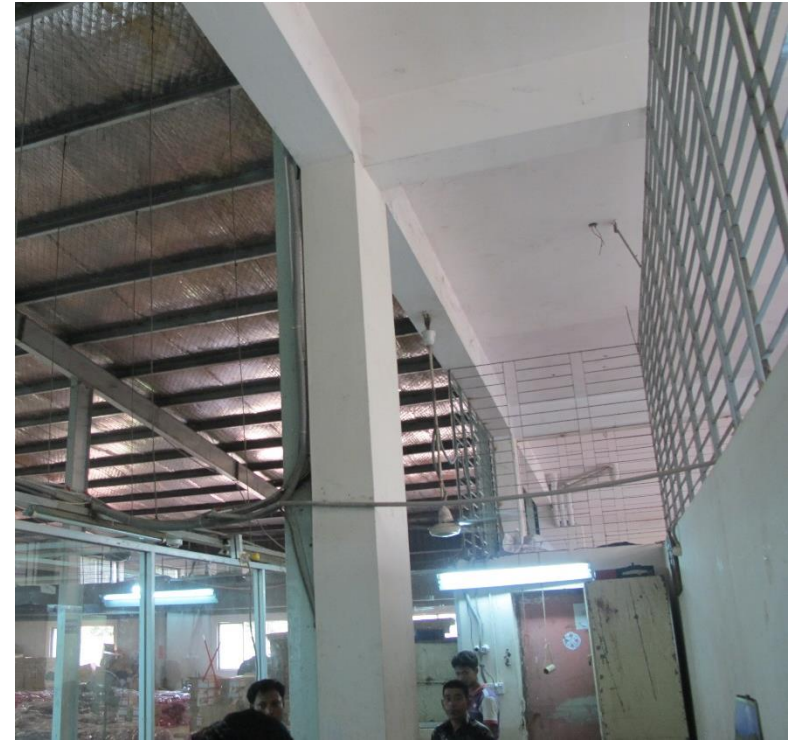
**Typical beam and slab structure looking at 1<sup>st</sup> Floor from Ground Fl**

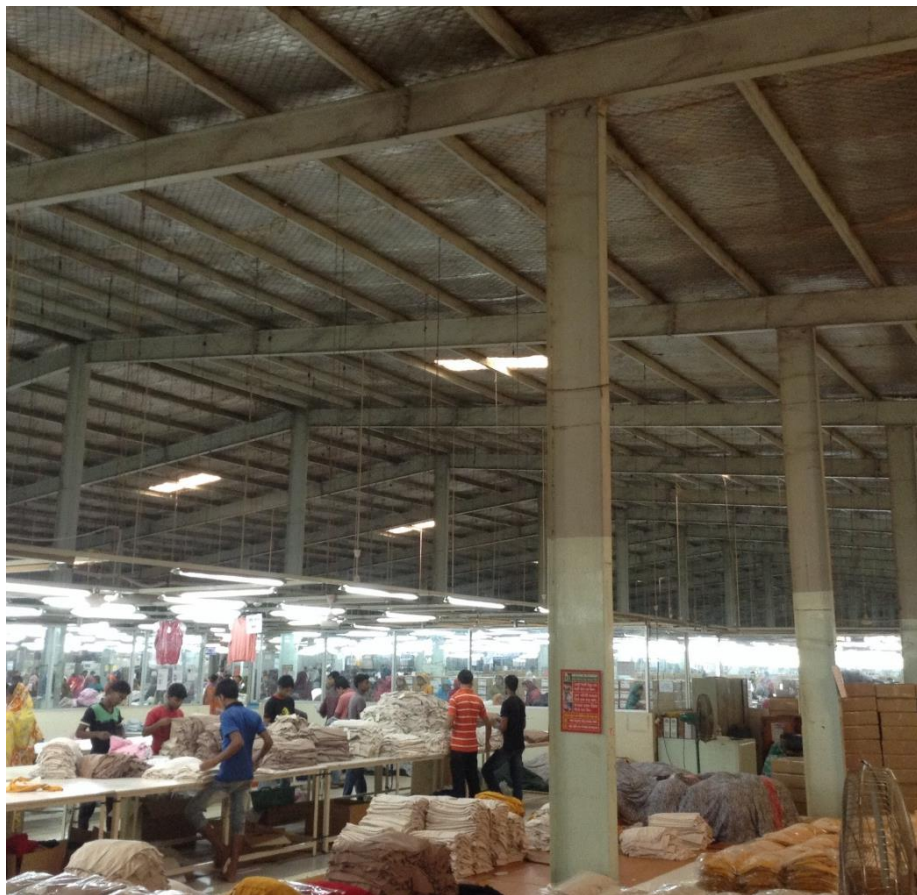
Typical Beam Column portal frame

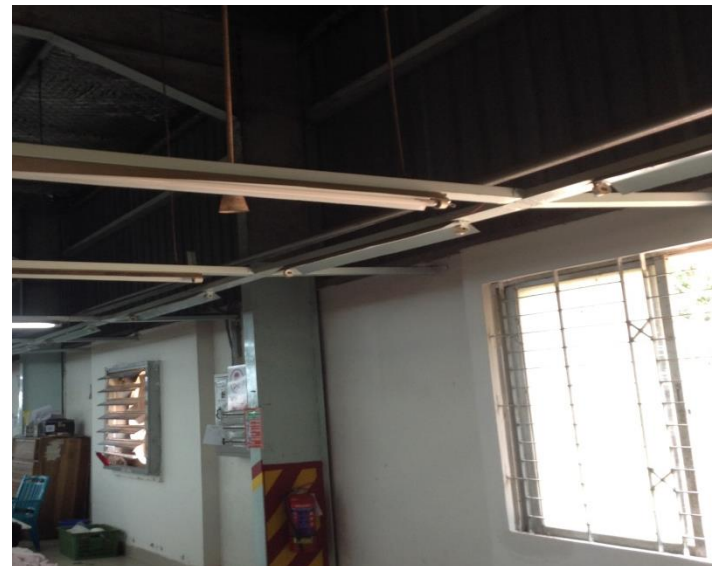
Brick Wall up to 2.65m height

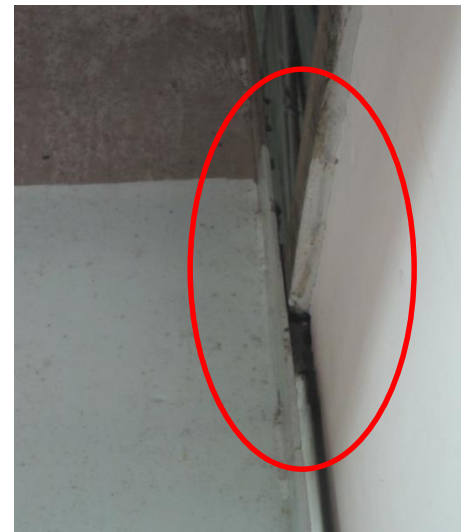
Cleat welded to Steel Column and  
built into the brick wall

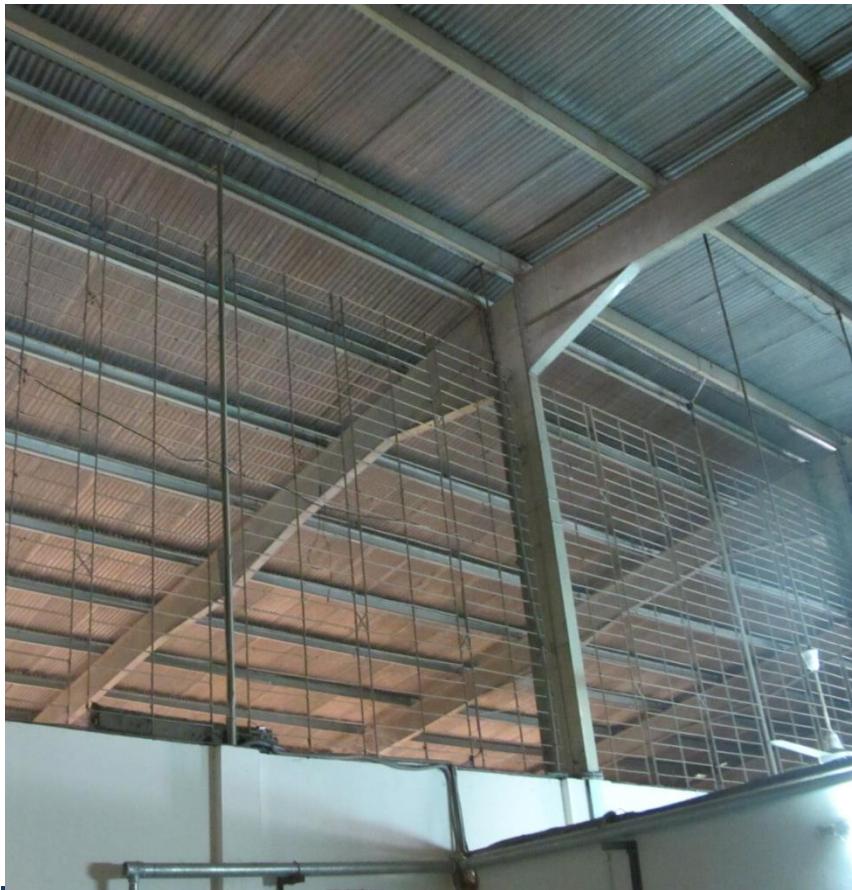
Portal with one central support

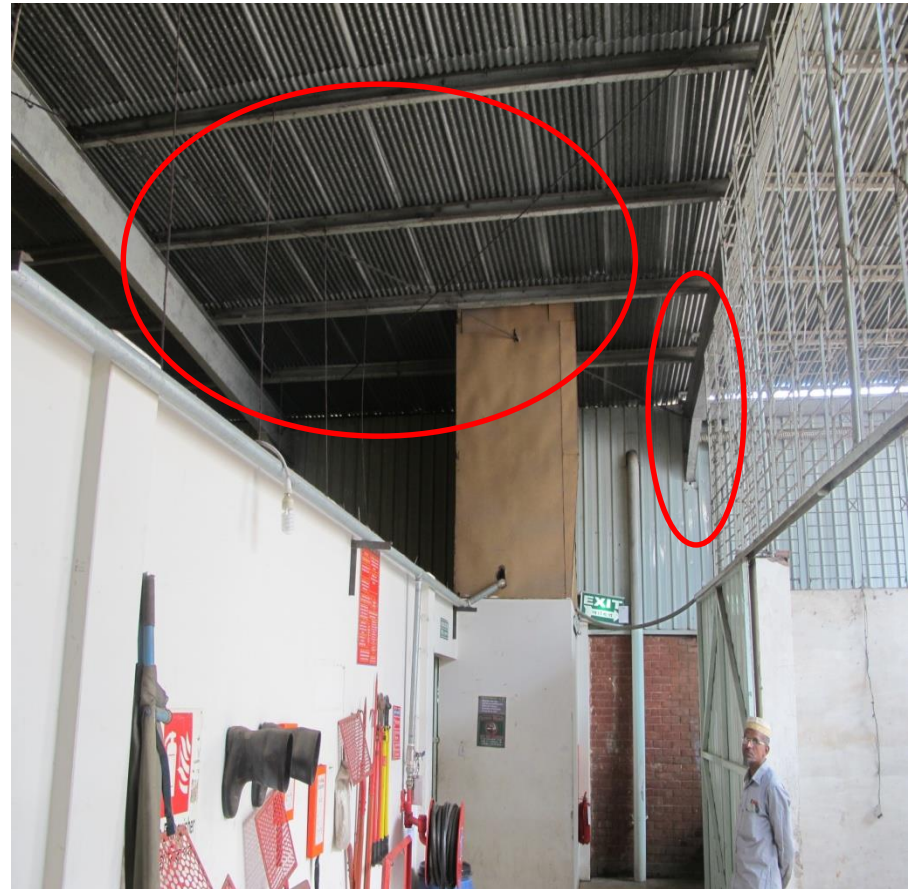
Portal rafters in Storage annex are a continuation of portals in Main Production shed, 6 portals to form a 5-bay wide storage shed

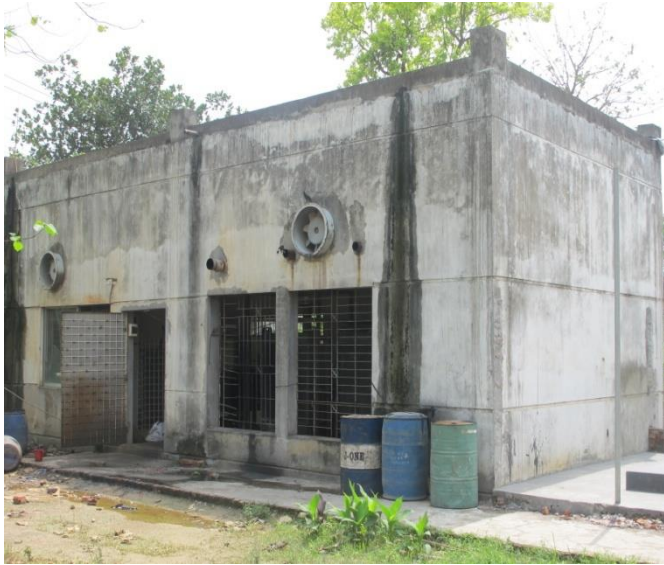
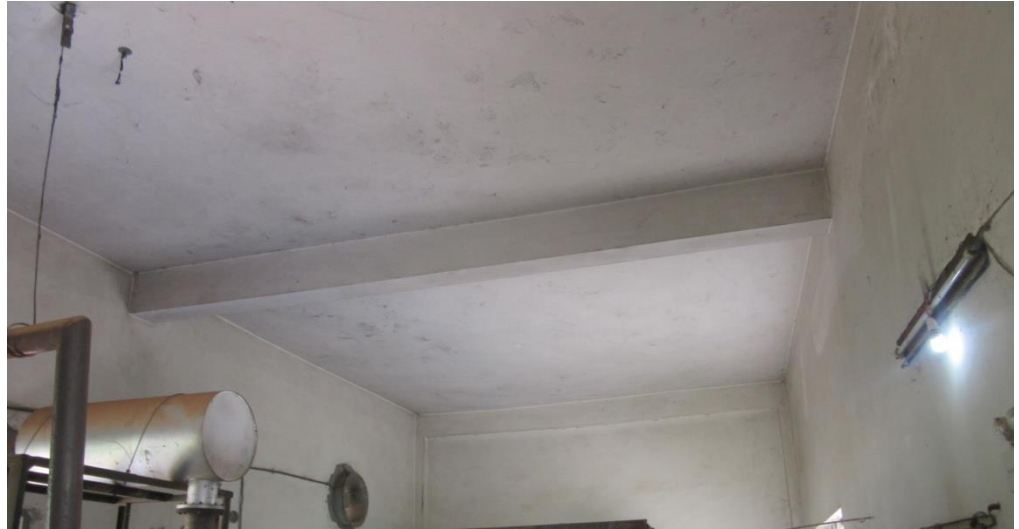
## Structural System – Storage annex to Production shed

- RC beams with two-way spanning slabs.
- Lateral stability is assumed to be provided by moment frame system and brick infill
- **Foundation:** Pad Foundation assumed (and also shown in permit drawing)

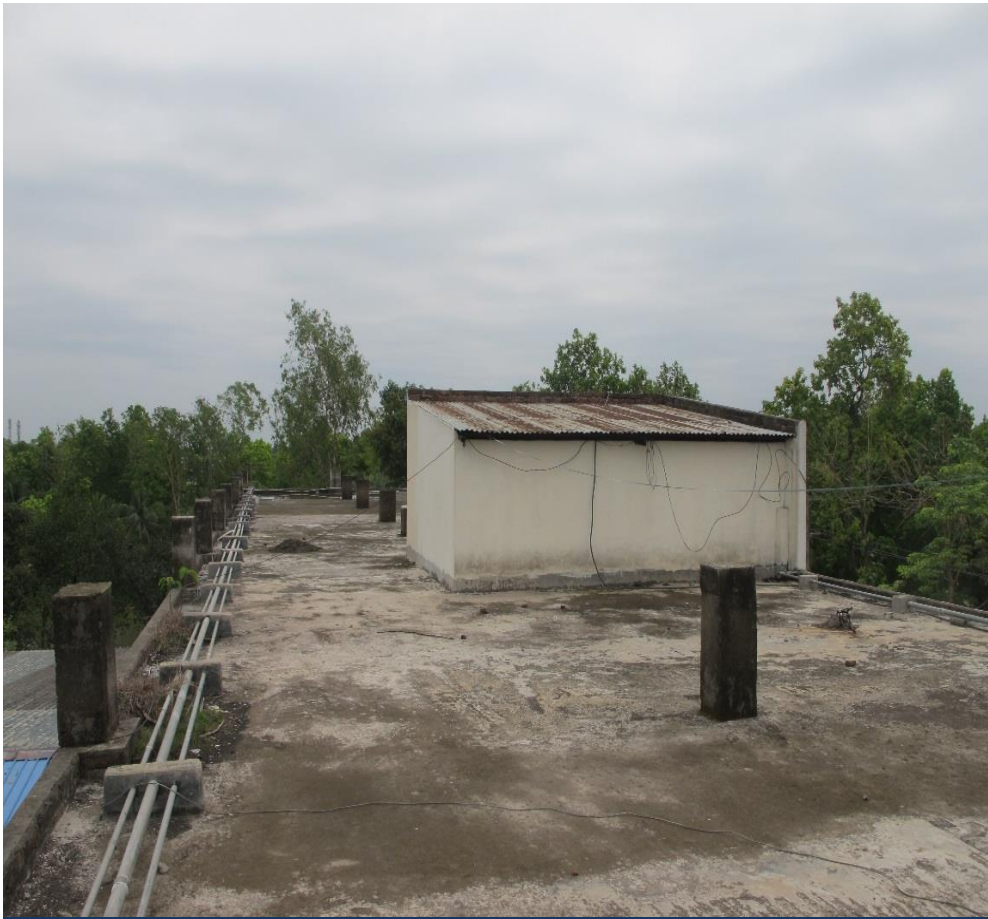
**No safety parapet on perimeter of Office  
building roof**

No safety barriers on any sides of roof top perimeter

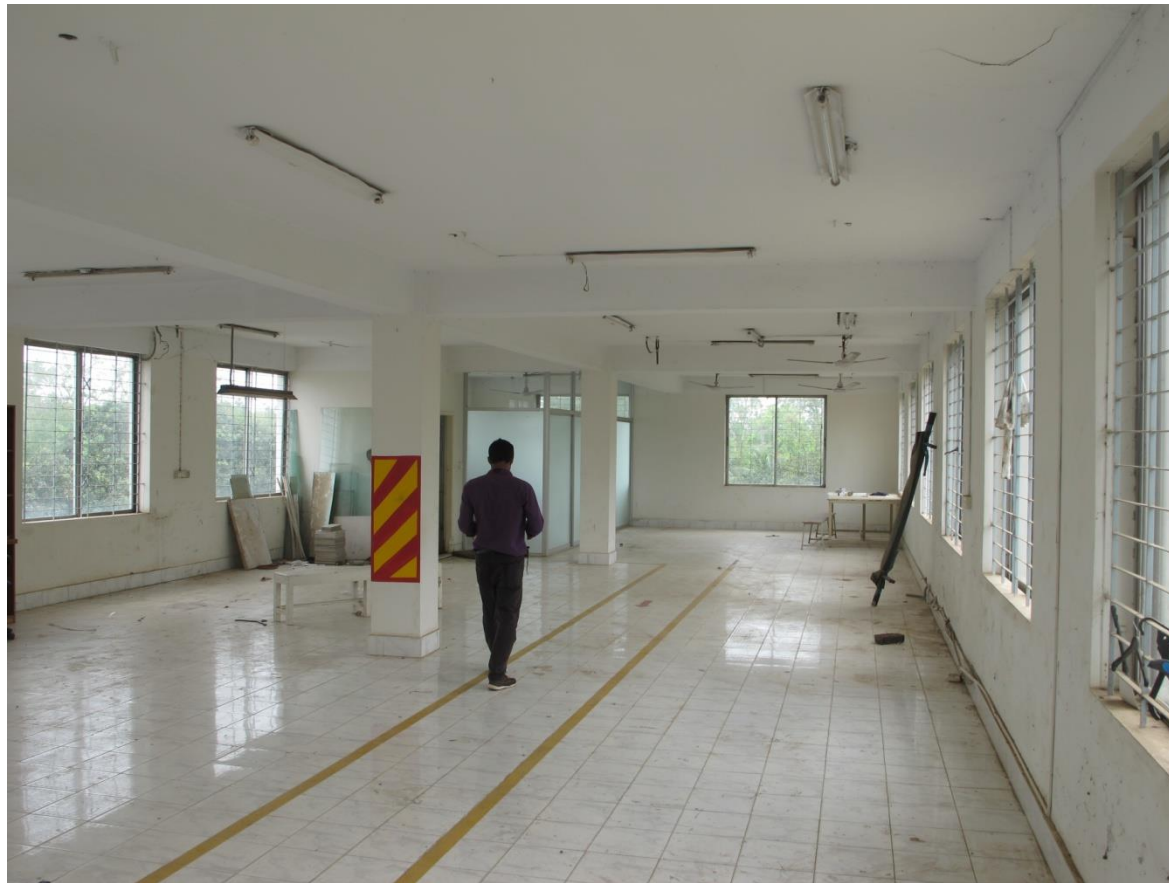
# **Lateral Stability system of Office building**

Building has 2 bays in short direction and 9 bays in long direction. The edge columns are 250mm x 500mm and orientated with the weak axis perpendicular to the short axis of the building. The ground floor height is 4.5m. This provides a weak lateral stability system for RC the building

- Structural engineer to review lateral stability system for the RC office building.
- Apply appropriate remedial measures if lateral stability found to be inadequate

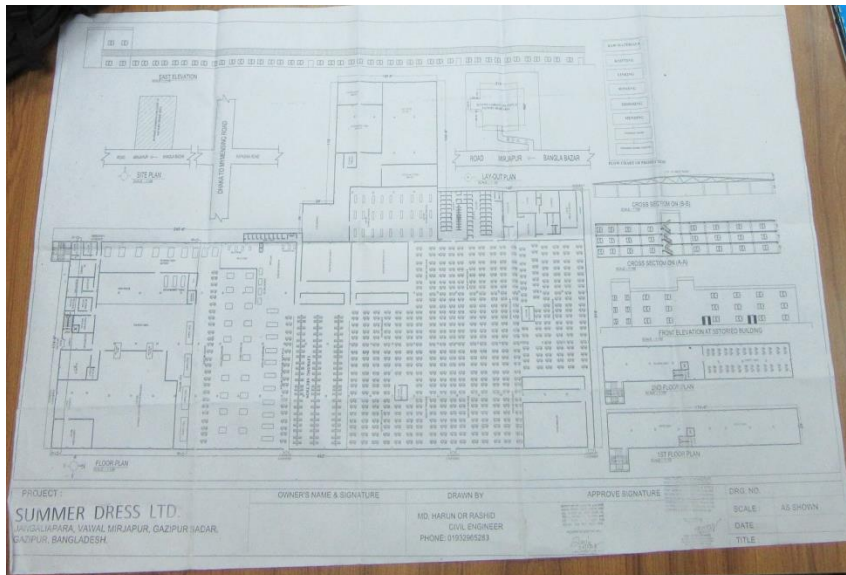
Industrial permit drawing

Except for what is shown on the Permit and Industrial Inspectorate drawings, no structural or architectural drawings were provided for Site survey visit

- Building engineer to collect information and produce accurate and complete as-built structural documentation for all buildings at soonest opportunity.

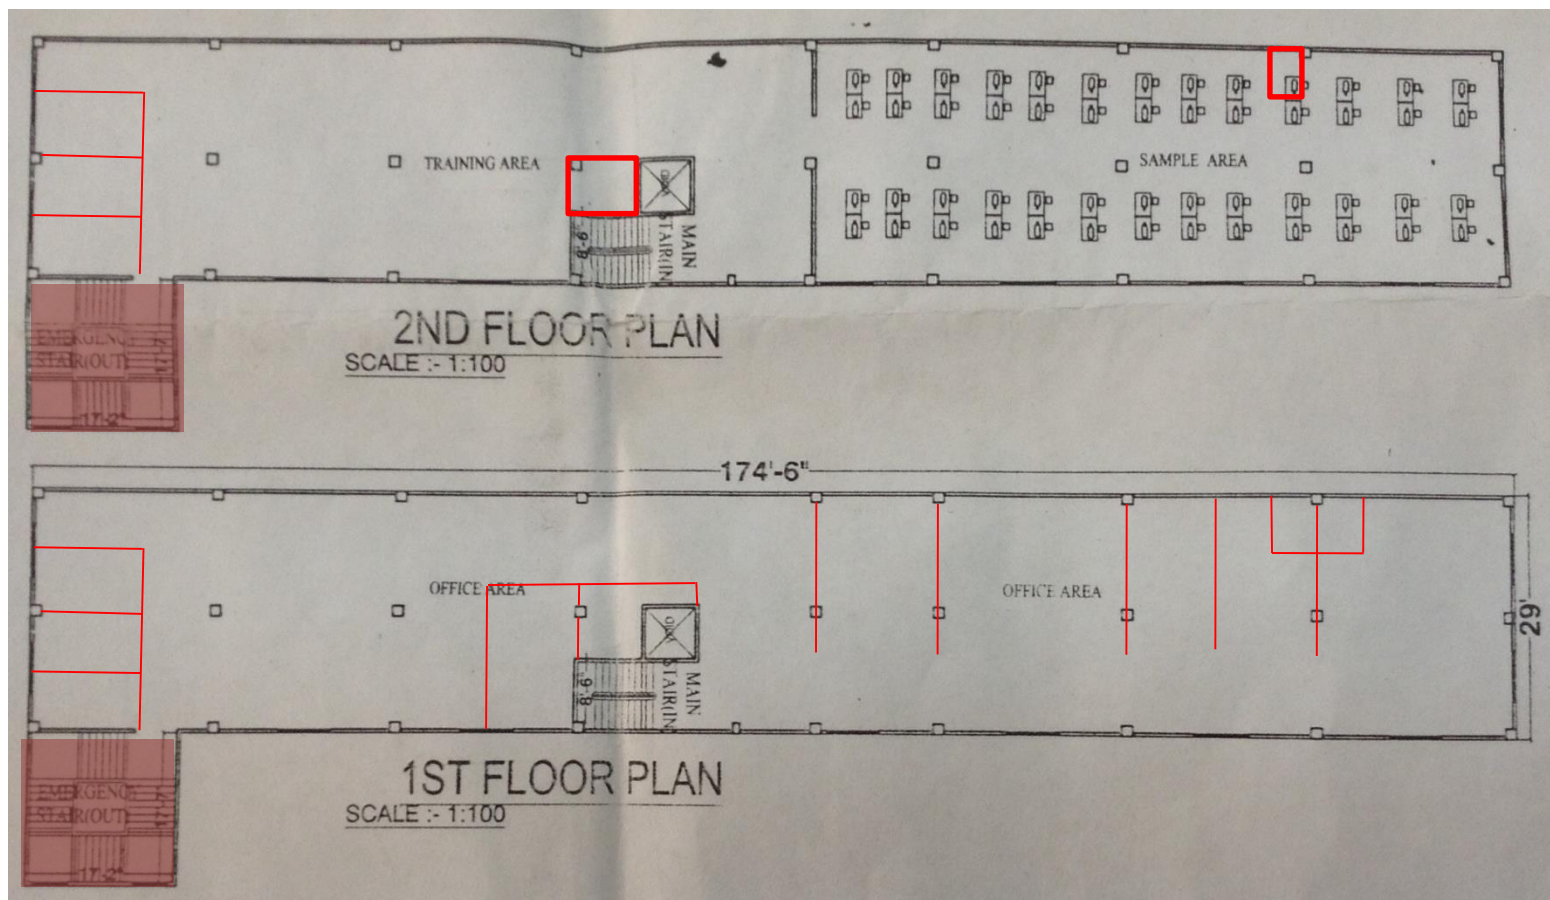
Grid dimensions are incorrect where shown on the Permit drawing  
 The shaded area shows an RC staircase that does not exist – a steel spiral stair has been erected in this location  
 Red lines indicate the walls which are not present in the permit drawing

- Building engineer modify permit drawings and re-submit showing actual layouts of buildings.

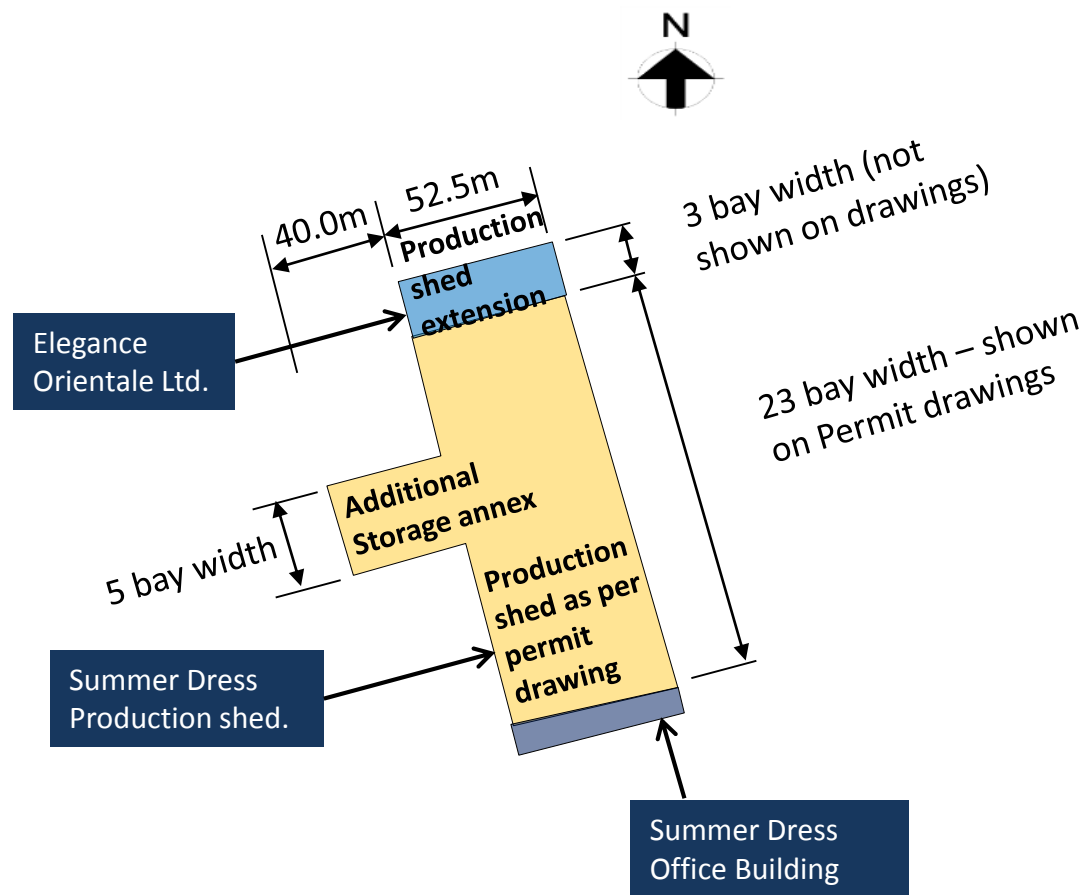
Permit drawings show a steel portal framed Production shed with 23 bays at 6.1m c/c; the shed observed on site has 26 bays at 6.1m c/c

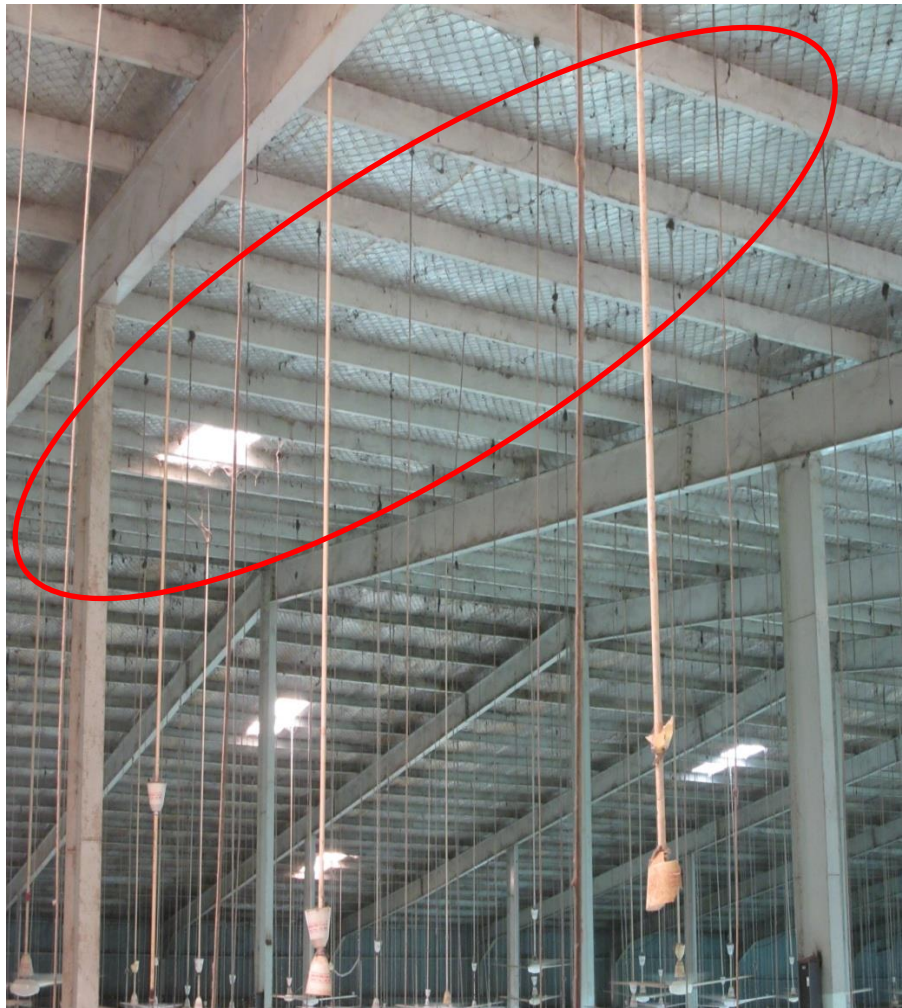
No horizontal roof bracing in any line of portals

- Structural engineer to review lateral bracing system for the Main production shed, and provide lateral bracing as appropriate.
- Document the bracing system on updated as-built drawings .

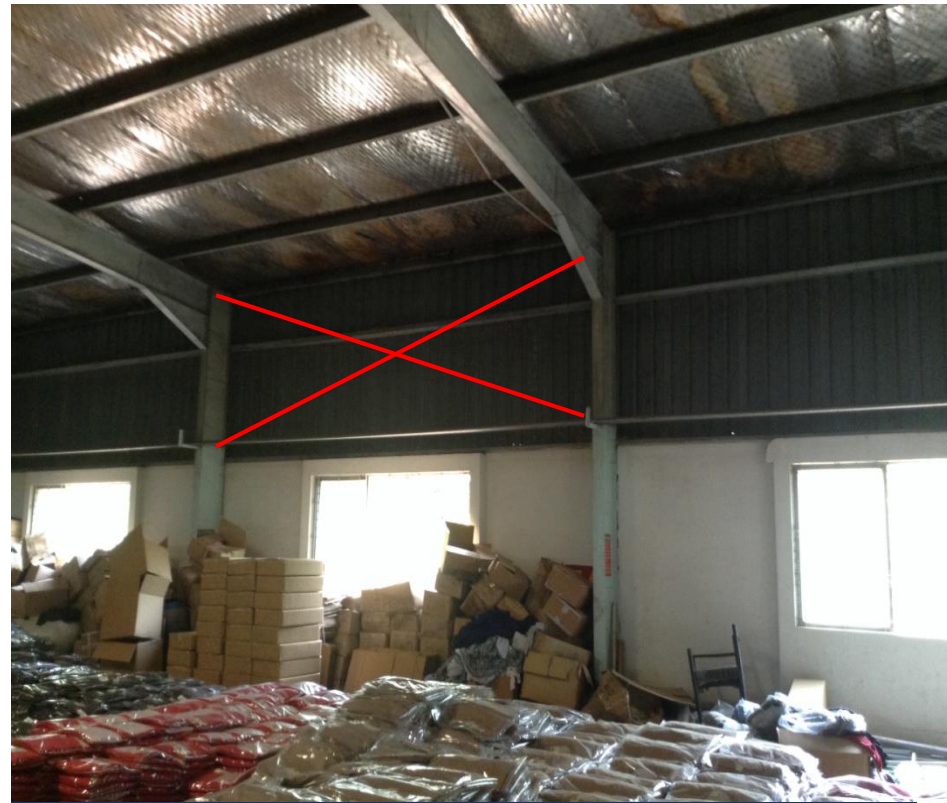
No cross bracing from eaves of the steel portals to the top of the brick wall  
The steel column cleats welded onto them and built into the top of the 2.65m brick wall to provide lateral stability at this level.
