FIRE SAFETY INSPECTION REPORT

**DIVINE TEXTILE LTD.
CHANDRA, KALIAKOIR**

ACCORD
on Fire and Building Safety in Bangladesh

March 31, 2014

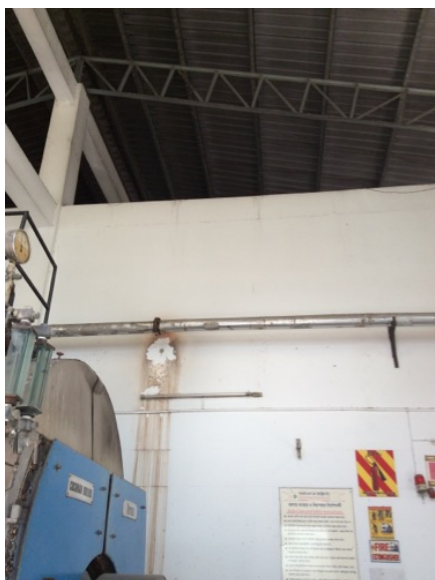
No.	Category	Finding	Recommendation	Remediation Timeframe
F-1	Fire Rated Construction	The boiler room is not separated by fire-rated construction (openings, non-rated doors, penetrations).	Separate the boiler room by a minimum 2-hr fire-rated construction. Seal and/or protected all openings to maintain the required fire separations	Within 3 months

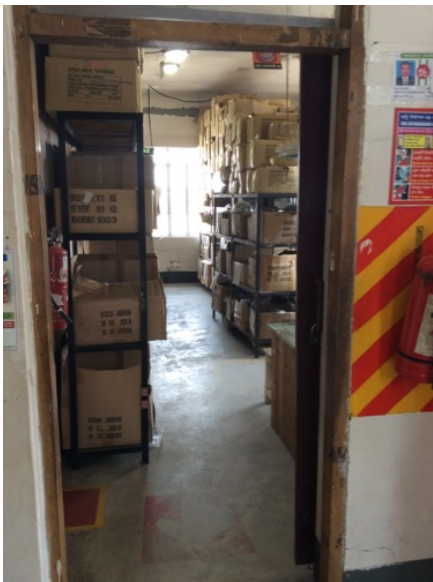
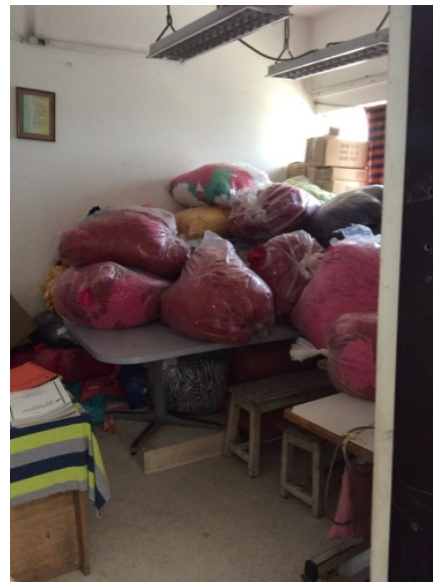
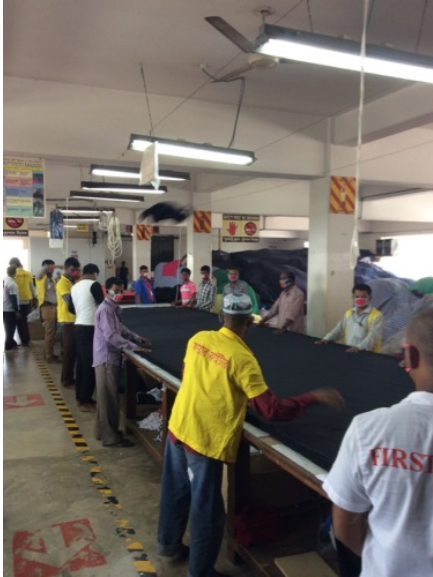
F-2	Fire Rated Construction	Areas used for combustible storage are not separated by fire-rated construction. Multiple floors within building.	Provide dedicated storage rooms separated by minimum 1-hr fire-rated construction. Where separate storage rooms are not feasible, provide defined storage areas and limit the storage arrangement as follows: - Maximum height of 2.4m and maximum area of 23m ² - If sprinkler protected: maximum height of 3.66m and maximum area of 93m ² Separate areas of unenclosed combustible storage by a minimum clear distance of 3m.	Within 3 months
-----	-------------------------	--	--	-----------------

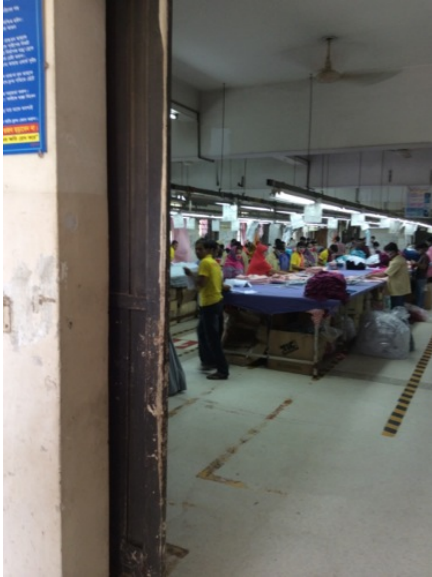
F-3	Fire Rated Construction	The exit stairs are not separated from work areas and other spaces on each floor by fire-rated construction.	Provide minimum 1.5-hr fire rated doors and seal all unprotected openings to separate the exit stairs from work areas and other building spaces on all floor levels. Ensure that the fire doors are self-closing and positive latching and that they are provided with fire exit (panic) hardware where serving production floors. If fire doors are required to be held open for functional reasons, provide automatic-closing devices tied to the fire alarm system.	Within 3 months
-----	-------------------------	--	---	-----------------

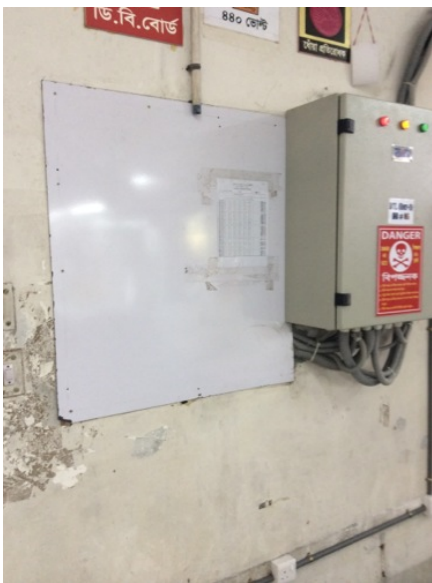
F-4	Fire Rated Construction	Unsealed penetrations and openings are located in the fire-rated floor/ceiling and wall assemblies.	Provide a minimum 2-hr fire-rated shaft to separate the utility risers from each floor level.	Within 3 months
			Seal all penetrations and openings in floor/ceiling assemblies to maintain the fire separation.

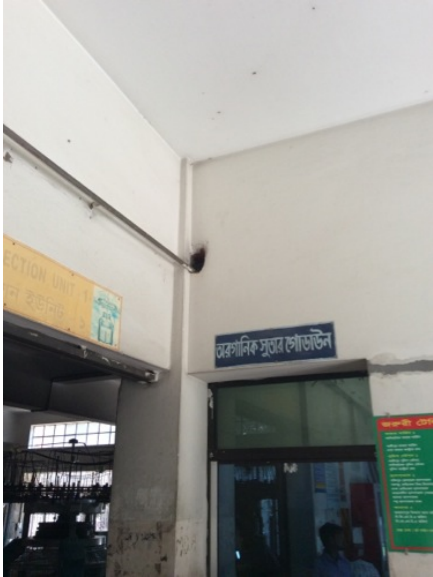
F-5	Fire Rated Construction	Unsealed penetrations and openings are located in exit stair enclosures.	Seal all penetrations and openings in exit stair enclosure walls to maintain the fire separation.	Within 3 months
-----	-------------------------	--	---	-----------------

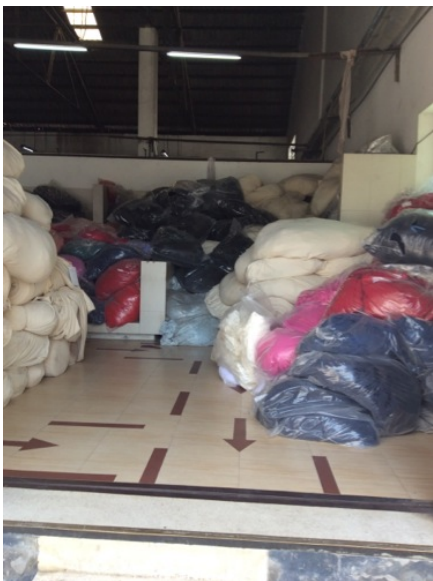
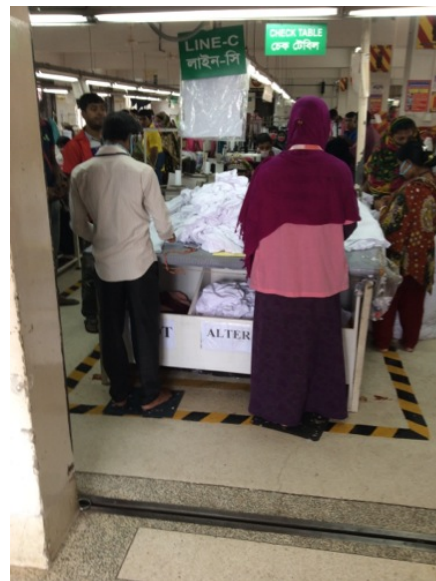
Locations:
Accessory building
2nd floor

F-6	Egress	Storage was located in the egress path.	Keep egress paths and stairs clear of storage.	Immediate
-----	--------	---	--	-----------

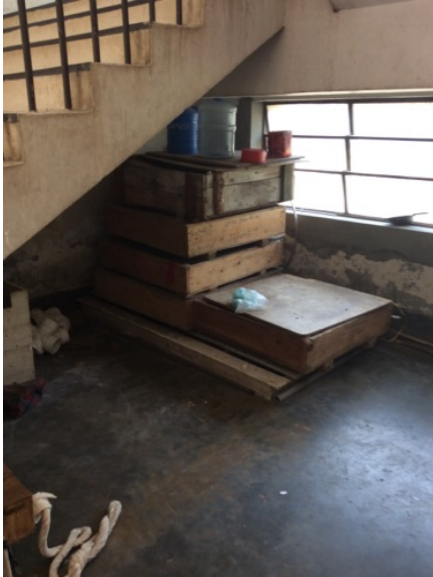
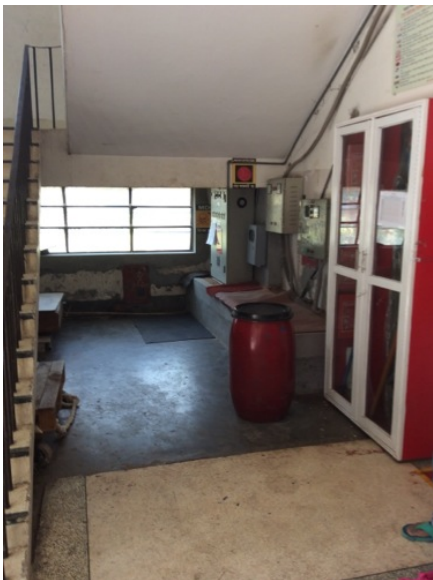
F-7 Egress Storage was located in the exit stair. Remove all storage from exit stairs and egress paths. Immediate

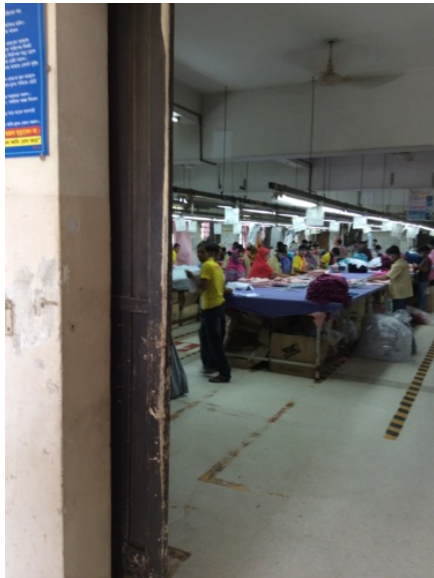
F-8	Egress	Collapsible gates / sliding doors are provided at building exits, exit stairs, along egress routes, and exit discharge. Locations: All floors	Replace all gates / sliding doors along the means of egress with side-hinged, swinging egress doors. If locks are required for security reasons, utilize special door locking features complying with NFPA 101.	Within 1 month

F-9	Egress	Egress doors / gates with locking features are provided at building exits, exit stairs, along egress routes, and exit discharge. Location: All Floors Gates/doors were open and unlocked during the inspection.	Remove locking features from all egress doors / gates. If locks are required for security reasons, utilize special door locking features complying with NFPA 101.	Within 3 months
-----	--------	--	--	-----------------

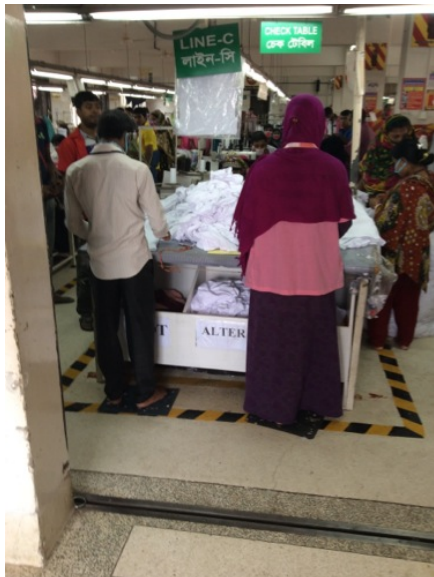
Locations:
2nd Floor.

F-10	Egress	The width of egress aisles is less than 36-in.	Provide minimum aisle widths of 36-in.	Within 3 months
------	--------	--	--	-----------------

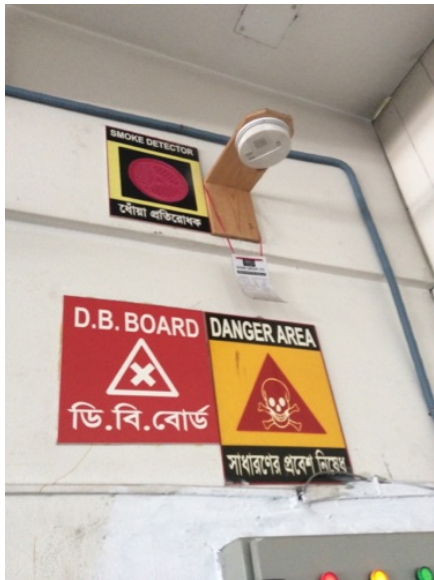
F-11	Fire Protection	The building is equipped with some single-station smoke alarms. Smoke alarm activation sounds only a local alarm and does not provide automatic fire alarm notification of occupants.	Replace the single-station smoke alarms with automatic smoke detectors tied into the fire alarm system. Configure the fire alarm system to initiate occupant notification upon activation of any two smoke detectors in addition to the manual fire alarm stations.	Design within 4 months, install within 9 months
------	-----------------	---	---	---
