# **FIRE SAFETY INSPECTION REPORT**

## **Madinaple Fashions Craft Ltd.**

**Inspected By: Raju Ahmed & Md. Atick Al Zaman**

**Date: June 5, 2016**

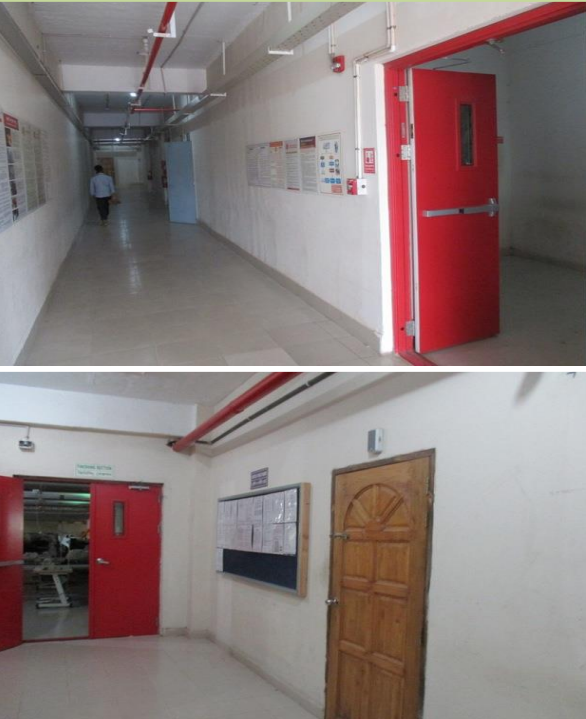
| Sl No. | Category | Findings | Required Action | Remediation Time Frame | Pictorial Evidence |
|---|---|---|---|---|---|
| 1 | Fire Rated Construction | The exit stairs are not separated from factory floor on each floor by fire-rated construction. | Provide minimum 1.5-hr fire rated doors and seal all unprotected openings to separate the exit stairs from work areas and other building spaces on all floor levels. Ensure that the fire doors are self-closing and positive latching and that they are provided with fire exit (panic) hardware where serving production floors. If fire doors are required to be held open for functional reasons, provide automatic closing devices tied to the fire alarm system. | Within 2 months | |

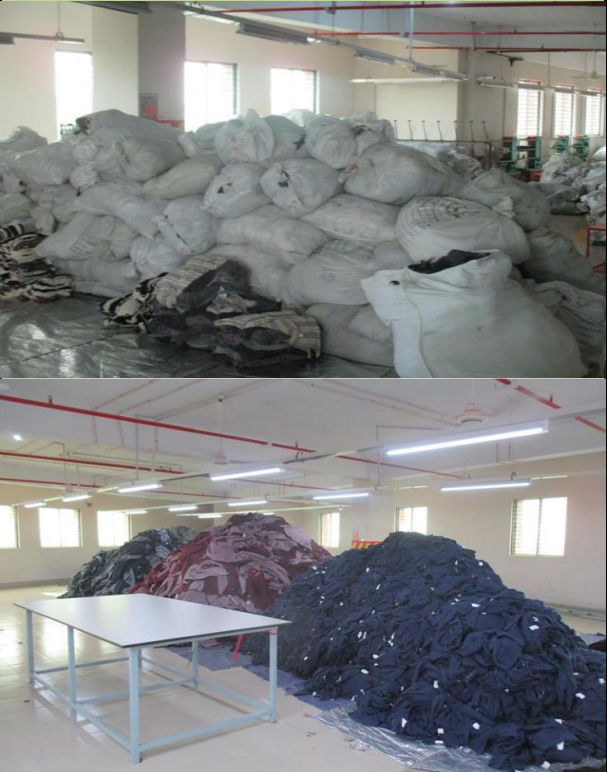
| Sl No. | Category | Findings | Required Action | Remediation Time Frame | Pictorial Evidence |
|---|---|---|---|---|---|
| 2 | Fire Rated Construction | Areas used for combustible storage are not separated by fire rated construction. Store room on seventh floor. | Provide dedicated storage rooms separated by minimum 1-hr fire-rated construction. Where separate storage rooms are not feasible, provide defined storage areas and limit the storage arrangement as follows: - Maximum height of 2.4m and maximum area of 23m <sup>2</sup> - If sprinkler protected: maximum height of 3.66m and maximum area of 93m <sup>2</sup> . Separate areas of unenclosed combustible storage by a minimum clear distance of 3m. | Within 3 months | |

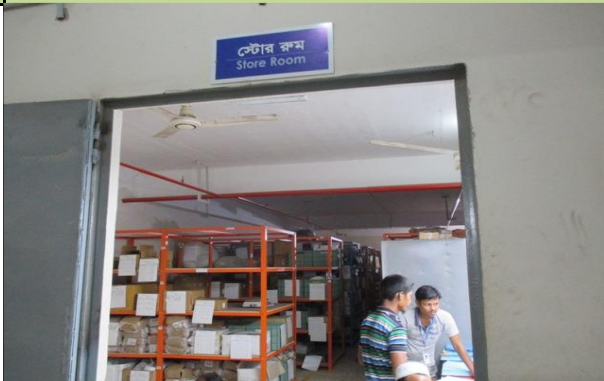
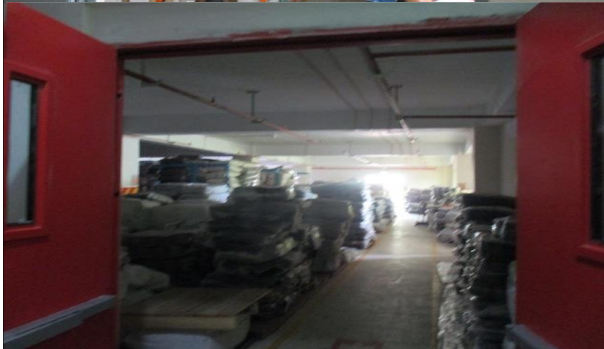
| Sl No. | Category | Findings | Required Action | Remediation Time Frame | Pictorial Evidence |
|---|---|---|---|---|---|
| 3 | Fire Rated Construction | Rooms used for combustible storage on the ground floor are not separated by fire-rated construction. Location: 1st and 4th floor. | Provide dedicated storage rooms separated by minimum 1-hr fire-rated construction. | Within 2 months | |

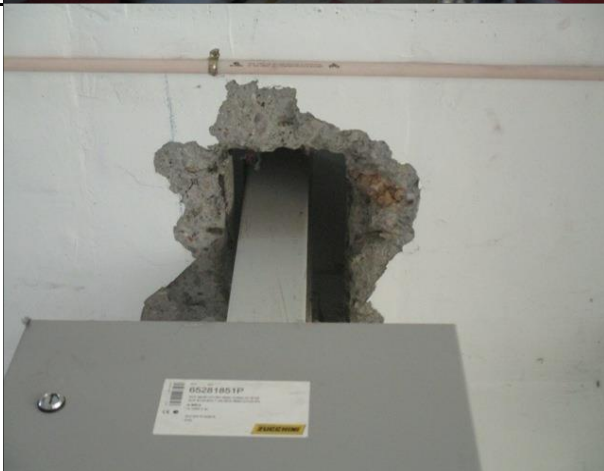
| Sl No. | Category | Findings | Required Action | Remediation Time Frame | Pictorial Evidence |
|---|---|---|---|---|---|
| 4 | Fire Rated Construction | Penetrations through floor/ceiling assemblies are found unsealed. | Seal all penetrations and openings in floor/ceiling (full thickness of the floor/ceiling) assemblies by fire rated materials to maintain the fire resistance rating. Provide a minimum 2-hr fire rated shaft to separate the utility risers from each floor if required. | Within 3 months | |

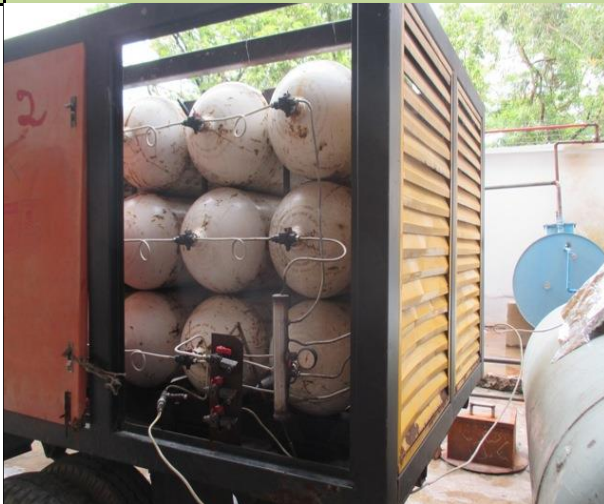
| Sl No. | Category | Findings | Required Action | Remediation Time Frame | Pictorial Evidence |
|---|---|---|---|---|---|
| 5 | Fire Rated Construction | Flammable gas storage area is not separated by fire-rated construction | Separate the flammable gas cylinder storage area by a minimum 2-hr fire-rated construction | Immediate | |

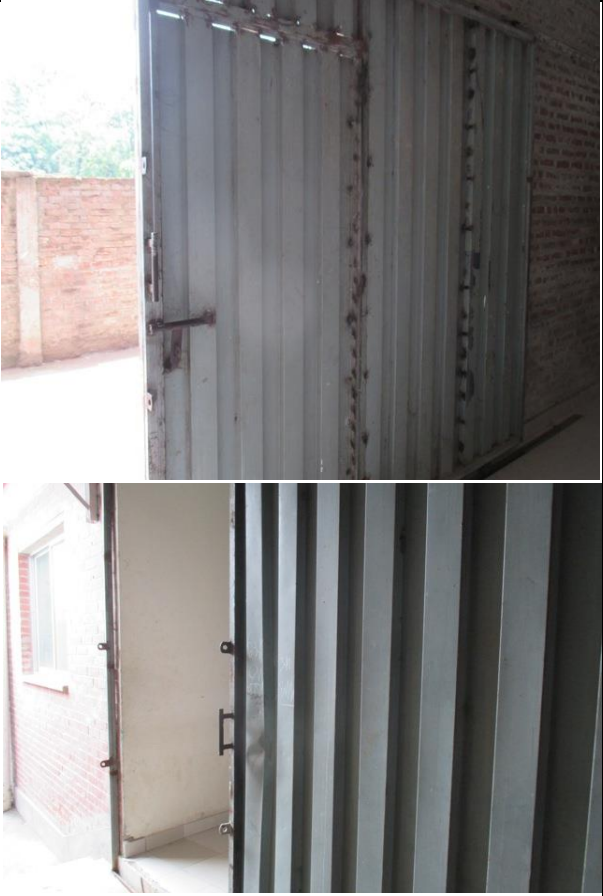
| Sl No. | Category | Findings | Required Action | Remediation Time Frame | Pictorial Evidence |
|---|---|---|---|---|---|
| 6 | Lockage Egress Doors | Egress doors/gates with locking features not complying with NFPA101 are provided at [ building exits, exit stairs, along egress routes, exit discharge] | Remove locking features from all egress doors/gates.<br>If locks are required for security reasons, utilize specialized door locking features complying with NFPA101. | Immediate | |

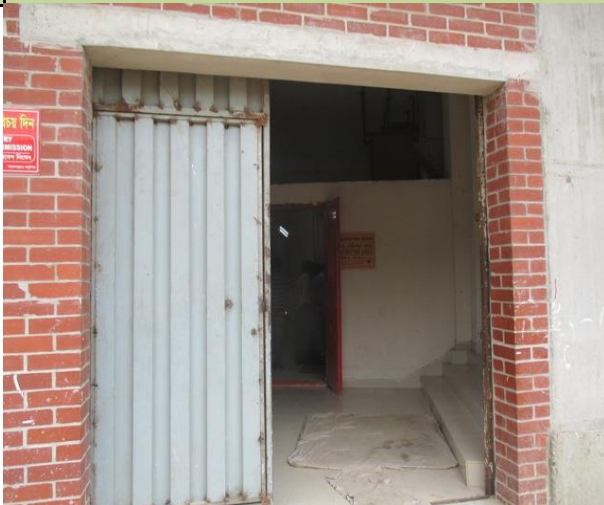
| Sl No. | Category | Findings | Required Action | Remediation Time Frame | Pictorial Evidence |
|---|---|---|---|---|---|
| 7 | Sliding Door & Gates | Collapsible gates/sliding doors/rolling shutter doors are provided at [building exits, exit stairs, along egress routes, exit discharge] | Replace all collapsible gates/sliding doors/ rolling shutter doors along the means of egress with side-hinged, swinging egress doors. | Immediate | |

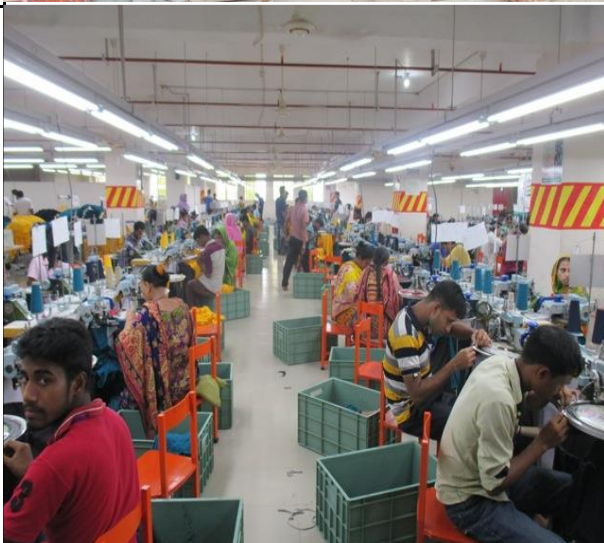
| Sl No. | Category | Findings | Required Action | Remediation Time Frame | Pictorial Evidence |
|---|---|---|---|---|---|
| 8 | Aisle Width | Width of aisles is less than 0.9m (36-in.). Location: 5th & 6th floor. | Aisles shall be provided with a minimum unobstructed clear-width of 0.9 m (36 in.). | Within 2 months | |

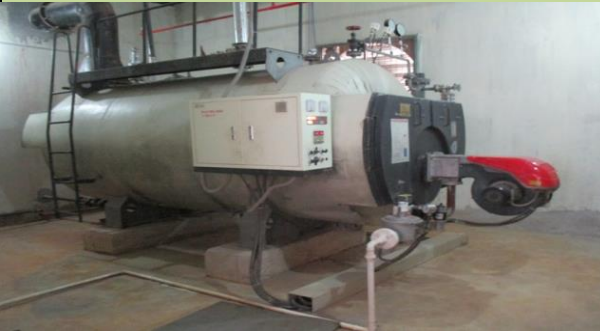
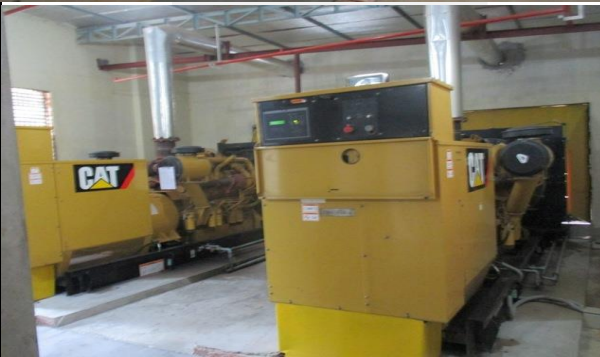
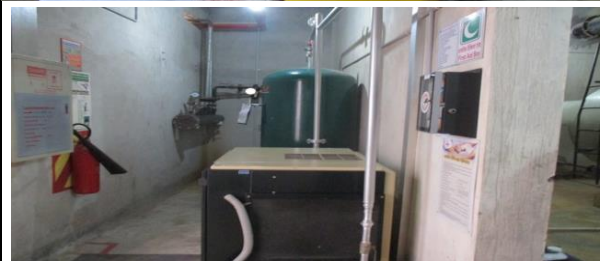
| Sl No. | Category | Findings | Required Action | Remediation Time Frame | Pictorial Evidence |
|---|---|---|---|---|---|
| 9 | Fire Rated Construction | The[boiler, generator & air compressor] room is not separated by fire rated construction (openings, non-rated doors, penetrations)<br>Specify location(s) | Specify appropriate upgrade based on conditions:<br>-Separate the boiler room by a minimum 2-hr fire rated construction (for high rise building)/ 1-hr fire rated construction (for low rise building). Seal and/or protected all openings to maintain fire separations.<br>-Separate the [generator/EMR/gas meter/air compressor] room by a minimum 2-hr fire rated construction. Seal and/or protected all openings to maintain fire separations. | Within 3 months | |

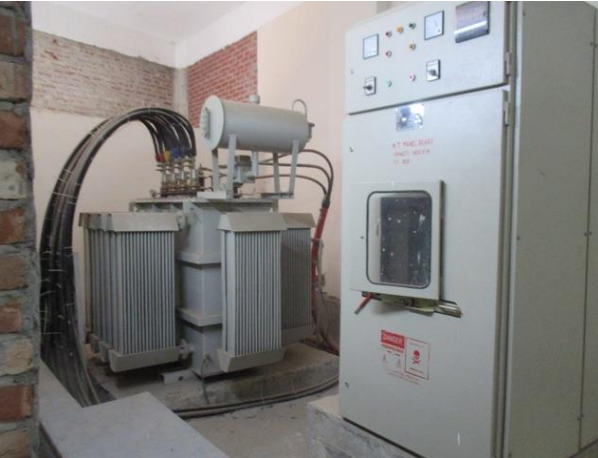
| Sl No. | Category | Findings | Required Action | Remediation Time Frame | Pictorial Evidence |
|---|---|---|---|---|---|
| 10 | Fire Rated Construction | Transformer is not properly separated by fire rated construction with other Occupancies/Areas (southwest exit stair) | Separate the transformer room by a minimum 2-hr fire rated construction. Seal and/or protected all openings to maintain fire separations. | Within 3 months | |

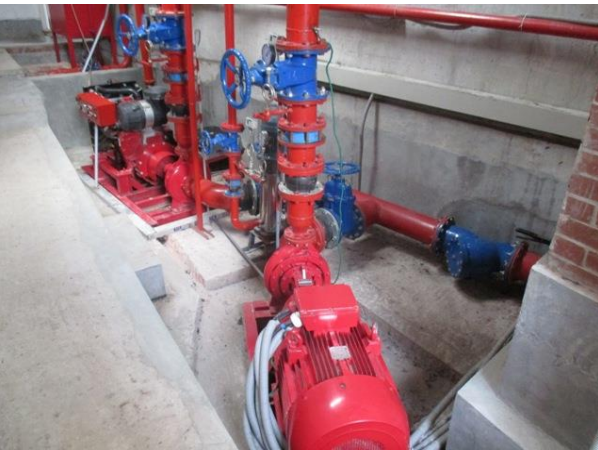
| Sl No. | Category | Findings | Required Action | Remediation Time Frame | Pictorial Evidence |
|---|---|---|---|---|---|
| 11 | Fire Rated Construction | The fire pump room is not provided with adequate fire separation | Provide fire pump room with 2 hr rated fire separation when not sprinkler and 1 hr rated fire separation when provided with automatic sprinklers in accordance with NFPA 20<br>Or,<br>Physically separate the pump room from the protected building by a minimum of 50 ft (15.3 m) in accordance with NFPA 20 | Within 2 months | |

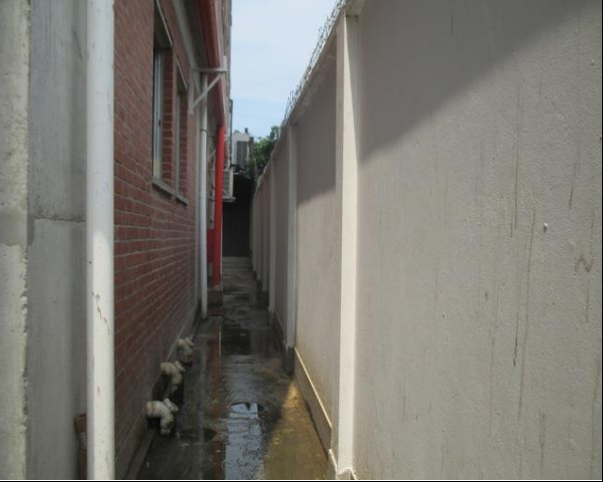
| SI No. | Category | Findings | Required Action | Remediation Time Frame | Pictorial Evidence |
|---|---|---|---|---|---|
| 12 | Fire Rated Construction | The exit discharge path southeast exit stair is less than 10 ft wide and is not separated from the building interior. | <p>Seal all penetrations and openings to the interior of the building along the discharge path, up to a height of 10 ft., to provide a minimum 1-hr fire separation.</p> <p>Alternatively, provide a second remote discharge path to the public way (only include this if feasible).</p> | Within 4 months | |

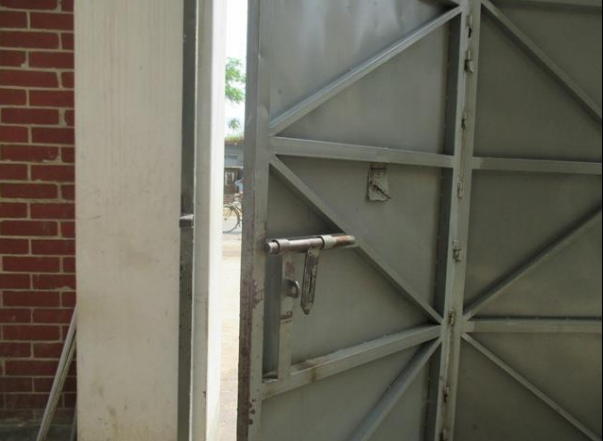
| Sl No. | Category | Findings | Required Action | Remediation Time Frame | Pictorial Evidence |
|---|---|---|---|---|---|
| 14 | Egress | Exit doors at ground floor serving 50 or more occupants does not swing in the direction of egress travel. | Modify the egress door to swing in the direction of egress travel. | Immediate | |

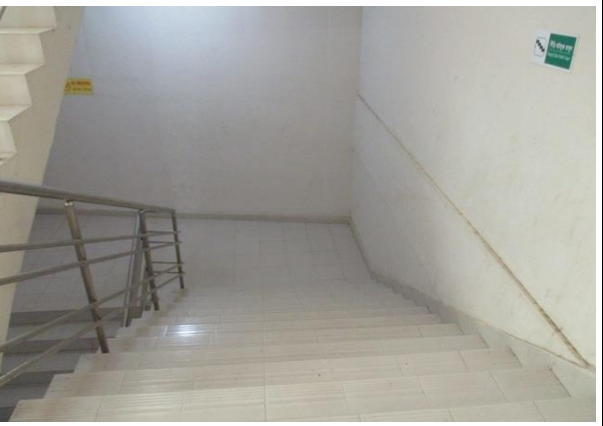
| Sl No. | Category | Findings | Required Action | Remediation Time Frame | Pictorial Evidence |
|---|---|---|---|---|---|
| 15 | Egress | Handrails are not provided on both sides of each exit stairs on all floors. Having handrails on one side of said staircase, may pose as a falling hazard during evacuation.<br>Or, Handrails are not provided at exit stairs. | Provide handrails on both sides of the exit stair. New handrails shall have a minimum height of 865 mm (34 in.) and a maximum height of 965 mm (38 in.) as measured from the leading edge of the tread. Intermediate handrails shall be provided when the stair width exceeds 2.2 m (87 in.) | Within 3 months | |

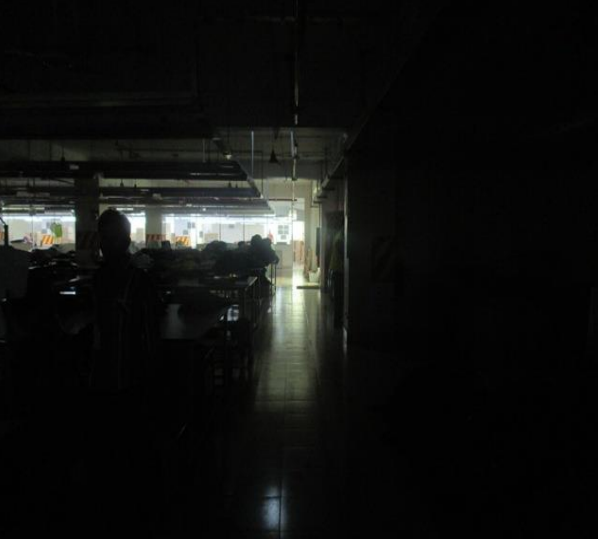
| Sl No. | Category | Findings | Required Action | Remediation Time Frame | Pictorial Evidence |
|---|---|---|---|---|---|
| 16 | Egress Lighting | Based on the number and location of emergency lights observed, adequate illumination levels are not anticipated along egress routes. Location: each floor | Test the emergency lighting system on each floor and provide additional emergency fixtures to provide adequate illumination along the means of egress. Provide a minimum illumination of 10 lux at the floor level within exit stairs and exit discharge paths and minimum 2.5 lux along exit access aisles. | Within 2 months | |

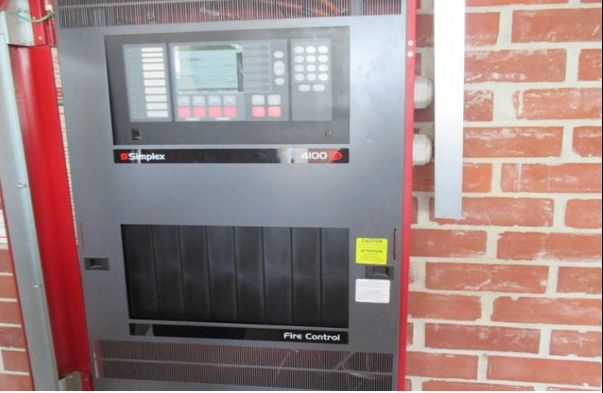
| Sl No. | Category | Findings | Required Action | Remediation Time Frame | Pictorial Evidence |
|---|---|---|---|---|---|
| 18 | Fire Alarm System | Fire alarm system installation requires detailed review to confirm compliance with NFPA 72 and ACCORD standards. | Submit as-built drawings, testing records, equipment certification and other relevant documentation to the ACCORD for review and approval. | Within 2 months | |

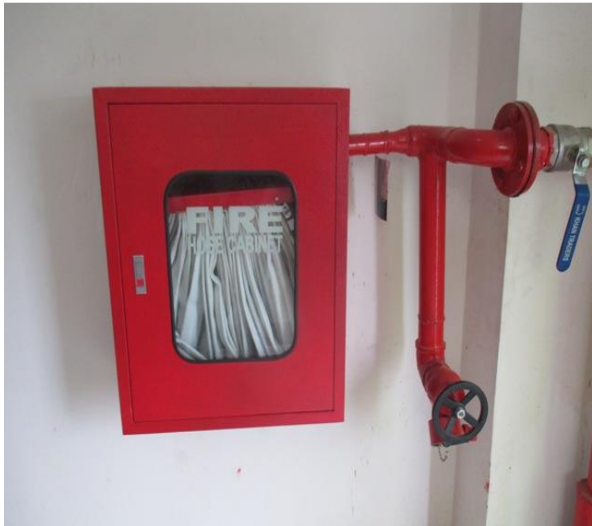
| Sl No. | Category | Findings | Required Action | Remediation Time Frame | Pictorial Evidence |
|---|---|---|---|---|---|
| 20 | Fire Protection System | The high-rise building has an occupied floor greater than 23 meter (75 feet) and is not provided with automatic sprinkler protection. The large occupant loads, heavy fuel loading, and anticipated extended egress times warrant sprinkler protection. | Provide automatic sprinkler protection throughout the building in accordance with NFPA 13. | Design within 2 months, Install within 6 months | |
