FIRE SAFETY INSPECTION REPORT

FACTORY: PROBRIDHI APPAREL LTD.

ACCORD ID: 12421

Date: 12/06/2016

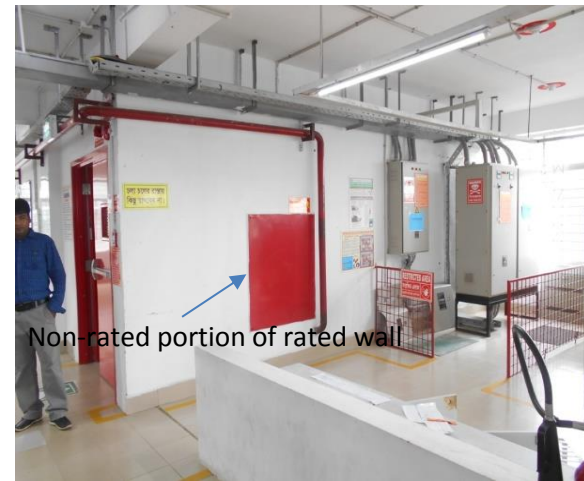
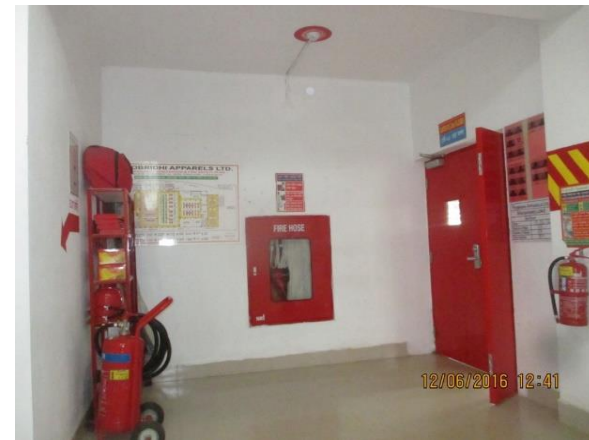
1 Fire Rated Construction

The exit stairs are not separated from [work areas, other spaces] on each floor by fire-rated construction. Unsealed penetration has been found due to wrong installation of non-rated hose box. However, fire doors were found open during working hour but those are not tied with fire alarm system by automatic closing devices. Moreover, door closer was not found with the small part of double leaf door.

Stair shall be enclosed with a minimum 2-hr fire-rated construction. Seal all unprotected openings and provide minimum 1.5-hr fire rated doors to separate the exit stairs from work areas and other building spaces on all floor levels. Ensure that the fire doors are self-closing, positive latching and that they are provided with fire exit (panic) hardware where serving production floors.

If fire doors are required to be held open for functional reasons, provide automatic-closing devices tied to the fire alarm system.

Within 3 Months

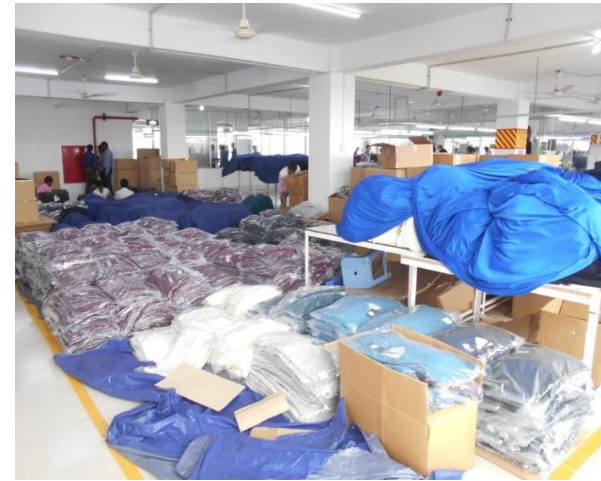
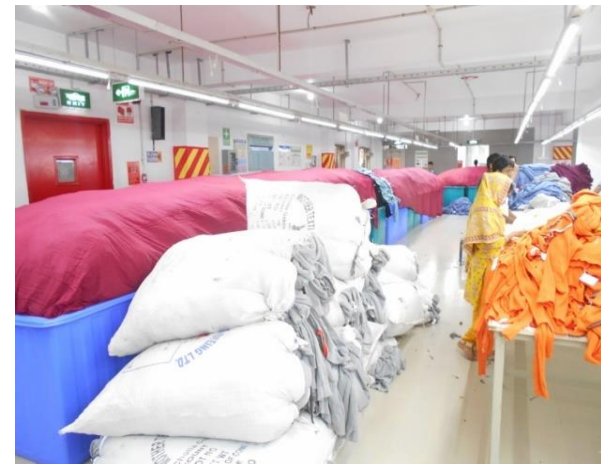
2

Areas used for in-process storage of combustible materials are open to the surrounding occupancy . Location: Ground floor, Second floor, Third floor.

Provide defined storage areas and limit the storage arrangement as follows:-

1. General Condition:
Maximum height of 2.4m and maximum area of 23m².
Separate areas of unenclosed combustible storage by a minimum clear distance of 3m.
2. If sprinkler protected:
maximum height of 3.66m and maximum area of 93m².
Separate areas of unenclosed combustible storage by a minimum clear distance of 3m.
- or
3. Enclose the storage area from the surrounding occupancy with a minimum 1 hour construction.

Within 3 Months

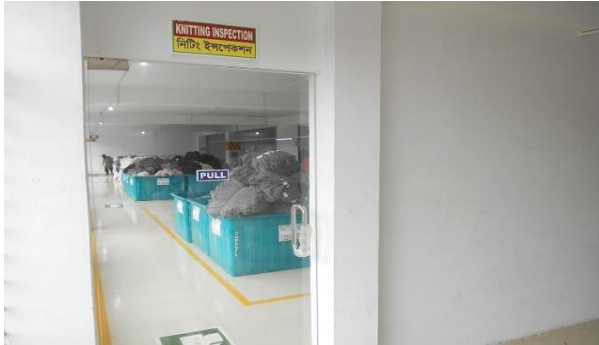
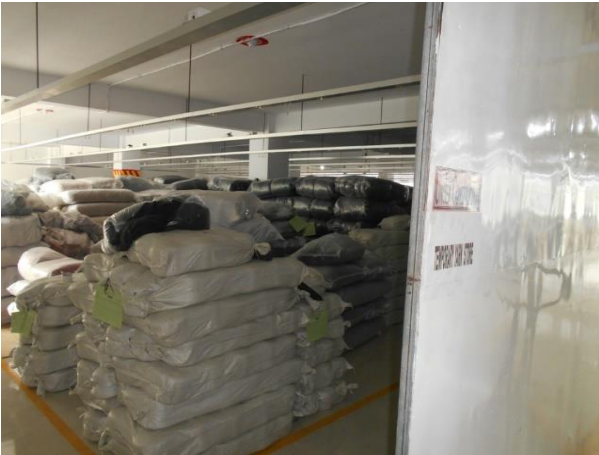
SI No.	Category	Findings	Required Action	Remediation Time Frame	Pictorial Evidence
3	Fire Rated Construction	Rooms used for storage of combustible materials are not separated from the surrounding occupancy/areas. Location : Ground floor, Third floor, Forth floor.	Rooms used for storage of combustible materials shall be separated from the surrounding occupancy with a minimum 1 hour construction.	Within 3 Months

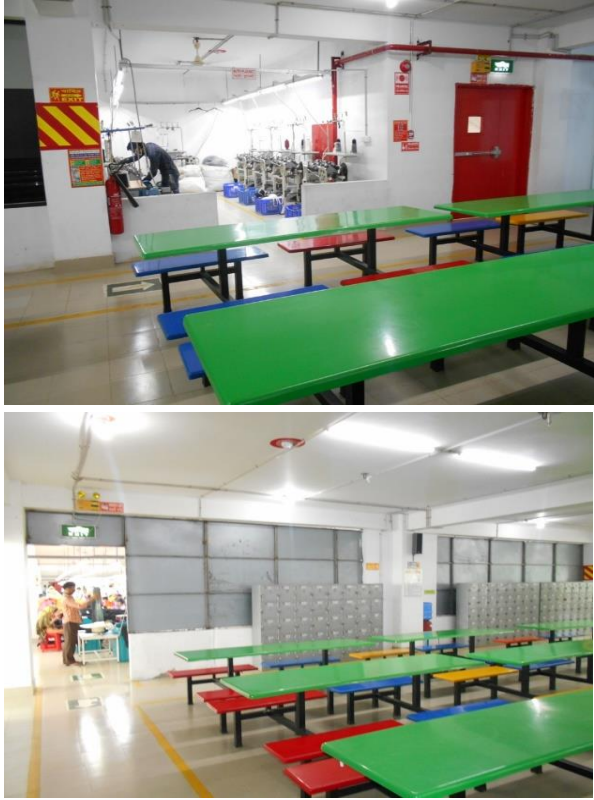
SI No.	Category	Findings	Required Action	Remediation Time Frame	Pictorial Evidence
4	Fire Rated Construction	The dining area is not separated from adjacent production floor area by fire rated construction.	Separate the dining area by a minimum 2-hr fire-rated construction having a direct access to exit stair. Seal and/or protected all openings to maintain the required fire eparations.	Within 3 Months

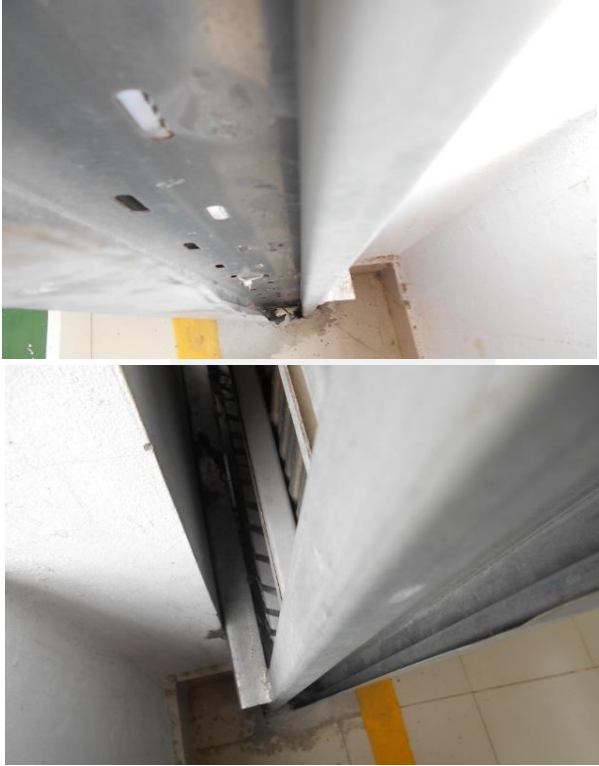
SI No.	Category	Findings	Required Action	Remediation Time Frame	Pictorial Evidence
5	Fire Rated Construction	Penetrations through floor/ceiling assemblies are found unsealed. Location : Third floor.	Seal all penetrations and openings in floor/ceiling (full thickness of the floor/ceiling) assemblies by fire rated materials to maintain the fire resistance rating. Or Provide a minimum 2-hr fire rated shaft to separate the utility risers from each floor if required.	Within 3 Months

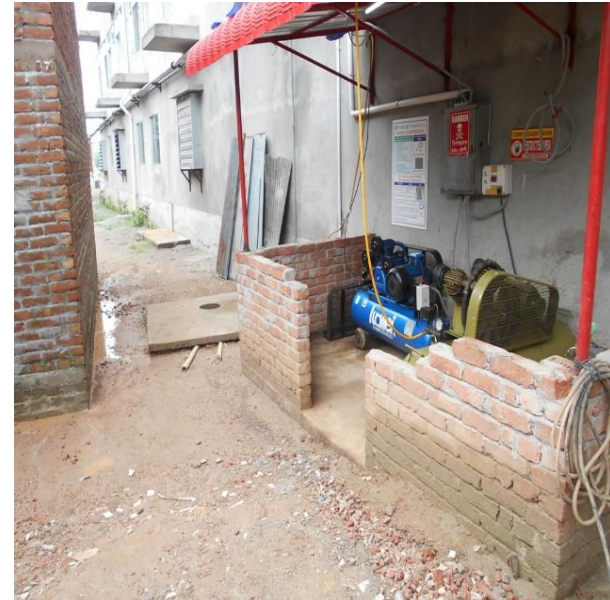
6 Fire Rated Construction

Compressor or furnace room is not properly separated by fire rated construction from west egress path.

Compressor or other heat producing equipment shall be separated from other occupancies by a minimum 1-hr (2-hr for highrise building) fire rated construction (wall, floor, slab etc). Seal all penetrations and openings (door, window etc.) should be protected by 0.75-hr (45 min) fire rated materials to maintain the fire separation if required. All exhaust systems shall discharge to the exterior of the building in a safe location.
Or
Relocate it to exterior of the building and maintain a minimum 3m (10 ft.) spatial separation distance from the building.

Within 3 Months

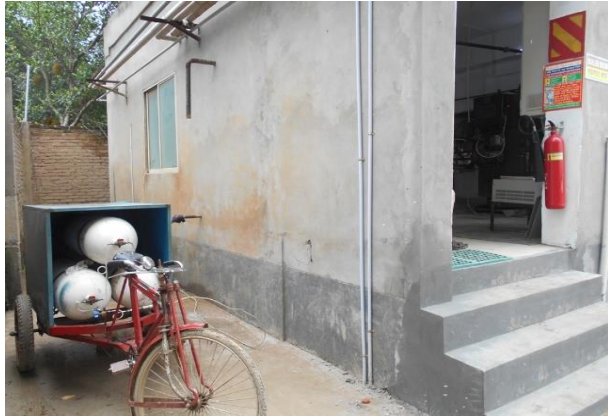
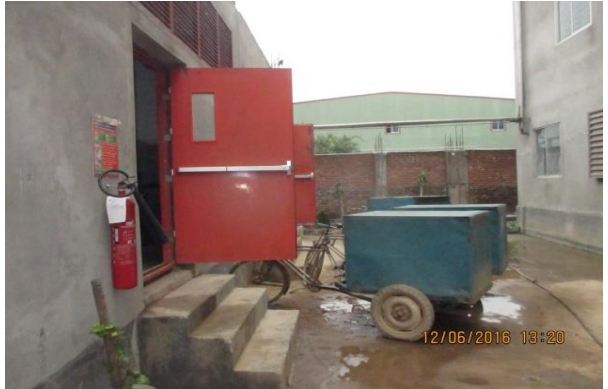
SI No.	Category	Findings	Required Action	Remediation Time Frame	Pictorial Evidence
7	Fire Rated Construction	Flammable gas storage area is not separated by fire-rated construction (openings, non-rated doors, penetrations) from the Boiler and Generator room.	Separate the flammable gas cylinder storage area by a minimum 2- hr fire-rated construction. Seal and/or protected all openings to maintain the required fire separations.	Within 3 Months
