# INITIAL FIRE ASSESSMENT REPORT (FAR)

Factory Name: **SIMBA FASHION LTD Extension plot**

Assessor: **BD Technologies**

Date: **17 Jan 2016**

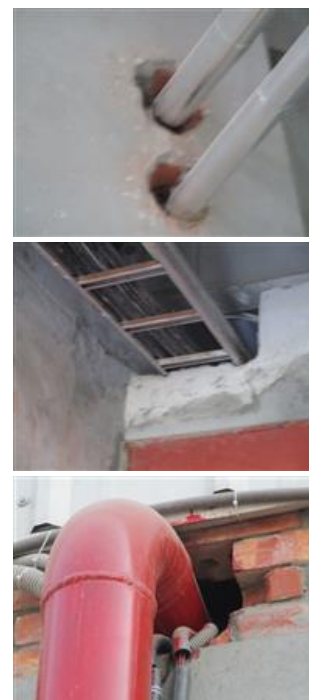
| Description: | Factory building is a single story prefabricated steel shed with Mezzanine floor. According to Alliance standard standpipe system is not required but the Factory has a Class I standpipe system. Design drawings and hydraulic calculations are not available. It is recommended to keep and maintain the standpipe system for added protection. |
| Source of Findings: | Photograph: Class I standpipe system installed. |

| Suggested Plan of Action: | Prepare shop drawings and hydraulic calculations (as outlined in NFPA 14) for the installed system and submit to the Alliance for review. Should the existing standpipe system be found to be not in compliance with the design requirements of NFPA 14, modify or replace the system, as needed, for compliance. Prepare revised drawings and calculations for review by the Alliance prior to any modification or installation. |
