# **FIRE SAFETY INSPECTION REPORT**

**REDPOINT JACKETS LTD, DHAKA, BANGLADESH**

**ACCORD**  
on Fire and Building Safety in Bangladesh

**January 3, 2014**

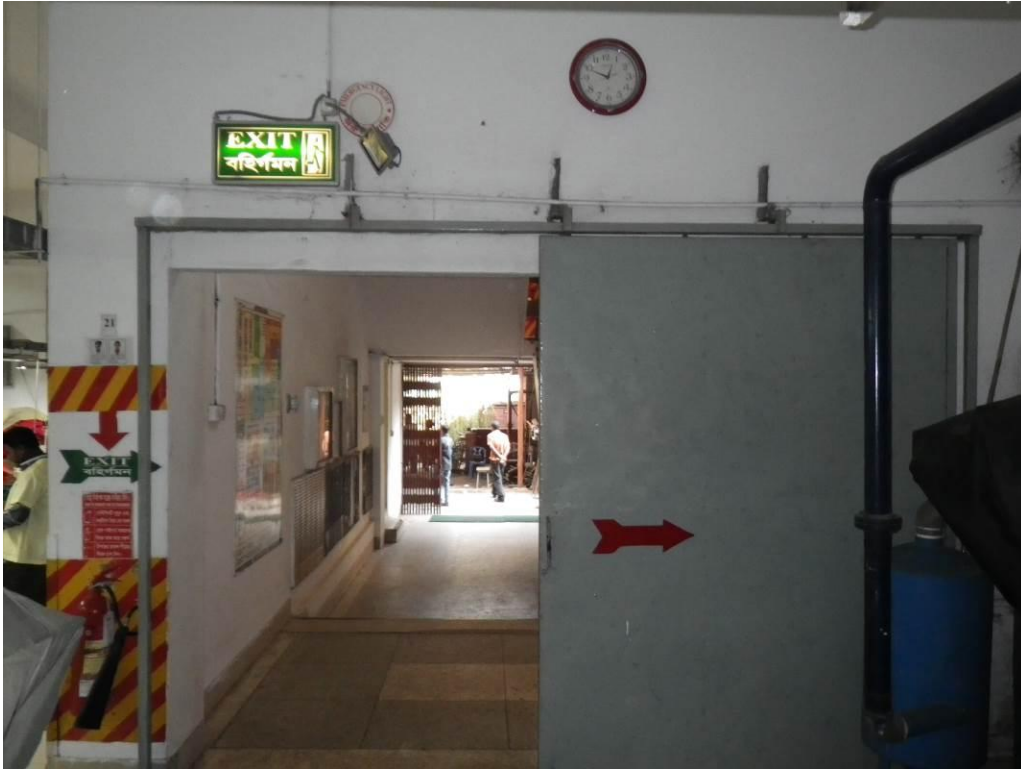
**Photo 1 – Exit stair open to production area (typical)**

| No. | Category | Finding | Recommendation | Priority | Photo Ref |
|---|---|---|---|---|---|
| F-1 | Fire-Rated Construction, Egress | The main exit stair and rear exit stair are separated from the work areas, and other spaces, on each floor by non-fire-rated construction. The stairs open directly into areas used for storage on some floors. A fabric spot cleaning room is located under the west stair. | Provide minimum 1.5-hr fire rated doors and seal all unprotected openings to separate the exit stairs from work areas and other building spaces on all floor levels. Ensure that the fire doors are self-closing and positive latching and that they are provided with fire exit (panic) hardware where serving production floors.<br><br>If fire doors are required to be held open for functional reasons, provide automatic-closing devices tied to the fire alarm system. | Critical | 1, 2, 3 |

| No. | Category | Finding | Recommendation | Priority | Photo Ref |
|---|---|---|---|---|---|
| F-10 | Egress | Collapsible (concertina) gates and sliding steel doors with locks are provided along means of egress and at exterior exit doors.<br><br>Note - all gates were open and unlocked during the inspection. | Remove all lockable gates and doors at exit stairs and along the means of egress.<br><br>If locks are required for security reasons, utilize special door locking features complying with NFPA 101. | Critical | 1, 14 |

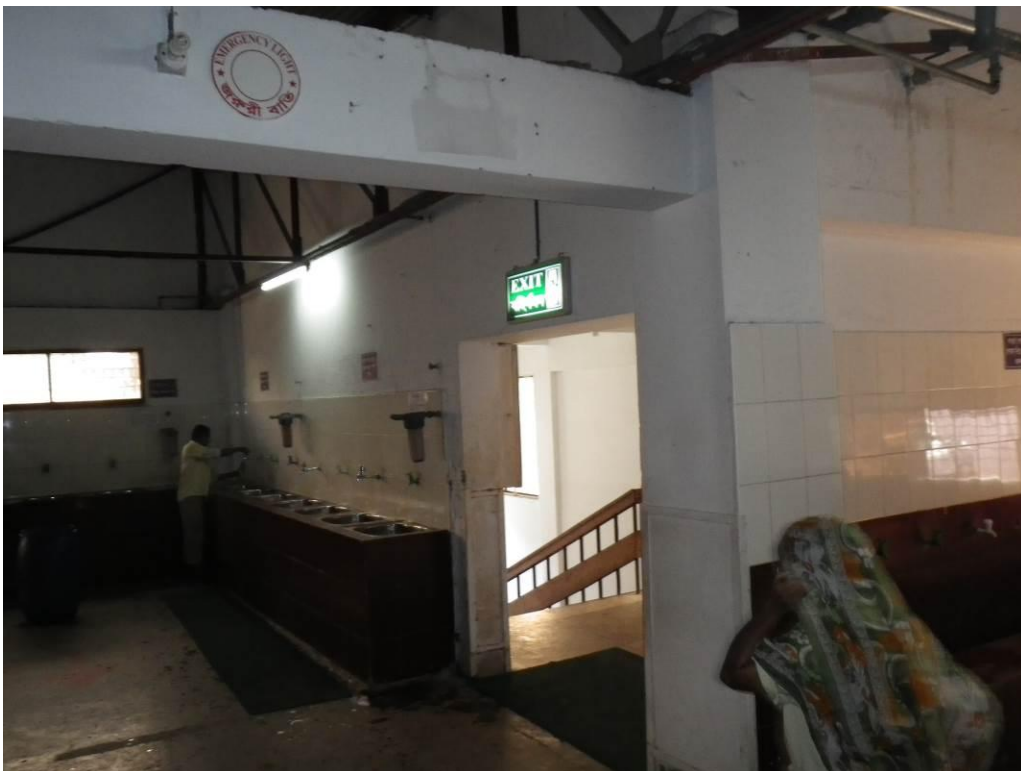
**Photo 2 – Exit stair open to production area (typical)**

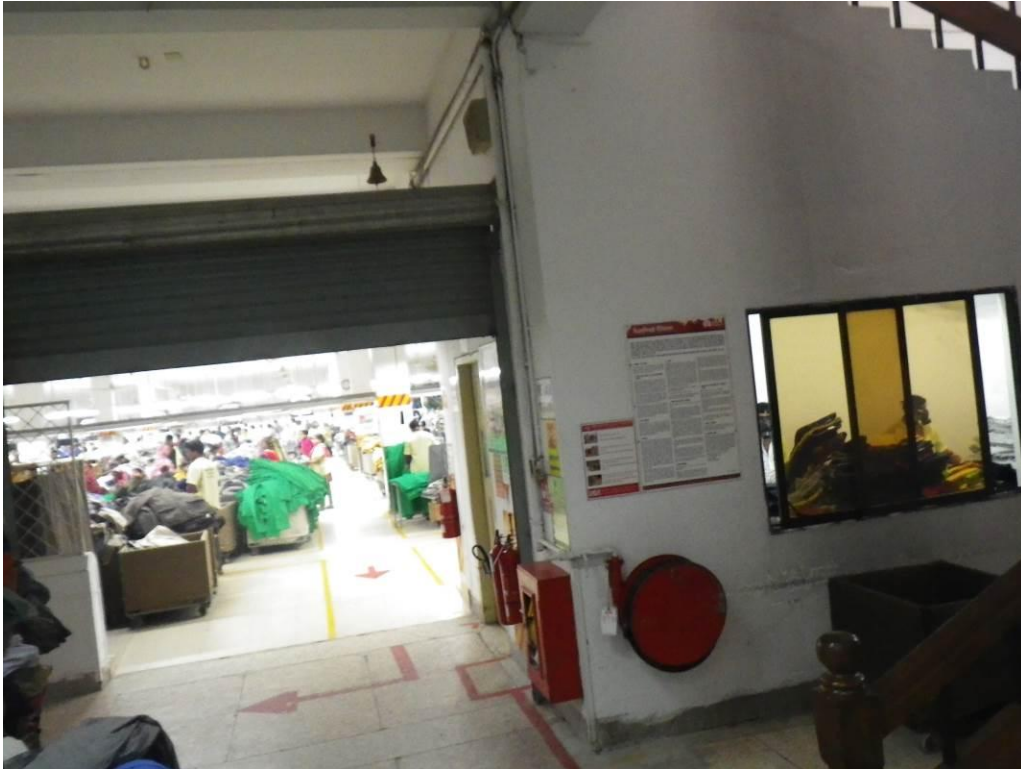
**Photo 3 – Exit stair open to production floor with spot cleaning room under the stair**

| No. | Category | Finding | Recommendation | Priority | Photo Ref |
|---|---|---|---|---|---|
| F-2 | Fire-Rated Construction, Egress | The west exit stair discharges inside the building on the ground floor. | Provide a 2-hour fire-rated separation of the exit discharge path from all areas on the ground floor and do not allow storage within the separated discharge path.<br><br>Alternatively, provide automatic sprinkler protection throughout the ground floor and provide a clear and unobstructed discharge path to the outside. | Critical | 3 |

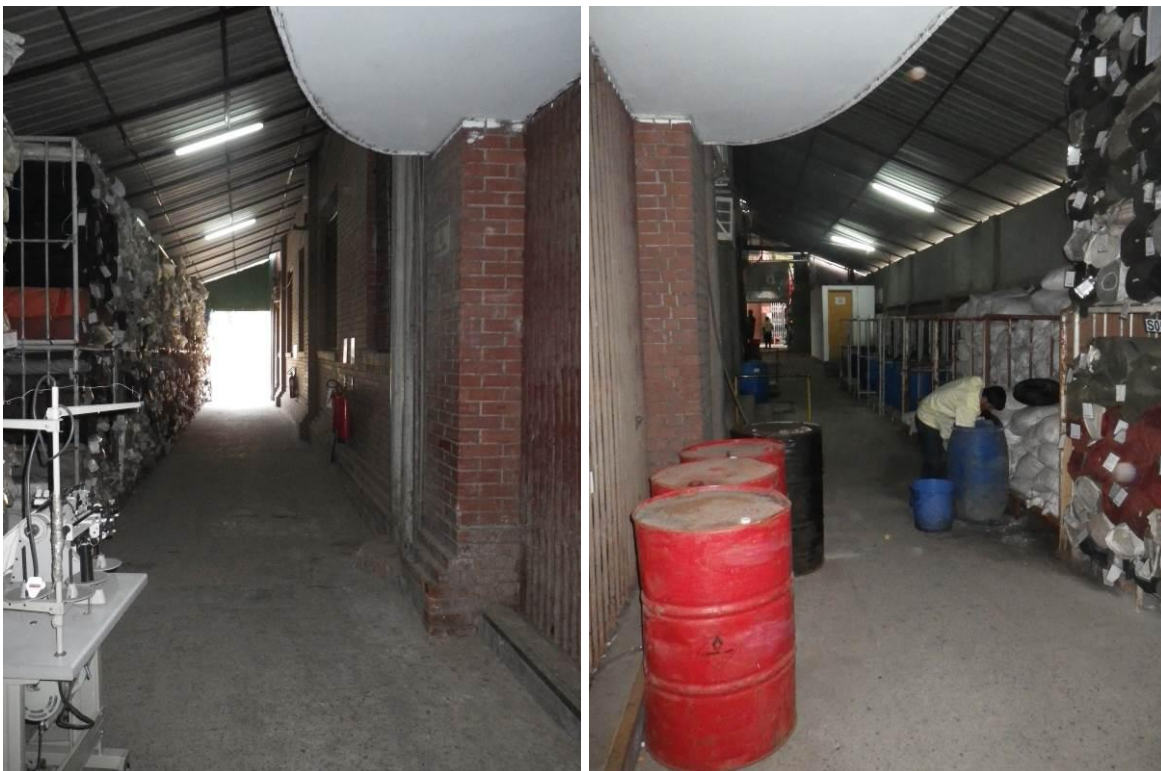
**Photo 4 – Flammable and combustible storage in covered exterior egress path**

| No. | Category | Finding | Recommendation | Priority | Photo Ref |
|---|---|---|---|---|---|
| F-3 | Fire-Rated Construction, Egress | Flammable liquid storage, combustible storage and boilers are located along exterior egress paths from the north exit stair discharge on the ground floor. | Remove all storage from egress paths. Provide dedicated storage rooms separated by minimum 2-hr fire-rated construction for flammable storage and boiler | Critical | 4, 5 |

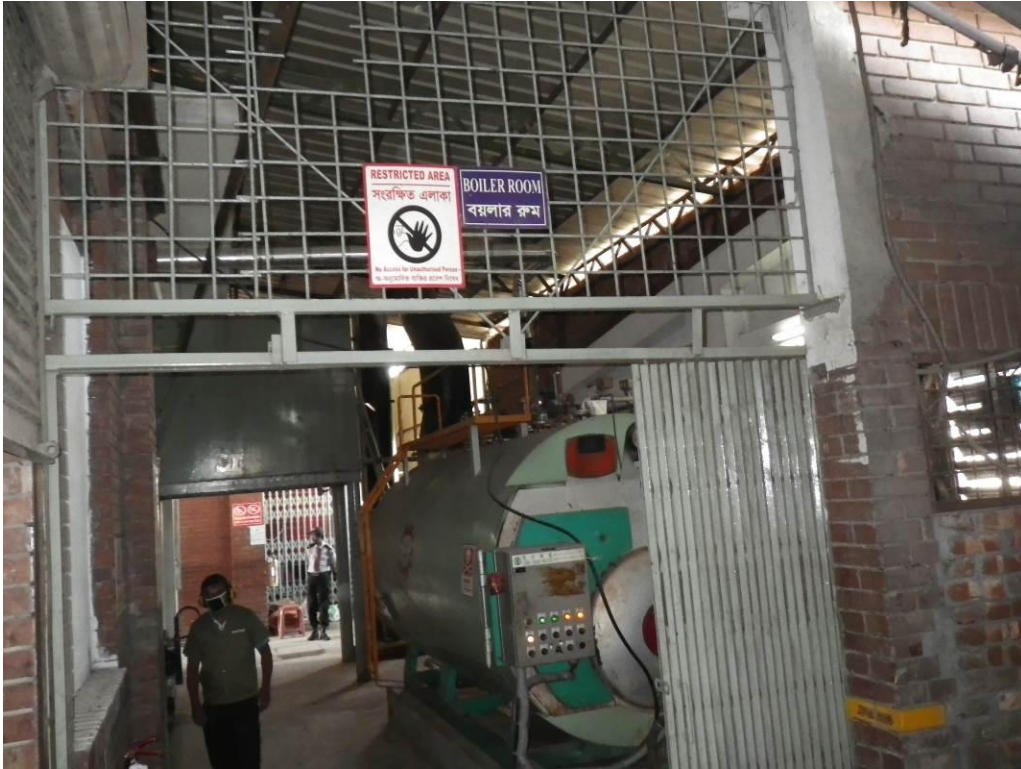
**Photo 5 – Boiler room open to exterior egress path**

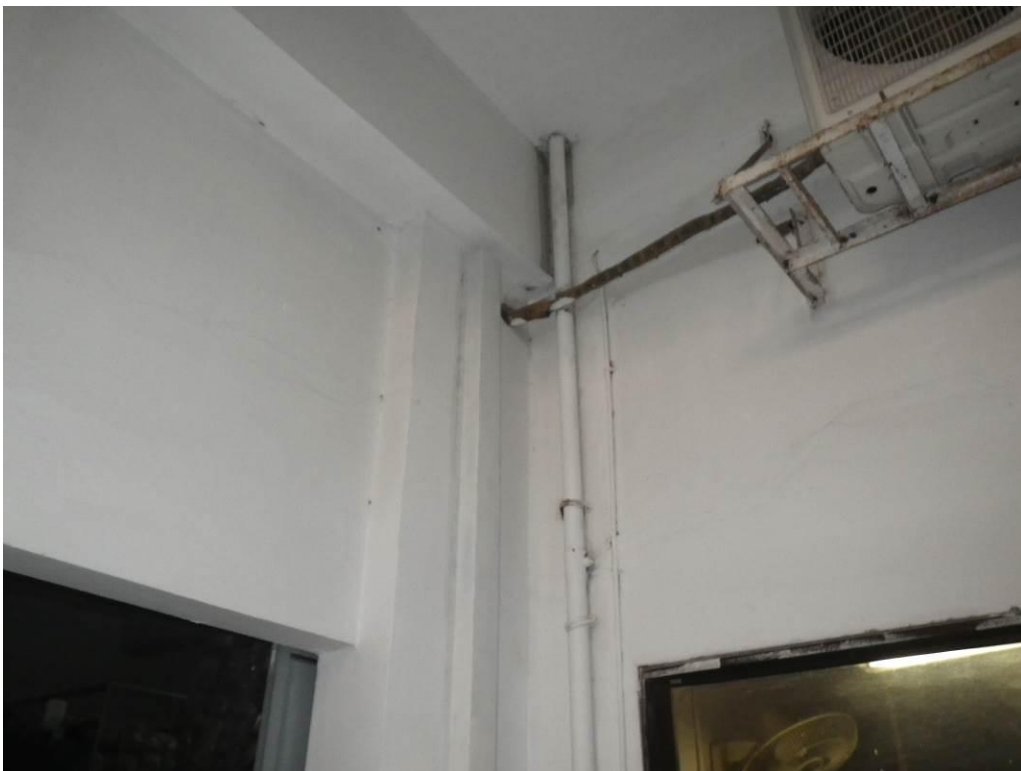
**Photo 6 – Unsealed opening in ground floor of north exit stair**

| No. | Category | Finding | Recommendation | Priority | Photo Ref |
|---|---|---|---|---|---|
| F-4 | Fire-Rated Construction, Egress | Unsealed penetrations and openings are located in the exit stair enclosures. | Seal all penetrations and openings in exit stair enclosure walls to maintain the fire separation. | Major | 6 |

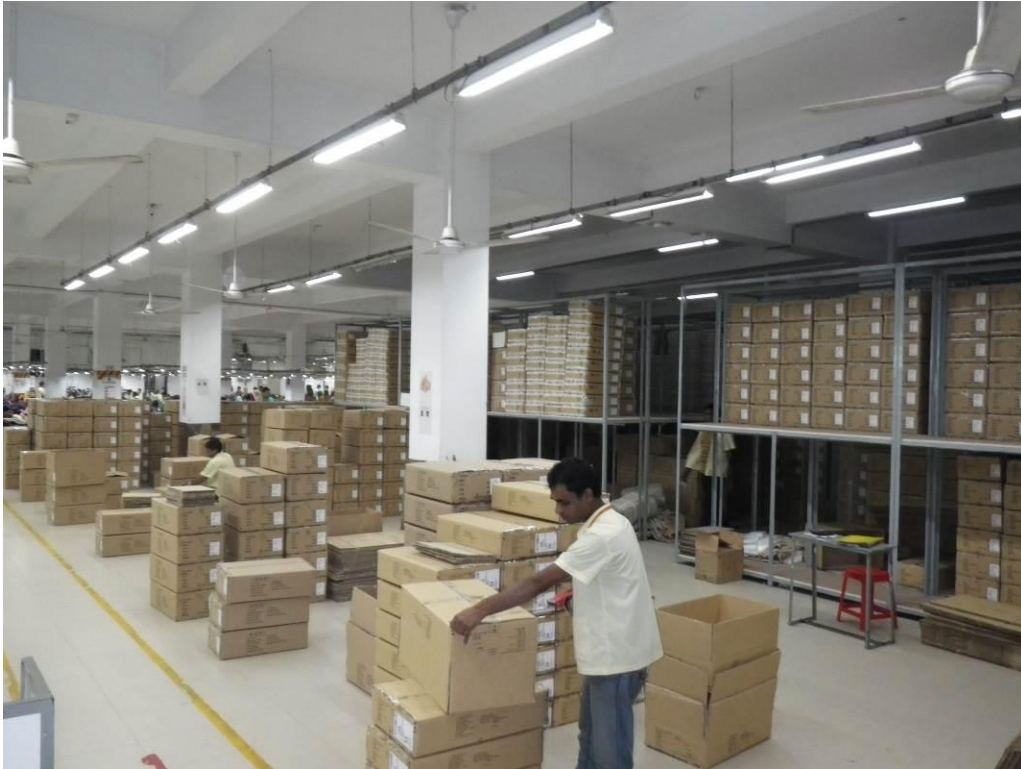
**Photo 7 – Storage areas on production floor**

| No. | Category | Finding | Recommendation | Priority | Photo Ref |
|---|---|---|---|---|---|
| F-5 | Fire-Rated Construction | Areas used for combustible storage on production floors and are not separated by fire-rated construction. | <p>Provide dedicated storage rooms separated by minimum 1-hr fire-rated construction on all production floors where transient storage is required for operations.</p> <p>Where separate storage rooms are not feasible, provide defined storage areas and limit the storage arrangement as follows:</p> <ul style="list-style-type: none"> <li>- Maximum height of 2.4 m and maximum area of 23m<sup>2</sup></li> <li>- If sprinkler protected: maximum height of 3.66m and maximum area of 93m<sup>2</sup></li> </ul> <p>Separate areas of unenclosed combustible storage by a minimum clear distance of 3m.</p> | Major | 7 |

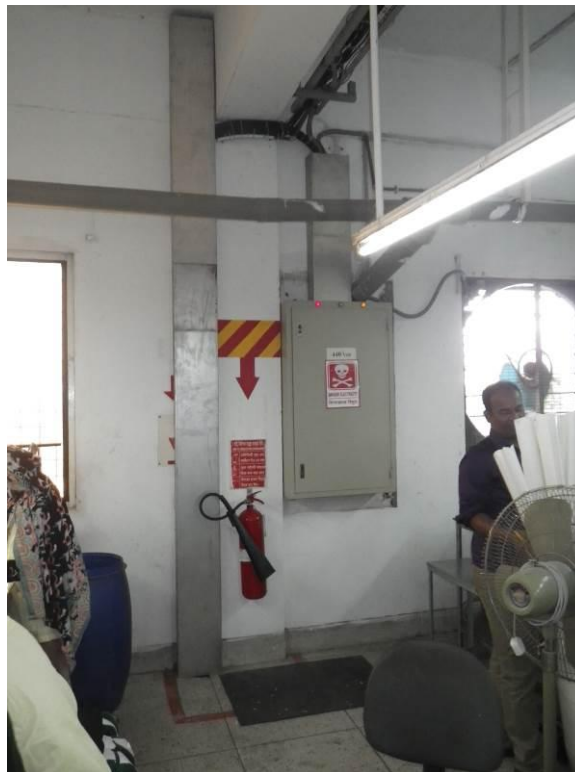
**Photo 8 – Unsealed ceiling/floor penetrations, electrical riser**

| No. | Category | Finding | Recommendation | Priority | Photo Ref |
|---|---|---|---|---|---|
| F-6 | Fire-Rated Construction | Unsealed penetrations and openings are located in the fire-rated floor/ceiling assemblies where the electrical service rises from floor-to-floor. | <p>Provide a minimum 2-hr fire-rated shaft to separate the utility risers from each floor level.</p> <p>Seal all penetrations and openings in floor/ceiling assemblies to maintain the fire separation.</p> | Major | 8 |

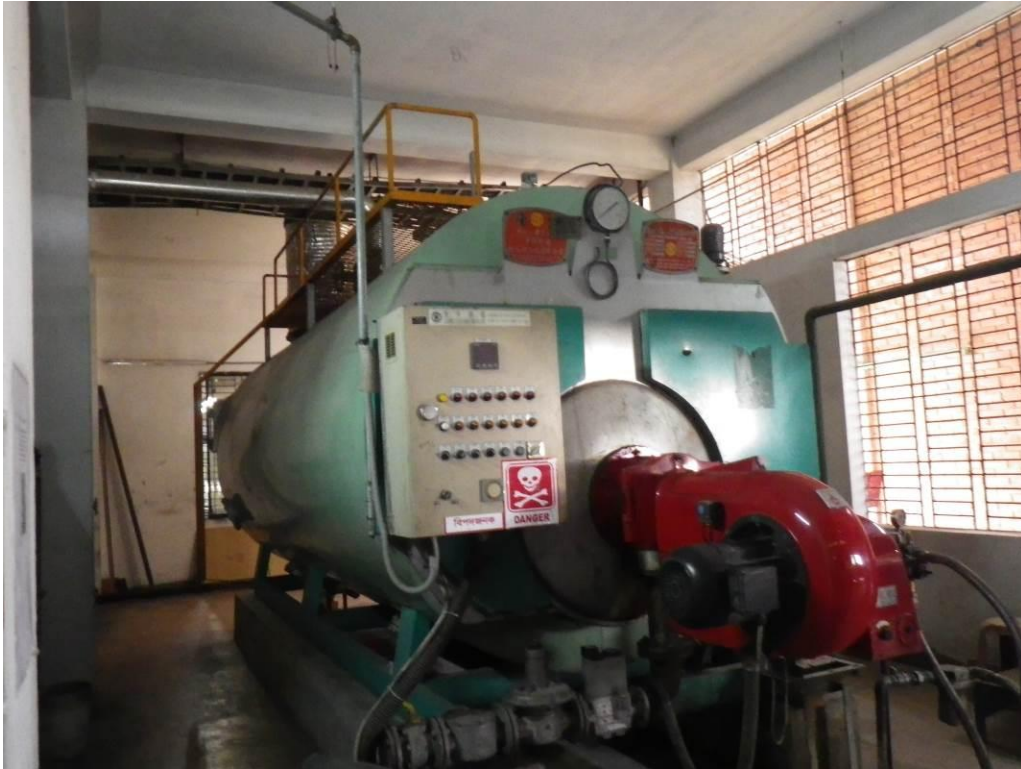
**Photo 9 – Boiler room, no fire separation**

| No. | Category | Finding | Recommendation | Priority | Photo Ref |
|---|---|---|---|---|---|
| F-7 | Fire-Rated Construction | The boiler room (ground floor) and transformer room (1 <sup>st</sup> floor) are not | Separate each of the rooms by minimum 2-hr fire-rated | Major | 9, 10 |

| No. | Category | Finding | Recommendation | Priority | Photo Ref |
|---|---|---|---|---|---|
| | | separated by fire-rated construction (openings, non-rated doors, penetrations). | construction. Seal and/or protected all openings to maintain the required fire separations. | | |

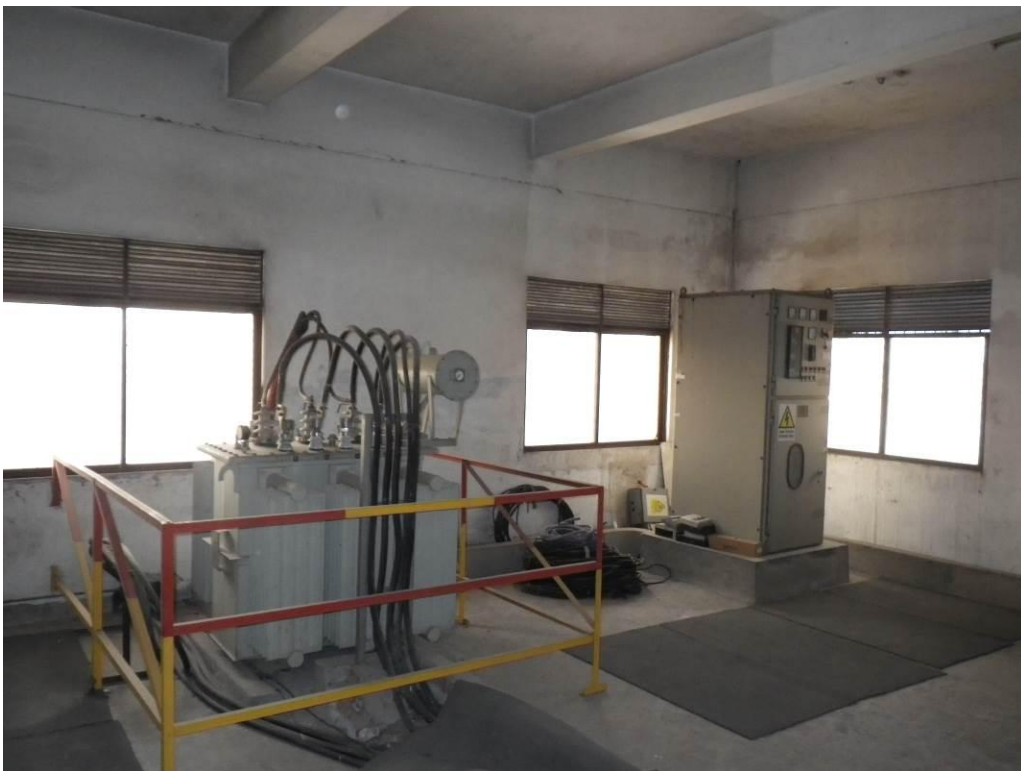
**Photo 10 – Oil transformer and switchgear, nor fire separation**

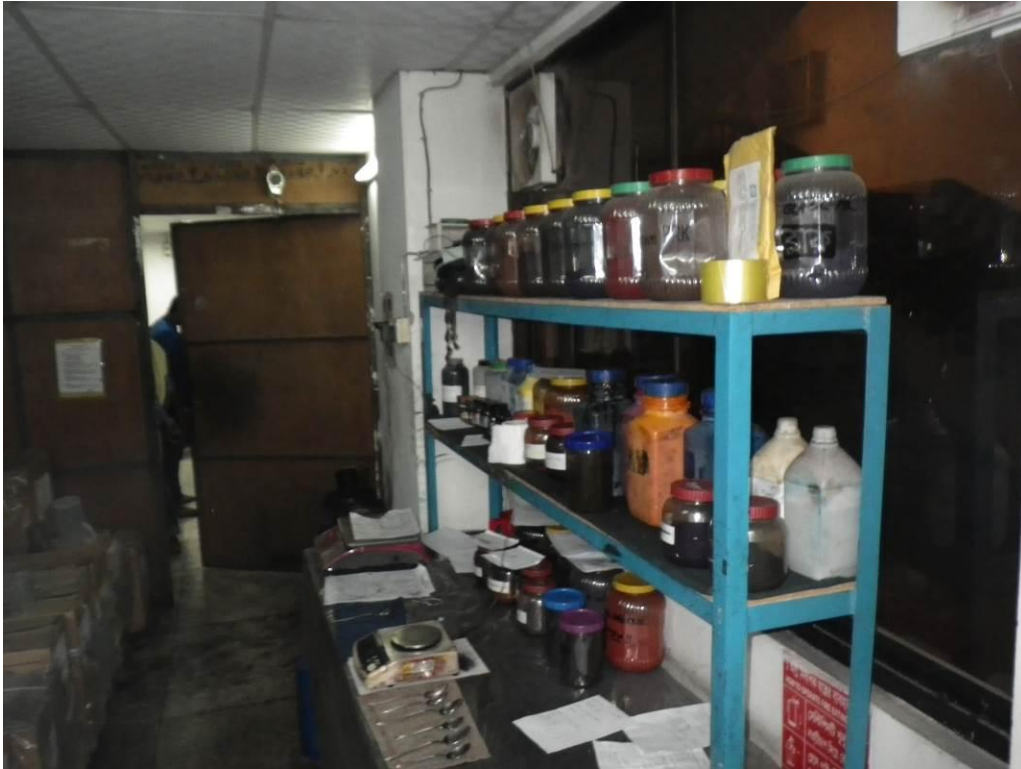
**Photo 11 – Chemical lab, no separation**

| No. | Category | Finding | Recommendation | Priority | Photo Ref |
|---|---|---|---|---|---|
| F-8 | Fire-Rated Construction | The chemical lab and flammable storage area are not separated from the floor and exit stair by fire-rated construction (openings, non-rated doors, penetrations). | Separate each of the rooms by minimum 2-hr fire-rated construction. Seal and/or protected all openings to maintain the required fire separations. | Major | 11, 12 |

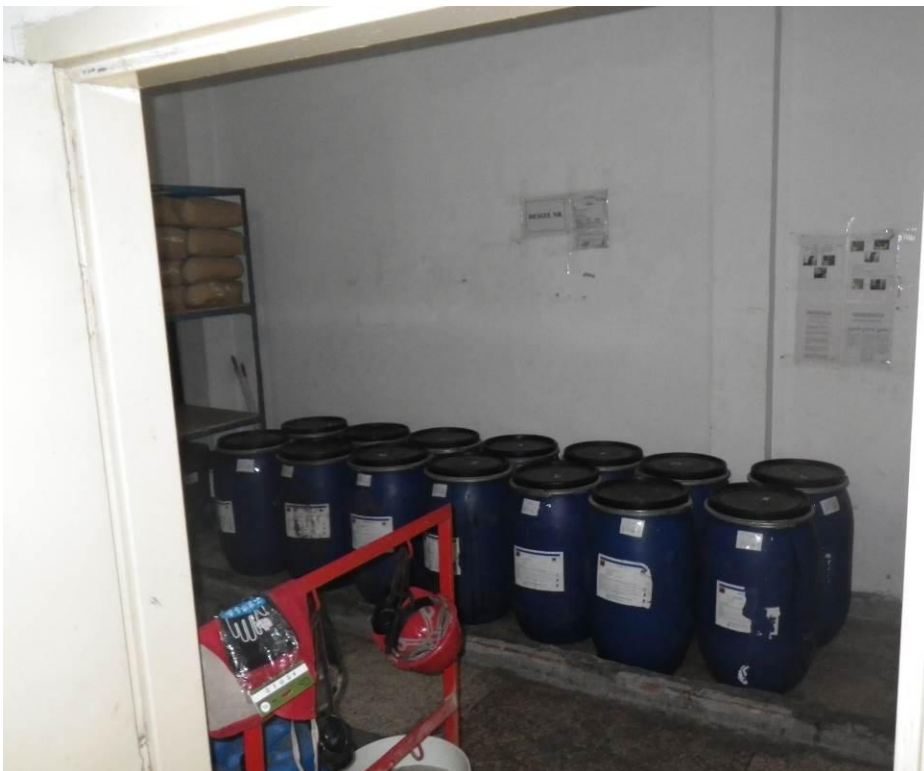
**Photo 12 – Chemical storage room, no separation**

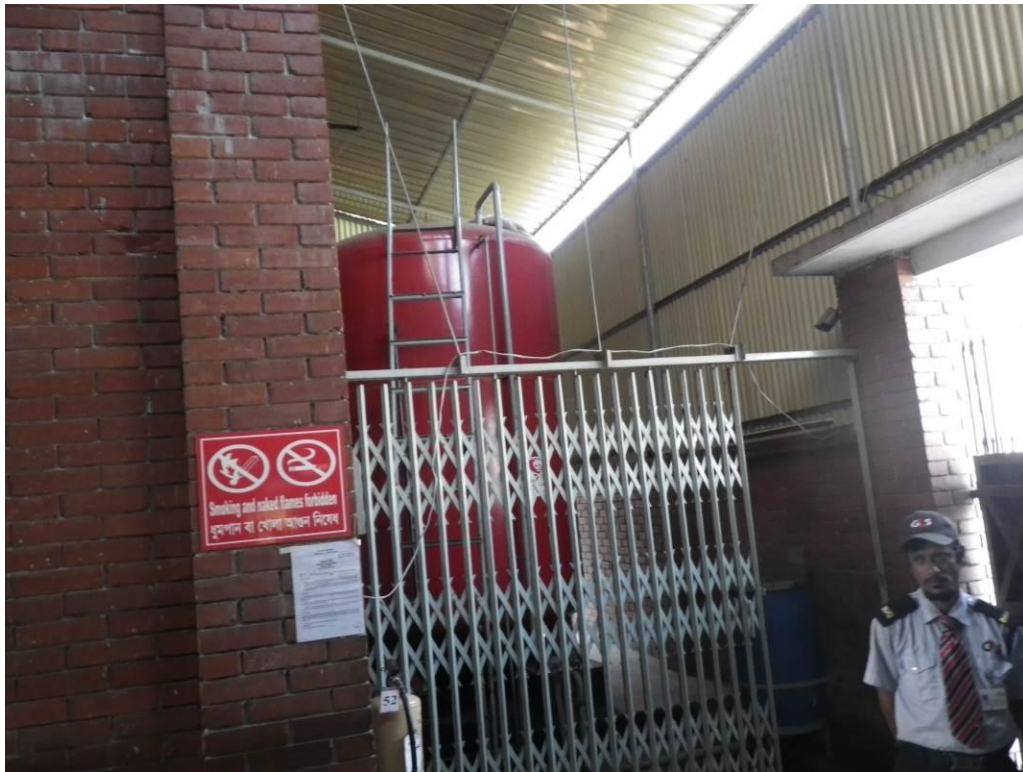
**Photo 13 – Diesel fuel storage tanks, no separation**

| No. | Category | Finding | Recommendation | Priority | Photo Ref |
|---|---|---|---|---|---|
| F-9 | Fire-Rated Construction | Diesel fuel storage tanks (18,000 L) are provided approximately 3 m from the building with no fire rated separations. | Provide containment of diesel fuel if tanks were to rupture. Separate diesel fuel tank area by minimum 2-hr fire-rated construction. Seal and/or protected all openings to maintain the required fire separations. | Major | 13 |

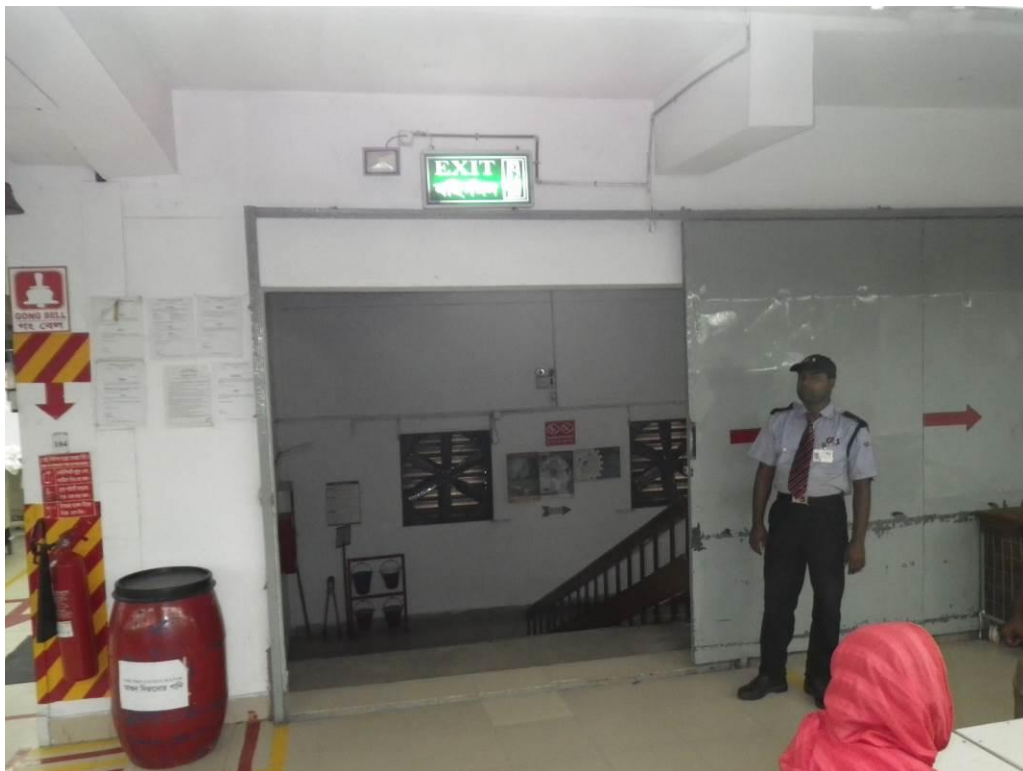
**Photo 14 – Lockable gates at exit stairs (typical)**

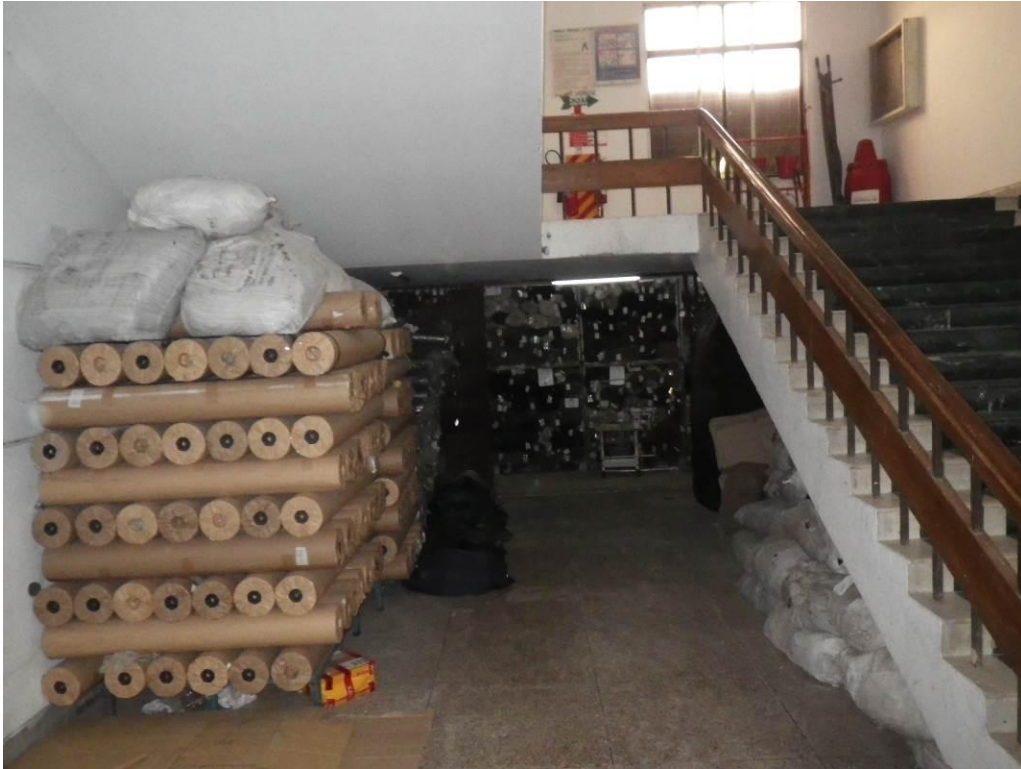
**Photo 15 – Storage located in exit stair**

| No. | Category | Finding | Recommendation | Priority | Photo Ref |
|---|---|---|---|---|---|
| F-11 | Egress | Storage is located in the exit stairs and in the egress path of the alley south of the building. | Maintain all designated egress pathways clear and remove storage from exit stairs. | Critical | 15 |

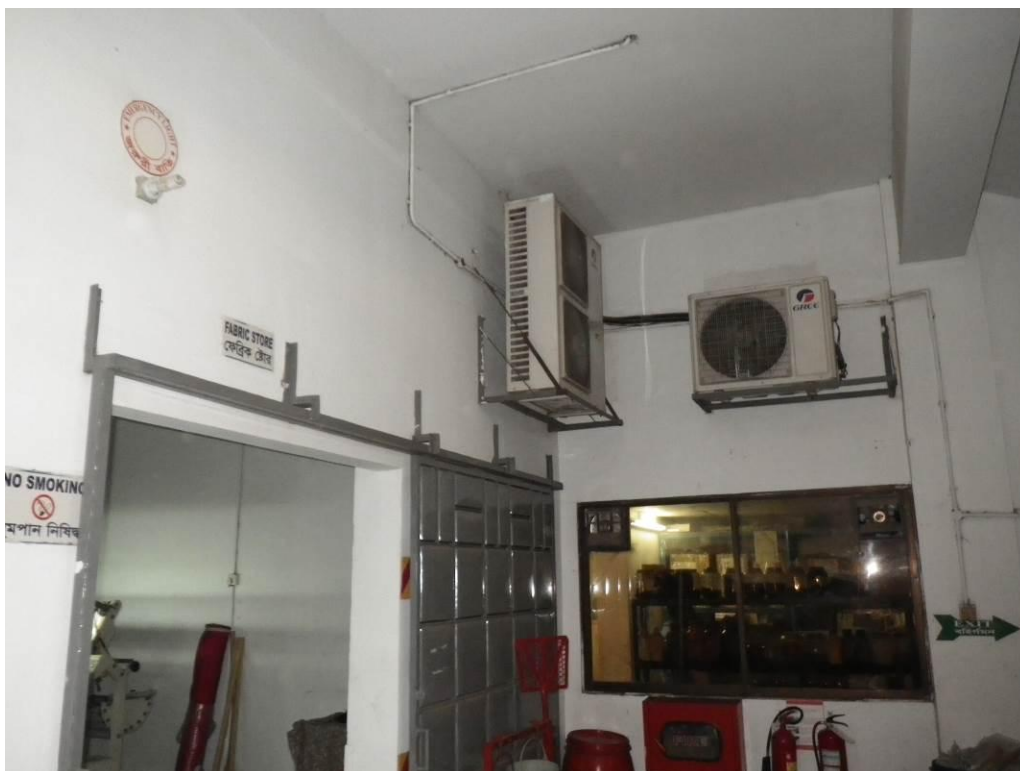
**Photo 16 – Non-fire life safety equipment located in exit stair (HVAC fans)**

| No. | Category | Finding | Recommendation | Priority | Photo Ref |
|---|---|---|---|---|---|
| F-12 | Egress | Non-fire and life safety related equipment is located in the exit stairs. | Remove all non-fire and life safety related equipment from the exit stairs. | Major | 16 |

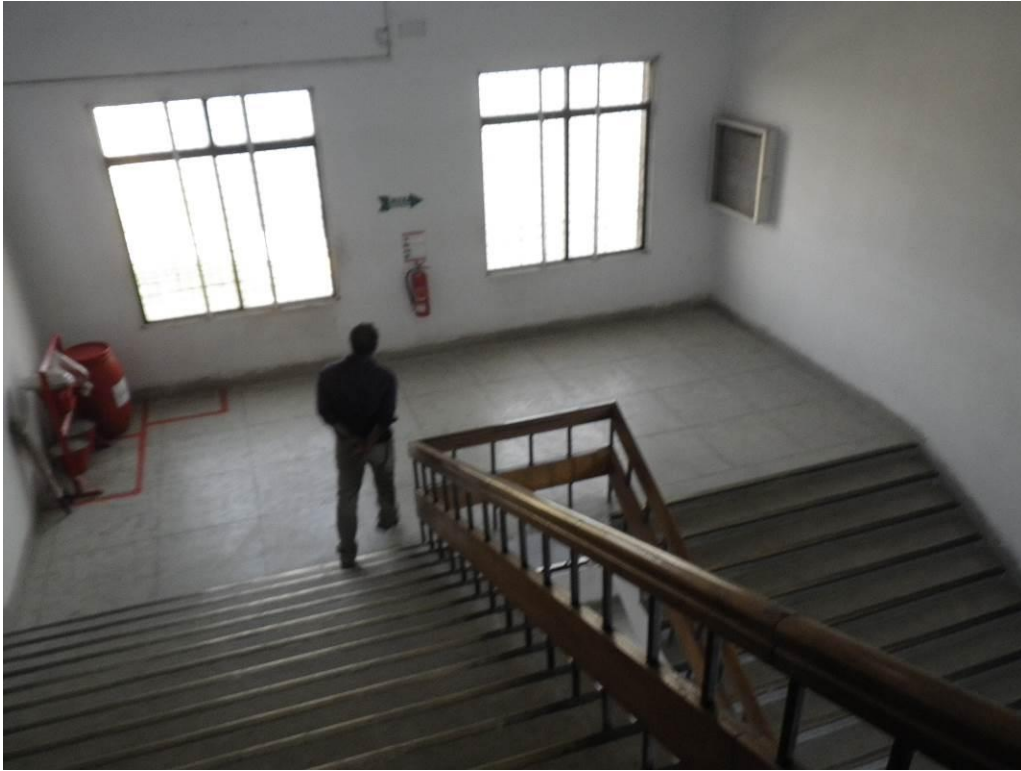
**Photo 17 – Handrails provided on inside of exit stair only (typical)**

| No. | Category | Finding | Recommendation | Priority | Photo Ref |
|---|---|---|---|---|---|
| F-13 | Egress | Handrails are only provided on the inside of stairs. North and west exit | Provide handrails on the inside and outside of all exit stairs. | Major | 17 |

| No. | Category | Finding | Recommendation | Priority | Photo Ref |
|---|---|---|---|---|---|
| | | stairs require an intermediate handrail due to width of stair. | Provide an intermediate handrail in all exit stairs greater than 2.24 m in width. | | |

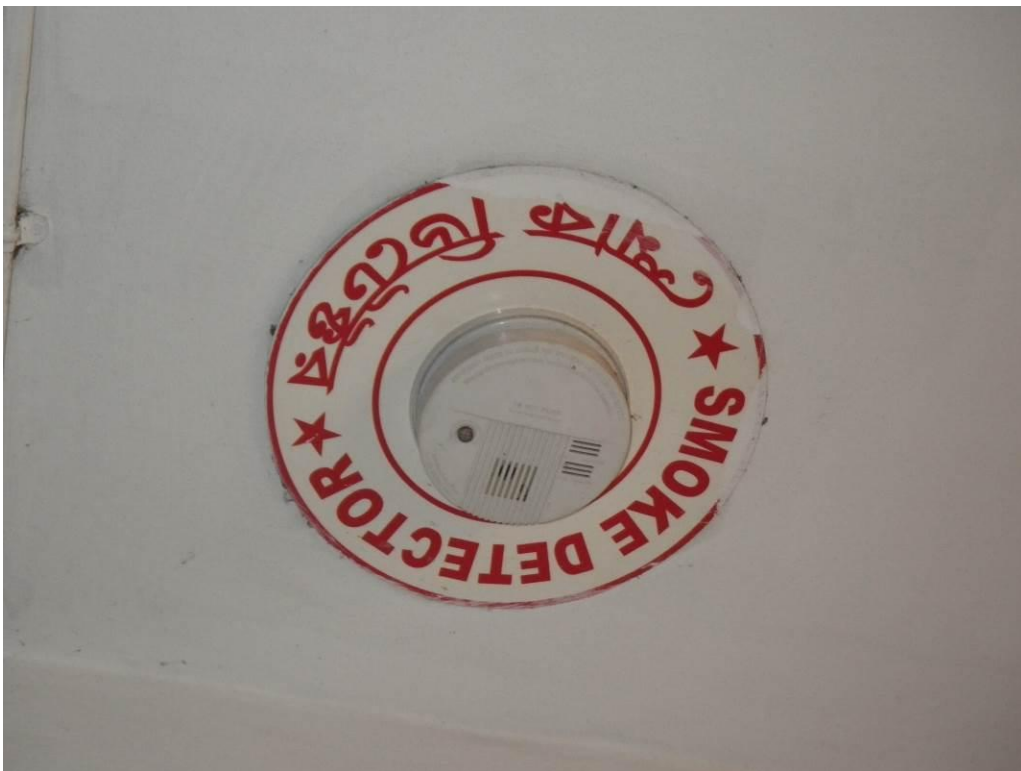
**Photo 18 – Single-station smoke alarm (typical)**

| No. | Category | Finding | Recommendation | Priority | Photo Ref |
|---|---|---|---|---|---|
| F-14 | Fire Alarm | The building is equipped with single-station smoke alarms. Smoke alarm activation sounds only a local alarm and does not provide automatic fire alarm notification of occupants. Some detectors are missing from their base or installed well below the ceiling. | Replace the single-station smoke alarms with automatic smoke detectors tied into the fire alarm system located in accordance with NFPA 72. Configure the fire alarm system to initiate occupant notification upon activation of any two smoke detectors in addition to the manual fire alarm stations. | Critical | 18, 19, 20 |

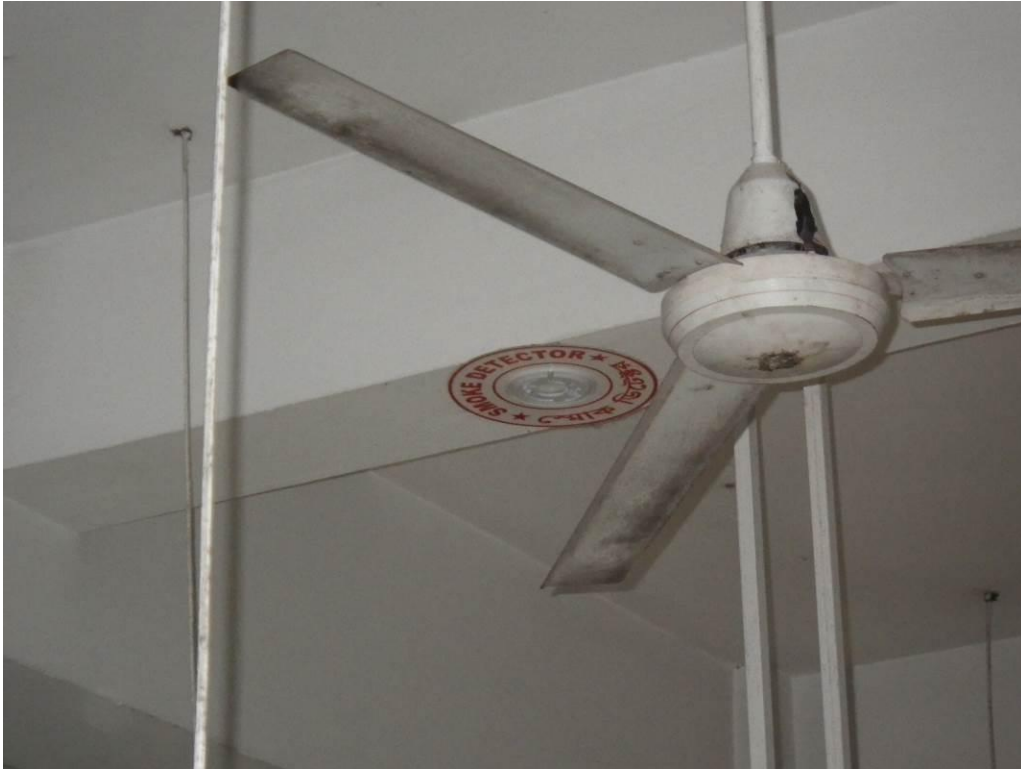
**Photo 19 – Smoke alarm missing from base**

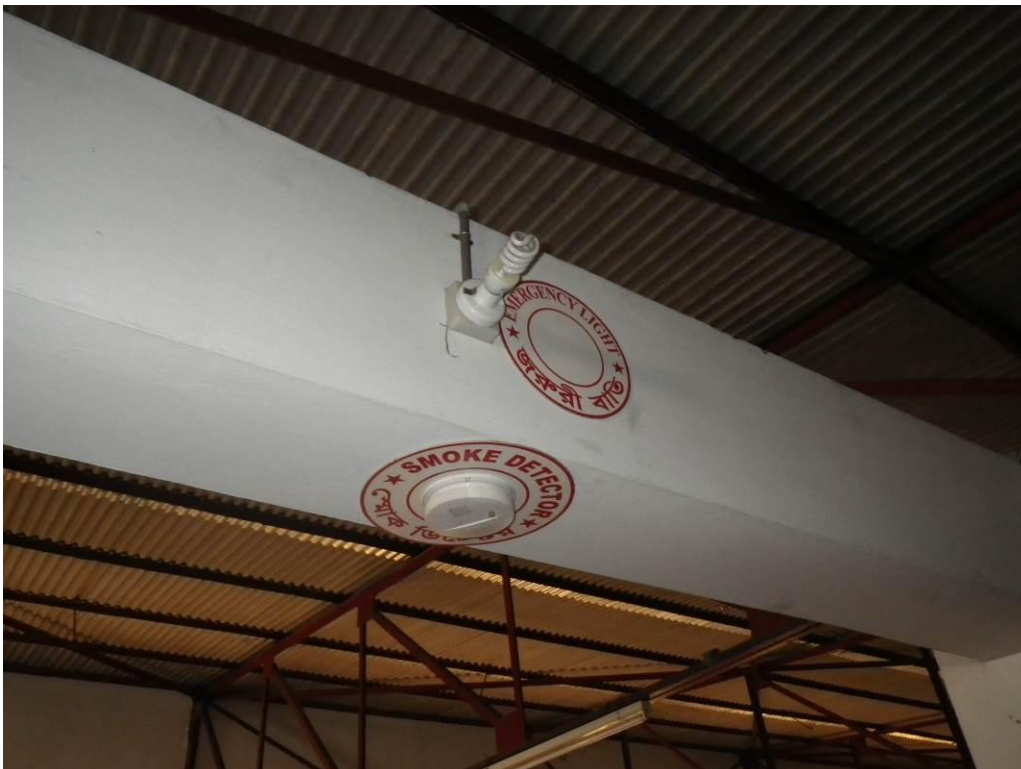
**Photo 20 – Smoke alarm located well below the ceiling**

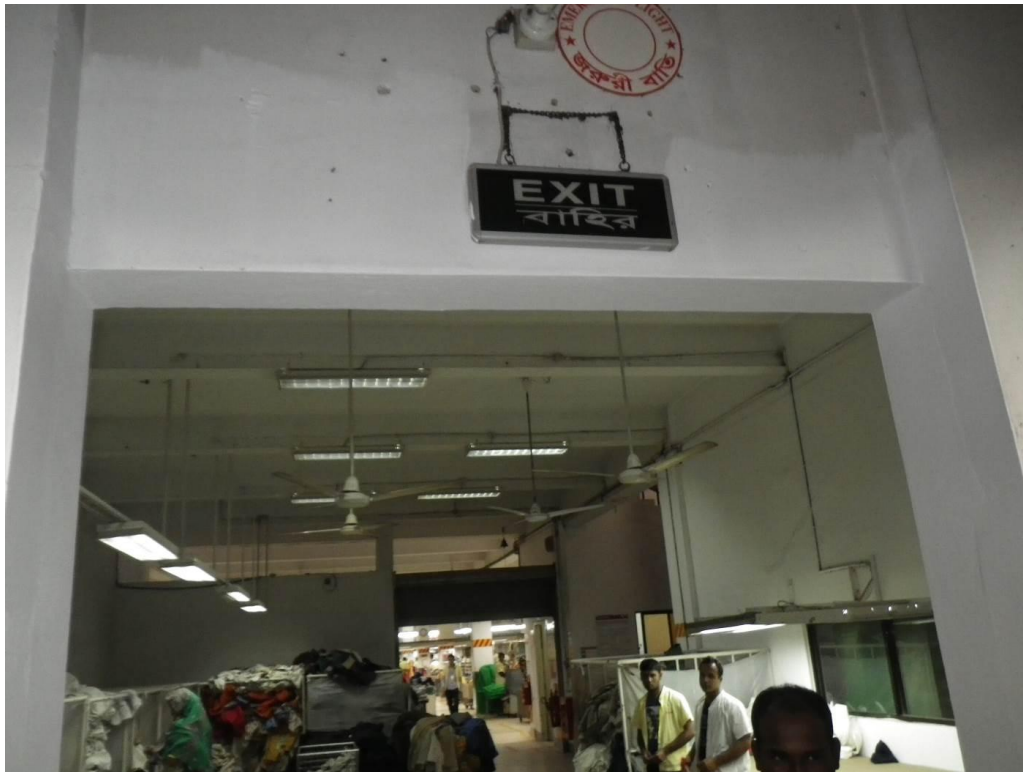
**Photo 21 – Exit sign not illuminated**

| No. | Category | Finding | Recommendation | Priority | Photo Ref |
|---|---|---|---|---|---|
| F-17 | Emergency Lighting | Emergency lighting is provided on the floors and in the exit stairs. The adequacy of the system was not fully tested; however several units did not function properly (lights were not lit). Based on the number and location of emergency lights observed, adequate illumination levels are not anticipated for all floor levels along egress routes. | Test the emergency lighting system on each floor and provide additional emergency fixtures to provide adequate illumination along the means of egress. Provide a minimum illumination of 10 lux at the floor level within exit stairs and exit discharge paths and minimum 2.5 lux along exit access aisles. | Major | 21 |

| No. | Category | Finding | Recommendation | Priority | Photo Ref |
|---|---|---|---|---|---|
| | | A manual on-off switch is also provided on the emergency lighting units. | Remove the manual switches from the units to prevent them from being switched off. | | |
