FIRE SAFETY INSPECTION REPORT

VIYELLATEX LTD., DHAKA, BANGLADESH

ACC   **RD**
on Fire and Building Safety in Bangladesh

January 3, 2014

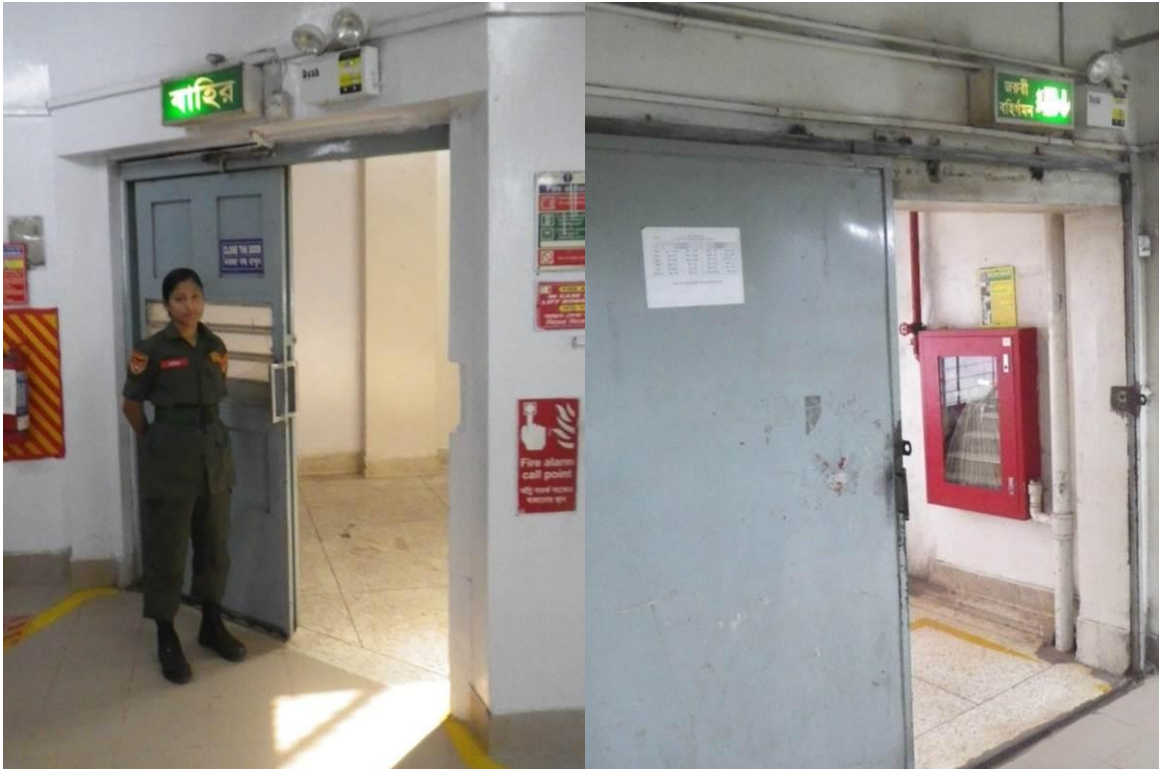
Photo 1 – Non-rated, sliding exit stair doors (GMT-1)

No.	Category	Finding	Recommendation	Priority	Photo Ref
F-1	Fire-Rated Construction, Egress	The three exit stairs are separated from the building interior with non-fire-rated sliding doors.	<p>Provide minimum 1.5-hr fire-rated doors to separate the exit stair from work areas and other building areas. Ensure that the fire doors are side-swinging, self-closing and positive latching and that they are provided with fire exit (panic) hardware where serving production floors.</p> <p>If the fire doors are required to be held open for functional reasons, provide automatic-closing devices tied to the fire alarm system.</p>	Critical	1
F-2	Fire-Rated Construction, Egress	The northwest exit stair has unprotected openings including ventilation louvers and access hatches.	Seal all penetrations and openings in the exit stair enclosure, or provided minimum 1.5-hr fire-rated opening protectives, to maintain the fire separation.	Critical	2

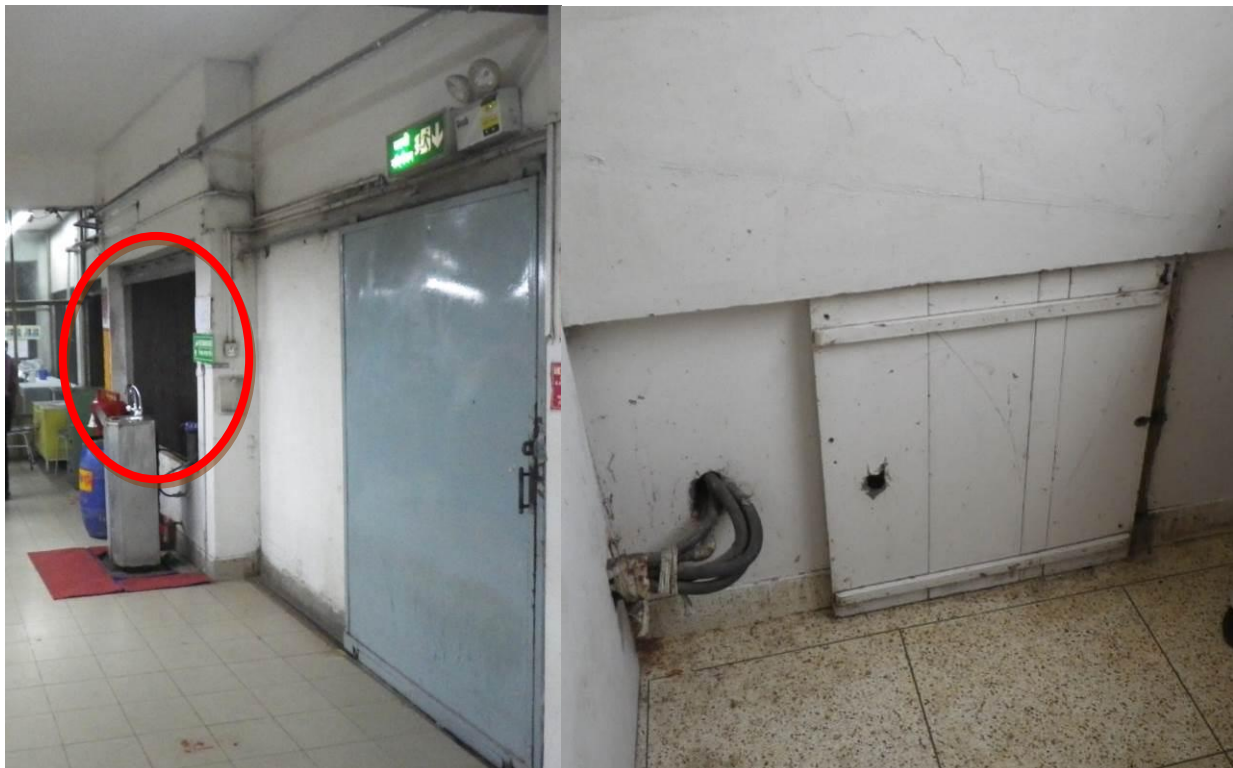
Photo 2 – Unprotected exit stair openings/penetrations (GMT-1, NW stair)

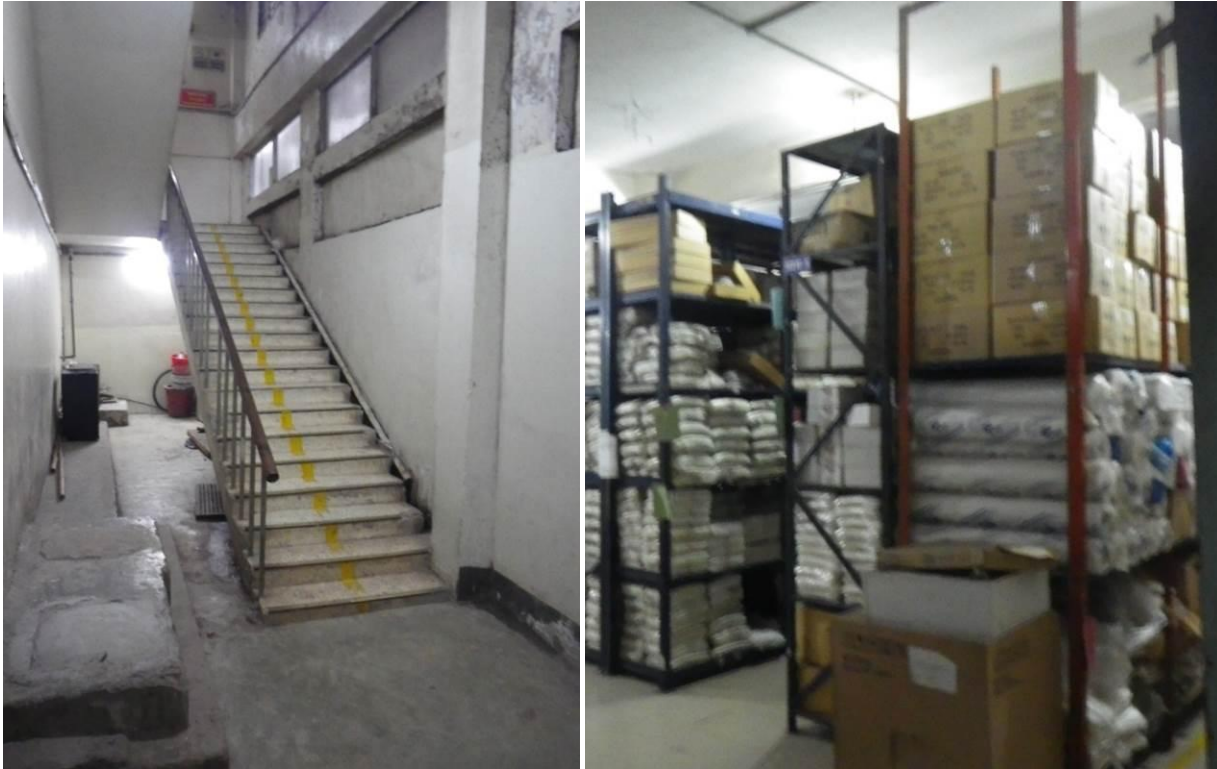
Photo 3 – Interior exit stair discharge open to storage areas (GMT-1)

F-3	Fire-Rated Construction, Egress	Two of the three exit stairs discharge inside the building on the ground floor. Ground floor areas used for combustible storage are not separated from the exit discharge by fire-rated construction.	Provide minimum 2-hr fire separation between the exit stair discharge paths and all storage areas on the ground floor. Provide vestibules with minimum 1.5-hr fire doors to protect any openings in the fire separation walls.	Critical	3

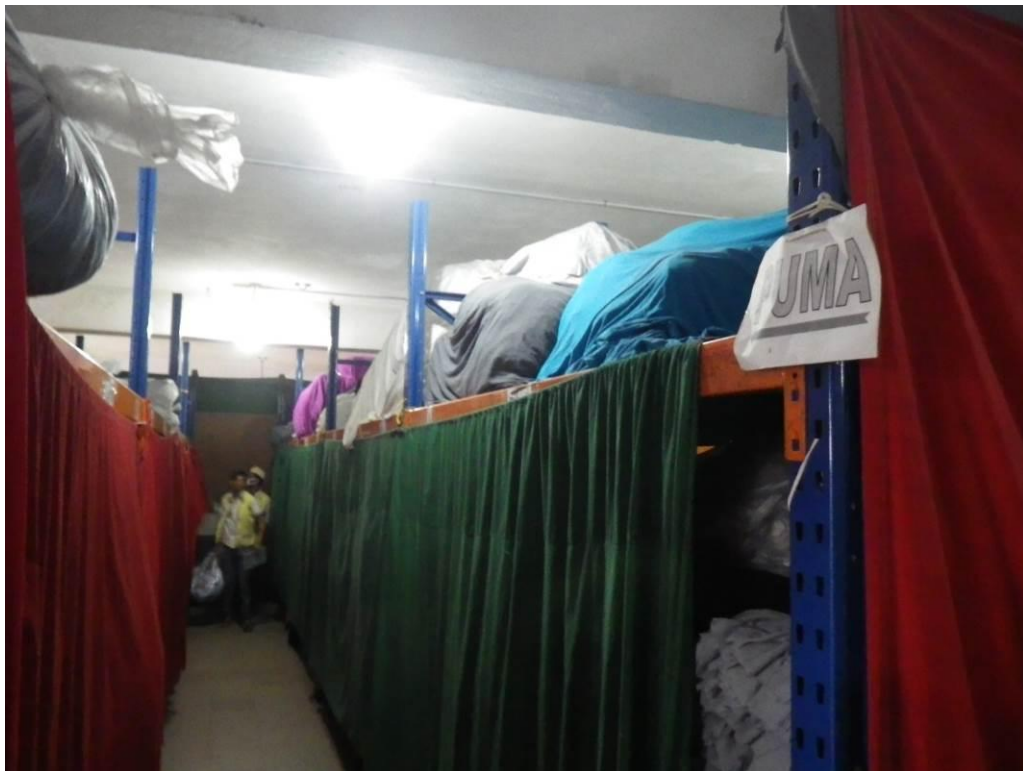
Photo 4 – Storage area on production floor (GMT-1)

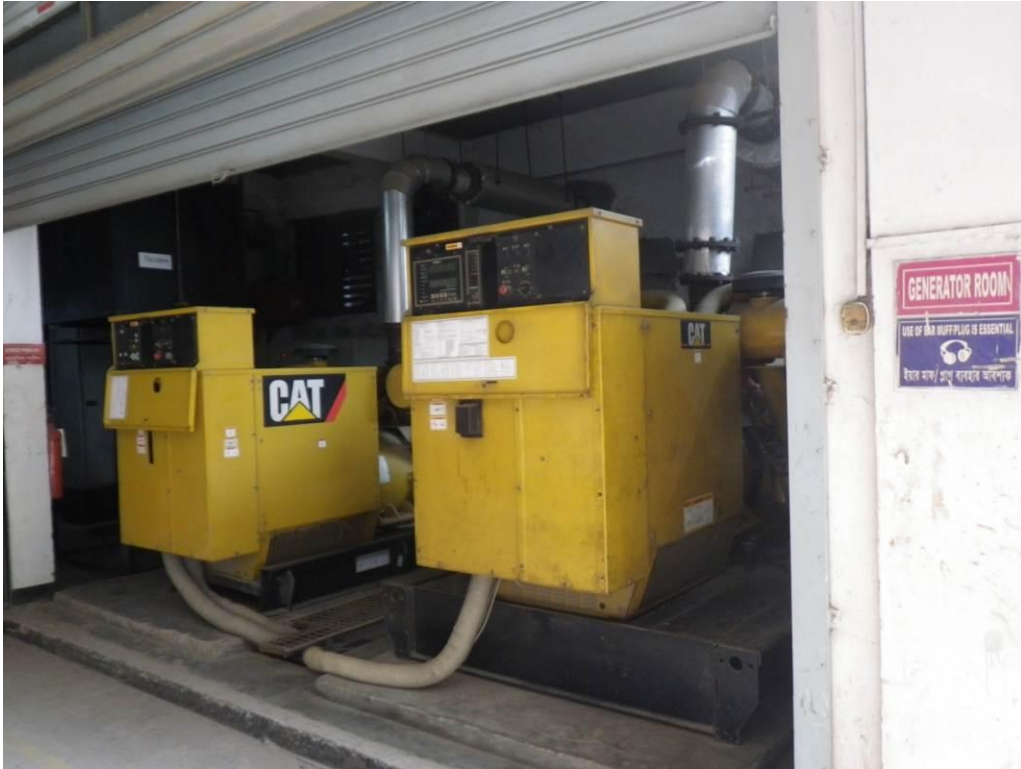
Photo 5 – Generator room (GMT-1)

No.	Category	Finding	Recommendation	Priority	Photo Ref
F-4	Fire-Rated Construction	Areas used for combustible storage on the 1st (cutting) and 2 nd (sewing) floors are not separated by fire-rated construction.	<p>Provide dedicated storage rooms separated by minimum 1-hr fire-rated construction on all production floors where transient storage is required for operations.</p> <p>Where separate storage rooms are not feasible, provide defined storage areas and limit the storage arrangement as follows:</p> <ul style="list-style-type: none"> - Maximum height of 2.4 m and maximum area of 23m² - If sprinkler protected: maximum height of 3.66m and maximum area of 93m² <p>Separate areas of unenclosed combustible storage by a minimum clear distance of 3m.</p>	Major	4
F-5	Fire-Rated Construction	Rooms housing the generator and large electrical equipment on the ground floor, as well as combustible fuel oil, are not separated by fire-rated construction.	Provide minimum 2-hr fire separation of the generator, electrical rooms and all fuel storage. Protect openings with minimum 1.5-hr, self- or automatic closing fire doors.	Major	5

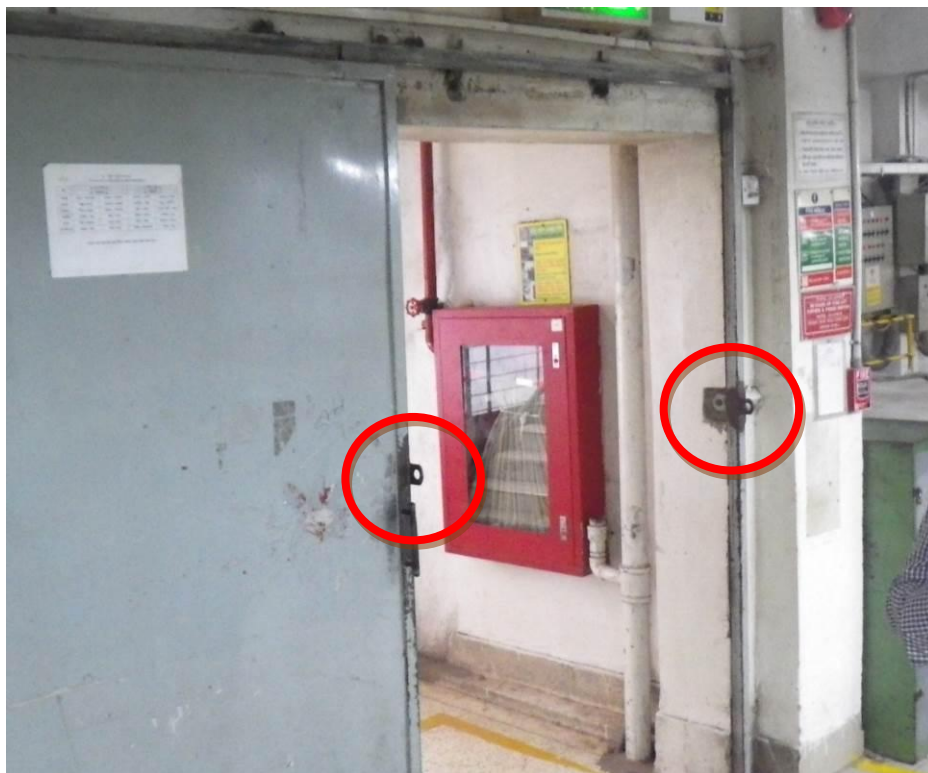
Photo 6 – Exit door with locking features (GMT-1)

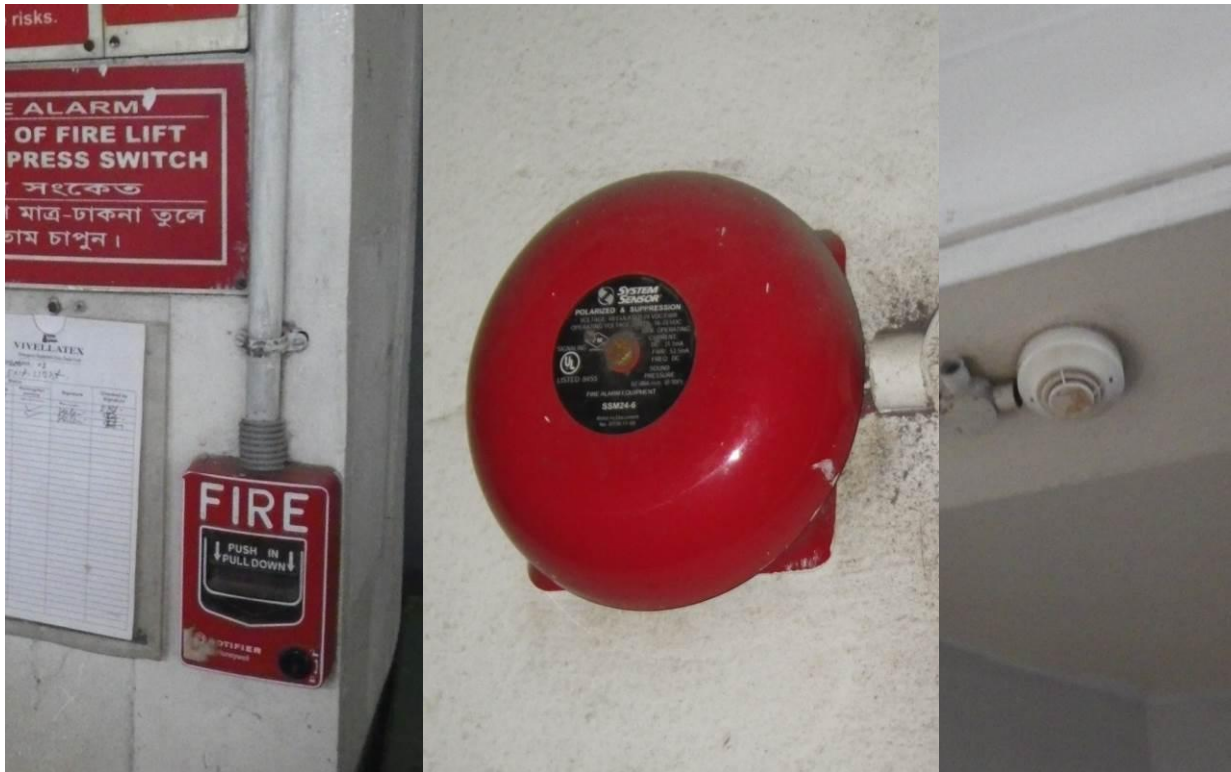
Photo 7 – Typical fire alarm devices (GMT-1)

No.	Category	Finding	Recommendation	Priority	Photo Ref
F-6	Egress	<p>The sliding doors at the exit stairs are provided with locking features.</p> <p>Note - all doors were unlocked during the inspection.</p>	<p>Remove all door/gate locking features at exit stairs and along the means of egress.</p> <p>If locks are required for security reasons, utilize special door locking features complying with NFPA 101.</p>	Critical	6
F-7	Fire Alarm	<p>Based on the number and location of notification appliances observed, the fire alarm system does not appear to provide adequate audible notification coverage on the production floor levels.</p> <p>Note – the system was tested on one of the floors and was not audible from all areas.</p>	<p>Provide additional fire alarm appliances to provide audible coverage throughout the building in accordance with NFPA 72 criteria.</p> <p>Where required based on ambient noise conditions (during operations), provide visual notification appliances.</p>	Critical	7

F-8	Fire Alarm	<p>Activation of the fire alarm system by a manual fire alarm station provides automatic occupant notification only on the floor of alarm and not throughout the building.</p>	<p>Configure the fire alarm system to initiate automatic occupant notification on all floor levels to facilitate whole-building evacuation upon alarm.</p>	Critical	7
F-9	Fire Alarm	<p>Smoke detector activation does not provide automatic fire alarm notification of occupants. Automatic notification is provided only by the manual fire alarm stations.</p>	<p>Configure the fire alarm system to initiate occupant notification upon activation of any two smoke detectors in addition to the manual fire alarm stations.</p>	Critical	7

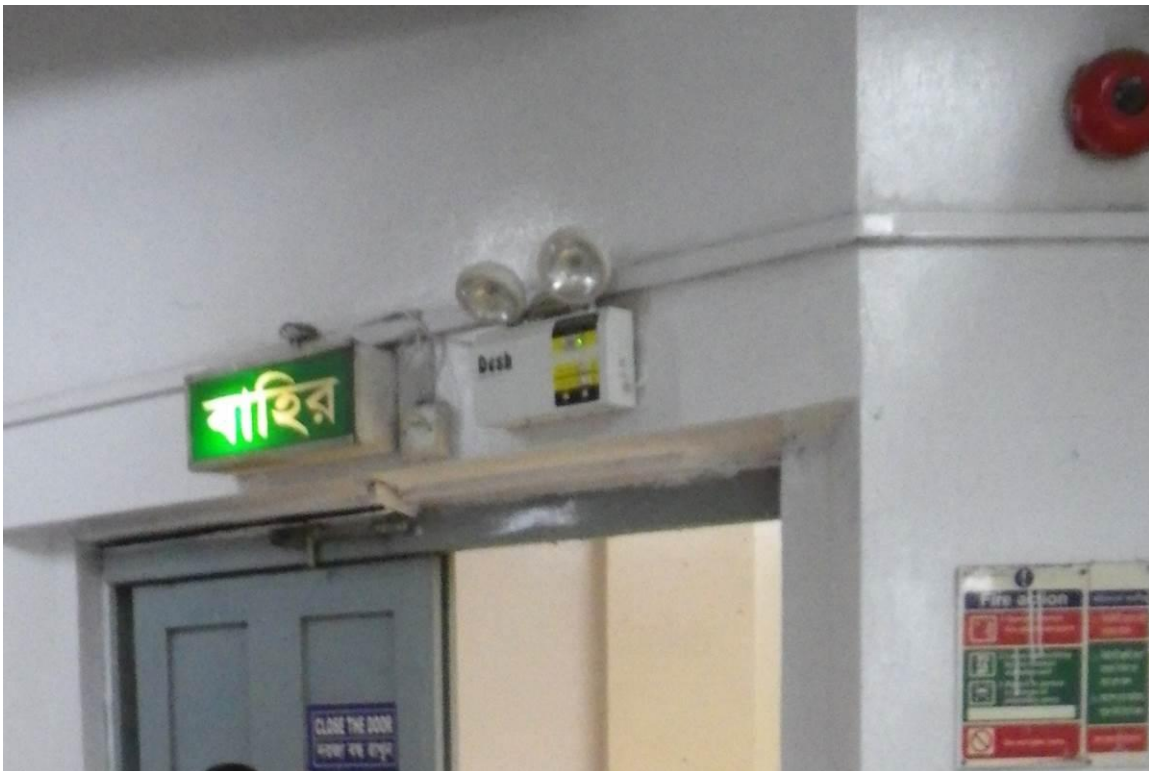
Photo 8 – Typical emergency lighting unit at exit stair (GMT-1)

No.	Category	Finding	Recommendation	Priority	Photo Ref
F-10	Fire Alarm	<p>The fire alarm system is not regularly tested and maintained.</p> <p>Note – the system is reportedly visually inspected regularly with maintenance / repairs provided as needed.</p>	<p>Inspect, test and maintain the fire alarm system, and keep written records on-site, in accordance with NFPA 72.</p>	Critical	7
F-11	Fire Protection	<p>The high-rise building is not provided with automatic sprinkler protection. The large occupant loads, heavy fuel loading, and anticipated extended egress times warrant sprinkler protection.</p>	<p>Provide automatic sprinkler protection throughout the building in accordance with NFPA 13.</p>	Critical	--
F-12	Emergency Lighting	<p>Emergency lighting is provided on the floors and in the exit stairs. The adequacy of the system was not fully tested. Based on the number and location of emergency lights observed, adequate illumination levels are not anticipated for all floor levels along egress routes.</p>	<p>Test the emergency lighting system on each floor and provide additional emergency fixtures to provide adequate illumination along the means of egress. Provide a minimum illumination of 10 lux at the floor level within exit stairs and exit discharge paths and minimum 2.5 lux along exit access aisles.</p>	Major	8

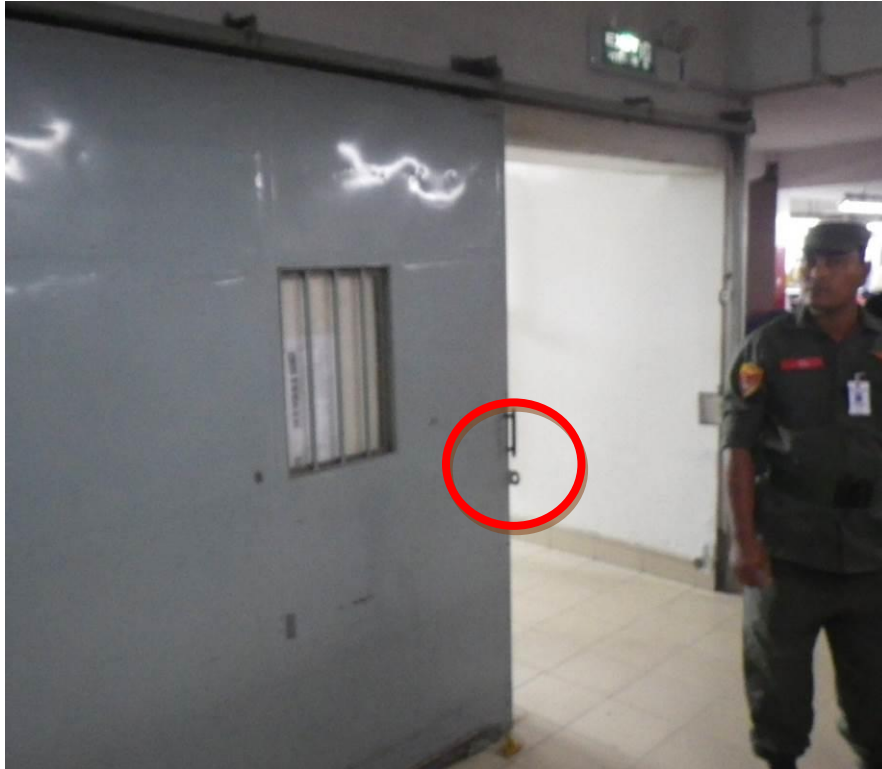
Photo 9 – Non-rated, sliding exit stair door with locking features (GMT-2)

No.	Category	Finding	Recommendation	Priority	Photo Ref
F-3	Fire-Rated Construction	Areas used for combustible storage on the 1 st and 4 th floor are not separated by fire-rated construction.	<p>Provide dedicated storage rooms separated by minimum 1-hr fire-rated construction on all production floors where transient storage is required for operations.</p> <p>Where separate storage rooms are not feasible, provide defined storage areas and limit the storage arrangement as follows:</p> <ul style="list-style-type: none"> - Maximum height of 2.4 m and maximum area of 23m² - If sprinkler protected: maximum height of 3.66m and maximum area of 93m² <p>Separate areas of unenclosed combustible storage by a minimum clear distance of 3m.</p>	Major	11
F-4	Egress	<p>The sliding doors at the exit stairs are provided with locking features.</p> <p>Note - all doors were unlocked during the inspection.</p>	<p>Remove all door/gate locking features at exit stairs and along the means of egress.</p> <p>If locks are required for security reasons, utilize special door locking features complying with NFPA 101.</p>	Critical	9

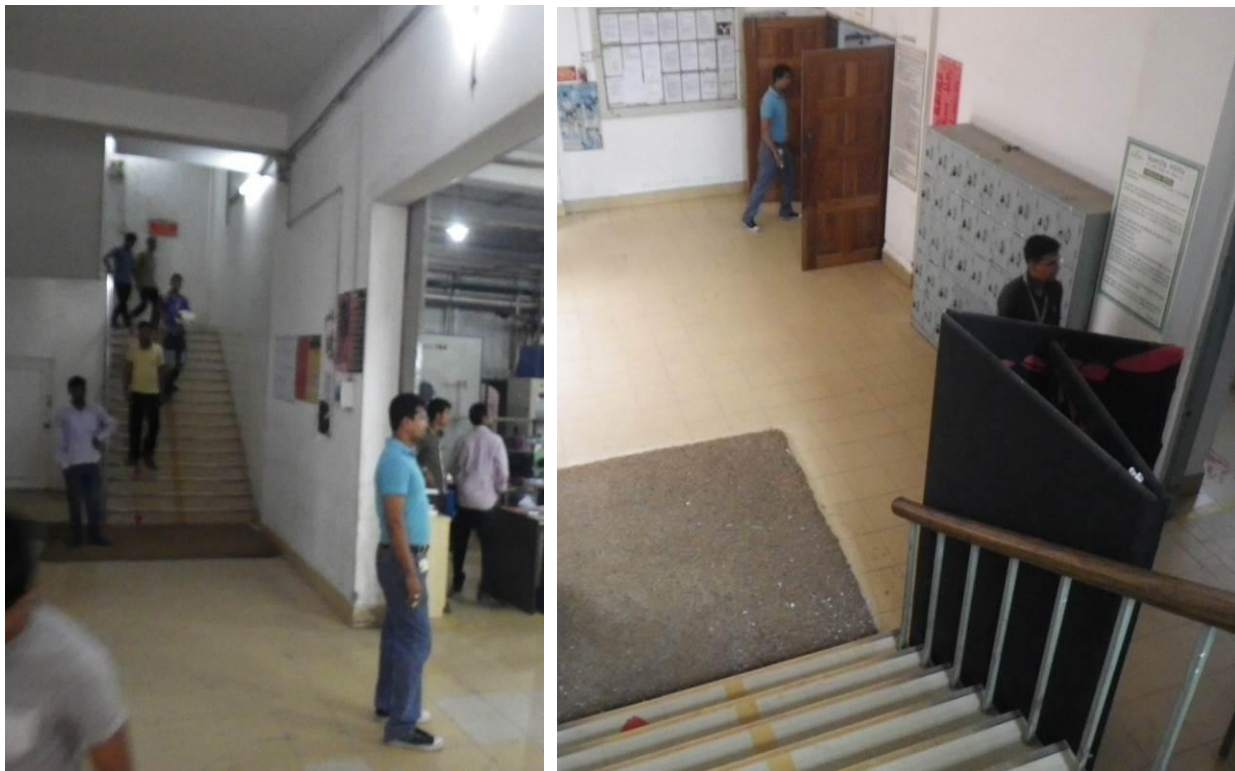
Photo 10 – Interior exit stair discharge open to storage and work areas (GMT-2)

No.	Category	Finding	Recommendation	Priority	Photo Ref
F-1	Fire-Rated Construction, Egress	The two exit stairs are separated from the building interior with non-fire-rated sliding doors.	<p>Provide minimum 1.5-hr fire-rated doors to separate the exit stair from work areas and other building areas. Ensure that the fire doors are side-swinging, self-closing and positive latching and that they are provided with fire exit (panic) hardware where serving production floors.</p> <p>If the fire doors are required to be held open for functional reasons, provide automatic-closing devices tied to the fire alarm system.</p>	Critical	9
F-2	Fire-Rated Construction, Egress	Both exit stairs discharge inside the building on the ground floor. Ground floor areas used for production, washing and combustible storage are not separated from the exit discharge by fire-rated construction.	<p>Provide minimum 2-hr fire separation between the exit stair discharge paths and all production, washing and storage areas on the ground floor. Provide vestibules with minimum 1.5-hr fire doors to protect any openings in the fire separation walls separating storage areas.</p>	Critical	10

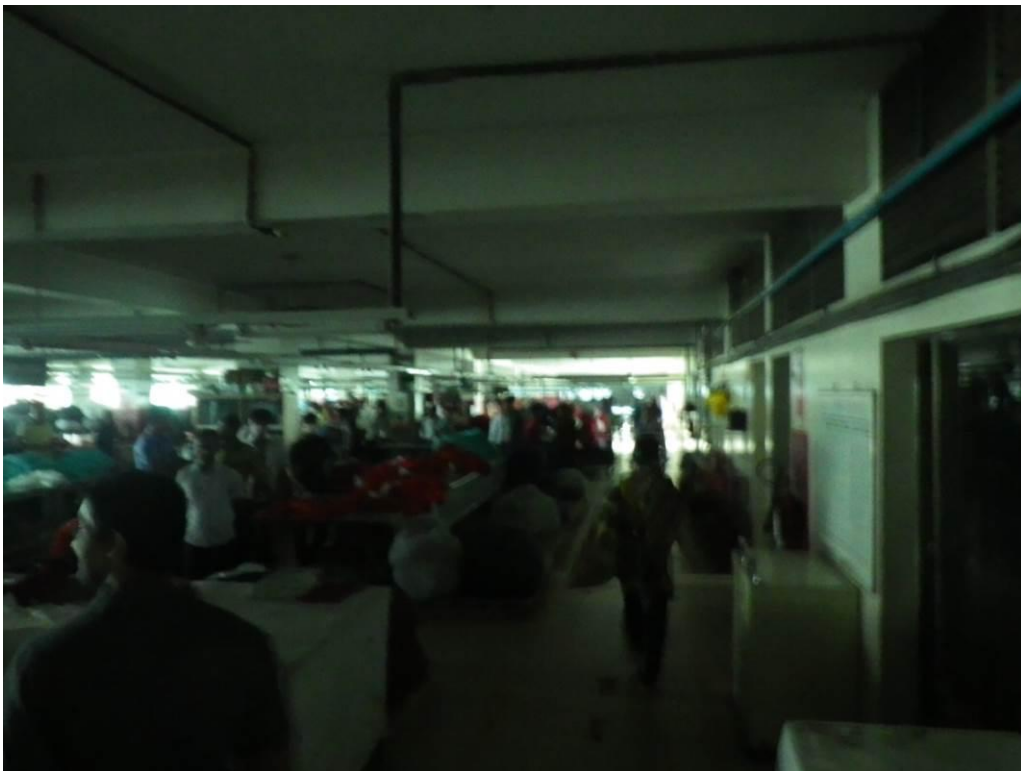
Photo 12 – Production floor operating without normal/emergency lighting (GMT-2)

No.	Category	Finding	Recommendation	Priority	Photo Ref
F-9	Fire Protection	The high-rise building is not provided with automatic sprinkler protection. The large occupant loads, heavy fuel loading, and anticipated extended egress times warrant sprinkler protection.	Provide automatic sprinkler protection throughout the building in accordance with NFPA 13.	Critical	--
F-10	Emergency Lighting	<p>Emergency lighting is provided on the floors and in the exit stairs. Based on the number and location of emergency lights observed, adequate illumination levels are not anticipated for all floor levels along egress routes.</p> <p>Note – the 1st floor was without power during the inspection with workers operating with no normal or emergency lighting.</p>	<p>Test the emergency lighting system on each floor and provide additional emergency fixtures to provide adequate illumination along the means of egress. Provide a minimum illumination of 10 lux at the floor level within exit stairs and exit discharge paths and minimum 2.5 lux along exit access aisles.</p>	Major	12

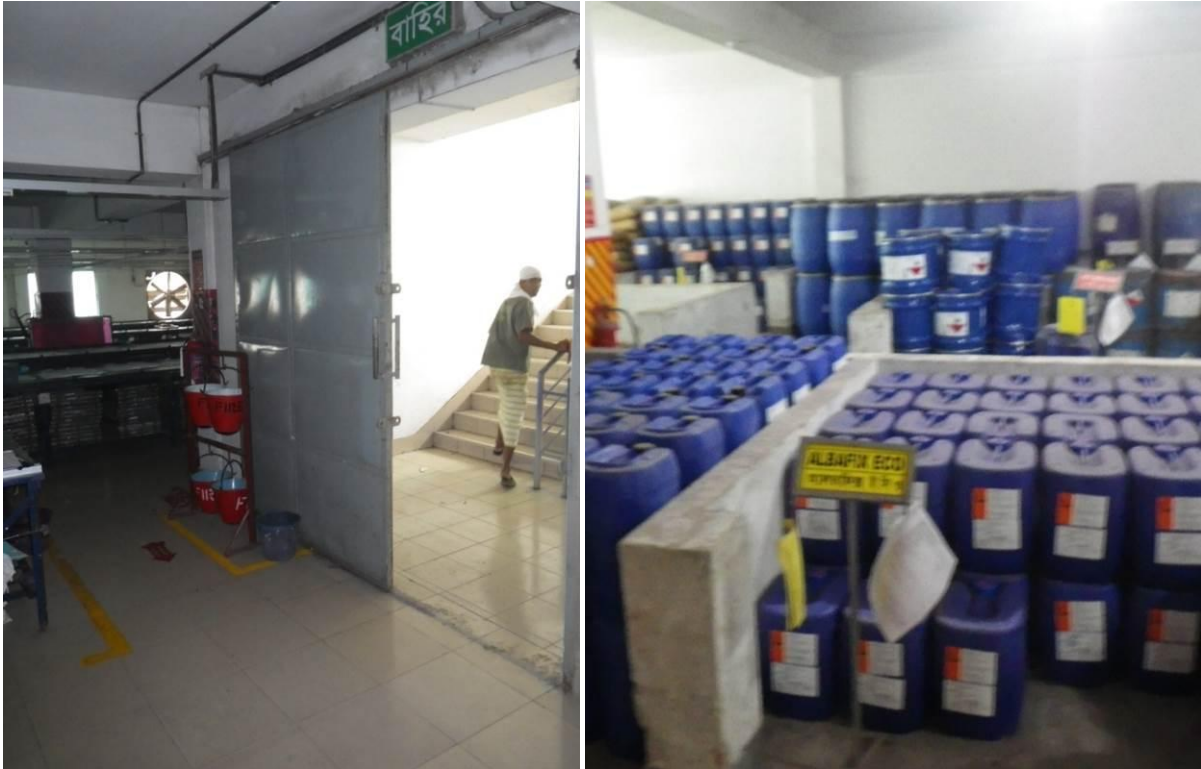
Photo 13 – Chemical storage, not separated from exit stair serving production floor (GMT-2)

No.	Category	Finding	Recommendation	Priority	Photo Ref
F-11	Hazardous Storage	<p>The 1st floor of the adjacent Chemical Storage building has been connected to the building and is used for printing production. The Chemical Storage building contains a variety of hazardous materials, including combustible and flammable liquids stored on the ground floor. The printing area and means of egress serving this area are not adequately separated and protected from the hazardous storage.</p>	<p>Discontinue using areas of the Chemical Storage building for production.</p> <p>Alternatively, provide a minimum 2-hr fire-rated separation between the production area and associated means of egress and all hazardous storage areas, provide automatic sprinkler protection throughout the Chemical Storage building, and upgrade the fire alarm system as specified in the recommendations for the GMT Unit #2.</p>	Major	13

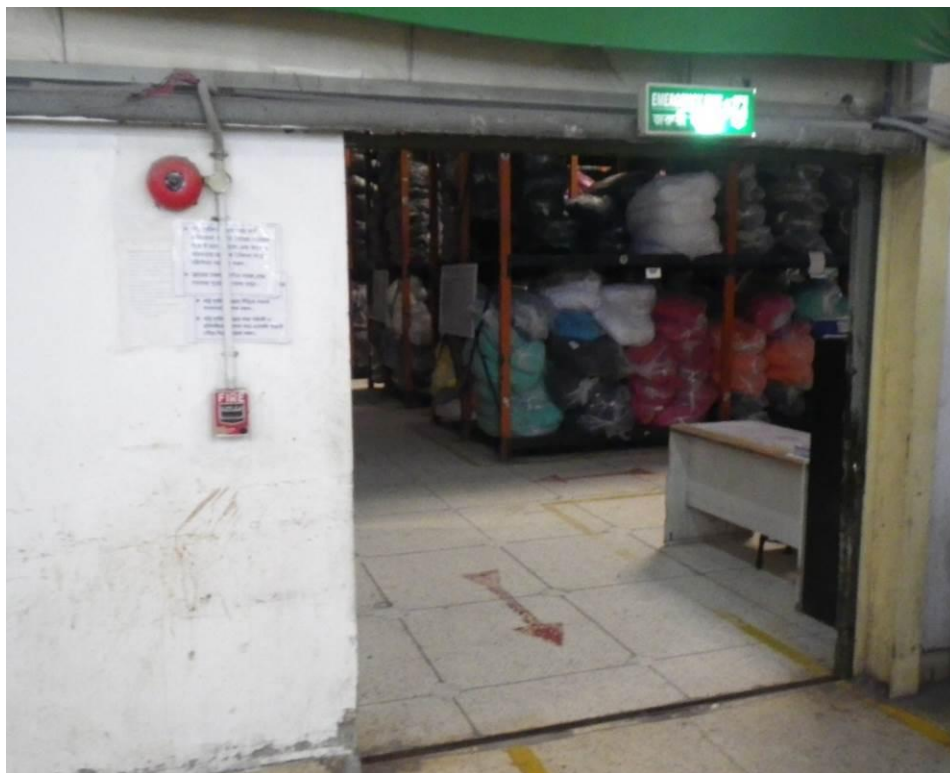
Photo 14 – Egress through storage warehouse (Dyeing-1)

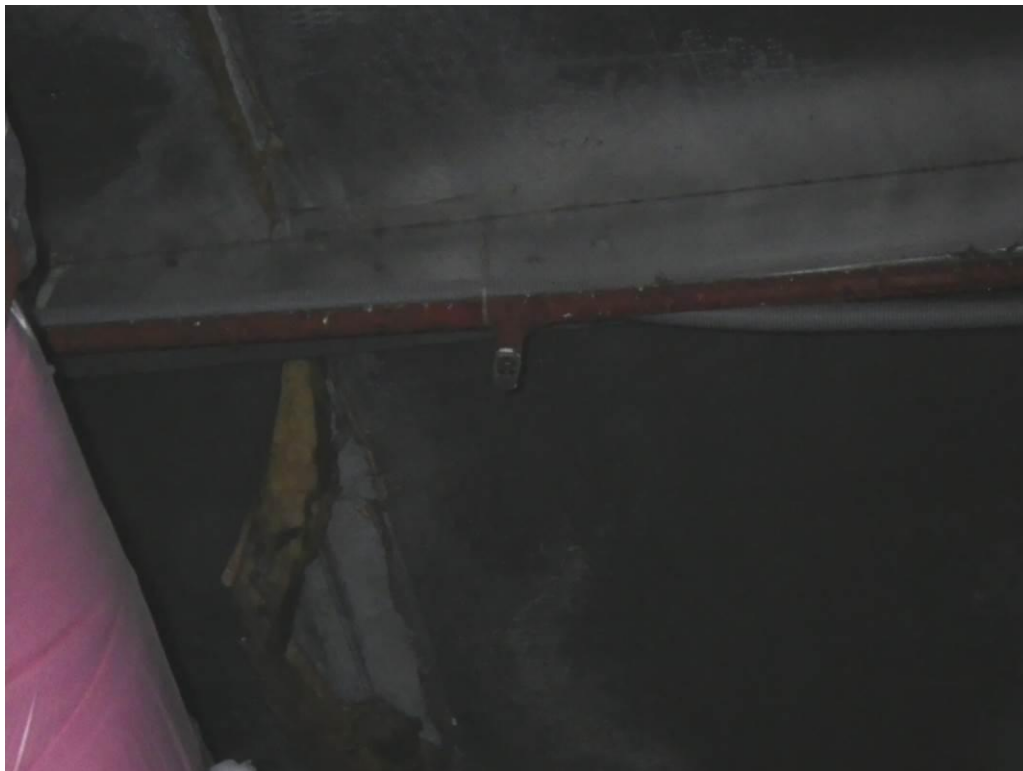
Photo 16 – Sprinkler system serving storage warehouse (Dyeing-1)

No.	Category	Finding	Recommendation	Priority	Photo Ref
F-4	Fire Alarm	Smoke detector (beam-type) activation does not provide automatic fire alarm notification of occupants. Automatic notification is provided only by the manual fire alarm stations.	Configure the fire alarm system to initiate occupant notification upon activation of any two smoke detectors in addition to the manual fire alarm stations.	Major	--
F-5	Fire Alarm	The fire alarm system is not regularly tested and maintained. Note – the system is reportedly visually inspected regularly with maintenance / repairs provided as needed.	Inspect, test and maintain the fire alarm system, and keep written records on-site, in accordance with NFPA 72.	Critical	--
F-6	Fire Protection	The storage warehouse area is provided with automatic sprinkler protection. The system appears to be designed for a light-hazard occupancy and is not appropriate for the high-rack combustible storage. The sprinkler-protected area is also not separated from the remainder of the building by fire-rated construction.	Modify the automatic sprinkler system for the warehouse area to provide appropriate protection in accordance with NFPA 13. Provide a minimum 2-hr fire-rated separation between the sprinklered warehouse area and non-sprinklered factory areas.	Major	16

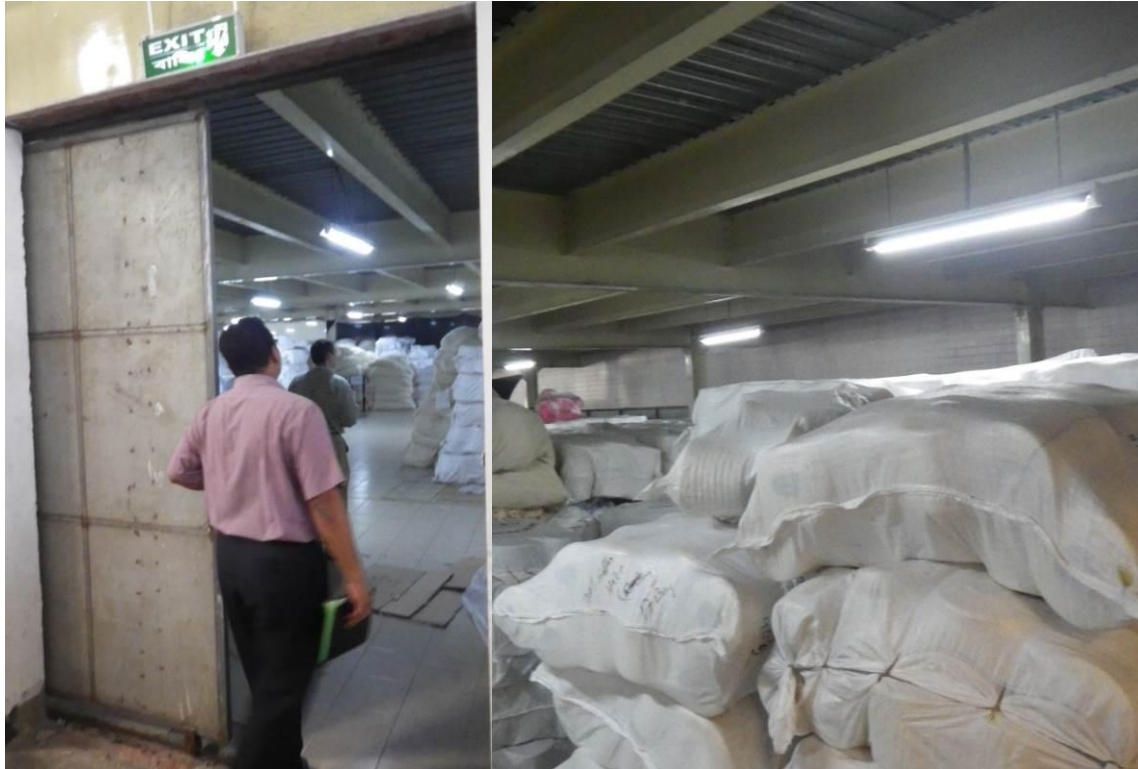
Photo 17 – Egress through storage warehouse, obstructed (Dyeing-2)

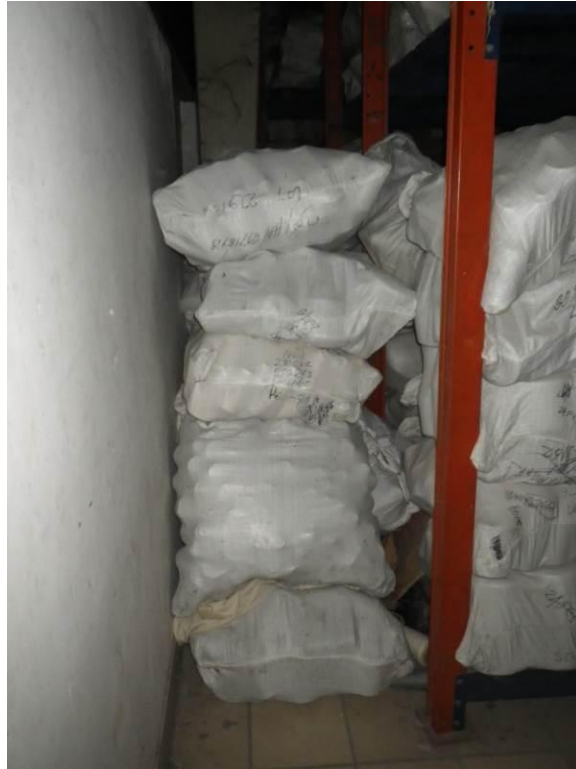
Photo 19 – Storage creating dead-end aisle in warehouse (Knitting)

No.	Category	Finding	Recommendation	Priority	Photo Ref
F-1	Egress	One of the two building exits requires exit access through the storage warehouse area. Additionally, the two exits paths for the factory area are not remotely located and create a maximum common path of travel of over 50 m.	Provide a remotely located second exit for the factory area such that exit access is not required through a storage area and the maximum common path of travel is less than 30 m.	Critical	--
F-2	Egress	Exits from the building consist of lockable sliding doors. Note - all doors were unlocked during the inspection.	Replace the sliding doors with side-swinging doors. Remove all door locking features along the means of egress. If locks are required for security reasons, utilize special door locking features complying with NFPA 101.	Critical	--
F-3	Egress	Dead-end aisles in excess of 30 m were observed both in the factory area and storage warehouse (due to storage obstructions).	Rearrange the factory equipment / work tables and remove all storage from aisles in the warehouse to eliminate dead-end conditions.	Major	19

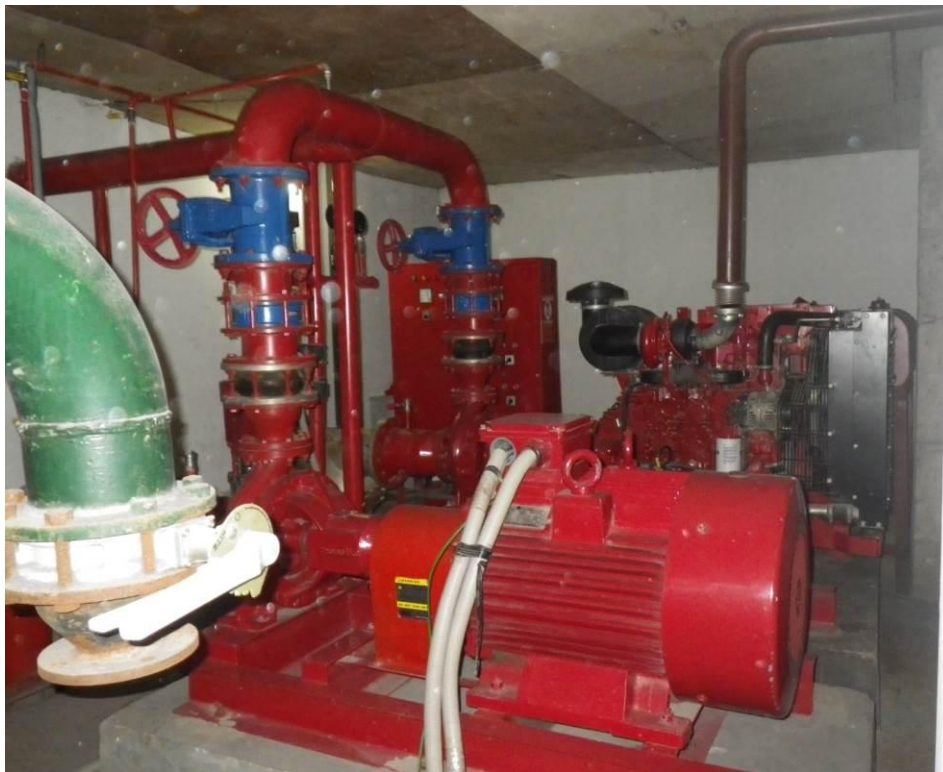
Photo 20 – Fire pump room with wood roof

No.	Category	Finding	Recommendation	Priority	Photo Ref
F-1	Egress	The Fashion Plastics & Packaging building is served by two exits that are not remotely located, creating a maximum common path of travel of over 50 m.	Provide a remotely located second exit for the factory area such that the maximum common path of travel is less than 30 m.	Critical	--
F-2	Fire Protection	The fire pump building has a wood roof, is located next to a waste storage area, and is not provided with sprinkler protection.	Replace the wood roof with a non-combustible, fire-rated roof assembly and provide sprinkler protection in the pump room.	Major	20
