# Artistic Design Ltd

232, 233 East Narashinghpur (Bangla Bazar), Asulia, Savar 1314, Dhaka  
(23.93780N, 90.30851E)

25 March 2014

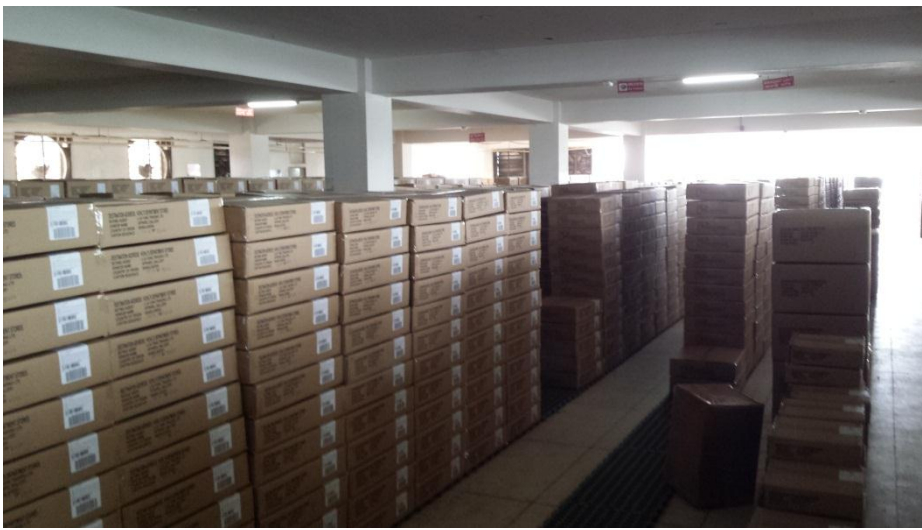
2<sup>nd</sup> floor storage area

**Building Engineer to prepare controlled loading plans for all floors which will designate where storage can be placed.**

| Item No. | Observation | Recommended Action Plan | Recommended Timeline |
|---|---|---|---|
| 2 | Management of storage loads | Produce and actively manage a loading plan for all floor plates within the factory giving consideration to floor capacity and column capacity. | 6-weeks |
| 3 | Management of storage loads | Continue to implement load management plan | 6-months |

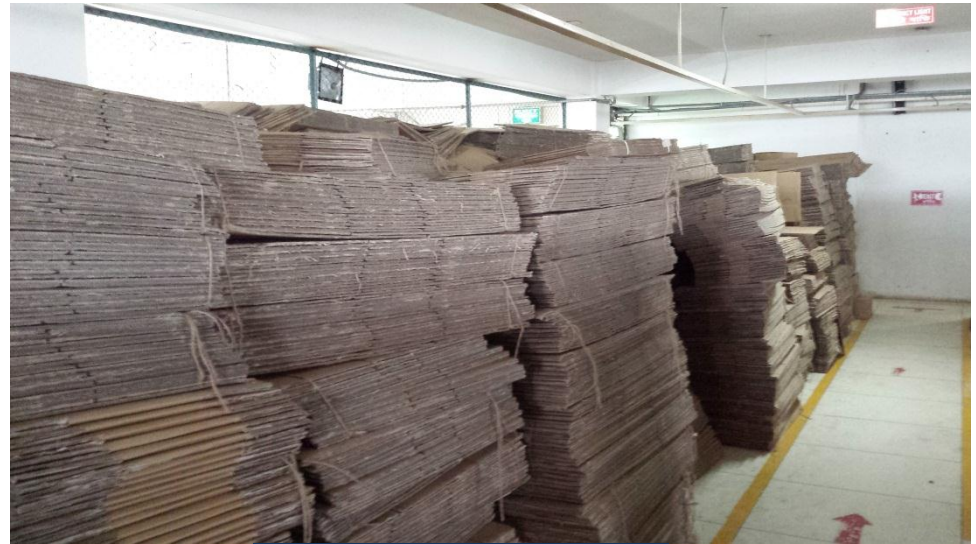
2<sup>nd</sup> floor storage area

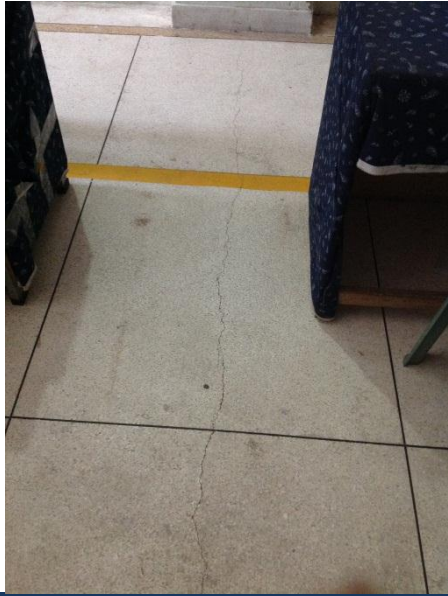
Cracking to ground floor slab

Building engineer to perform calculation to prove supporting beam (North-South) is adequately sized to take point load from supported beam (East-West)

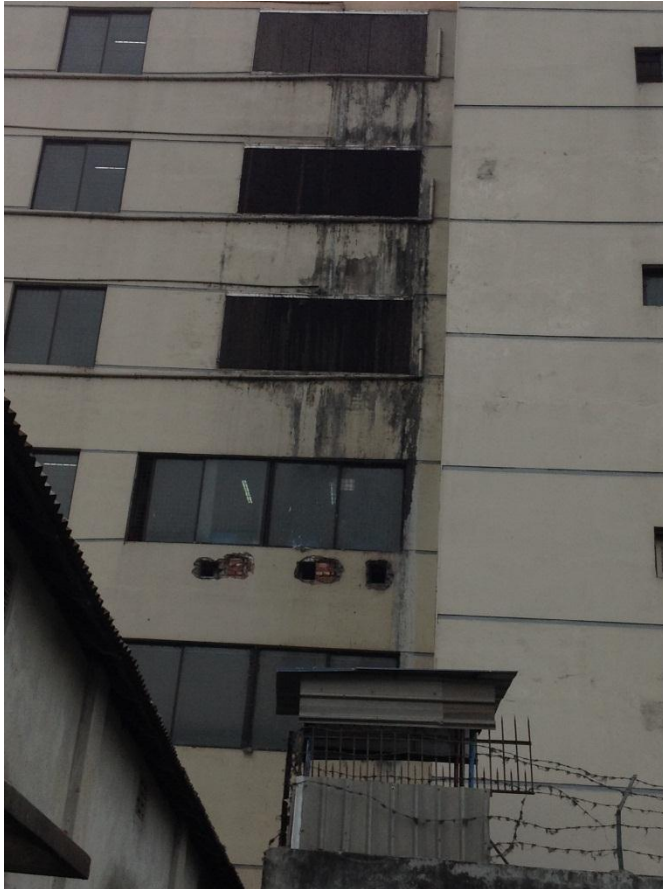
Water damage to façade on North Elevation

**Building engineer to monitor water ingress and take preventative measures if necessary**

| Item No. | Observation | Recommended Action Plan | Recommended Timeline |
|---|---|---|---|
| 6 | Water ingress | Building Engineer to review and prepare plan for remediation | 6-months |
| 7 | Water ingress | Remediation to be carried out | 6-months |

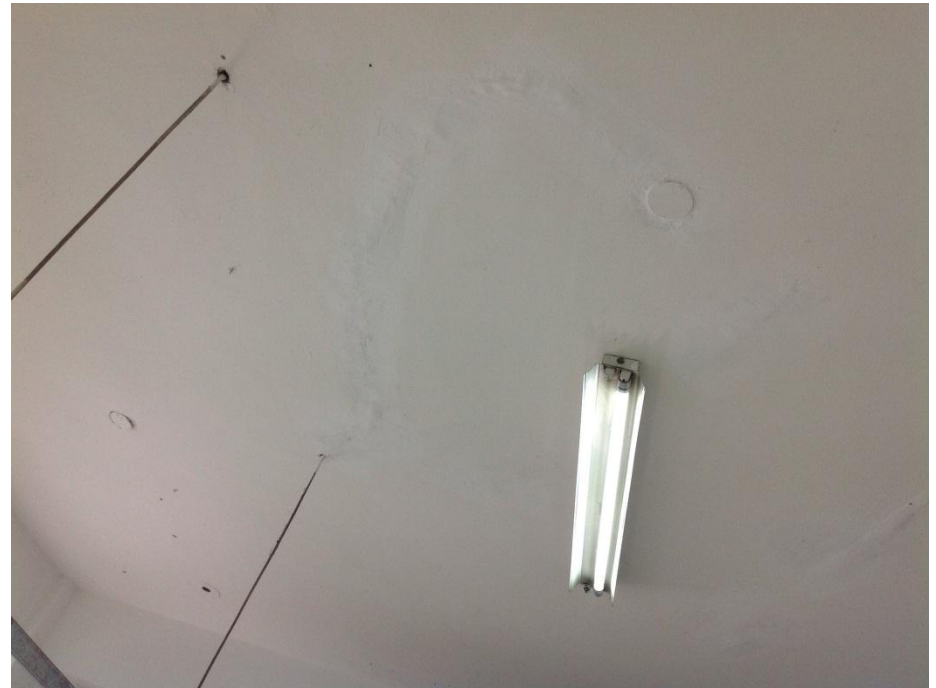
Water damage at soffit of roof slab

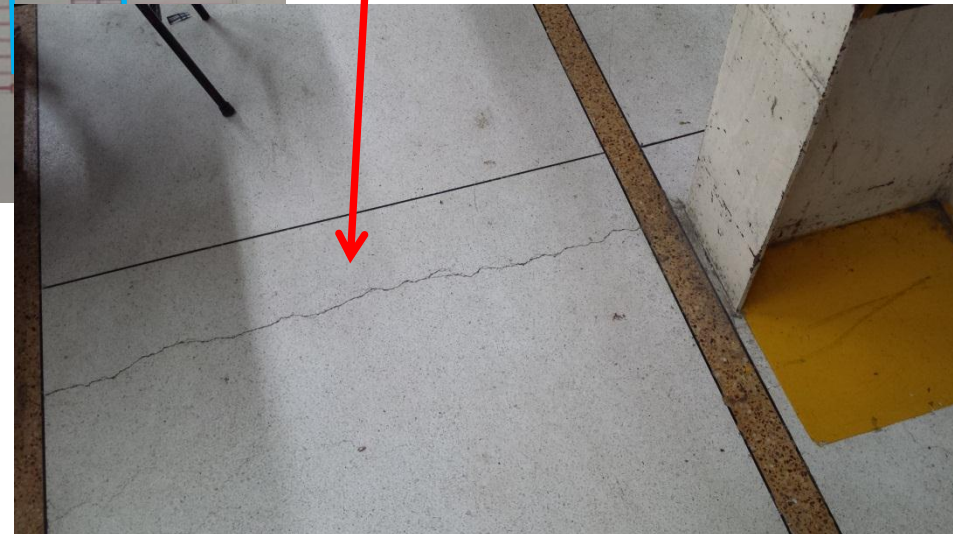
Cracks generally occur along line of primary beam (shown in blue), as slab is spanning east-west this does not constitute a problem.

Cracking concrete slab

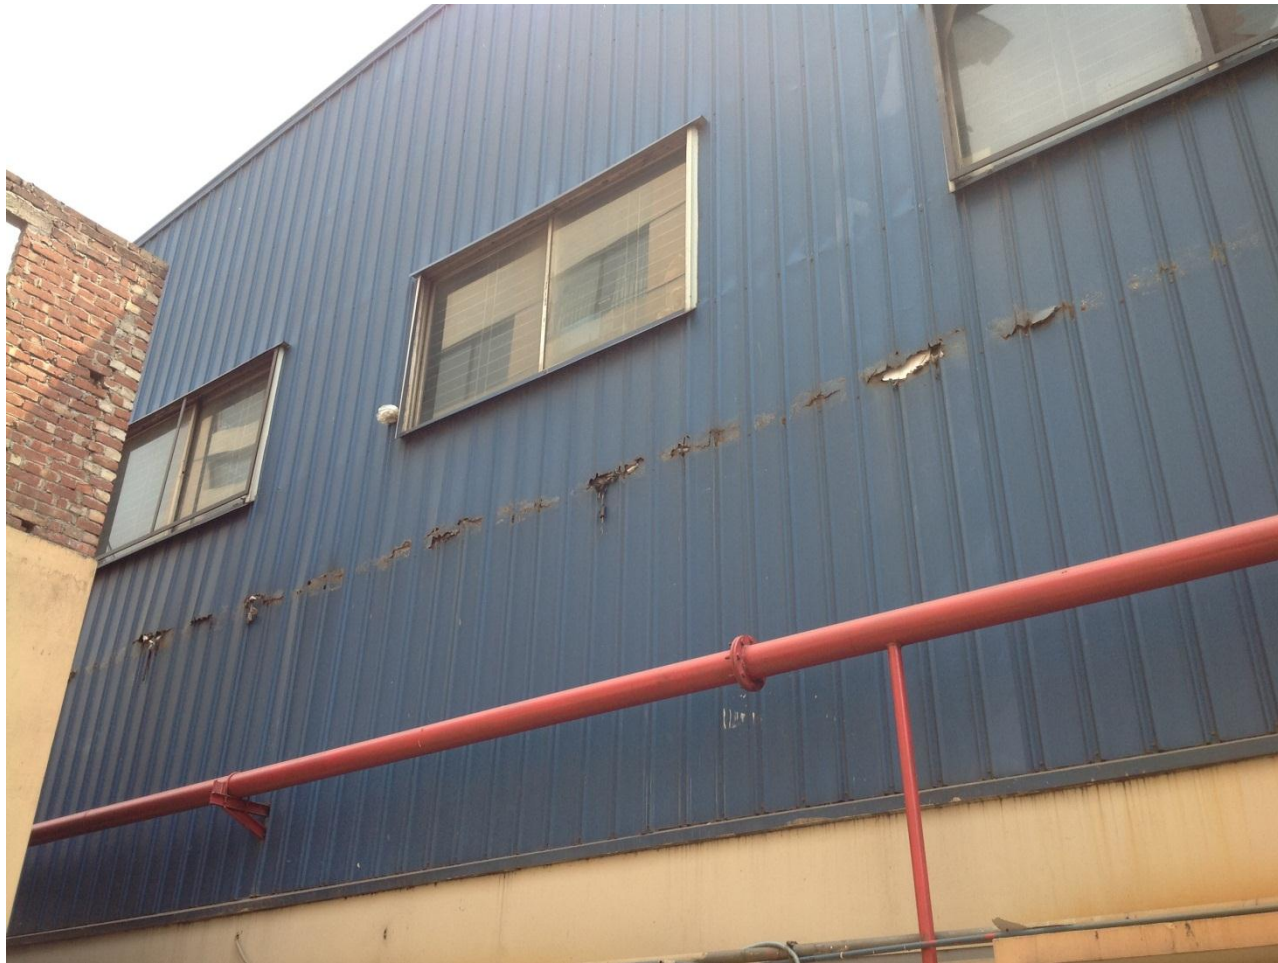
Damage to façade on the North Elevation

Façade should be repaired in order to ensure water does not permeate into building.

| Item No. | Observation | Recommended Action Plan | Recommended Timeline |
|---|---|---|---|
| 8 | Damage to façade of steel building | Damage to façade of steel building | 6-months |
