# **FIRE SAFETY INSPECTION REPORT**

## **MASTRADE**

**HELAL COMPLEX (4TH-6TH FLOOR), PLOT # 72  
BYPASS BISWA ROAD, MOGARTHAT, GAZIPUR**

June 18, 2014

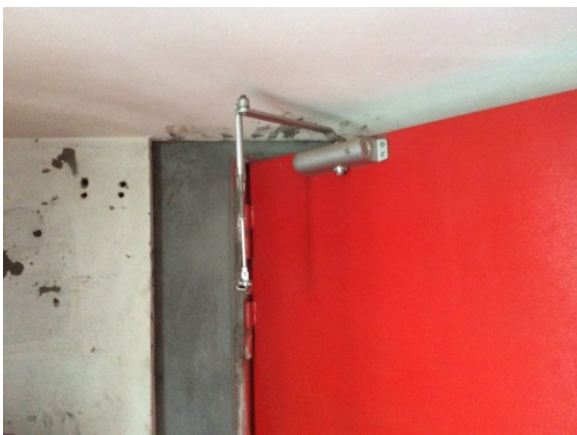
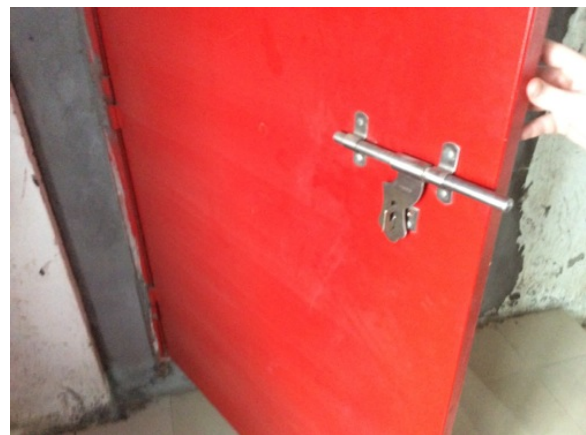
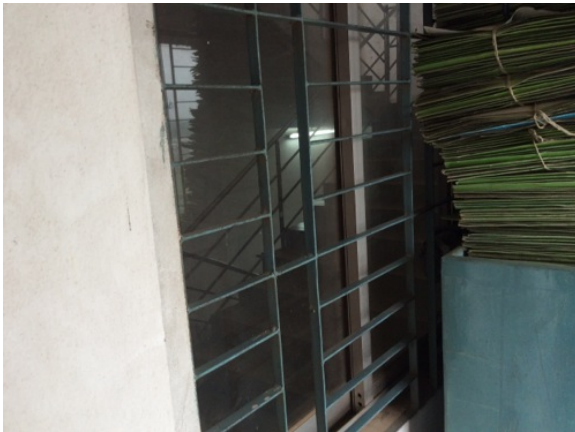
| No. | Category | Finding | Recommendation | Remediation Timeframe |
|---|---|---|---|---|
| F-1 | Fire Rated Construction | <p>The exit stairs are not separated from work areas on each floor by fire-rated construction. Swing doors provided do not have labels for listed assemblies, some doors do not have operable closers, and some have bolt locks.</p> <p>Location: At all floors.</p> | <p>Provide minimum 1.5-hr fire rated doors and seal all unprotected openings to separate the exit stairs from work areas and other building spaces on all floor levels. Ensure that the fire doors are self-closing and positive latching and that they are provided with fire exit (panic) hardware where serving production floors.</p> <p>If fire doors are required to be held open for functional reasons, provide automatic-closing devices tied to the fire alarm system.</p> | Within 3 months |

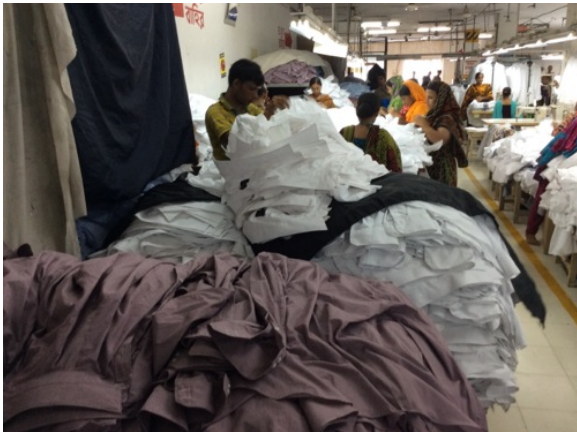
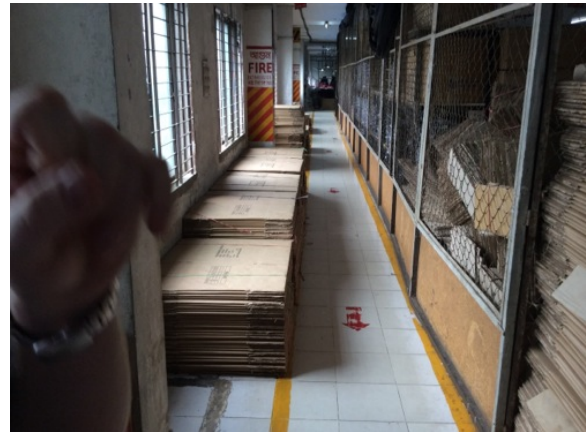
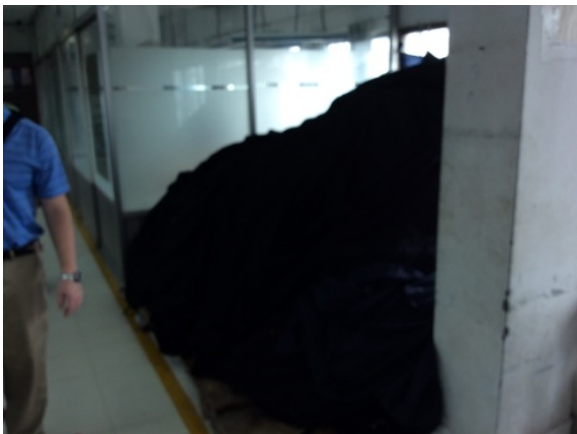
| F-2 | Fire Rated Construction | <p>Areas used for combustible storage are not separated by fire-rated construction.</p> <p>Location: All factory floors.</p> | <p>Provide dedicated storage rooms separated by minimum 1-hr fire-rated construction.</p> <p>Where separate storage rooms are not feasible, provide defined storage areas and limit the storage arrangement as follows:</p> <ul style="list-style-type: none"><li>- Maximum height of 2.4m and maximum area of 23m<sup>2</sup></li><li>- If sprinkler protected: maximum height of 3.66m and maximum area of 93m<sup>2</sup></li></ul> <p>Separate areas of unenclosed combustible storage by a minimum clear distance of 3m.</p> | Within 3 months |

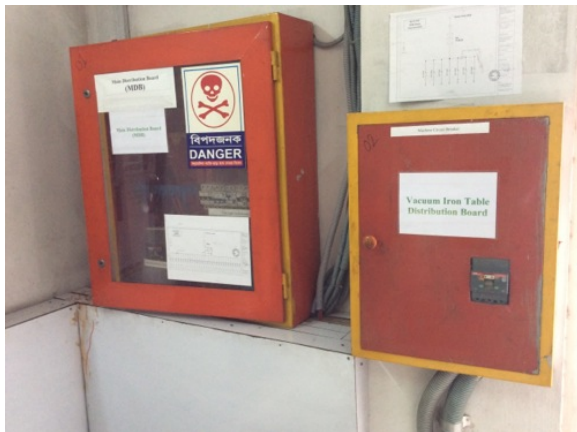
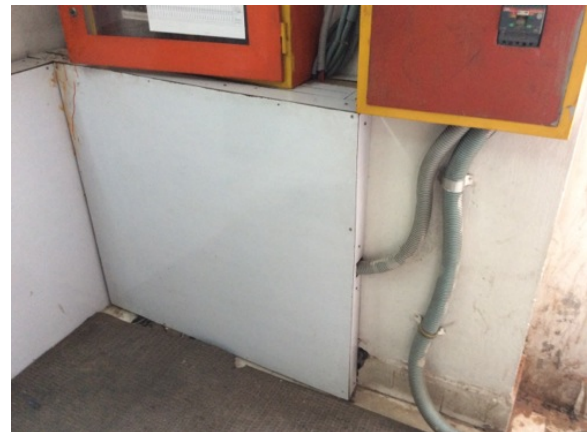
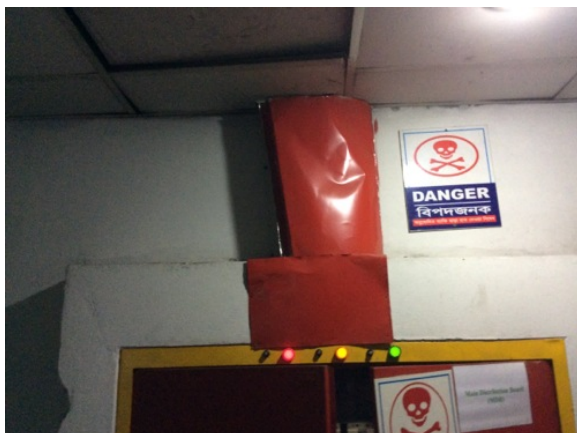
| F-3 | Fire Rated Construction | Unsealed penetrations and openings are located in the fire-rated floor/ceiling assemblies.<br><br>Location: Equipment cables penetrating floor in 4th floor IPS room. | Provide a minimum 2-hr fire-rated shaft to separate the utility risers from each floor level. | Within 3 months |

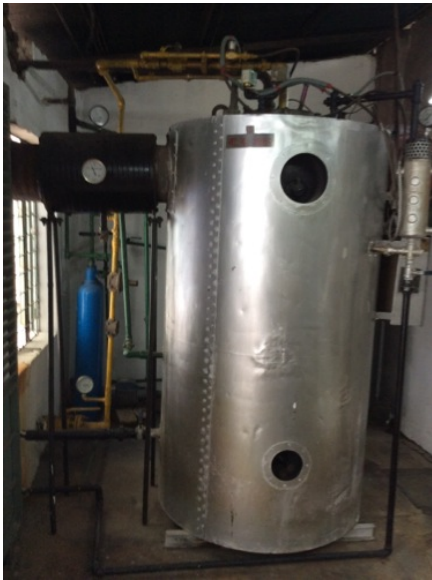
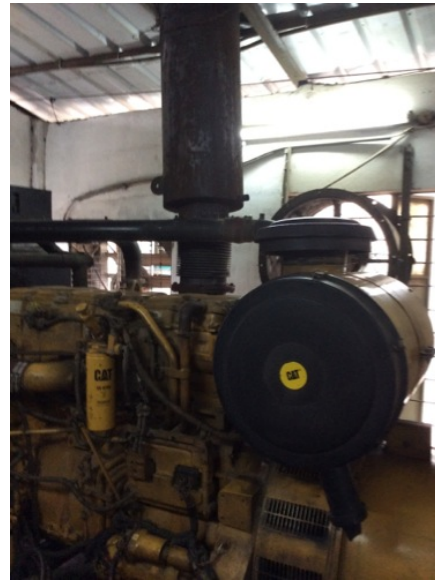
| F-4 | Fire Rated Construction | <p>The boiler, generator, transformer rooms are not separated by fire-rated construction openings and non-rated.</p> <p>Location: Along the northwest exit stair discharge along the west side of the main building.</p> | <p>Separate the boiler, generator, and transformer rooms by a minimum 2-hr fire-rated construction. Seal and/or protected all openings to maintain the required fire separations</p> | <p>Within 3 months</p> |

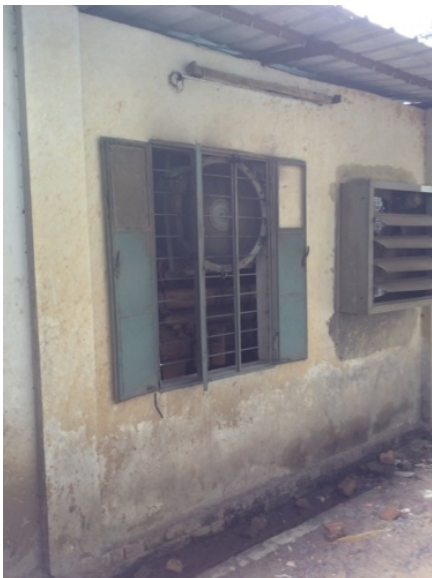
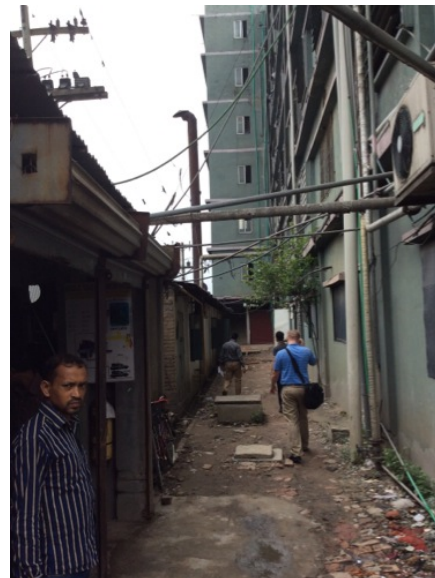
| F-5 | Fire Rated Construction | The exit discharge path serving the northwest stair discharge exits past unprotected openings in the generator, transformer, and boiler building interior. | Seal all penetrations and openings to the interior of the building along the discharge path, up to a height of 10 ft., to provide a minimum 1-hr fire separation. | Within 6 months |

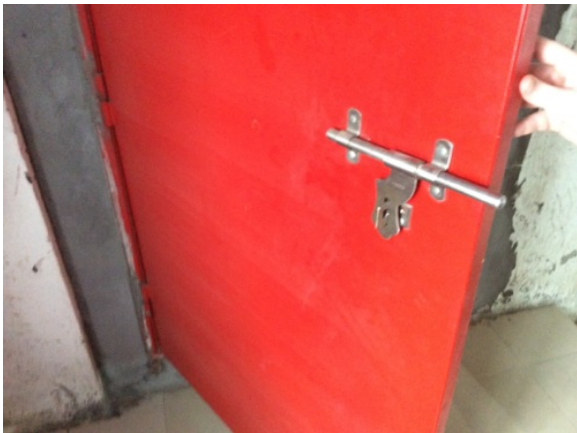
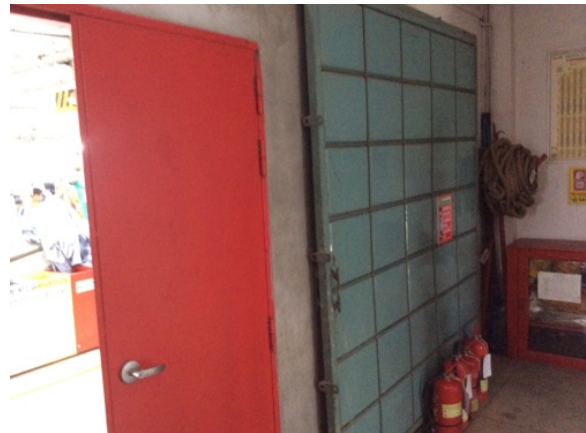
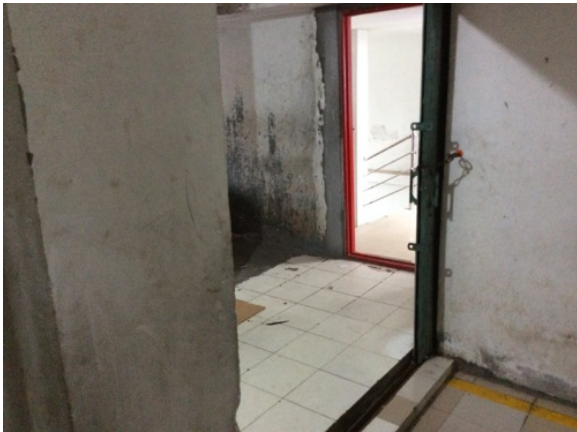
| F-6 | Egress | <p>Egress doors / gates with locking features are provided at exit stairs and along egress routes.</p> <p>There were locking sliding gates, locking sliding doors, and bolts on swinging doors.</p> <p>There was a cage and door in the stairs at the mid landing below the 4th floor. All gates and doors were open and unlocked during the inspection.</p> <p>Location: At all factory floors.</p> | <p>Remove locking features from all egress doors and gates.</p> <p>If locks are required for security reasons, utilize special door locking features complying with NFPA 101.</p> | Immediate |

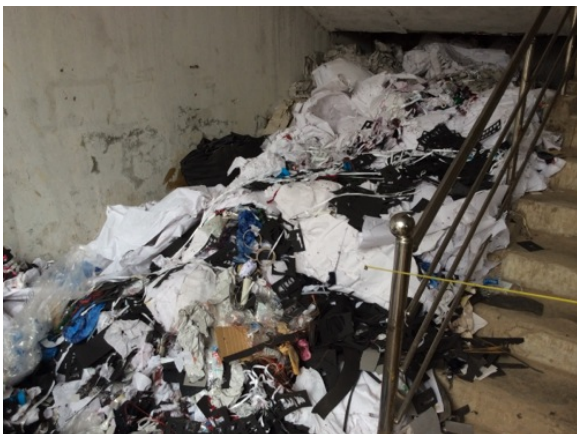
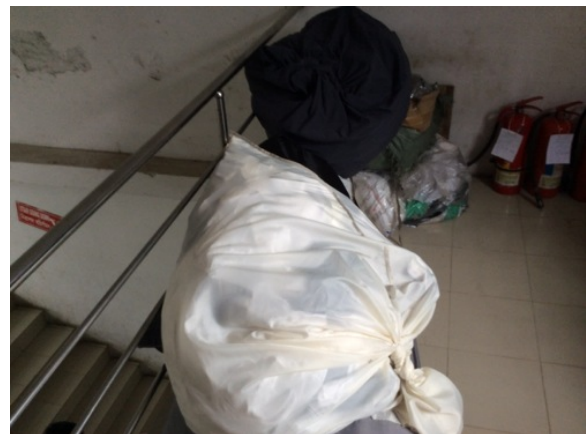
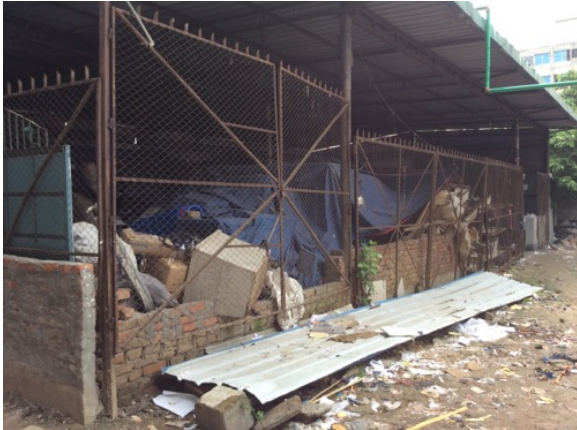
| F-7 | Egress | Storage was located in the exit stair. | Remove all storage from exit stairs and egress paths. | Immediate |
| | | Location: Storage in northwest and northeast stair on 6th floor. Storage under southeast stair at ground floor. Storage in northeast stair at ground floor and in adjacent non-factory building without separation. | | |

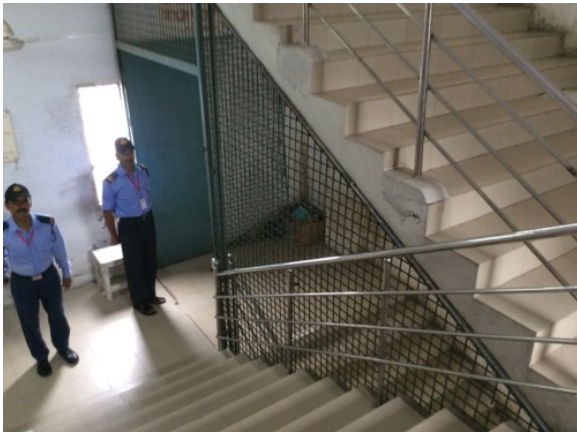
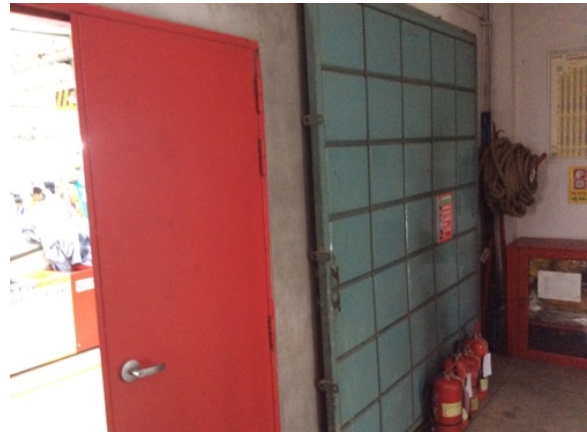
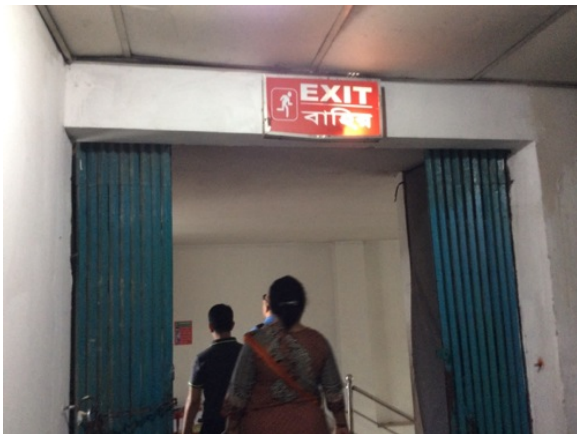
| F-8 | Egress | Collapsible gates / sliding doors are provided at exit stairs and along egress routes | Replace all gates / sliding doors along the means of egress with side-hinged, swinging egress doors. | Within 1 month |
| | | There were sliding gates and sliding doors that slide over swinging doors at exit stairs. There was a cage and door located in the stairs at the mid landing below the 4th floor. | If locks are required for security reasons, utilize special door locking features complying with NFPA 101. | |
| | | Location: At all factory floors. | | |

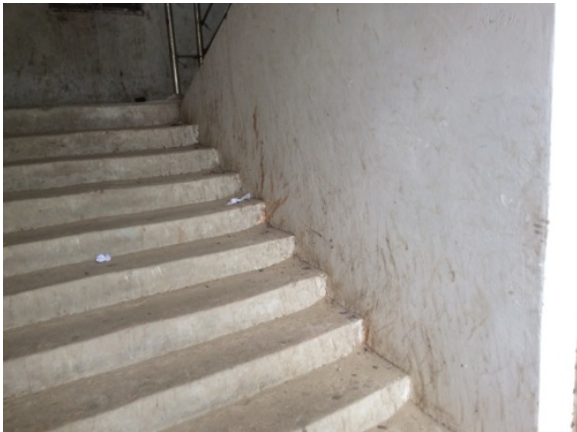
F-9

Handrails are not provided in the exit stair.

Location: At the ground level of the northwest stair.

Provide handrails on at least one side of exit stair.

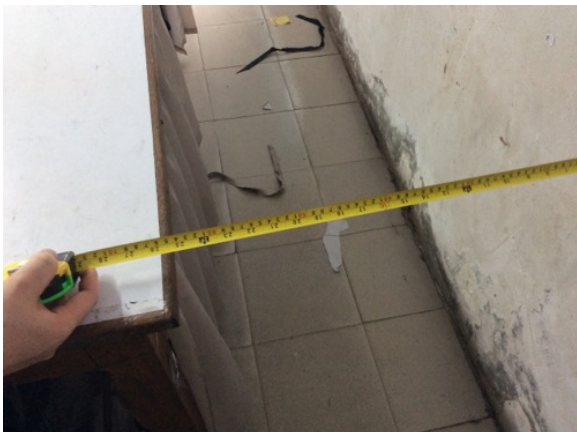
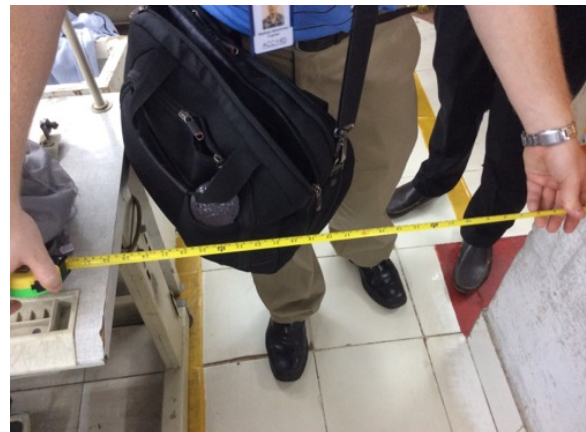
| F-10 | Egress | The width of egress aisles is less than 36-in. | Provide minimum aisle widths of 36-in. | Within 3 months |
| | | Two aisles on 5th and 6th floor factory floors were less than required width. | | |

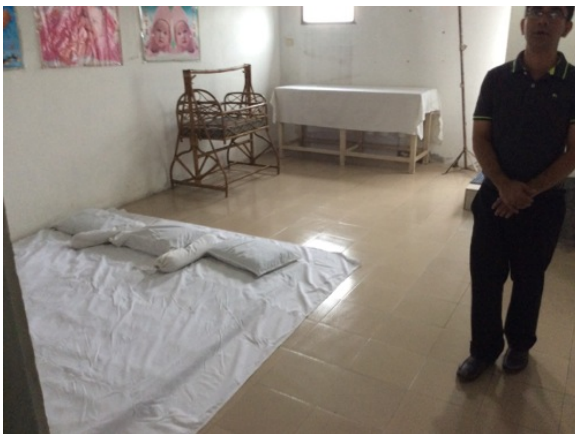
| F-11 | Egress | <p>The day-care room does not have direct access to an exit stair.</p> <p>Day-care is located along the west wall of the 6th floor and is not adjacent to the northwest stair (closest stair).</p> | <p>Provide a minimum 2-hr fire-rated exit corridor between the day-care room and exit stair.</p> <p>or</p> <p>Relocate day-care room to ground floor with maximum travel distance of 9m (30 ft).</p> | Within 3 months |

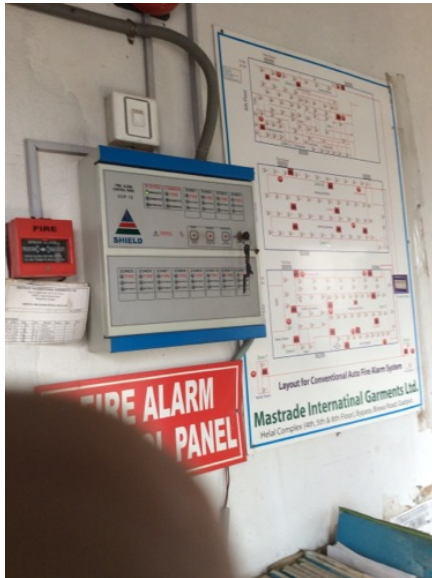
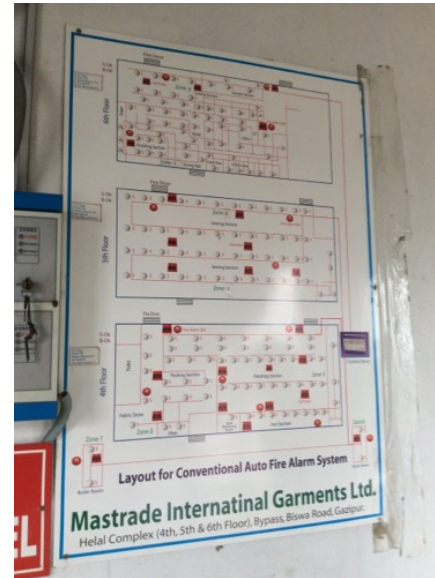
| F-12 | Fire Protection | <p>The fire alarm system is antiquated, not a listed system, and does not provide alarm and notification features consistent with acceptable standards.</p> | <p>Replace the fire alarm system with a new, listed addressable fire alarm system in accordance with NFPA 72.</p> | <p>Design within 4 months, install within 9 months</p> |

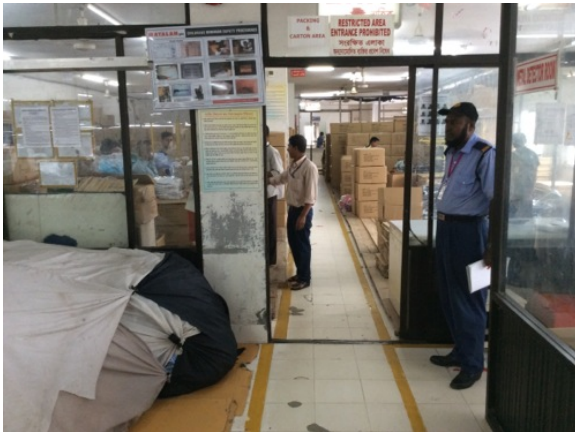
| F-14 | Egress Lighting | <p>Exit sign provided is improper signage.</p> <p>Exit sign directs occupants into storage cage instead of around it to the northeast stair on the 4th floor.</p> | <p>Provide exit signs correctly to direct occupants to the exit stair, not through the storage cage.</p> | <p>Within 1 month</p> |

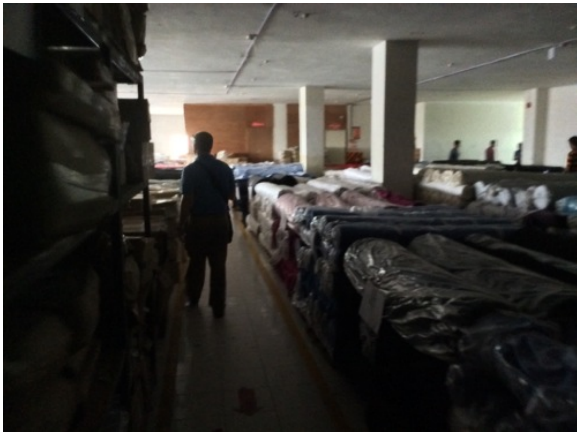
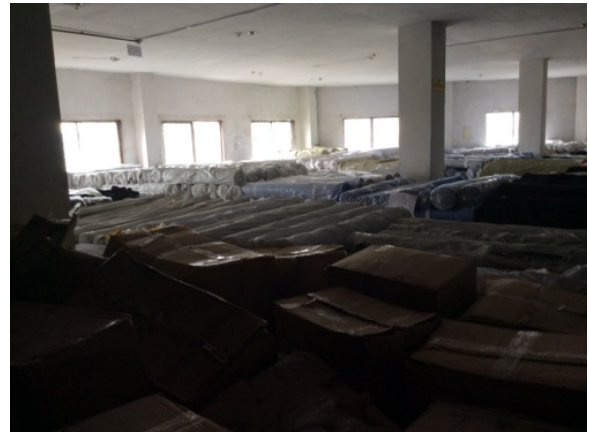
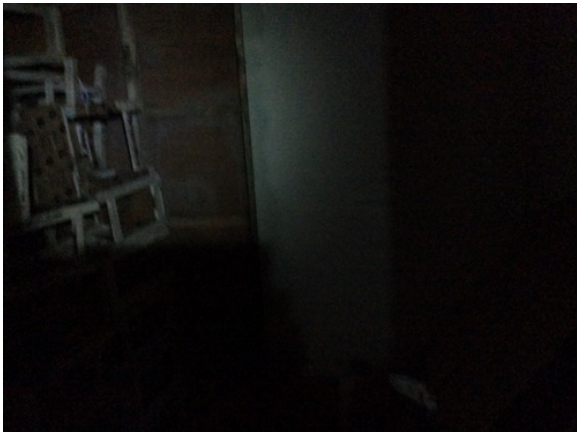
| F-16 | Egress Lighting | Based on the number and location of emergency lights observed, adequate illumination levels are not anticipated along egress routes.<br><br>Warehouse on 4th floor does not have any lighting fixtures. | Test the emergency lighting system on each floor and provide additional emergency fixtures to provide adequate illumination along the means of egress. Provide a minimum illumination of 10 lux at the floor level within exit stairs and exit discharge paths and minimum 2.5 lux along exit access aisles. | Within 3 months |
