# **FIRE SAFETY INSPECTION REPORT**

**Factory Name: AGAMI FASHION LTD.**

**Date: 27 July, 2016**

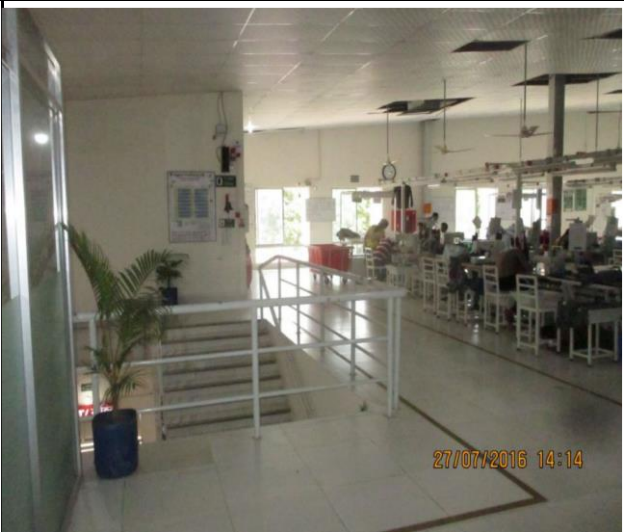
| SI No. | Category | Findings | Required Action | Remediation Time Frame | Pictorial Evidence |
|---|---|---|---|---|---|
| 1 | Fire Rated Construction | The exit stairs are not separated from [work areas, other spaces] on each floor by fire-rated construction. | Stair shall be enclosed with a minimum 1-hr fire-rated construction. Seal all unprotected openings and provide minimum 1-hr fire rated doors to separate the exit stairs from work areas and other building spaces on all floor levels. Ensure that the fire doors are self-closing, positive latching and that they are provided with fire exit (panic) hardware where serving production floors. If fire doors are required to be held open for functional reasons, provide automatic-closing devices tied to the fire alarm system. | Within 3 Months | |

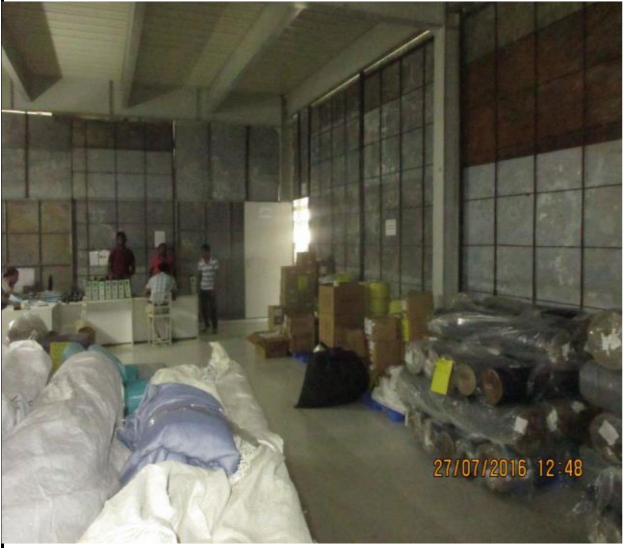
| Sl No. | Category | Findings | Required Action | Remediation Time Frame | Pictorial Evidence |
|---|---|---|---|---|---|
| 2 | Fire Rated Construction | Rooms used for storage of combustible materials are not separated from the surrounding occupancy/areas.<br>Location: Ground floor | Rooms used for storage of combustible materials shall be separated from the surrounding occupancy with a minimum 1 hour construction. | Within 3 Months | |

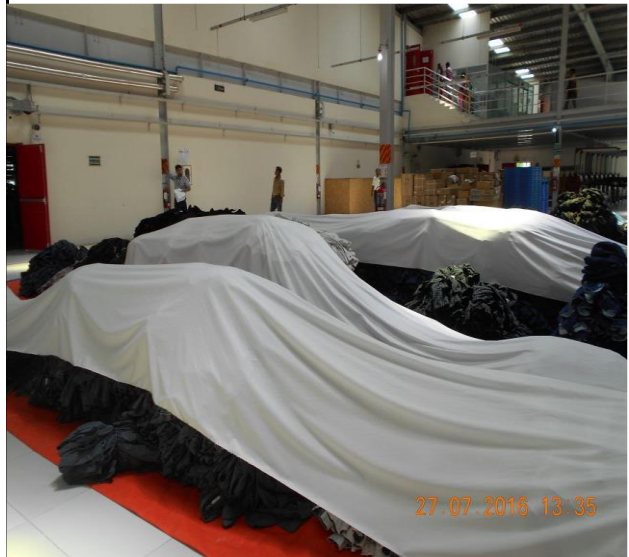
| Sl No. | Category | Findings | Required Action | Remediation Time Frame | Pictorial Evidence |
|---|---|---|---|---|---|
| 3 | Fire Rated Construction | Areas used for in-process storage of combustible materials are open to the surrounding occupancy | <p>Provide defined storage areas and limit the storage arrangement as follows:-</p> <p>1. General Condition:<br/>Maximum height of 2.4m and maximum area of 23m<sup>2</sup>.<br/>Separate areas of unenclosed combustible storage by a minimum clear distance of 3m.</p> <p>2. If sprinkler protected:<br/>maximum height of 3.66m and maximum area of 93m<sup>2</sup>.<br/>Separate areas of unenclosed combustible storage by a minimum clear distance of 3m.</p> <p>or</p> <p>3. Enclose the storage area from the surrounding occupancy with a minimum 1 hour construction.</p> | Within 3 Months | |

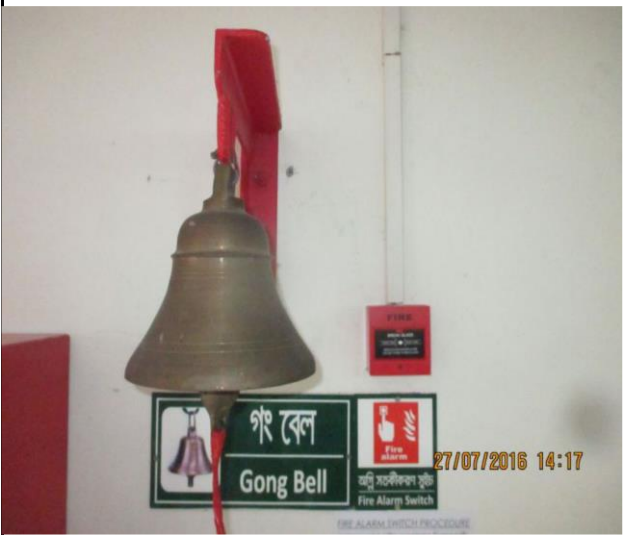
| Sl No. | Category | Findings | Required Action | Remediation Time Frame | Pictorial Evidence |
|---|---|---|---|---|---|
| 6 | Fire Alarm & Detection System | The existing fire alarm system is not a listed system and does not provide automatic alarm and notification features consistent with acceptable standards. | Replace the fire alarm system with a new, listed addressable fire alarm system in accordance with NFPA 72. | Design within 04 Months & installation within 09 Months | |

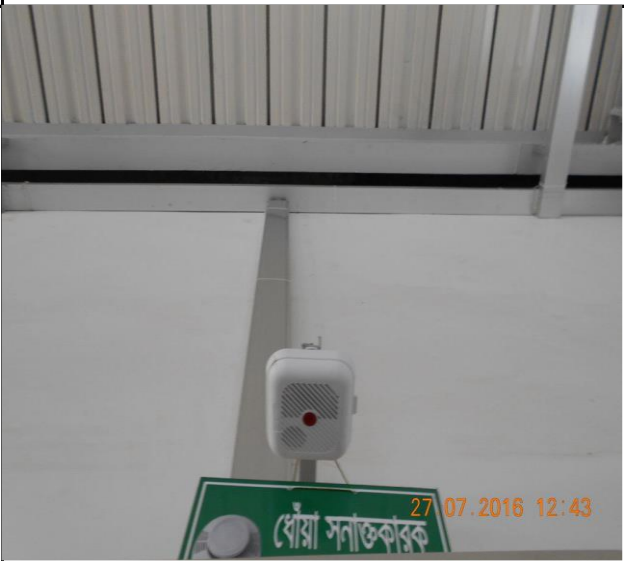
| Sl No. | Category | Findings | Required Action | Remediation Time Frame | Pictorial Evidence |
|---|---|---|---|---|---|
| 7 | Fire Alarm & Detection System | The building is equipped with single-station smoke alarms. Smoke alarm activation sounds only a local alarm and does not provide automatic fire alarm notification of occupants. | Remove single-station smoke alarms. Provide automatic smoke detection throughout the building, tied into the fire alarm system, in accordance with NFPA 72. | Within 6 Months | |
