# FIRE SAFETY INSPECTION REPORT

## K A Design Ltd.

ADDRESS: Baro Beraid, Badda, Dhaka  
23.795209, 90.468086

Inspected By: Md. Rakibul Alam & Kazi Raian Mahmood  
Date: 03 August 2016

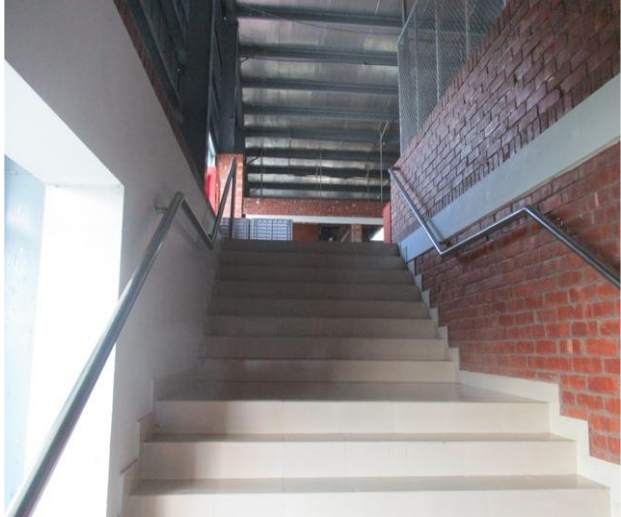
| SI No. | Category | Findings | Required Action | Remediation Time Frame | Pictorial Evidence |
|---|---|---|---|---|---|
| 1 | Fire Rated Construction | The exit stairs are not separated from work areas, other spaces on each floor by fire rated construction. | <p>Provide minimum 1.5-hr fire rated doors and seal all unprotected openings to separate the exit stairs from work areas and other building spaces on all floor levels. Ensure that the fire rated doors are self-closing and positive latching and that they are provided with fire exit (panic) hardware where serving production floors.</p> <p>If fire rated doors are required to be held open for functional reasons, provide automatic closing devices tied to the fire alarm system.</p> | Within 3 months | |

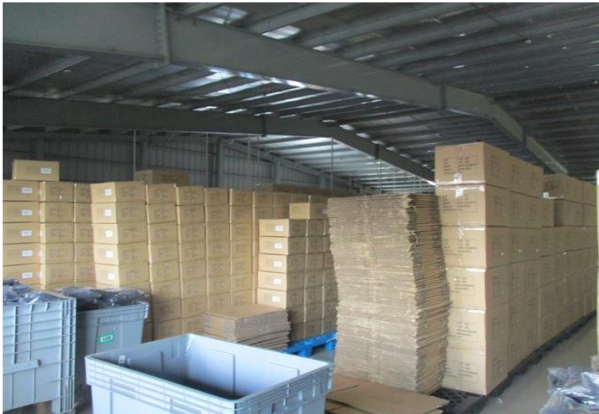
| Sl No. | Category | Findings | Required Action | Remediation Time Frame | Pictorial Evidence |
|---|---|---|---|---|---|
| 2 | Fire Rated Construction | Areas used for in-process storage (Temporary Goods) of combustible materials are open to the surrounding occupancy. Location: Mezzanine of Production Shed | Provide defined storage areas and limit the storage arrangement as:<br>Maximum height of 2.4m and maximum area of 23m <sup>2</sup> . Separate areas of unenclosed combustible storage by a minimum clear distance of 3m | Within 3 months | |

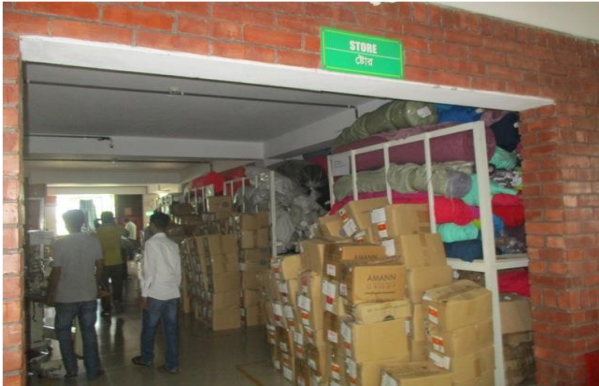
| Sl No. | Category | Findings | Required Action | Remediation Time Frame | Pictorial Evidence |
|---|---|---|---|---|---|
| 3 | Fire Rated Construction | Rooms used for storage of combustible materials is not separated from the surrounding occupancy. | Rooms used for storage of combustible materials shall be separated from the surrounding occupancy with a minimum 1 hour construction. | Within 3 months | |

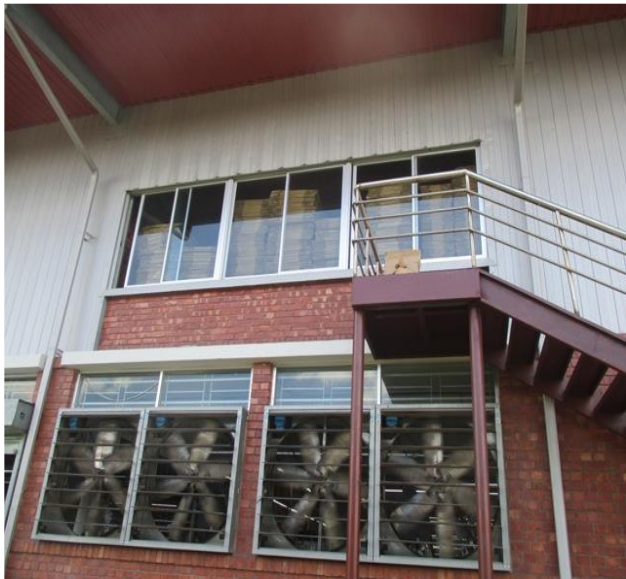
| Sl No. | Category | Findings | Required Action | Remediation Time Frame | Pictorial Evidence |
|---|---|---|---|---|---|
| 4 | Fire Rated Construction | The exterior exit stair is not separated from the building.<br>Location: Mezzanine floor Stair 2 of Production Shed | Exterior exit stairs shall be separated from the building with a rating requirement of 1 hr fire rating. The rating of the exterior wall shall extend 3.05 m (10 ft) beyond the ends of the stair structure. | Within 3 months | |

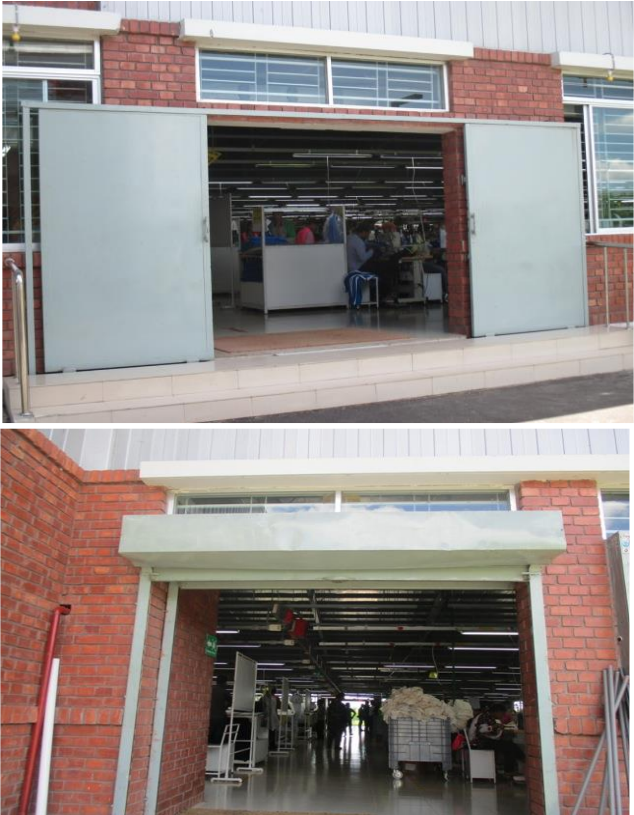
| Sl No. | Category | Findings | Required Action | Remediation Time Frame | Pictorial Evidence |
|---|---|---|---|---|---|
| 5 | Egress | Roll down shutter & sliding type doors have been provided along means of egress (building exits, along egress routes, exit discharge). | <p>Replace all rolling shutter/ collapsible/ sliding type doors &amp; gates by the side-hinged swinging type doors.</p> <p>If locks are required for security reasons, utilize special door locking features complying with NFPA 101.</p> | Within 1 month | |

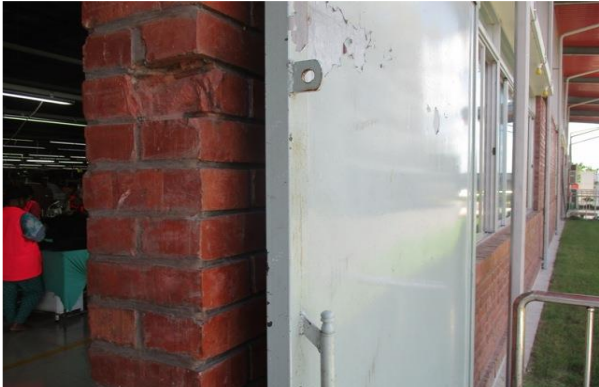
| Sl No. | Category | Findings | Required Action | Remediation Time Frame | Pictorial Evidence |
|---|---|---|---|---|---|
| 6 | Egress | Doors along means of egress are provided with non compliant locking system | <p>Remove all non compliant locking features from egress doors.</p> <p>If locks are required for security reasons, utilize special door locking features complying with NFPA 101.</p> | Immediate | |

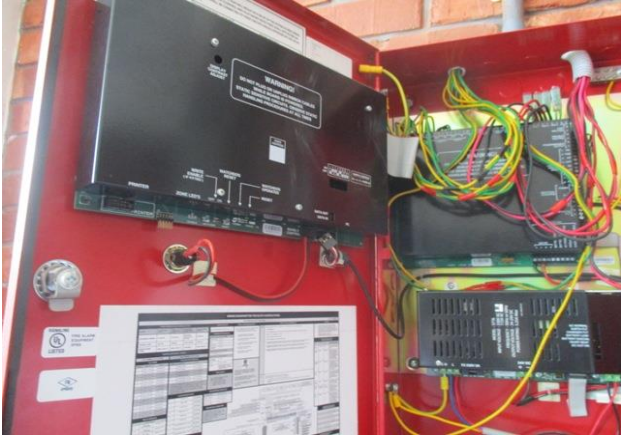
| Sl No. | Category | Findings | Required Action | Remediation Time Frame | Pictorial Evidence |
|---|---|---|---|---|---|
| 7 | Fire Protection | The existing fire alarm system is a listed system but does not provide automatic alarm and notification features consistent with acceptable standards and does not have as built drawing. | Submit as-built drawing, testing record, equipment certification and other relevant documents to the ACCORD for review and modify the system as per reviewed design in accordance with NFPA 72 (if applicable). | Design Submission 1 month and Modification within 6 months. | |

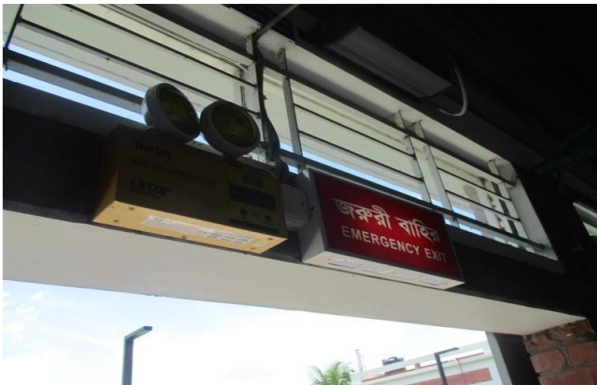
| Sl No. | Category | Findings | Required Action | Remediation Time Frame | Pictorial Evidence |
|---|---|---|---|---|---|
| 11 | Egress Lighting | Manual on-off switch is provided for both emergency lighting & exit signage units. | Remove manual on/off switches from emergency lighting & exit signage units to prevent them from being switched off. | Within 3 months | |

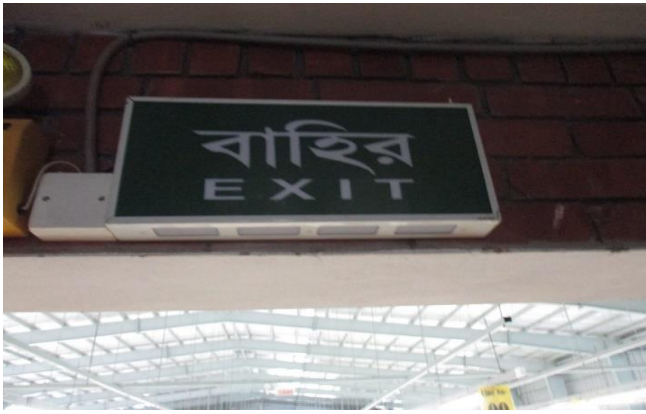
| Sl No. | Category | Findings | Required Action | Remediation Time Frame | Pictorial Evidence |
|---|---|---|---|---|---|
| 12 | Egress Lighting | Exit signage not illuminated (burned out, broken, etc.). | Regularly inspect all exit signage and replace/install lights as needed to illuminate signs. The source of illumination shall provide not less than 50 lux at the illuminated surface with a contrast of not less than 0.5. Approved self luminous signs which provide evenly illuminated letters having a minimum luminance of 0.2 cd/m2 may also be used. | Within 1 month | |

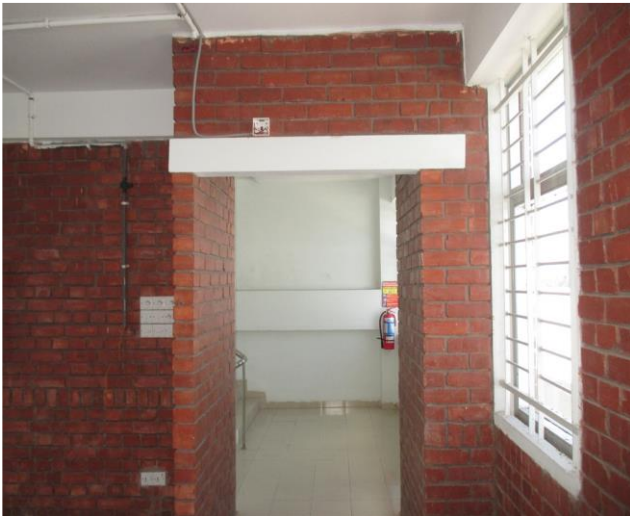
| SI No. | Category | Findings | Required Action | Remediation Time Frame | Pictorial Evidence |
|---|---|---|---|---|---|
| 1 | Fire Rated Construction | The exit stairs are not separated from other occupancies on each floor by fire rated construction. | Provide minimum 1.5-hr fire rated doors and seal all unprotected openings to separate the exit stairs from work areas and other building spaces on all floor levels. Ensure that the fire rated doors are self-closing and positive latching and that they are provided with fire exit (panic) hardware where serving production floors.<br>If fire rated doors are required to be held open for functional reasons, provide automatic closing devices tied to the fire alarm system. | Within 3 months | |

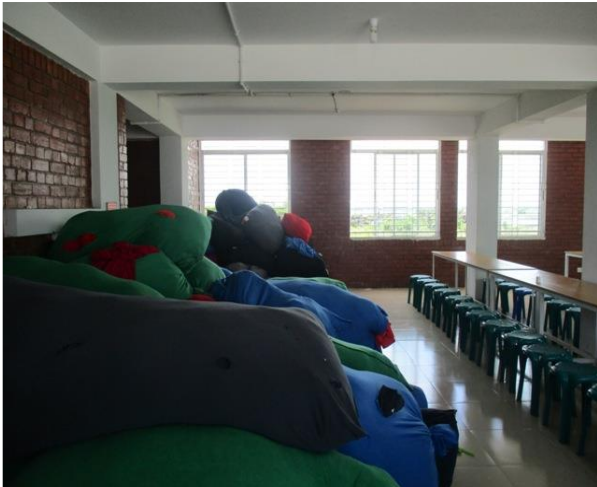
| Sl No. | Category | Findings | Required Action | Remediation Time Frame | Pictorial Evidence |
|---|---|---|---|---|---|
| 2 | Fire Rated Construction | Storage was located at the dining area. Location: 1st, 2nd & 3rd Floors. | Remove all storage from the dining room/area.<br>Or<br>Provide 1- hr separated defined storage room. | Immediate | |

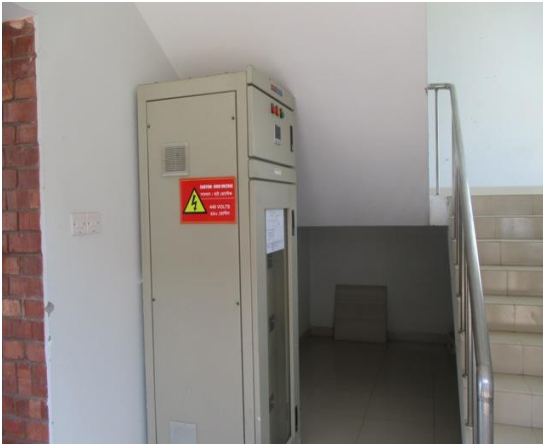
| Sl No. | Category | Findings | Required Action | Remediation Time Frame | Pictorial Evidence |
|---|---|---|---|---|---|
| 3 | Egress | Electrical DB was located in the exit stair. Location: Ground Floor, South Exit stair. | Remove all storage from exit stairs. | Immediate | |

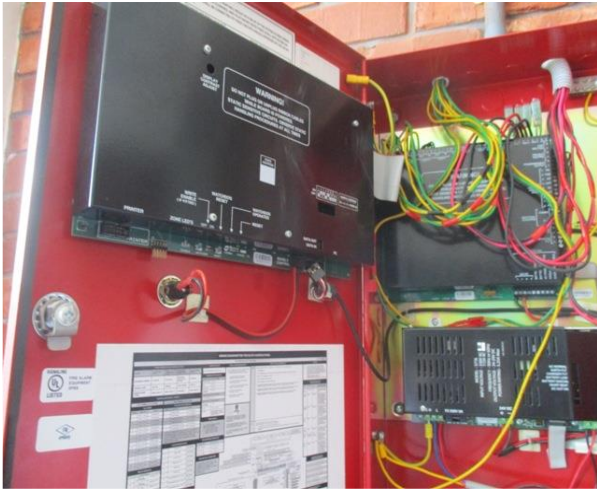
| SI No. | Category | Findings | Required Action | Remediation Time Frame | Pictorial Evidence |
|---|---|---|---|---|---|
| 4 | Fire Protection | The existing fire alarm system is a listed system but does not provide automatic alarm and notification features consisted with acceptable standards and does not have as built drawing. | Submit as-built drawing, testing record, equipment certification and other relevant documents to the ACCORD for review and modify the system as per reviewed design in accordance with NFPA 72 (if applicable). | Design Submission 1 month and Modification within 6 months. | |

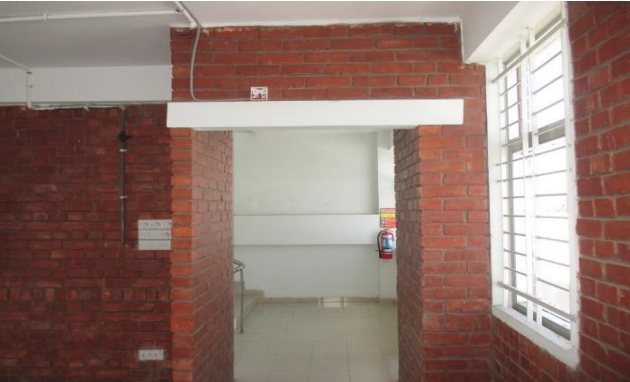
| Sl No. | Category | Findings | Required Action | Remediation Time Frame | Pictorial Evidence |
|---|---|---|---|---|---|
| 7 | Egress Lighting | Exit sign not provided at exits. | Lighted exit signs shall be placed at entrance to an exit. Additional exit signs shall be placed throughout the facility anywhere the continuation of the egress is not obvious.<br>Lighted exit signs shall be provided with either battery backup or uninterruptable power supply systems and shall be continuously illuminated. | Within 1 month | |

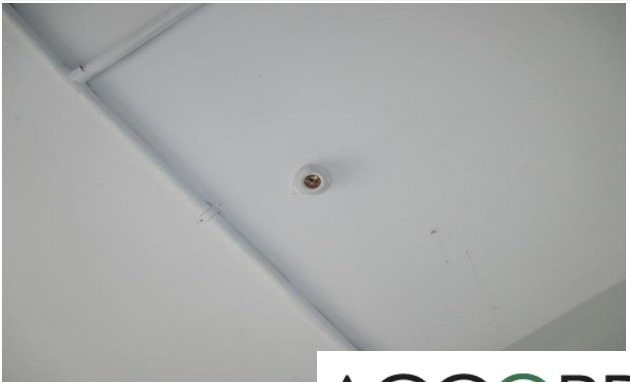
| Sl No. | Category | Findings | Required Action | Remediation Time Frame | Pictorial Evidence |
|---|---|---|---|---|---|
| 8 | Egress Lighting | Emergency lights not illuminated during testing (burned out, broken, etc.).<br>Location: Throughout the building. | Regularly inspect all emergency lighting system as per Accord standard and replace/install lights as needed to illuminate signs. | Within 1 month | |
