FIRE SAFETY INSPECTION REPORT

Factory Name: MAAA Apparels Limited

ADDRESS: Plot # 1187, 1214-15, Gacha Maddhapara, Gazipur Sadar, Gazipur, Bangladesh

Date: 30th August 2016

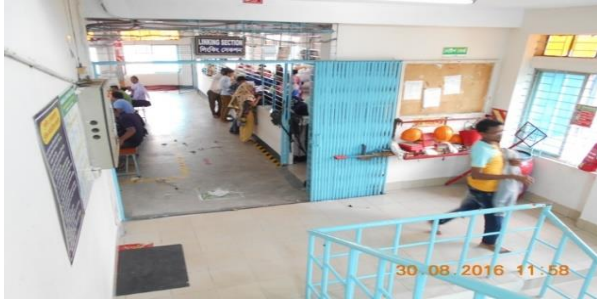
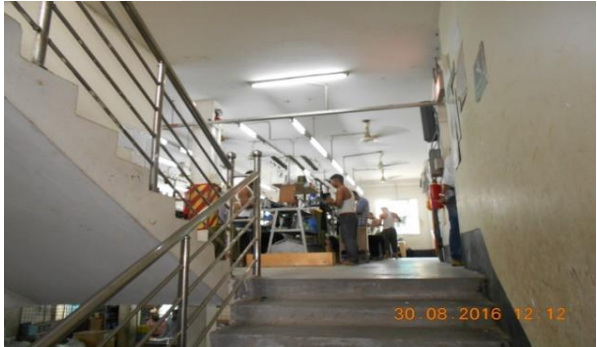
SI No.	Category	Findings	Required Action	Remediation Time Frame	Pictorial Evidence
1	Fire Rated Construction	The exterior exit stair is not separated from the building. Location: Building 1, Building 2 .	Provide minimum 1.5-hr fire rated doors and seal all unprotected openings to separate the exit stairs from work areas and other building spaces on all floor levels. Ensure that the fire doors are self-closing and positive latching and that they are provided with fire exit (panic) hardware where serving production floors. If fire doors are required to be held open for functional reasons, provide automatic closing devices tied to the fire alarm system.	Within 3 months

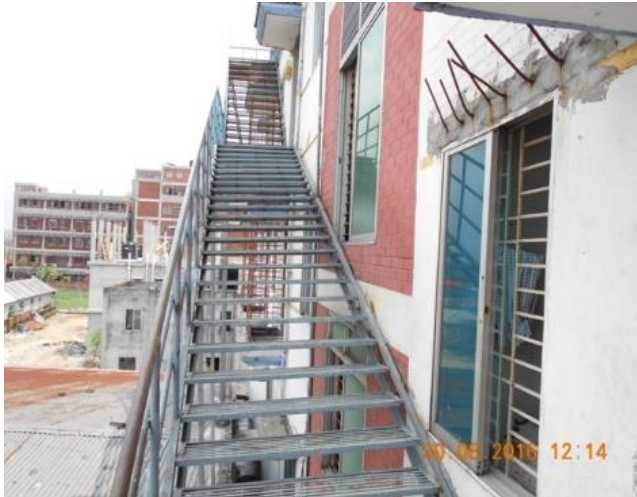
SI No.	Category	Findings	Required Action	Remediation Time Frame	Pictorial Evidence
2	Fire Rated Construction	The exterior exit stair is not separated from the building. Location: Building 2.	<p>Exterior exit stairs shall be separated by minimum 2-hr fire-rated construction and The rating of the exterior wall shall extend 3.05 m (10 ft.) beyond the ends of the stair structure. Provide minimum 1.5-hr fire rated doors to separate the exit stairs from work areas and other building spaces on all floor levels. Ensure that the fire doors are self-closing, positive latching and that they are provided with fire exit (panic) hardware where serving production floors.</p> <p>If fire doors are required to be held open for functional reasons, provide automatic-closing devices tied to the fire alarm system.</p>	Within 3 months

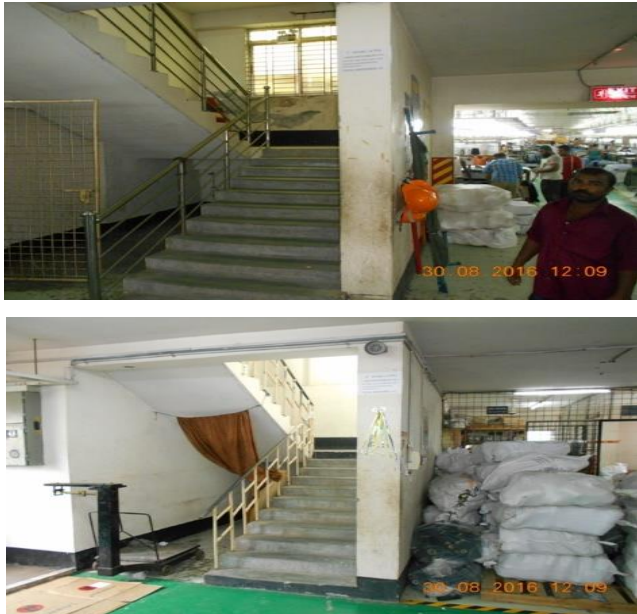
SI No.	Category	Findings	Required Action	Remediation Time Frame	Pictorial Evidence
3	Fire Rated Construction	Exit stair(s) is discharge the occupants inside the building. Location: Both exits of Building 2 (Ground floor).	1. Modify stair to discharge directly outside. Or 2. Provide 2-hr fire-rated exit passageway leading directly outside (vestibules to separate any storage areas). Or 3. Provide sprinkler protection for discharge floor in accordance with NFPA 13.	Within 3 months

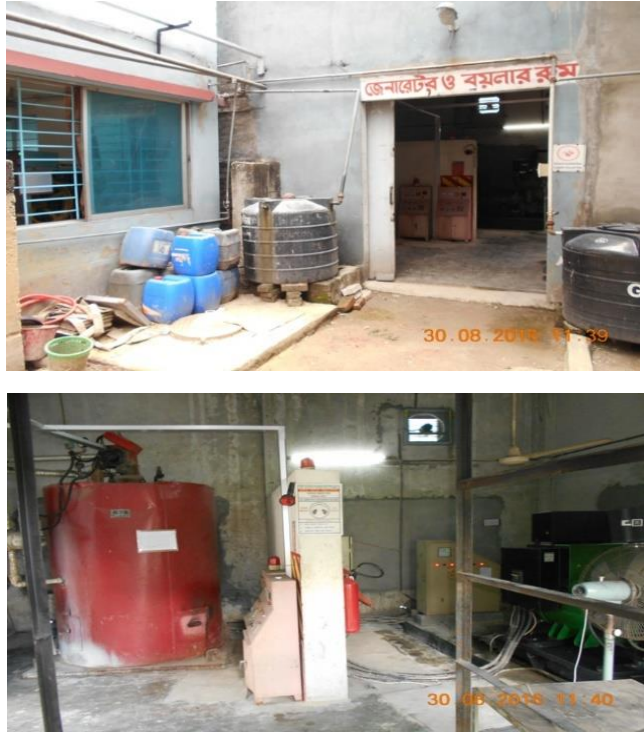
SI No.	Category	Findings	Required Action	Remediation Time Frame	Pictorial Evidence
4	Fire Rated Construction	Generator/ Boiler room is not properly separated from each other and from production floor at north-west corner of the factory premises.	<p>Generator/ boiler room shall be separated from the stair by a minimum 2-hr fire rated construction (wall, floor, slab etc.).</p> <p>Seal all penetrations and openings (door, window etc.) shall be protected by 1.5-hr fire rated materials to maintain the fire separation if required. All exhaust systems shall discharge to the exterior of the building in a safe location.</p> <p>Or, relocate the utility room to a safe place.</p>	Within 3 months

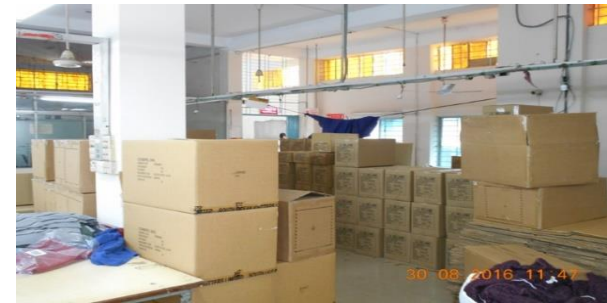
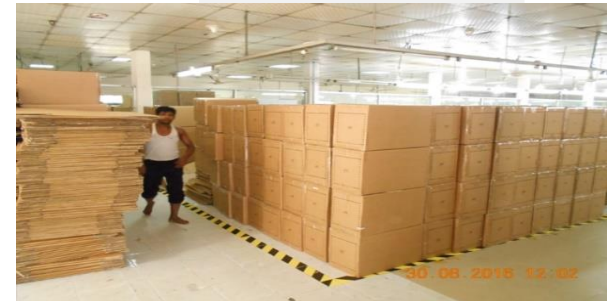
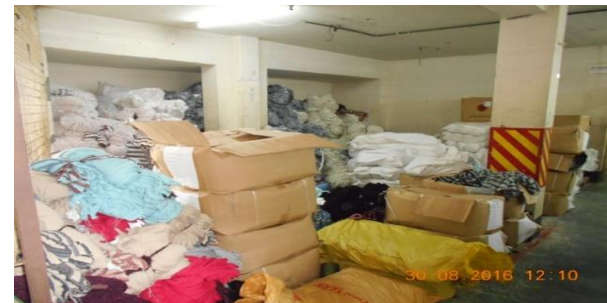
5 Fire Rated Construction

Areas used for in-process storage (Inspection Goods) of combustible materials are open to the surrounding occupancy. Location: Building 1, Shed 1, Building 2.

Provide defined storage areas and limit the storage arrangement as: Maximum height of 2.4m and maximum area of 23m². Separate areas of unenclosed combustible storage by a minimum clear distance of 3m

Within 2 months

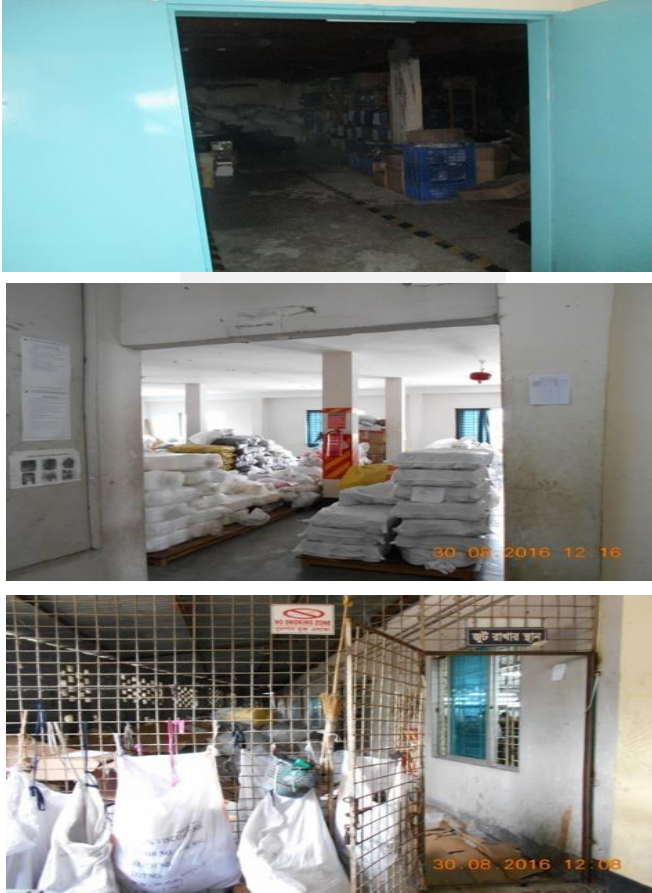
SI No.	Category	Findings	Required Action	Remediation Time Frame	Pictorial Evidence
6	Fire Rated Construction	<p>Room used for storage of combustible materials (Accessories store & Bonded Ware House) is not separated from the surrounding occupancy (sewing section). Location: Building 1, Shed 1, Building 2 (Ground floor & yarn store), Shed 2 (Jhute godown).</p>	<p>Rooms used for storage of combustible materials shall be separated from the surrounding occupancy with a minimum 1 hour construction.</p>	<p>Within 3 months</p>

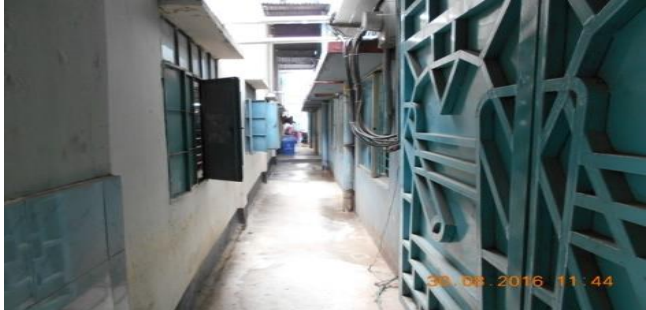
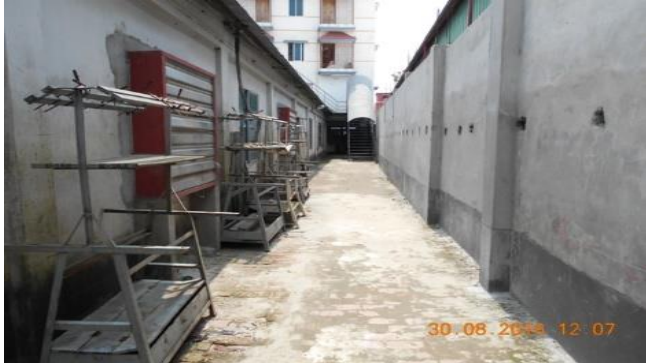
SI No.	Category	Findings	Required Action	Remediation Time Frame	Pictorial Evidence
7	Fire Rated Construction	<p>The exit discharge path [serving South East Exit & North East Exit] is less than 10 ft. wide and is not separated from the building interior.</p> <p>Location: Path between Building 1 & Shed 1, West exit of Shed 2, North-West exit of Building 2.</p>	<p>Seal all penetrations and openings to the interior of the building along the discharge path, up to a height of 10 ft. to provide a minimum 1-hr fire separation.</p> <p>Alternatively, provide a second remote discharge path to the public way (only include this if feasible).</p>	Within 2 month

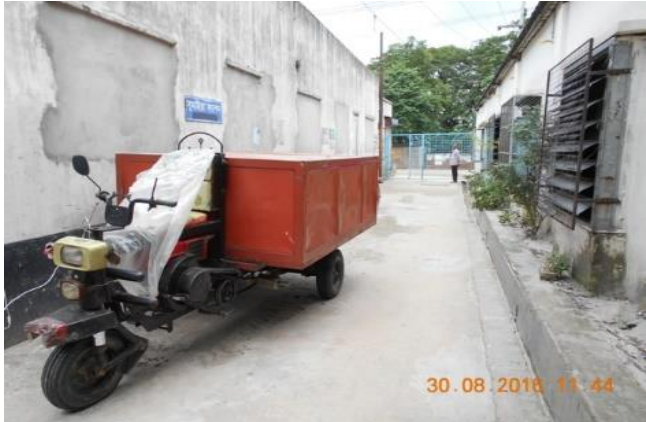
8	Fire Rated Construction	<p>The factory is using/ storing liquefied gas cylinder without any separation.</p>	<p>Remove them from the factory building.</p> <p>Or,</p> <p>Provide 2-hr rated room for using/ storing liquefied gas cylinder and ensure proper ventilation of that room. Source of fire such as electrical connection is prohibited.</p>	Immediate

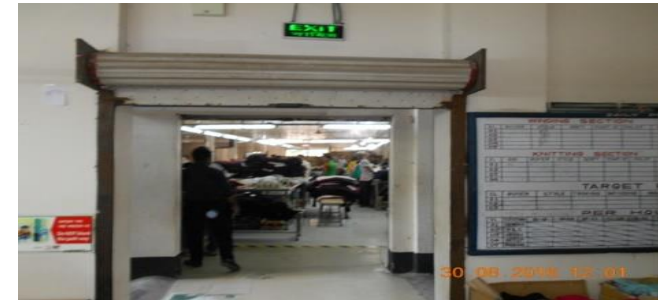
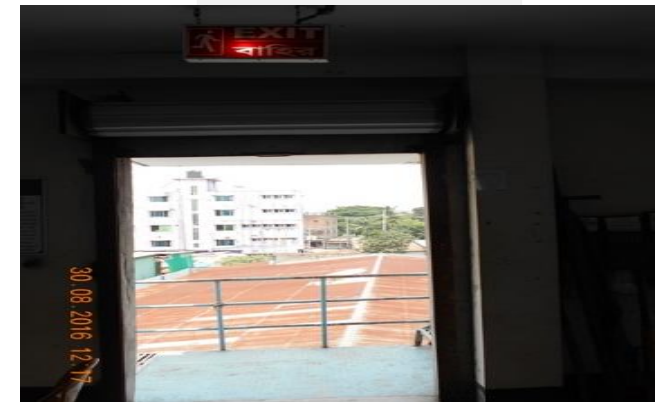
9 Egress

Collapsible/ sliding/ Shutter type doors have been provided along means of egress (building exits, along egress routes, exit discharge).
Location: Building 1 & 2, Shed 1.

Replace all collapsible/ sliding/ shutter type doors & gates by the side-hinged swinging type doors.
If locks are required for security reasons, utilize special door locking features complying with NFPA 101.

Immediate

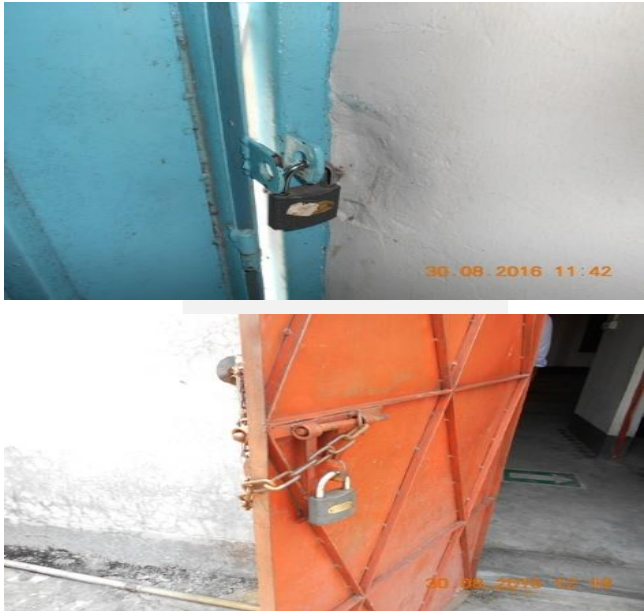
SI No.	Category	Findings	Required Action	Remediation Time Frame	Pictorial Evidence
10	Egress	Doors along means of egress are provided with non compliant locking system Location: Building 1 & 2, Shed 1.	<ol style="list-style-type: none"> 1. Remove all non compliant locking features from egress doors. 2. If locks are required for security reasons, utilize special door locking features complying with NFPA 101. 	Immediate

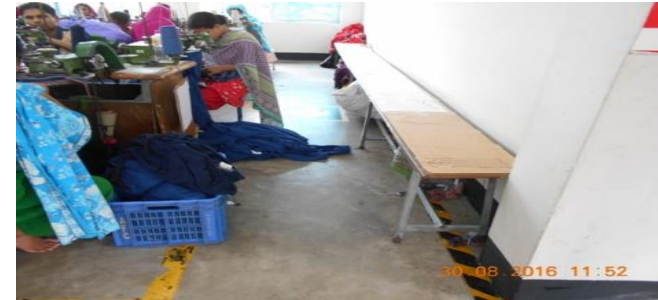
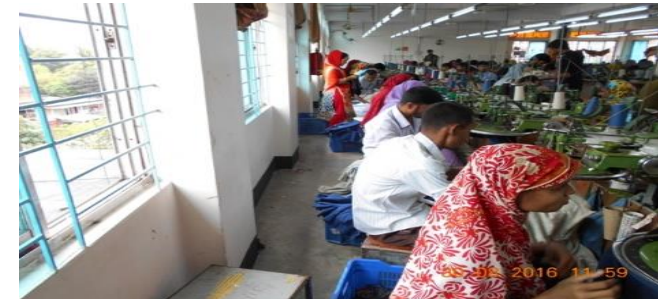
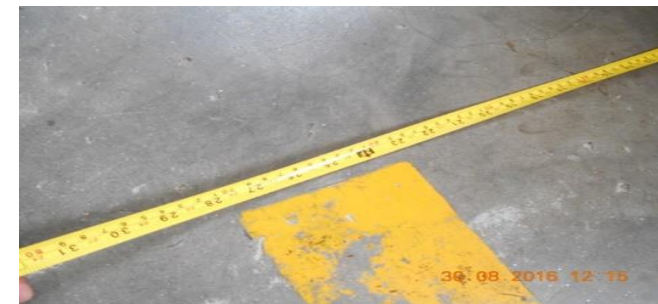
11 Egress

Width of aisles is less than 0.9m (36-in.).
Location: Building 1 & 2, Shed 1 & 2.

Aisles shall be provided with a minimum unobstructed clear-width of 0.9 m (36 in.).

Within 2 months

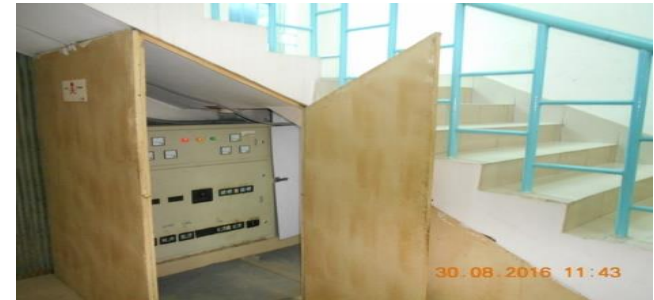
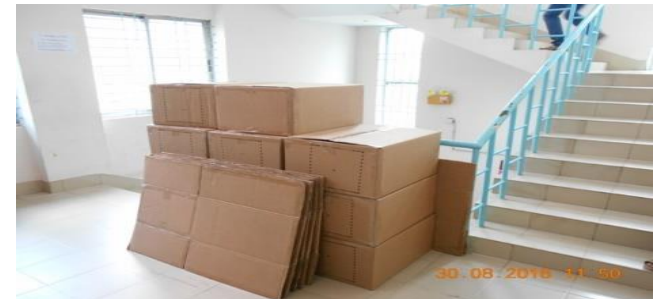
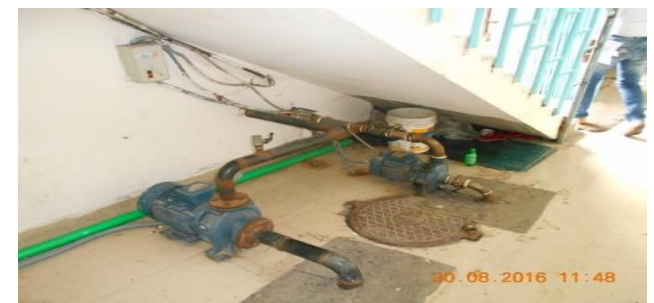
12 Egress

Storage was located in the exit stair.
Location: Building 1 & 2.

Remove all storage from exit stairs.

Immediate

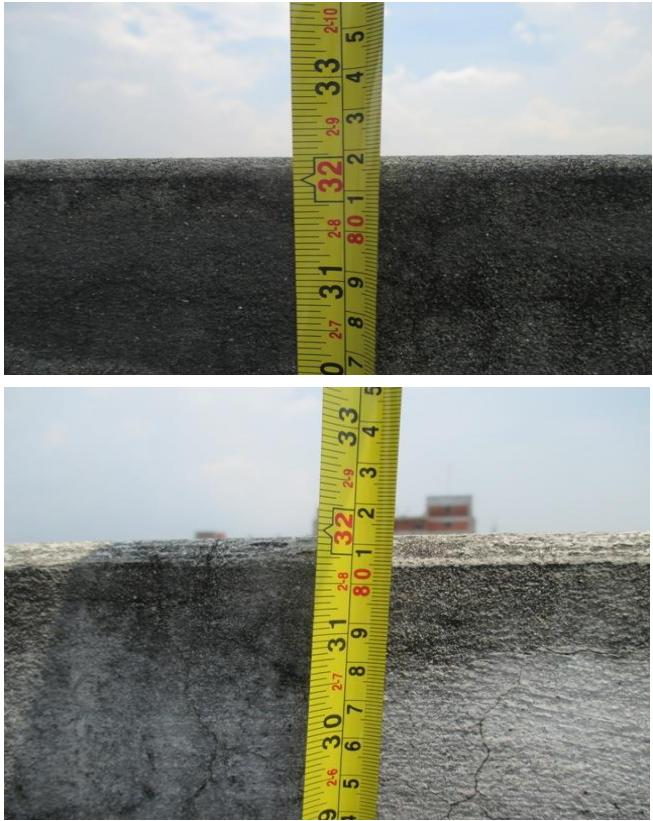
SI No.	Category	Findings	Required Action	Remediation Time Frame	Pictorial Evidence
13	Egress	Parapets or guards are not provide in occupiable roof. Location: Building 1 & 2.	Provide parapets or guards with a minimum height of 1067mm (42 inch.).	Within 1 month

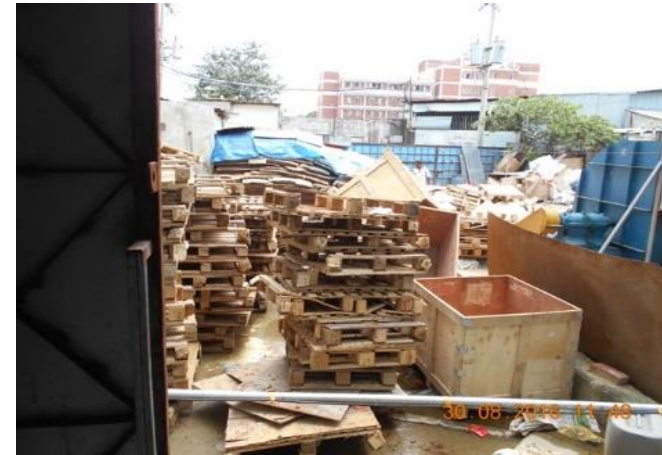
14 Egress

The egress path along means of egress has interrupted by obstruction/storage.
 Location: Building 1 (East exit & several floors)

Means of egress shall be maintained continuously free and clear of all obstructions/storage.
 Or
 Keep egress paths and stairs clear of storage.

Immediate

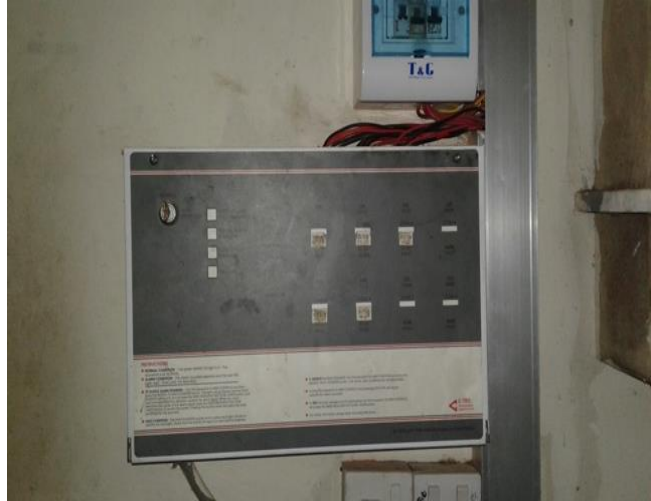
15 Fire Alarm System

The Required Fire Alarm system is not installed in accordance with the ACCORD standard Or NFPA-72.
 Location: Building 1 & 2, Shed 1 & 2.

Design of Fire Alarm system shall be in accordance with ACCORD standard and NFPA 72.

Design Submission 4 months and Installation 9 months.

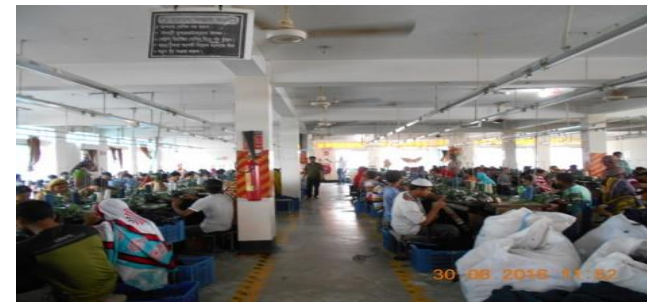
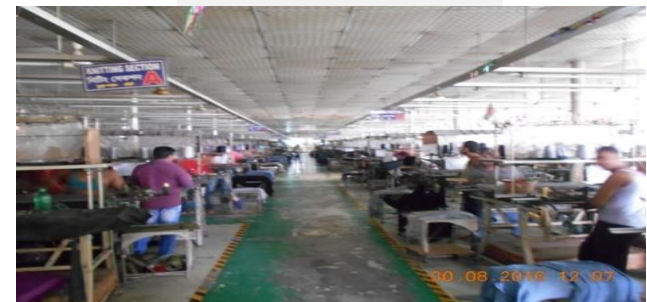
21	Emergency Egress Lighting	<p>Based on the number and location of emergency lights observed, adequate illumination levels are not anticipated along egress routes.</p> <p>Location: Building 1 & 2, Shed 1 & 2.</p>	<p>Test the emergency lighting system on each floor and provide additional emergency fixtures to provide adequate illumination along the means of egress. Provide a minimum illumination of 10 lux at the floor level within exit stairs and exit discharge paths and minimum 2.5 lux along exit access aisles.</p>	<p>Within 3 months</p>	
----	---------------------------	--	---	------------------------	--

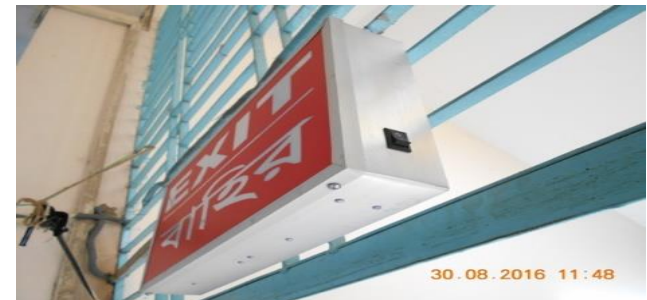
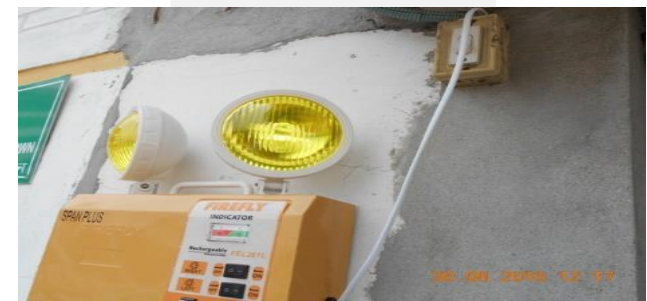
23	Manual On/Off Switch	Manual on-off switch is provided for [emergency lighting / exit signage] units. Location : Buildin 1 & 2, Shed 1 & 2.	Remove manual on/off switches from emergency lighting / exit signage units to prevent them from being switched off.	Within 1 months	
----	----------------------	--	---	-----------------	--
