# **FIRE SAFETY INSPECTION REPORT**

**LIBAS TEXTILE LTD.  
MOUCHAK, KALIAKOIR**

**ACCORD**  
on Fire and Building Safety in Bangladesh

April 6, 2014

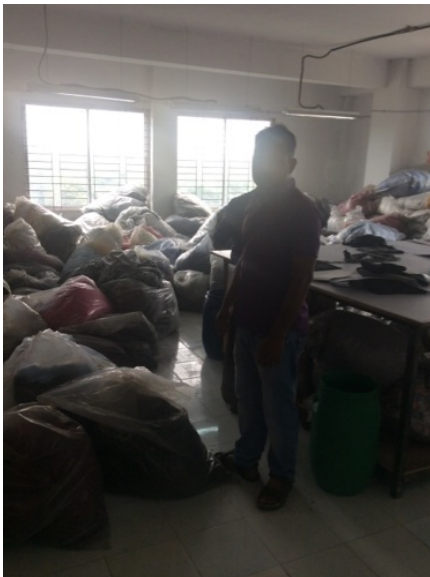
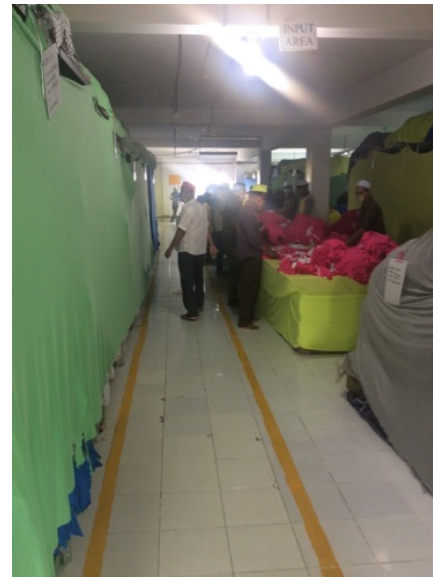
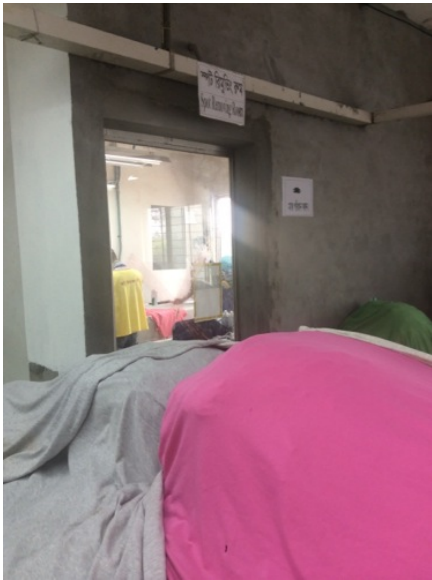
| No. | Category | Finding | Recommendation | Remediation Timeframe |
|---|---|---|---|---|
| F-1 | Fire Rated Construction | <p>Areas used for combustible storage are not separated by fire-rated construction.</p> <p>Locations:<br/>All floors</p> | <p>Provide dedicated storage rooms separated by minimum 1-hr fire-rated construction.</p> <p>Where separate storage rooms are not feasible, provide defined storage areas and limit the storage arrangement as follows:</p> <ul style="list-style-type: none"> <li>- Maximum height of 2.4m and maximum area of 23m<sup>2</sup></li> <li>- If sprinkler protected: maximum height of 3.66m and maximum area of 93m<sup>2</sup></li> </ul> <p>Separate areas of unenclosed combustible storage by a minimum clear distance of 3m.</p> | Within 3 months |

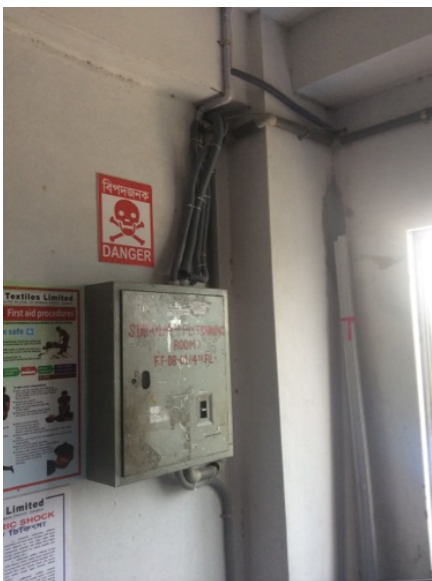
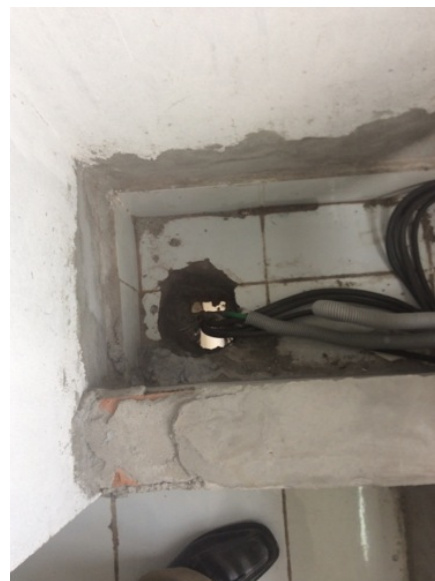
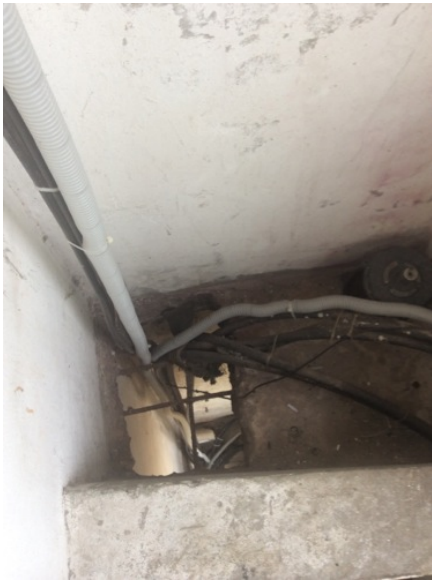
| F-2 | Fire Rated Construction | Unsealed penetrations and openings are located in the fire-rated floor/ceiling assemblies. | Provide a minimum 2-hr fire-rated shaft to separate the utility risers from each floor level. | Within 3 months |

| | | | Seal all penetrations and openings in floor/ceiling assemblies to maintain the fire separation. | |

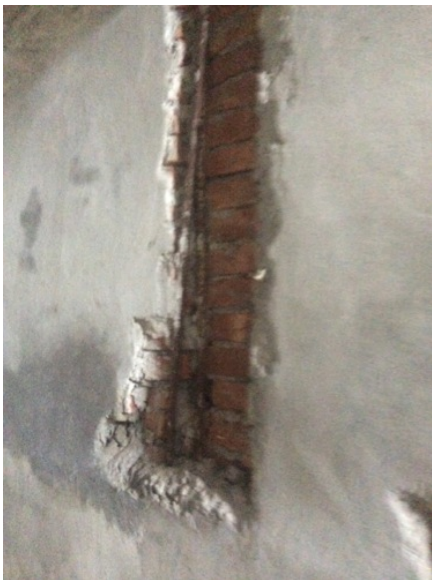
| F-3 | Fire Rated Construction | Unsealed penetrations and openings are located in exit stair enclosures. | Seal all penetrations and openings in exit stair enclosure walls to maintain the fire separation. | Within 3 months |

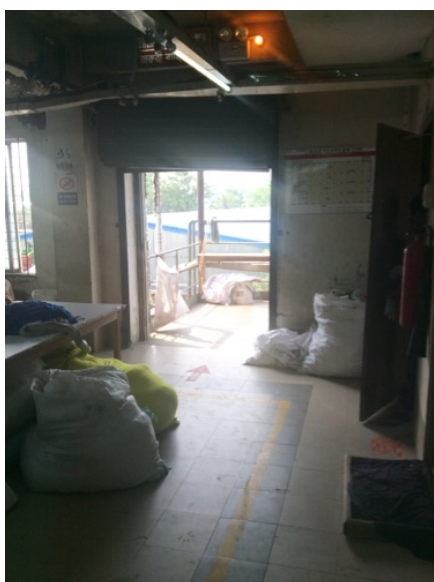
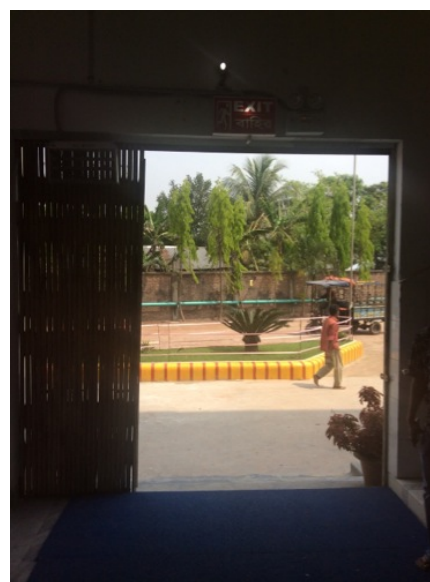
| F-5 | Egress | Egress doors / gates with locking features are provided at building exits, exit stairs, along egress routes, and exit discharge. | Remove locking features from all egress doors / gates.<br><br>If locks are required for security reasons, utilize special door locking features complying with NFPA 101. | Immediate |
| | | Located on all floors. | | |
| | | All gates/doors were open and unlocked during the inspection. | | |

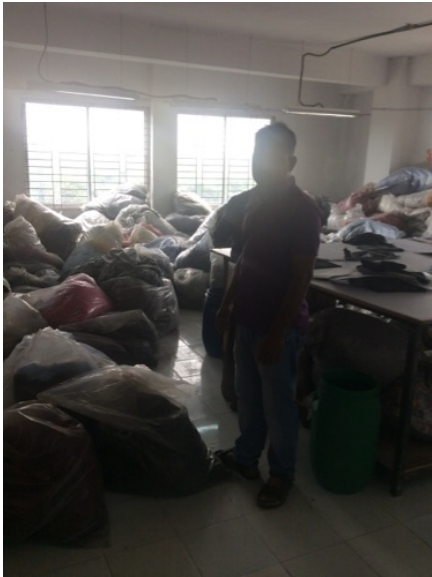
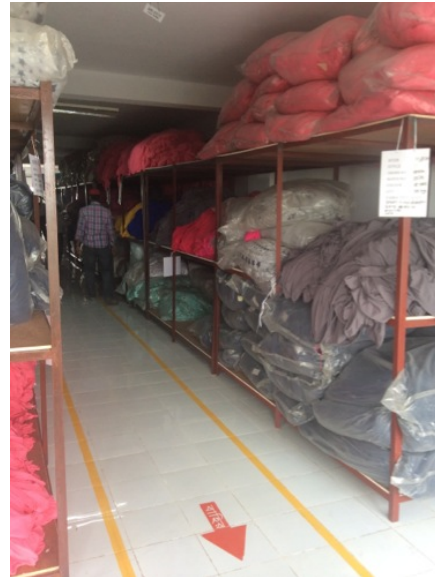
| F-6 | Egress | Storage was located in the egress path. | Keep egress paths and stairs clear of storage. | Immediate |

Locations:  
All floors.

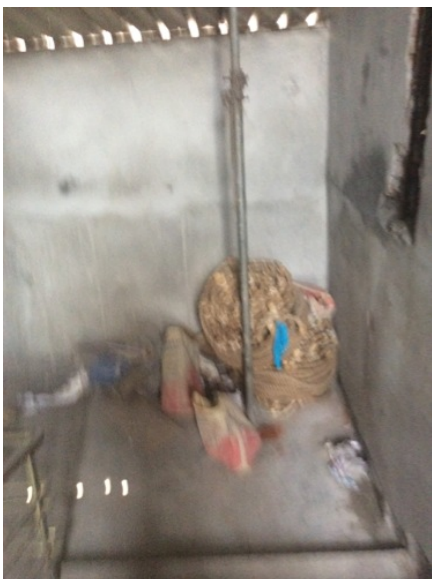
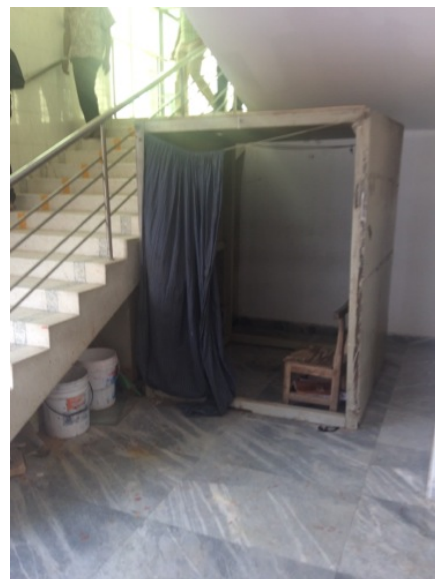
| F-7 | Egress | Storage was located in the exit stair. | Remove all storage from exit stairs and egress paths. | Immediate |

Locations:  
Northeast Stair.

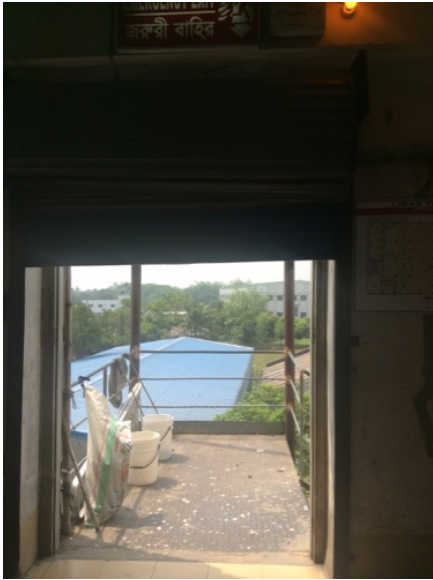
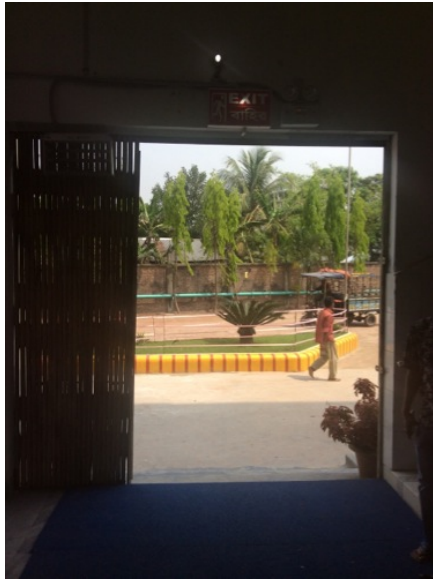
| F-8 | Egress | <p>Collapsible gates / sliding doors are provided at building exits, exit stairs, along egress routes, and exit discharge.</p> <p>Locations:<br/>All floors.</p> | <p>Replace all gates / sliding doors along the means of egress with side-hinged, swinging egress doors.</p> <p>If locks are required for security reasons, utilize special door locking features complying with NFPA 101.</p> | Within 1 month |

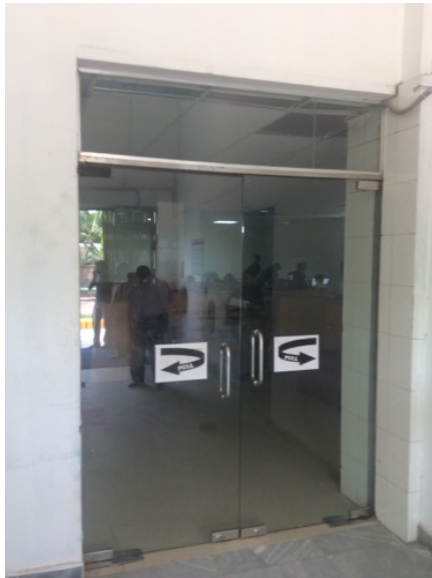
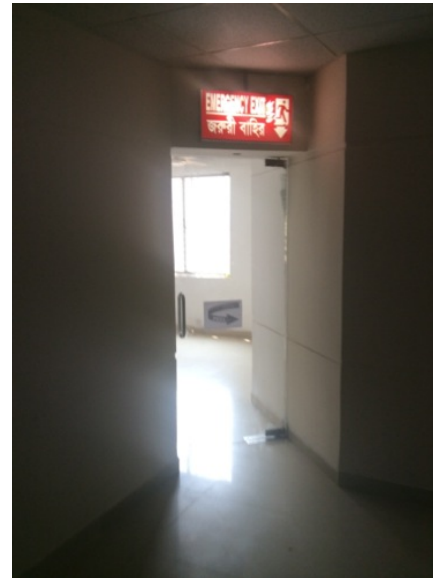
| F-9 | Egress | <p>Exit stair door does not swing in the direction of egress travel.</p> <p>Locations:<br/>Ground Floor Office</p> | <p>Modify the egress door to swing in the direction of egress travel.</p> | Within 3 months |

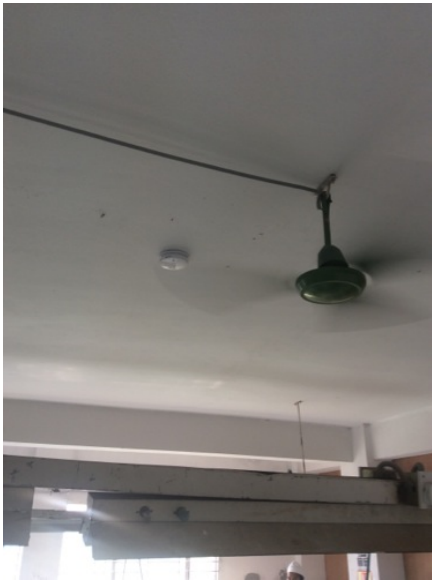
| F-12 | Fire Protection | The building is equipped with single-station smoke alarms. Smoke alarm activation sounds only a local alarm and does not provide automatic fire alarm notification of occupants. | Replace the single-station smoke alarms with automatic smoke detectors tied into the fire alarm system. Configure the fire alarm system to initiate occupant notification upon activation of any two smoke detectors in addition to the manual fire alarm stations. | Within 6 months |

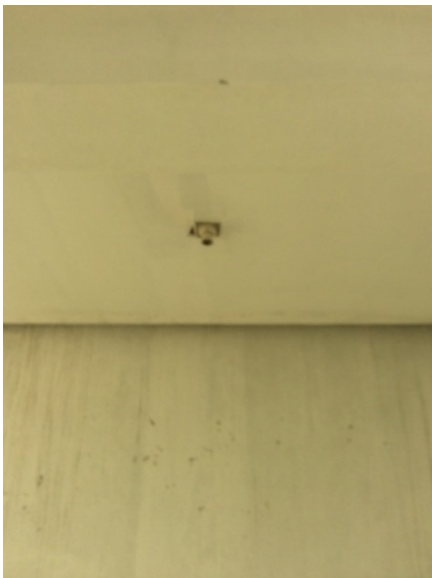
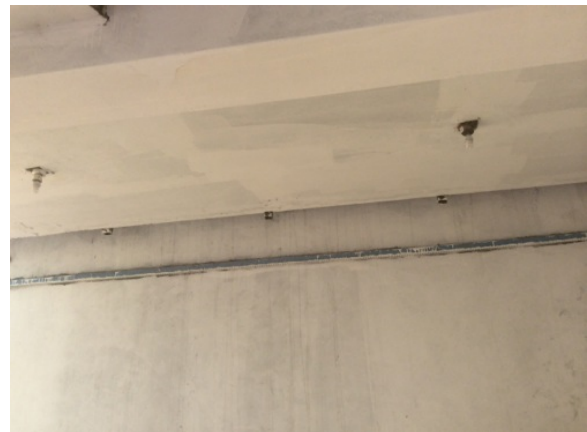
| F-13 | Egress Lighting | Emergency lighting did not function in test mode (burned out, broken, etc.). | Regularly test the emergency lighting system on each floor and replace/repair lights as needed. | Within 3 months |
| | | Locations:<br>Northeast stairwell. | | |

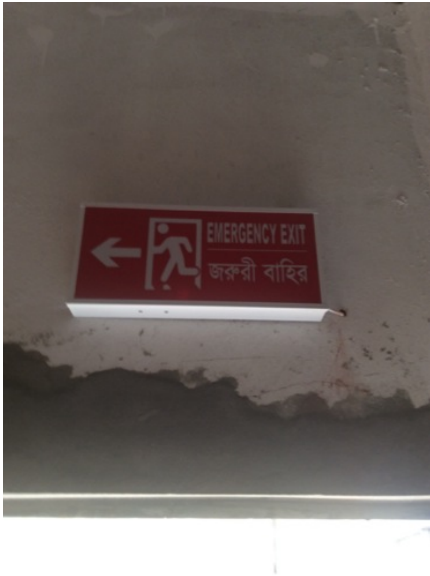
| F-14 | Egress Lighting | Exit signage not illuminated (burned out, broken, etc.).<br><br>Locations:<br>Ground Floor Office area | Regularly inspect all exit signage and replace/install lights as needed to illuminate signs. | Within 3 months |

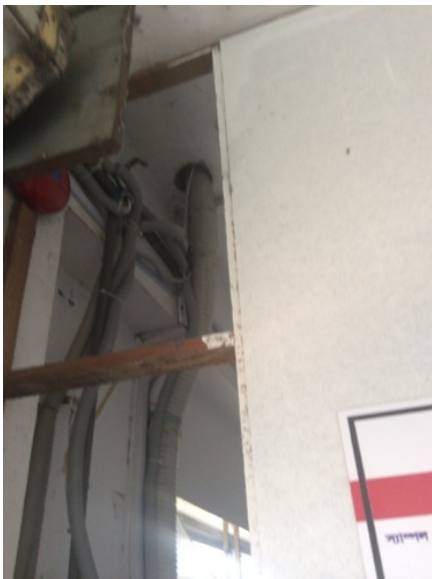
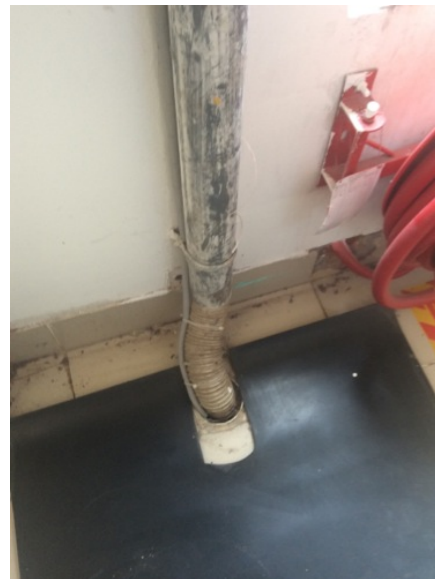
| No. | Category | Finding | Recommendation | Remediation<br>Timeframe |
|---|---|---|---|---|
| F-1 | Fire Rated<br>Construction | Unsealed penetrations and openings are located in the fire-rated floor/ceiling assemblies. | Provide a minimum 2-hr fire-rated shaft to separate the utility risers from each floor level.<br><br>Seal all penetrations and openings in floor/ceiling assemblies to maintain the fire separation. | Within 3 months |

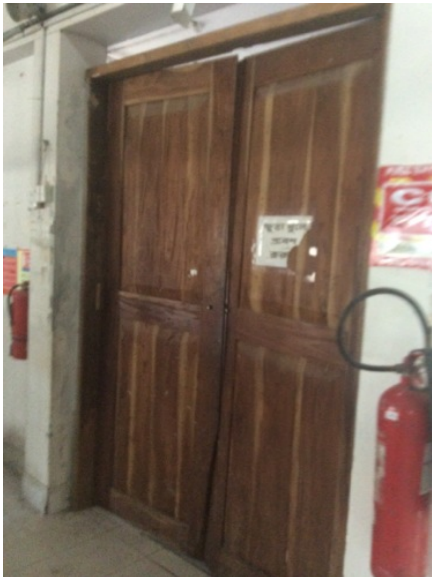
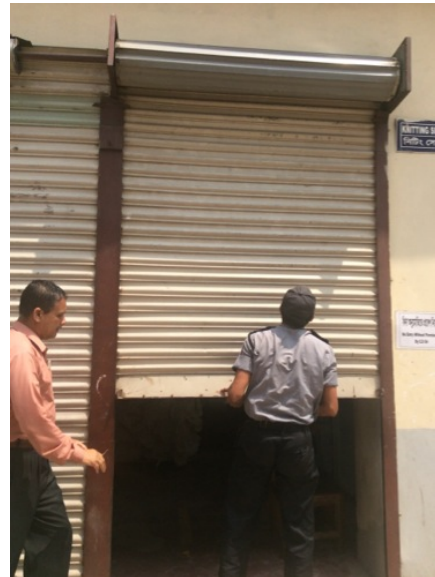
| F-2 | Egress | <p>Egress doors / gates with locking features are provided at building exits, exit stairs, along egress routes, and exit discharge.</p> <p>All gates/doors were open and unlocked during the inspection on floors occupied.</p> | <p>Remove locking features from all egress doors / gates.</p> <p>If locks are required for security reasons, utilize special door locking features complying with NFPA 101.</p> | Immediate |

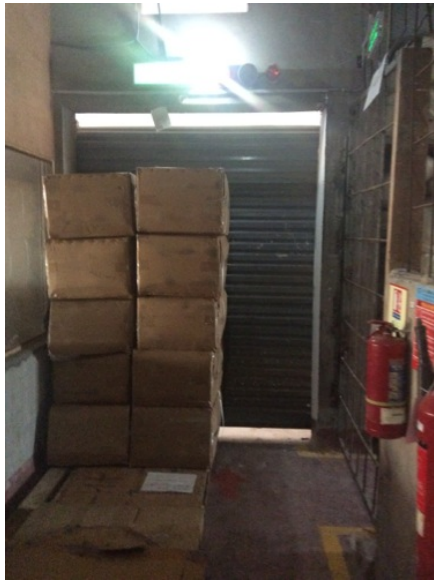
| F-3 | Egress | <p>Storage was located in the egress path.</p> <p>Locations:<br/>Ground Floor (It is currently un-occupied)</p> | <p>Keep egress paths and stairs clear of storage.</p> | Immediate |

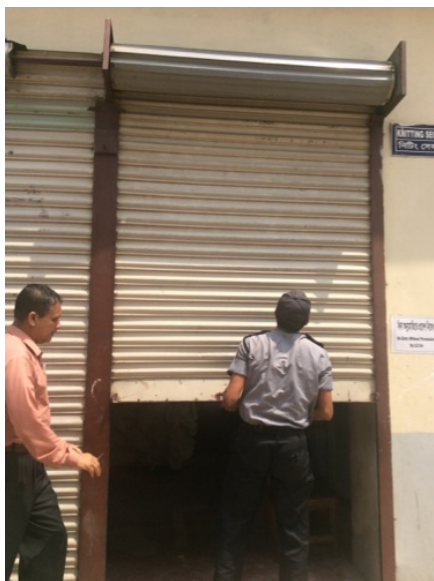
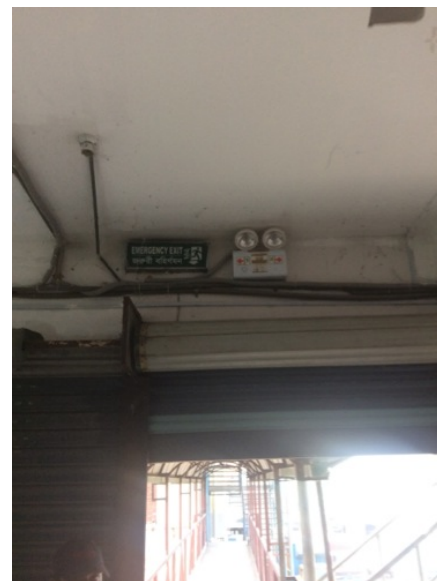
| F-4 | Egress | Collapsible gates / sliding doors are provided at building exits, exit stairs, along egress routes, and exit discharge. | <p>Replace all gates / sliding doors along the means of egress with side-hinged, swinging egress doors.</p> <p>If locks are required for security reasons, utilize special door locking features complying with NFPA 101.</p> | Within 1 month |

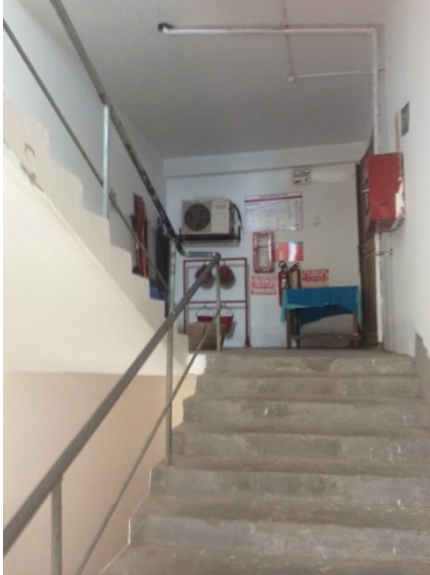
North Stairwell

| F-5 | Egress | Storage was located in the exit stair. | Remove all storage from exit stairs and egress paths. | Within 3 months |

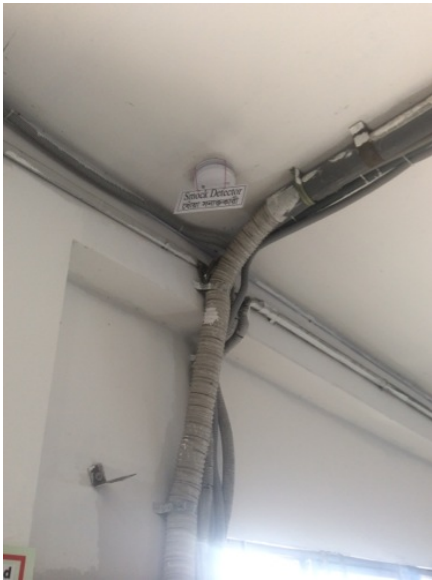
| F-8 | Fire Protection | The building is equipped with single-station smoke alarms. Smoke alarm activation sounds only a local alarm and does not provide automatic fire alarm notification of occupants. | Replace the single-station smoke alarms with automatic smoke detectors tied into the fire alarm system. Configure the fire alarm system to initiate occupant notification upon activation of any two smoke detectors in addition to the manual fire alarm stations. | Within 6 months |

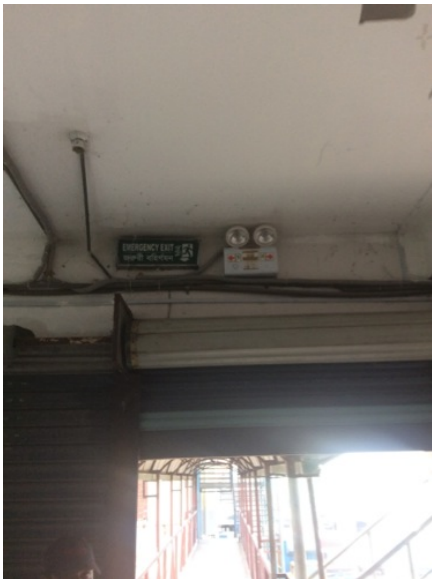
| F-9 | Egress Lighting | Exit signage not illuminated (burned out, broken, etc.). | Regularly inspect all exit signage and replace/install lights as needed to illuminate signs. | Within 3 months |
