# **FIRE SAFETY INSPECTION REPORT**

**Factory Name: UHM LTD.**

**Date: 07 August 2016**

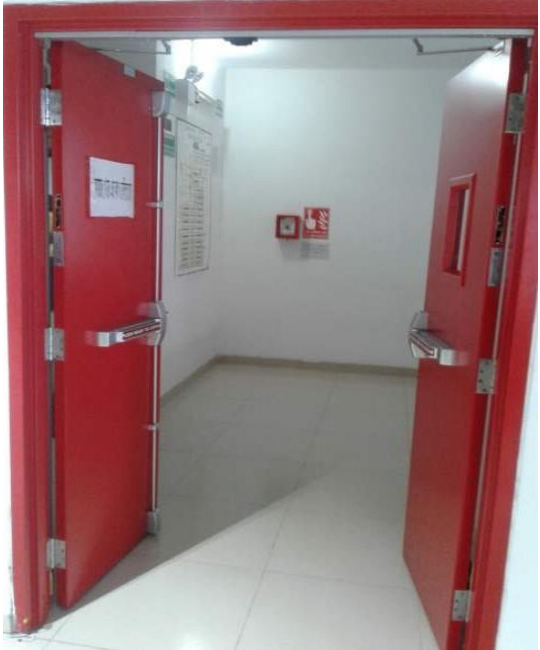
| Sl No. | Category | Findings | Required Action | Remediation Time Frame | Pictorial Evidence |
|---|---|---|---|---|---|
| 1 | Fire rated construction | (Building-1) The exit stairs are not separated from work areas on each floor by fire-rated construction. <b>(Note: Fire rated door installation on-going)</b> | <p>Stair shall be enclosed with a minimum 1-hr fire-rated construction. Seal all unprotected openings and provide minimum 1-hr fire rated doors to separate the exit stairs from work areas and other building spaces on all floor levels. Ensure that the fire doors are self-closing, positive latching and that they are provided with fire exit (panic) hardware where serving production floors.</p> <p>If fire doors are required to be held open for functional reasons, provide automatic-closing devices tied to the fire alarm system.</p> | Within 3 months | |

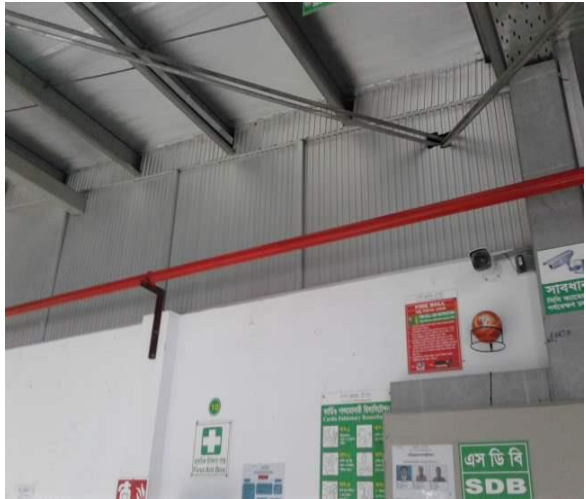
3 Fire rated construction

(Building-1) Unsealed penetrations and openings are located in exit stair enclosures.

Seal all penetrations and openings in exit stair enclosure walls to maintain the fire separation.

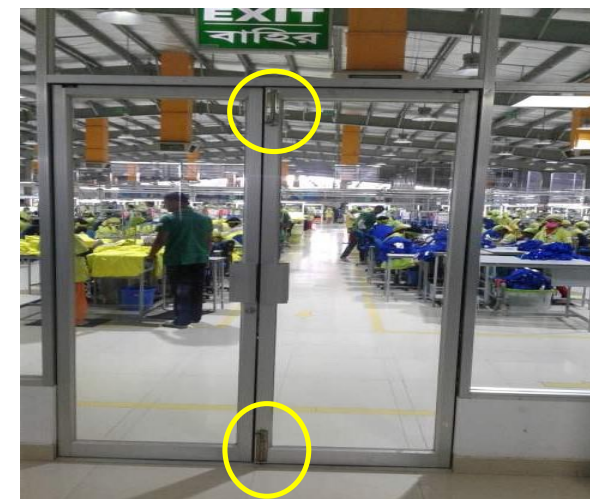
| 4 | Egress | <b>(Building-1)</b> Egress doors / gates with locking features are provided along egress routes and exit discharge. | Remove locking features from all egress doors / gates. If locks are required for security reasons, utilize special door locking features complying with NFPA 101. | Immediately |

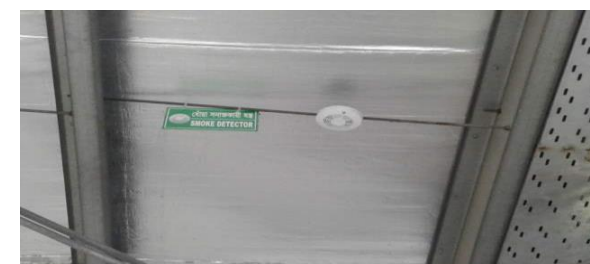
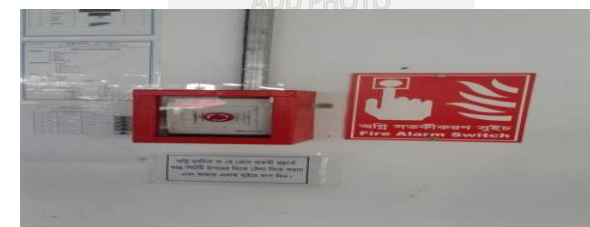
| 5 | Fire Protection | <b>(Building-1)</b> Fire alarm system is not as per NFPA-72 | Provide fire alarm system in accordance with NFPA 72. | Design within 2 months, install within 6 months |

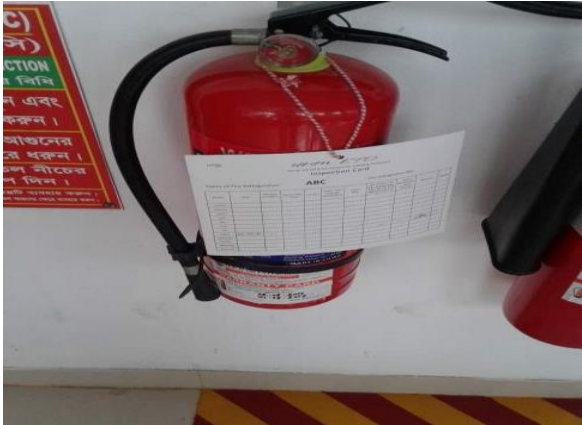
| 7 | <b>Fire Protection</b> | <b>(Building-1)</b> Inspection, testing, and maintenance for the fire extinguishers is not in accordance with NFPA 10 or as per Accord standard. | Inspect, test and maintain the fire extinguishers, and keep written records on-site, in accordance with NFPA 10 or as per Accord standard. | Within 3 months | |

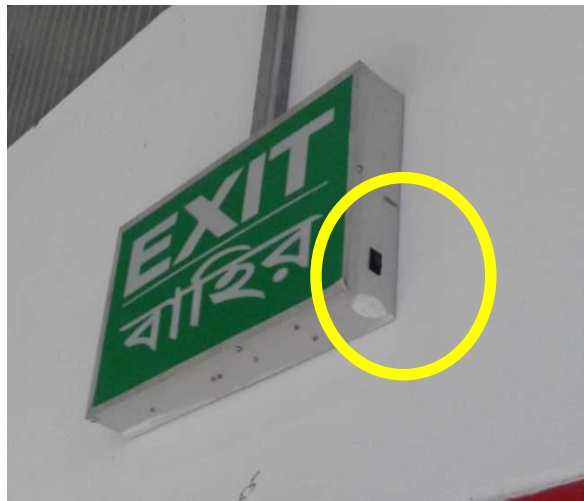
| 9 | <b>Egress Lighting</b> | <b>(Building-1)</b> Manual on-off switch is provided for exit signage units. | Remove manual on/off switches from exit signage units to prevent them from being switched off. | Within 1 month | |

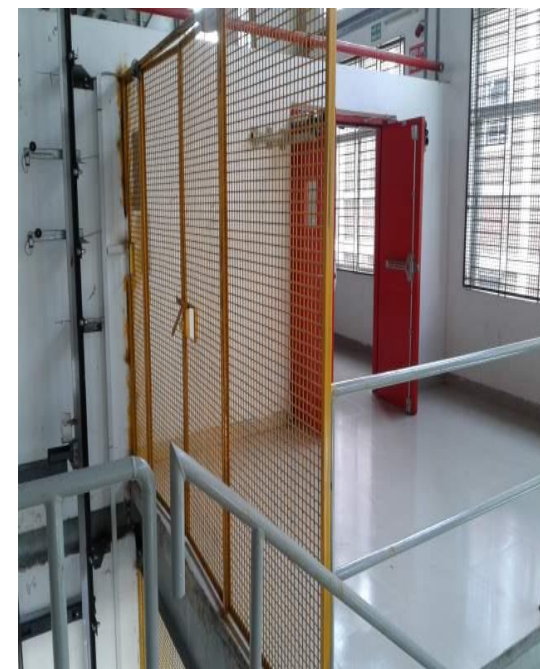
11 Fire rated construction

**(Building-2)** The exit stairs are not separated from work areas on each floor by fire-rated construction. **(Note: Fire rated door installation on-going)**

Stair shall be enclosed with a minimum 1-hr fire-rated construction. Seal all unprotected openings and provide minimum 1-hr fire rated doors to separate the exit stairs from work areas and other building spaces on all floor levels. Ensure that the fire doors are self-closing, positive latching and that they are provided with fire exit (panic) hardware where serving production floors.

If fire doors are required to be held open for functional reasons, provide automatic-closing devices tied to the fire alarm system.

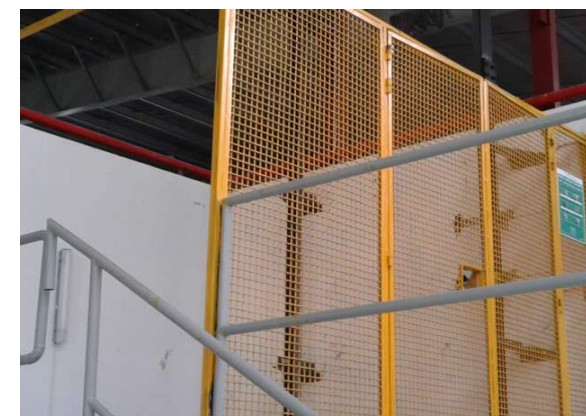
12 Fire rated construction

**(Building-2)** Unsealed penetrations and openings are located in exit stair enclosures..

Seal all penetrations and openings in exit stair enclosure walls to maintain the fire separation.

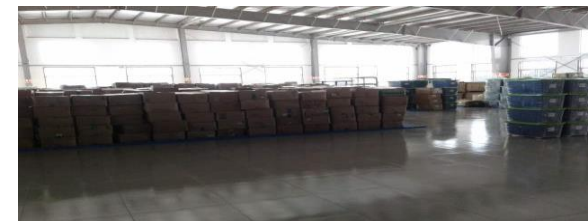
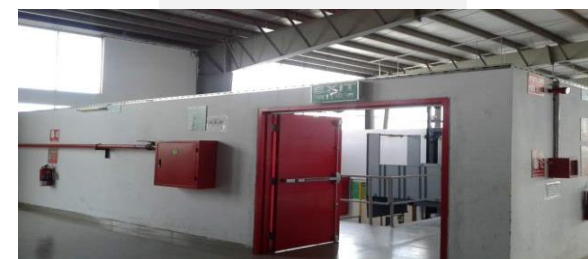
13

**(Building-2)** Rooms used for storage of combustible materials are not separated from the exit stair enclosures..

Rooms used for storage of combustible materials shall be separated from the surrounding occupancy with a minimum 1 hour construction.

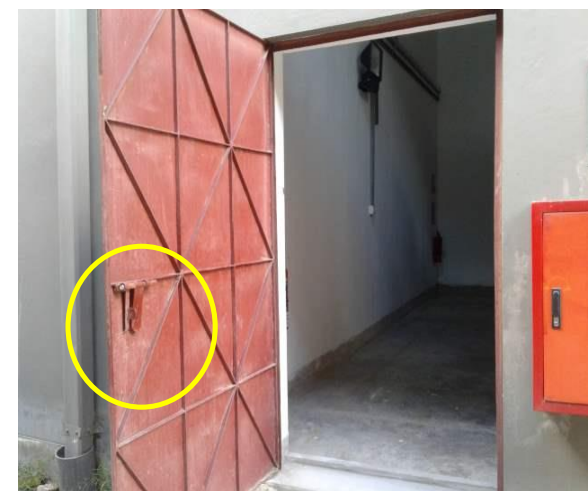
14

**(Building-2)** Egress doors / gates with locking features are provided along egress routes and exit discharge.

Remove locking features from all egress doors / gates. If locks are required for security reasons, utilize special door locking features complying with NFPA 101.

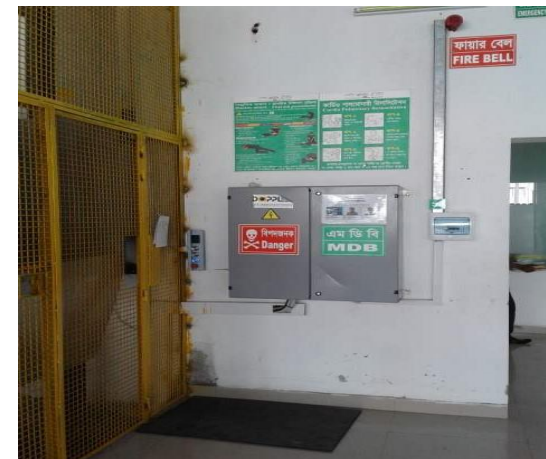
15 Egress

**(Building-2)** Storage was located inside the exit stair enclosure. **(Electric panel board)**

Remove all storage from exit stairs and egress paths

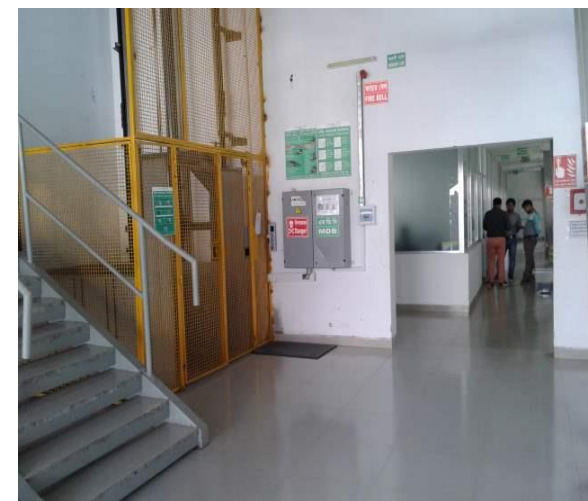
16 Egress

**(Building-2)** Exit stairs discharge inside the building.

Modify stair to discharge directly outside.  
Or  
Provide 2-hr fire-rated exit passageway leading directly outside (vestibules to separate any storage areas).

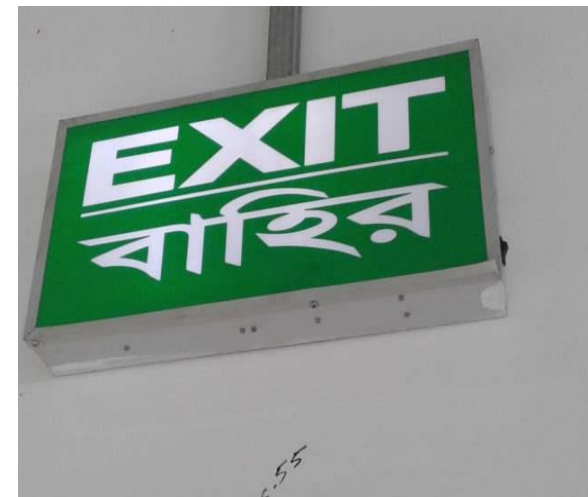
| 21 | <b>Egress Lighting</b> | (Building-2) Manual on-off switch is provided for exit signage units. | Remove manual on/off switches from exit signage units to prevent them from being switched off. | Within 1 month |
