# Starlight Sweaters Ltd.

National University, Gazipur, Sadar  
(23.97906N, 90.37702E)

19 March 2014

# Observations

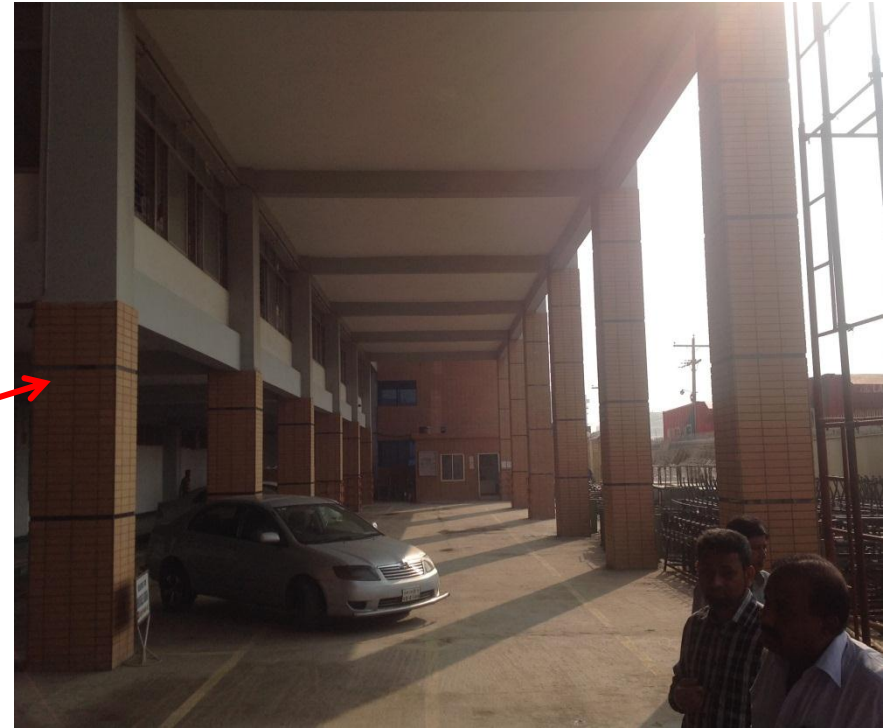
Delivery Area

16 No columns in delivery area at risk of being struck by vehicle.

Building Engineer to check that the columns have been adequately designed for impact loading. Adequate protection to be provided to columns at risk of damage due to impact loading.

| Item No. | Observation | Recommended Action Plan | Priority |
|---|---|---|---|
| 1 | Columns at the south of the building adjacent to the entrances are in danger of being accidentally hit by vehicles entering/ leaving the facility. | Suitable column protection barriers to be designed and constructed. | 6-weeks |
| 2 | Columns at the south of the building adjacent to the entrances are in danger of being accidentally hit by vehicles entering/ leaving the facility. | Building Engineer to check that the columns have been adequately designed for impact loading | 6-weeks |

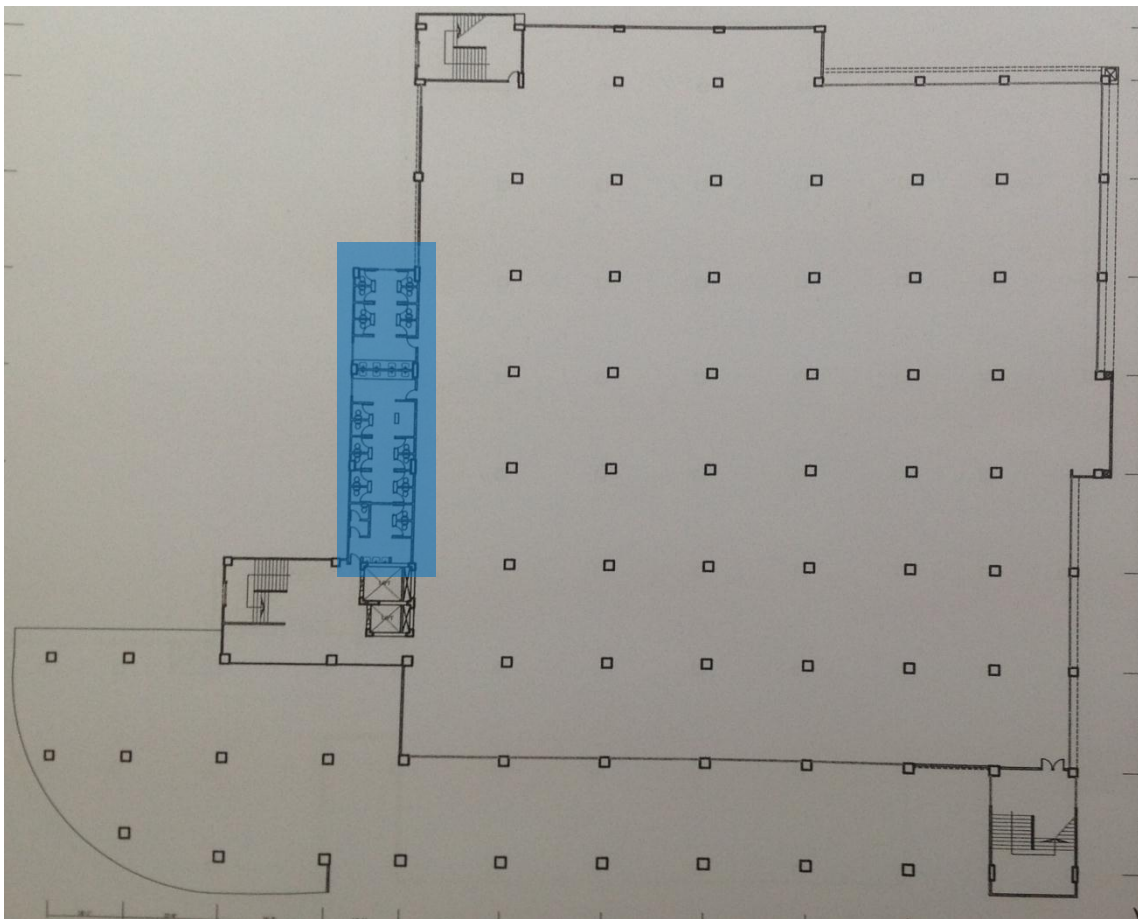
Typical Column Layout

**Columns below storage areas and water tanks appear to be stressed in excess of normal design limits – Building Engineer to verify concrete stresses and in-situ concrete strength**

Cursory calculations indicate that the working stresses of columns in the area of the concrete water tank are in excess of normal design limits

Building Engineer to check that columns in the area highlighted have been designed to accommodate loads.

| Item No. | Observation | Recommended Action Plan | Priority |
|---|---|---|---|
| 3 | Columns under storage areas and water tanks appear to be stressed in excess of normal design limits | Factory Engineer to review design, loads and columns stresses in area identified above. | 6-weeks |
| 4 | Columns under storage areas and water tanks appear to be stressed in excess of normal design limits | Verify in-situ concrete stresses either by 100mm diameter cores or existing cylinder strength data for cores from minimum 4 columns. | 6-weeks |
| 5 | Columns under storage areas and water tanks appear to be stressed in excess of normal design limits | Factory Engineer to confirm that column stresses are within acceptable limits. | 6-months |
| 6 | Columns under storage areas and water tanks appear to be stressed in excess of normal design limits | Produce and actively manage a loading plan for all floor plates within the factory giving consideration to floor capacity and column capacity. | 6-months |

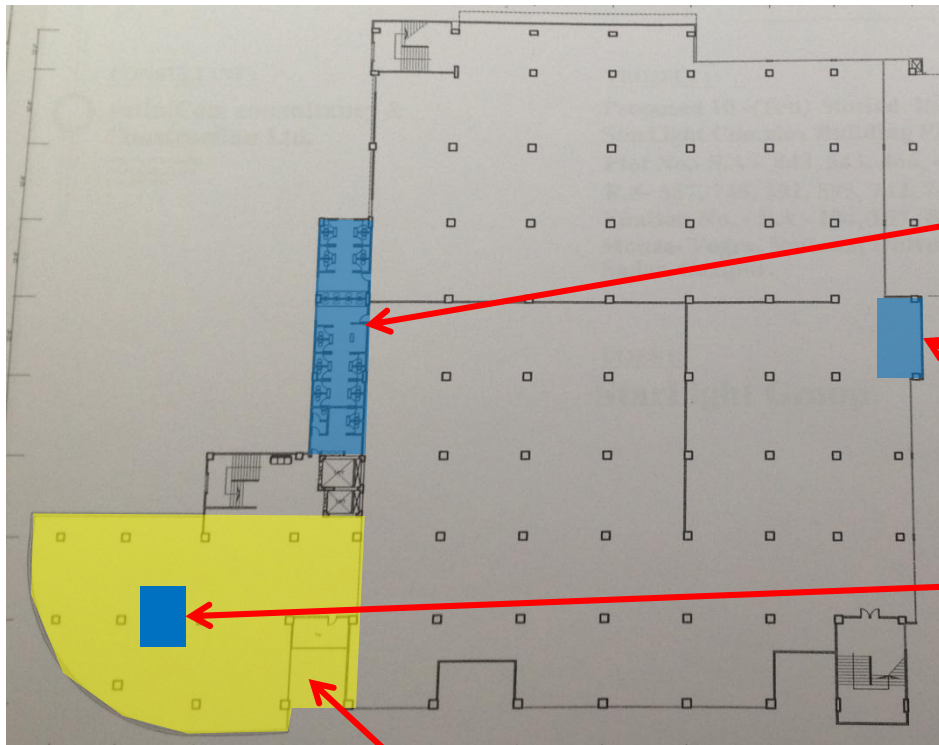
Typical Floor Plan

**Design Check required for the loading from the water tanks (plastic and concrete) at roof level and for areas of observed high floor loading as indicated**

Building Engineer to prepare controlled loading plans for all floors, which will designate where storage can be placed.

| Item No. | Observation | Recommended Action Plan | Priority |
|---|---|---|---|
| 7 | Design Check required for the loading from the water tanks (plastic and concrete) at roof level and for areas of observed high floor loading as indicated | Locations of loading noted to be surveyed and capacity of floor structure to be assessed by the Building Engineer to confirm that the floor slab is designed to carry these loads. | 6-months |
| 8 | Design Check required for the loading from the water tanks (plastic and concrete) at roof level and for areas of observed high floor loading as indicated | Produce and actively manage a loading plan for all floor plates within the factory giving consideration to floor capacity including punching shear in flat slabs and column capacity. | 6-months |

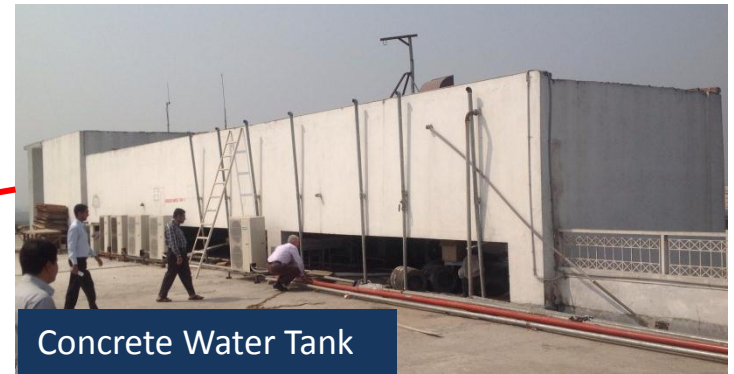
Concrete Water Tank

- 1 no. concrete and 7 no. plastic water tanks located on roof slab.
- Building Engineer to check that the slab and beams have been adequately designed to carry loads due to concrete and plastic water tanks.

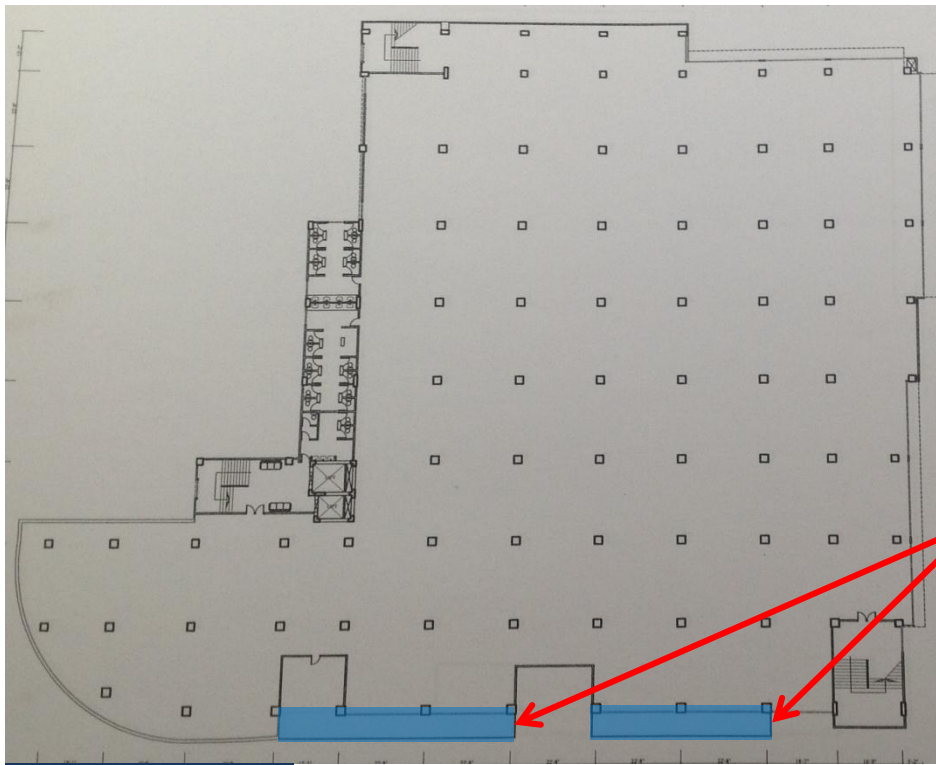
Plan

**Design check required for the slab cantilevers at the south of the building to confirm their load capacity to support floor and façade loadings**

Floor slab cantilevers (with no downstand beams) on south side on various floors

Building Engineer to check that the slab has been adequately designed to carry loading due to façade and floor loads

| Item No. | Observation | Recommended Action Plan | Priority |
|---|---|---|---|
| 9 | Design check required for the slab cantilevers at the south of the building to confirm their load capacity to support floor and façade loadings. | Building Engineer to confirm the capacity of the slab to support the combination of the floor loading and the façade loading. | 6-months |
