# INITIAL FIRE ASSESSMENT REPORT (FAR)

Factory Name: **Glory Fashionwear Ltd**  
Address: **Degerchala Road, 6th Floor National  
University, Gazipur, Floors 2 and 3 Gazipur Dhaka  
Bangladesh**  
Assessor: **Emkay Enterprises LTD**  
Date: **21 Jul 2014**

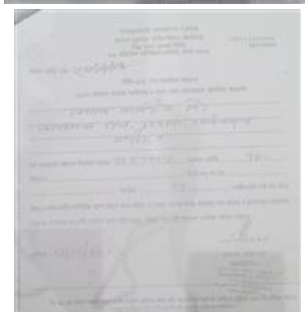
| Question: | Are all applicable permits up to date including Fire License & Boiler License. | <br><br> |
| Description: | Not in compliance. Fire license valid up to 30 June 2014 but Boiler license expired on 18 February 2014. Also BERC license was not found (Generator Capacity-1270 KVA) but Waiver certificate found for 1270 KVA that is not reliable. | |
