FIRE SAFETY INSPECTION REPORT

MG Niche Stitch Ltd.

ACCORD ID: 12549

Plot No-3929, Dogri, Mirjapur, Gazipur.

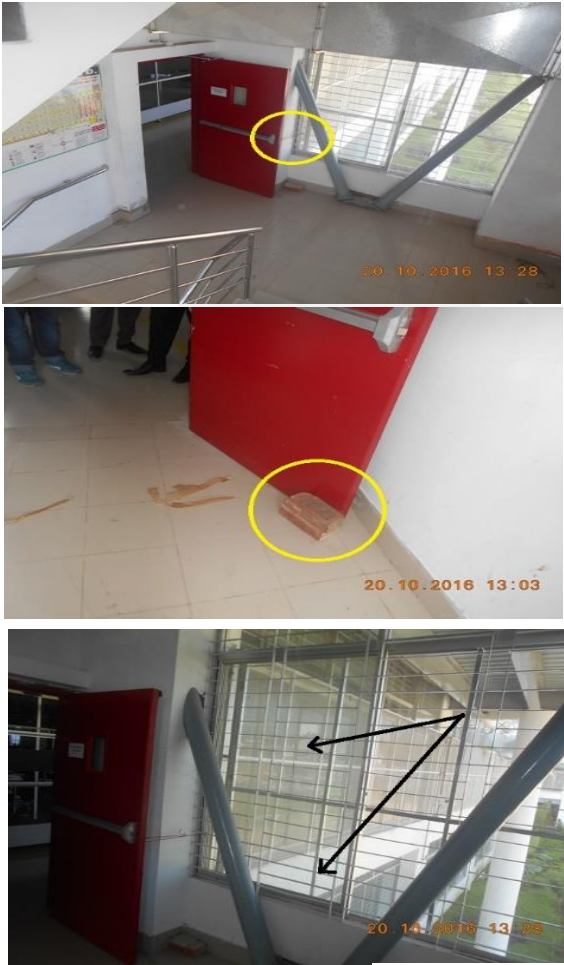
SI No.	Category	Findings	Required Action	Remediation Time Frame	Pictorial Evidence
1	Fire Rated Construction	The exit stairs are not separated from work areas & other spaces on each floor by fire rated construction.	<p>Seal all unprotected openings to separate the exit stairs from work areas and other building spaces on all floor levels. If fire doors are required to be held open for functional reasons, provide automatic closing devices tied to the fire alarm system.</p> <p>Note: Factory has provided 2-hr fire rated, self-closing, positive latching door with fire exit hardware. However fire doors were held open in unacceptable/manual way. Also in some cases the stairs are not protected due to the window openings from production floor.</p>	Within 3 months

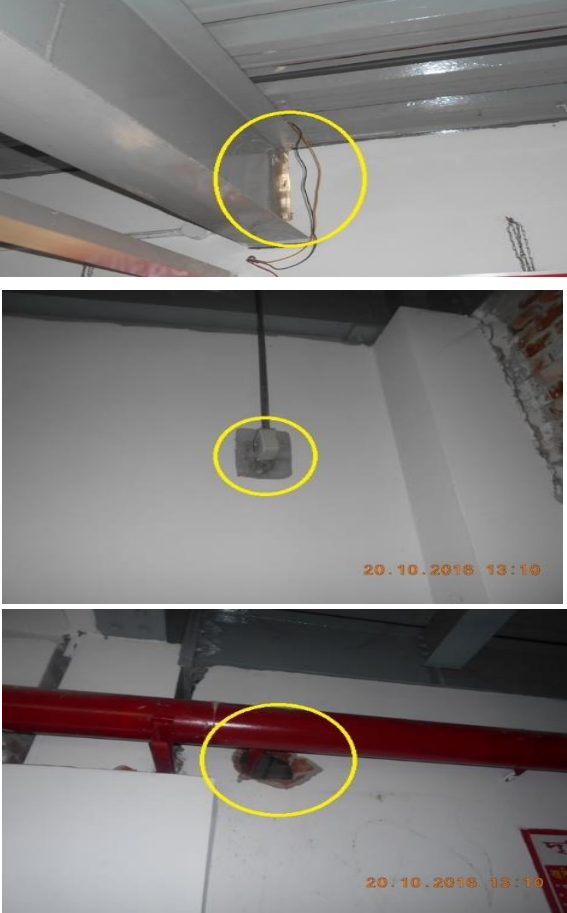
SI No.	Category	Findings	Required Action	Remediation Time Frame	Pictorial Evidence
2	Fire Rated Construction	Unsealed penetrations and openings are located in the exit stair enclosures.	Seal all penetrations and openings in exit stair enclosure walls to maintain the fire separations.	Within 3 months

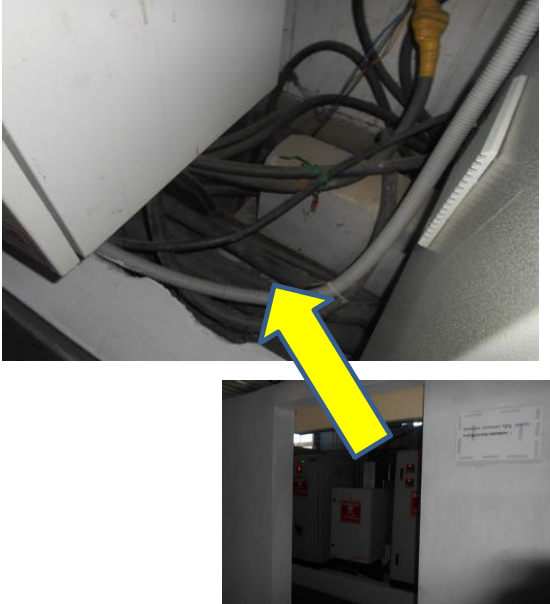
Sl No.	Category	Findings	Required Action	Remediation Time Frame	Pictorial Evidence
3	Fire Rated Construction	Unsealed penetrations and openings are located in the fire rated floor/ceiling assemblies.	<p>Provide a minimum 2-hr fire rated shaft to separate the utility risers from each floor level.</p> <p>Seal all penetrations and openings in floors/ceiling assemblies to maintain the fire separation.</p>	Within 3 months

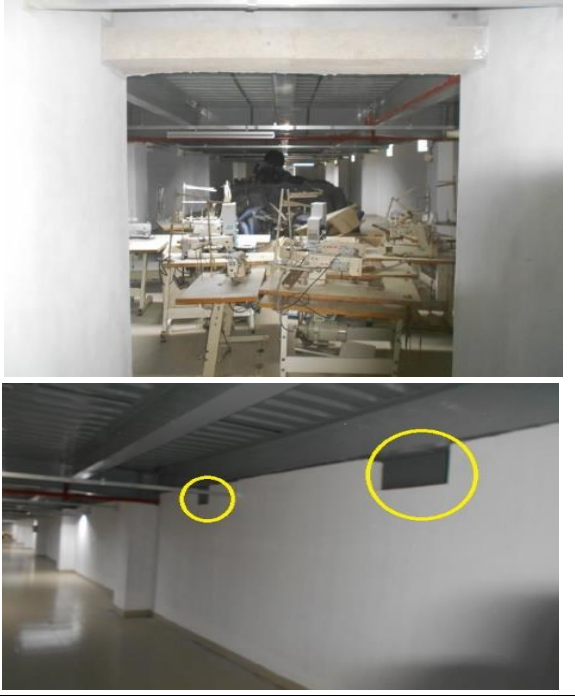
SI No.	Category	Findings	Required Action	Remediation Time Frame	Pictorial Evidence
4	Fire Rated Construction	Rooms used for combustible storage on the ground floor are not separated by fire-rated construction. Location: Idle machine room (Adjacent to dining area)	Provide dedicated storage rooms separated by minimum 1-hr fire-rated construction.	Within 3 months

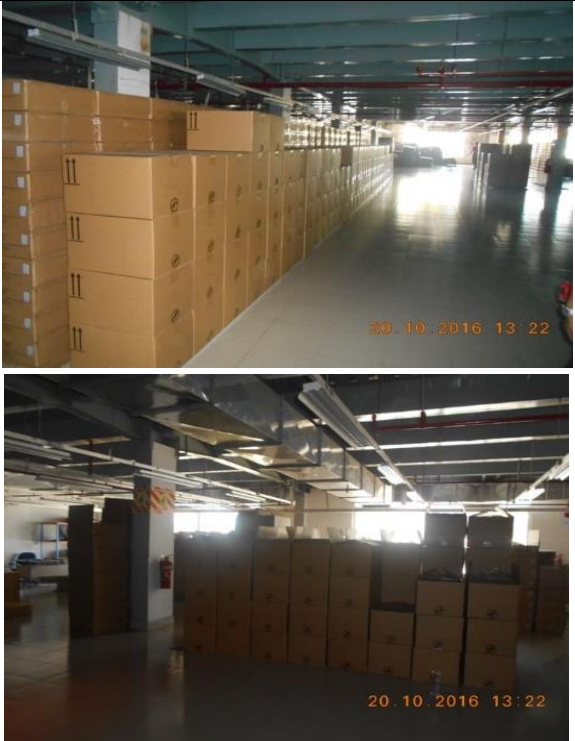
SI No.	Category	Findings	Required Action	Remediation Time Frame	Pictorial Evidence
5	Fire Rated Construction	<p>Areas used for combustible storage are not separated by fire-rated construction. Location: Finished goods & packing area (1st floor, South)</p>	<p>Provide dedicated storage rooms separated by minimum 1-hr fire-rated construction.</p> <p>Where separate storage rooms are not feasible, provide defined storage areas and limit the storage arrangement as follows:</p> <ul style="list-style-type: none"> - Maximum height of 2.4m and maximum area of 23m² - If sprinkler protected: maximum height of 3.66m and maximum area of 93m² <p>Separate areas of unenclosed combustible storage by a minimum clear distance of 3m</p>	Within 3 months

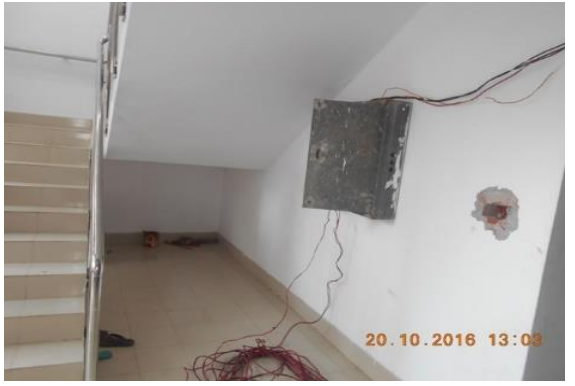
6	Fire Rated Construction	<p>Electrical panels were located in the exitstair enclosure. Location: West Stair</p>	<p>Remove and re-locate all electrical panels from exit stair enclosures.</p>	Within 3 months

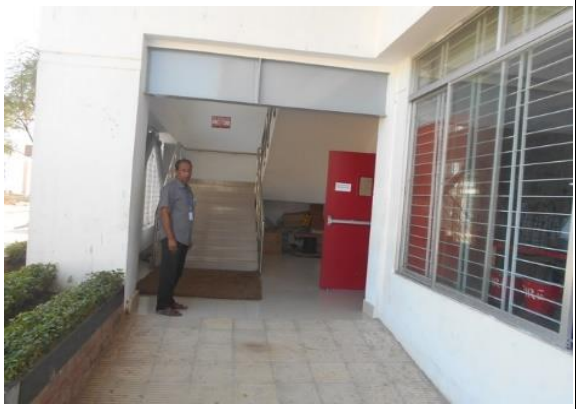
SI No.	Category	Findings	Required Action	Remediation Time Frame	Pictorial Evidence
7	Egress	The East exit discharge path is less than 10 ft. wide and has an unprotected opening with building interior	Seal all penetrations and openings to the interior of the building along the discharge path up to a height of 10 ft., to provide a minimum 1-hr fire separation.	Within 3 months

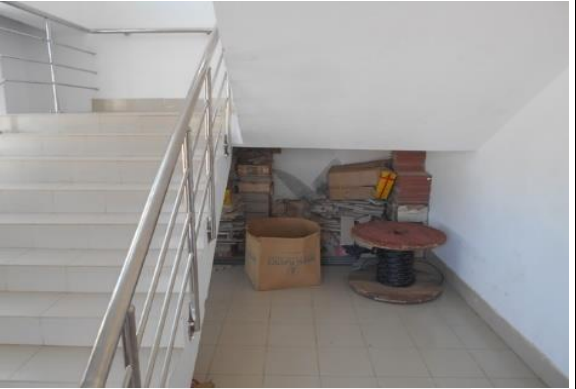
8	Egress	Storage was located in exit stair. Location: East Stair	Remove storage from the exit stairs and egress path	Immediate

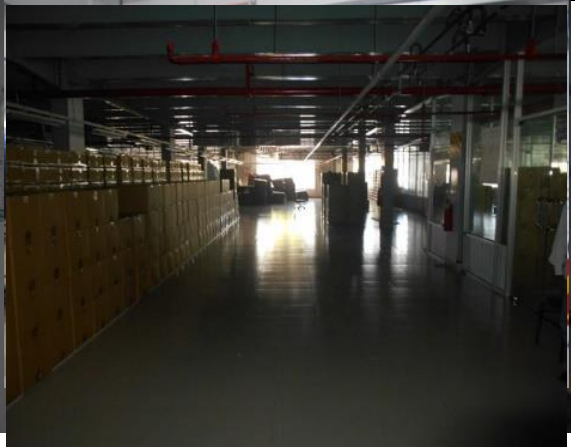
SI No.	Category	Findings	Required Action	Remediation Time Frame	Pictorial Evidence
9	Egress Lighting	Based on the number and location of emergency lights observed, adequate illumination levels are not anticipated along egress routes. Location: All floors	Test the emergency lighting system on each floor and provide additional emergency fixtures to provide adequate illumination along the means of egress. Provide a minimum illumination of 10 lux at the floor level within exit stairs and exit discharge paths and minimum 2.5 lux along exit access aisles.	Within 3 months

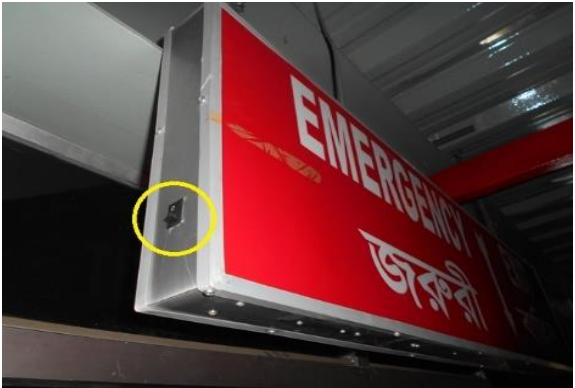
10	Egress Lighting	Manual on-off switch is provided for exit signage	Remove manual on/off switches from the emergency lighting /exit signage units to prevent them from being switched off	Within 1 month
