# Fashion Asia Ltd. Tosrifa Industries Ltd.

135 Gopalpur, Munnu Nagar, Tongi, Gazipur, Bangladesh  
(23.898563N,90.41089E)

26 September 2013

# High loading from water tanks on overrun slabs

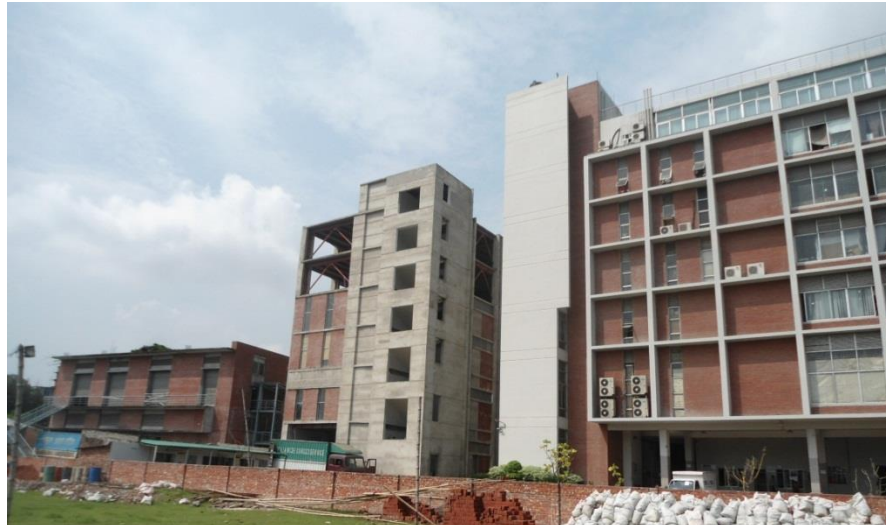
Fire water tanks on overrun slabs. Total water weight of 24.000 kg.

Evidence of cracking on slab plaster cover.

**ITEM 1:** High loading from water tanks on overrun slabs.  
Evidence of cracking on bottom slab plaster.

**Action: Empty tanks immediately.**

Building Engineer to check that slabs have been designed to accommodate loads. Investigate where cracks are coming from.

| Item No. | Observation | Recommended Action Plan | Recommended Timeline |
|---|---|---|---|
| 1 | High loading from water tanks on overrun slabs | Empty water tanks immediately | Immediate - Now |
| 2 | High loading from water tanks on overrun slabs | Verify that slab has sufficient capacity to support fully filled water tanks plus concrete plinth, if not relocate tanks to proper areas according building Engineer. | 6-weeks |
| 3 | High loading from water tanks on overrun slabs | Analyze cracking on slab bottom side. If necessary proceed to repair | 6-weeks |
