# **FIRE SAFETY INSPECTION REPORT**

**NAFA APPARELS LIMITED**  
**HIZALHATI, BAROIPARA, KALIAKOR**

**ACCORD**  
on Fire and Building Safety in Bangladesh

April 9, 2014

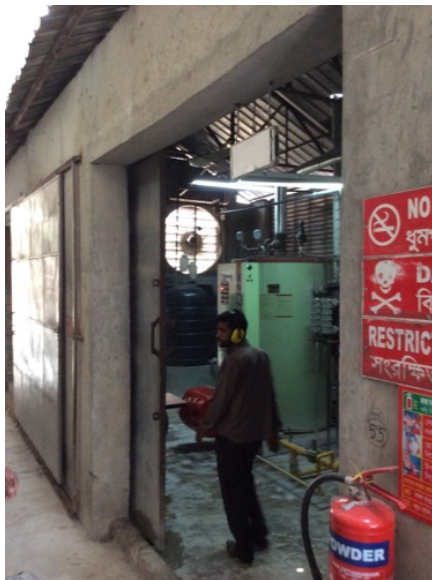
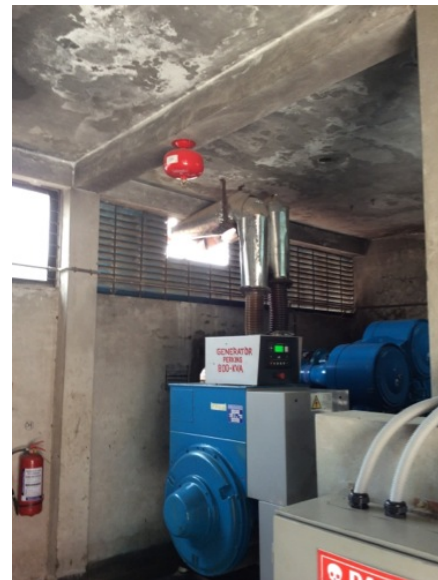
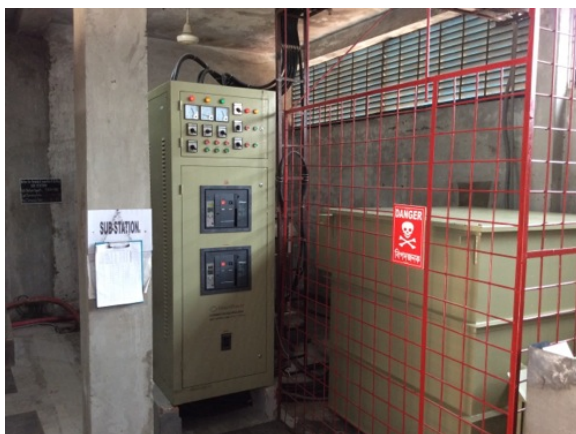
| No. | Category | Finding | Recommendation | Remediation Timeframe |
|---|---|---|---|---|
| F-1 | Fire Rated Construction | The boilers, generators, and transformer are not separated from adjacent areas by fire-rated construction (openings, penetrations). | Separate the boilers, generators, and transformer by a minimum 2-hr fire-rated construction. Seal and/or protect all openings to maintain the required fire separations. | Within 3 months |

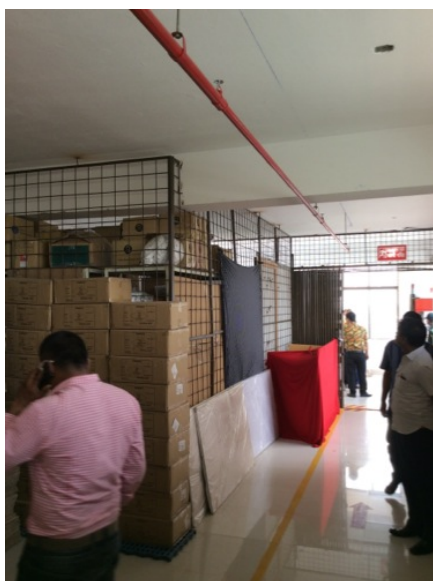
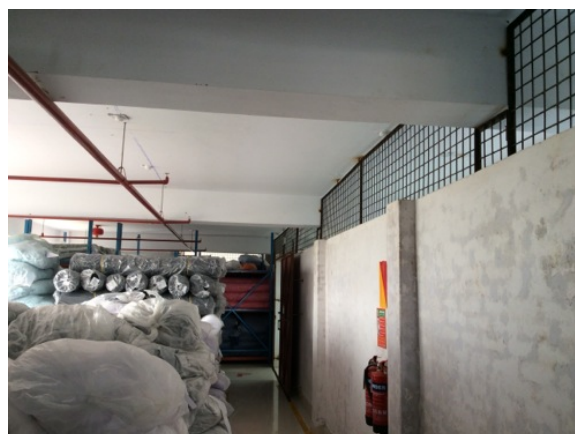
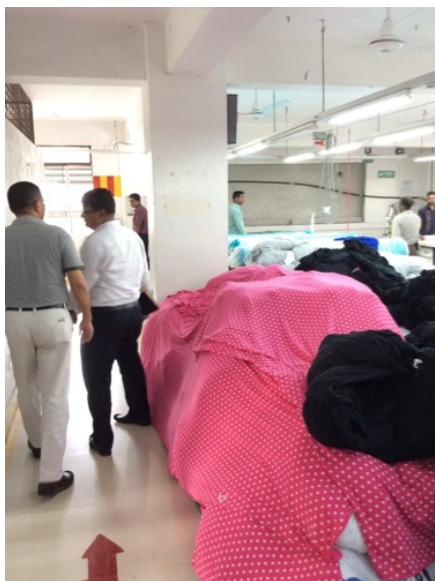
| F-2 | Fire Rated Construction | <p>Areas used for combustible storage are not separated by fire-rated construction.</p> <p>Locations:</p> <ul style="list-style-type: none"> <li>-Storage rooms on all floors with ventilation ports along the walls and open, gated doors that compromise the fire barrier.</li> <li>-General storage on multiple floors was open to production areas.</li> </ul> | <p>Provide dedicated storage rooms separated by minimum 1-hr fire-rated construction.</p> <p>Where separate storage rooms are not feasible, provide defined storage areas and limit the storage arrangement as follows:</p> <ul style="list-style-type: none"> <li>- Maximum height of 2.4m and maximum area of 23m<sup>2</sup></li> <li>- If sprinkler protected: maximum height of 3.66m and maximum area of 93m<sup>2</sup></li> </ul> <p>Separate areas of unenclosed combustible storage by a minimum clear distance of 3m.</p> | Within 3 months |

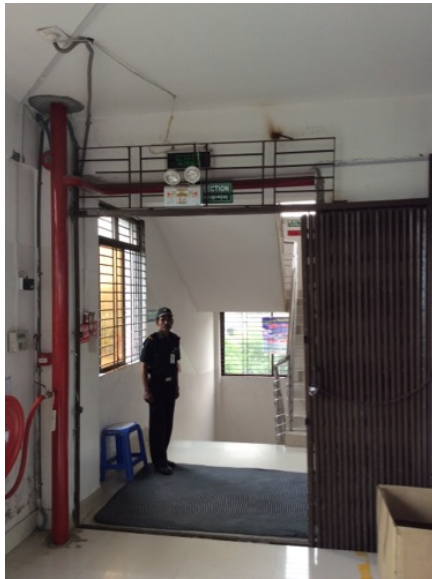
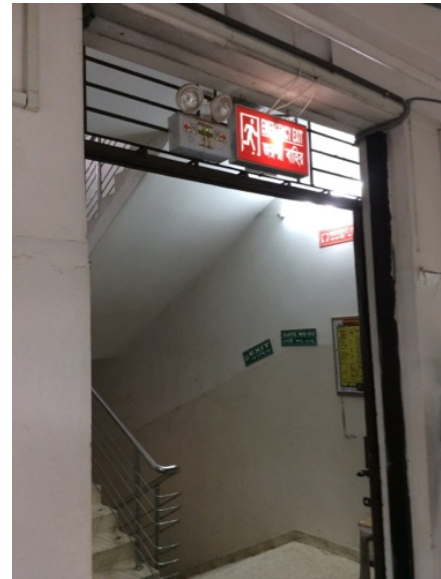
| F-3 | Fire Rated Construction | The exit stairs are not separated from work areas and other spaces on each floor by fire-rated construction. | Provide minimum 1.5-hr fire rated doors and seal all unprotected openings to separate the exit stairs and bridge from work areas and other building spaces on all floor levels. Ensure that the fire doors are self-closing and positive latching and that they are provided with fire exit (panic) hardware where serving production floors.<br><br>If fire doors are required to be held open for functional reasons, provide automatic-closing devices tied to the fire alarm system. | Within 3 months |

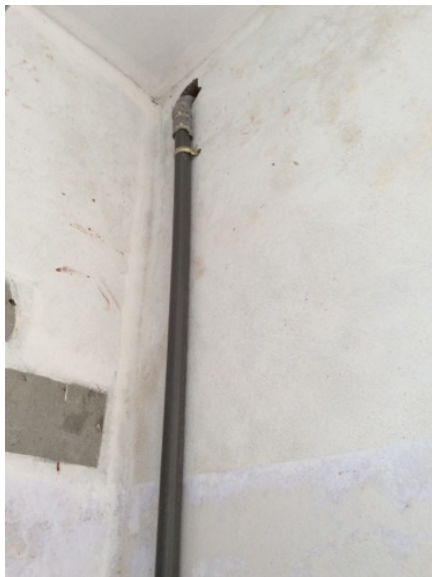
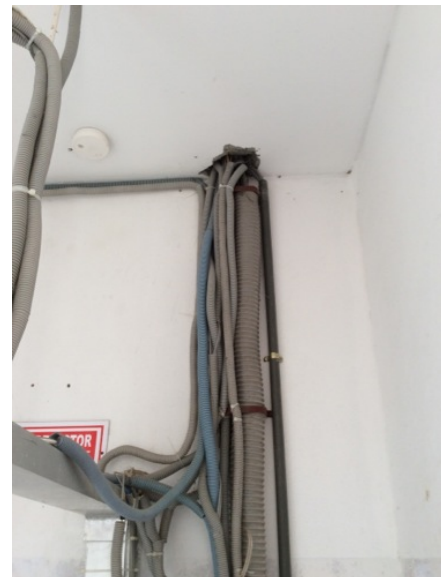
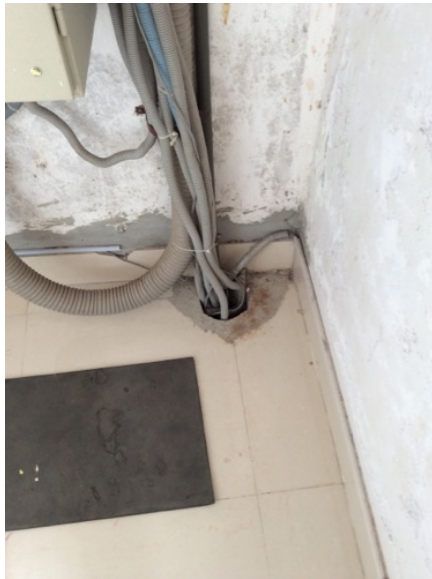
| F-4 | Fire Rated Construction | Unsealed penetrations and openings are located in the fire-rated floor/ceiling assemblies. | Provide a minimum 2-hr fire-rated shaft to separate the utility risers from each floor level. | Within 3 months |
| | | Location:<br>All floors. | Seal all penetrations and openings in floor/ceiling assemblies to maintain the fire separation. | |

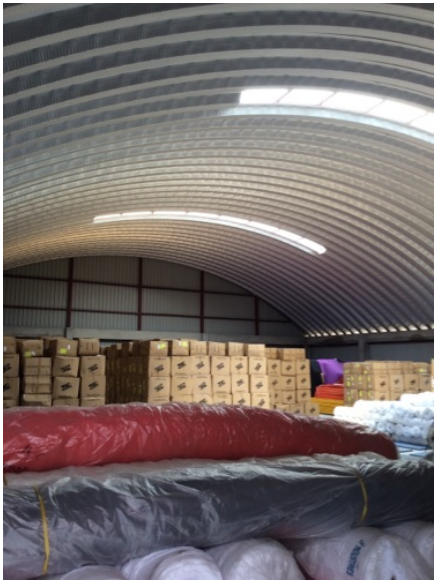
| F-5 | Fire Rated Construction | <p>Areas used for combustible storage are not separated by fire-rated construction.</p> <p>Location:<br/>Storage/godown shed approximately 10 feet from the north side of the main building.</p> | <p>Provide dedicated storage rooms separated by minimum 1-hr fire-rated construction.</p> <p>Where separate storage rooms are not feasible, provide defined storage areas and limit the storage arrangement as follows:</p> <ul style="list-style-type: none"><li>- Maximum height of 2.4m and maximum area of 23m<sup>2</sup></li><li>- If sprinkler protected: maximum height of 3.66m and maximum area of 93m<sup>2</sup></li></ul> <p>Separate areas of unenclosed combustible storage by a minimum clear distance of 3m.</p> | Within 3 months |

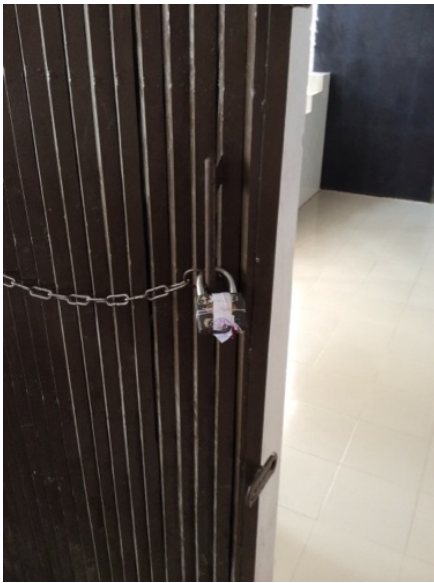
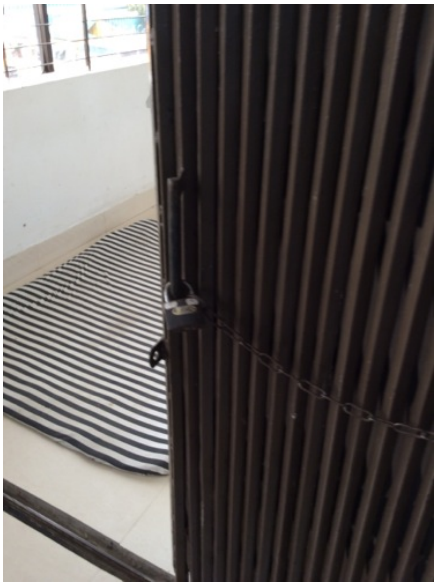
| F-6 | Egress | <p>Egress doors / gates with locking features are provided at building exits, exit stairs, along egress routes, and exit discharge.</p> <p>Locations:<br/>Collapsible gates and sliding doors on all floors. Doors were open and unlocked during the survey.</p> | <p>Remove locking features from all egress doors / gates.</p> <p>If locks are required for security reasons, utilize special door locking features complying with NFPA 101.</p> | Immediat |

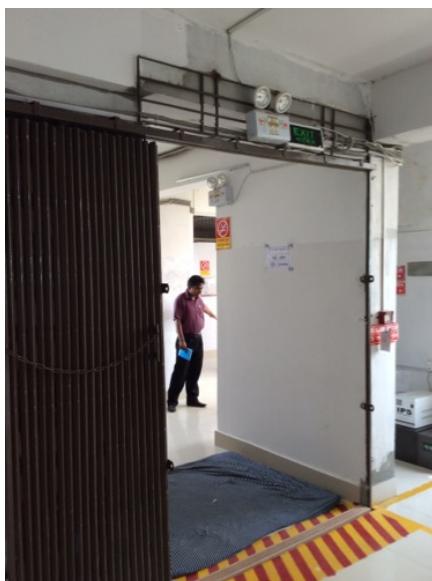
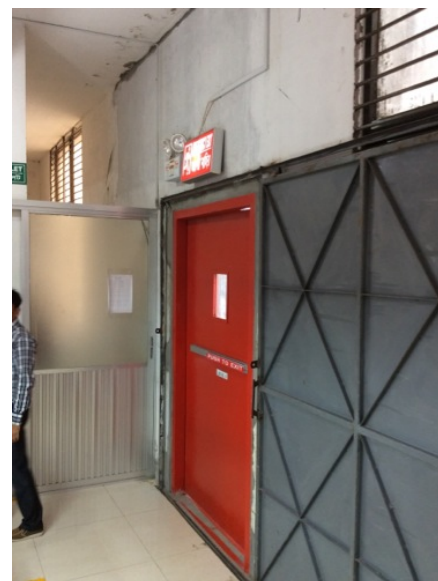
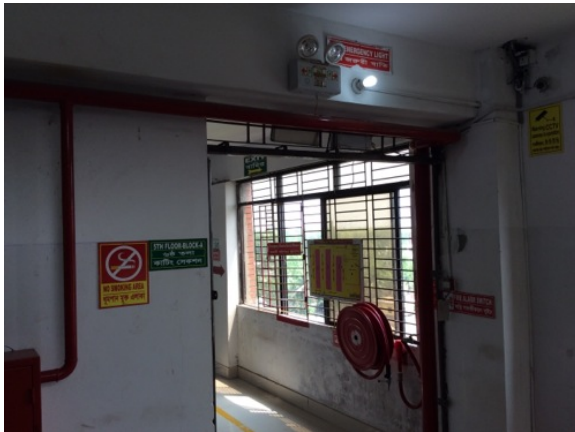
| F-8 | Egress | <p>Collapsible gates / sliding doors are provided at building exits, exit stairs, along egress routes, and exit discharge.</p> <p>Locations:<br/>Collapsible gates and sliding doors on all floors.</p> | <p>Replace all gates / sliding doors along the means of egress with side-hinged, swinging egress doors.</p> <p>If locks are required for security reasons, utilize special door locking features complying with NFPA 101.</p> | Within 1 month |

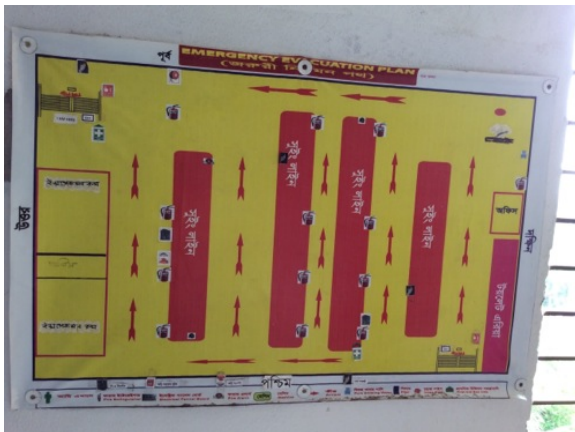
| F-9 | Egress | Evacuation plans on various floors do not indicate use of an outside exit stair which is marked as an exit. | Update evacuation plans to indicate relevant exits and to provide adequate exit knowledge. | Within 1 month |

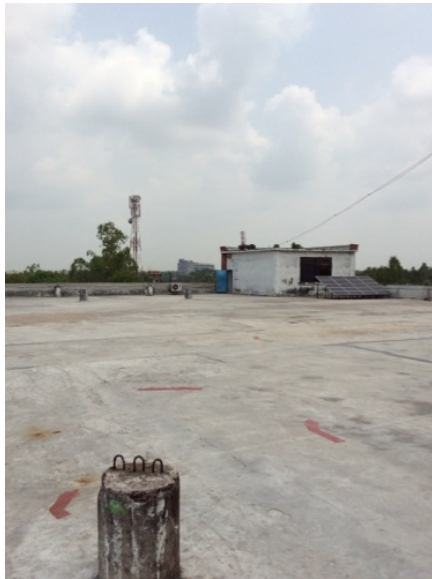
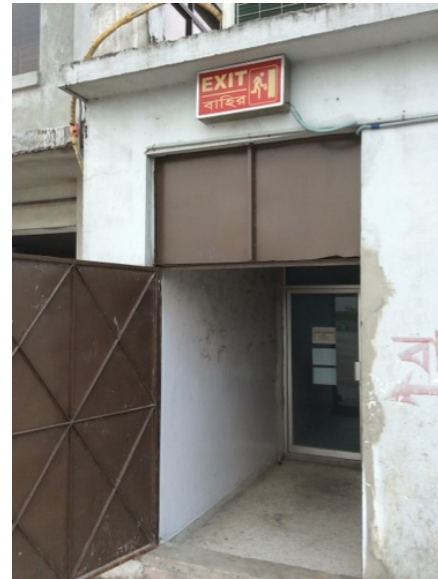
| F-10 | Egress | Exit stair door does not swing in the direction of egress travel. | Modify the egress door to swing in the direction of egress travel. | Within 3 months |
| | | Locations:<br>Doors leading to exit stairs from rooftop of the three story portion of the building. | | |

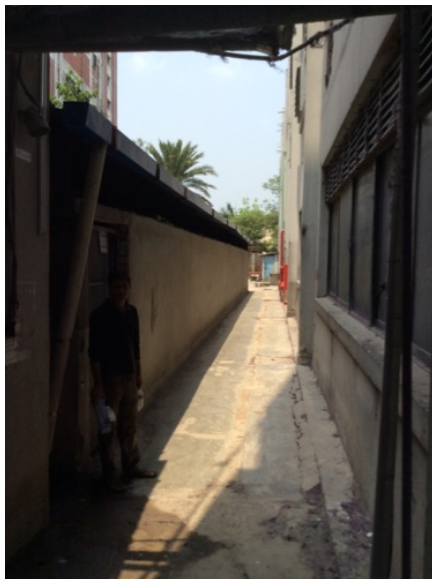
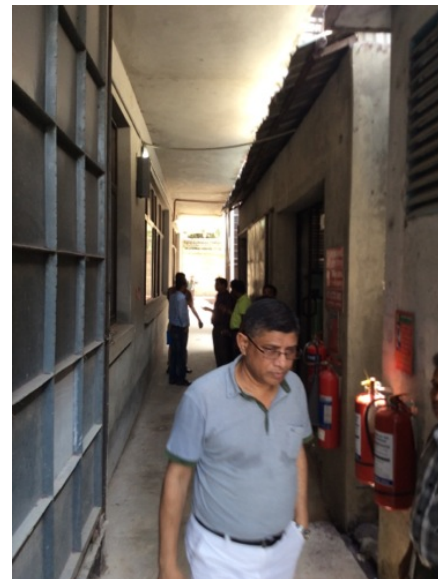
| F-11 | Egress | Exit discharge path along west side of building is an egress court less than 10 feet wide. | Provide minimum 1-hr fire-rated factory exterior wall up to 10ft above grade. Seal and/or protect all openings to maintain the required fire separations. | Within 3 months |

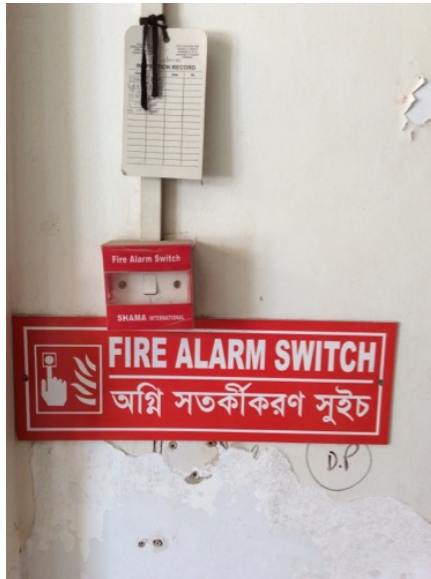
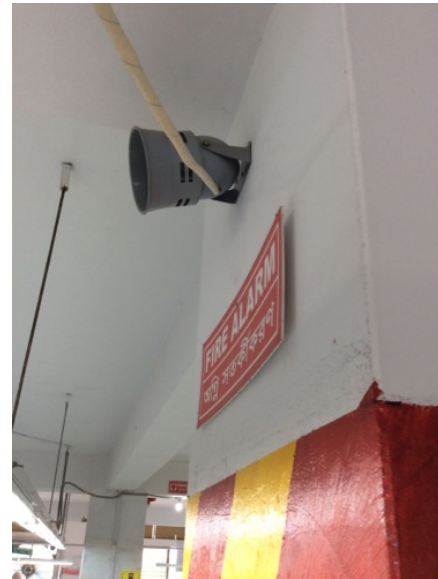
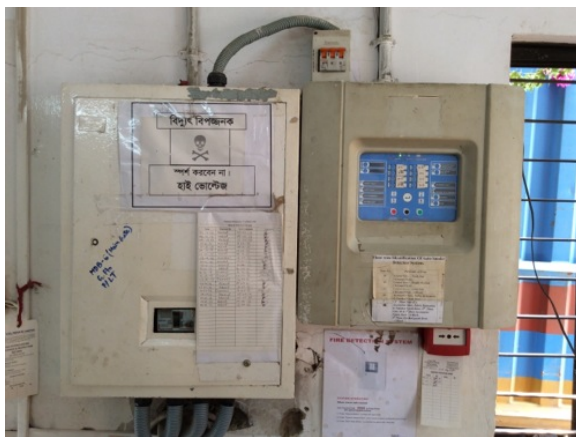
| F-12 | Fire Protection | The fire alarm system is antiquated, not a listed system, and does not provide alarm and notification features consistent with acceptable standards. | Replace the fire alarm system with a new, listed addressable fire alarm system in accordance with NFPA 72. | Design within 4 months, install within 9 months |

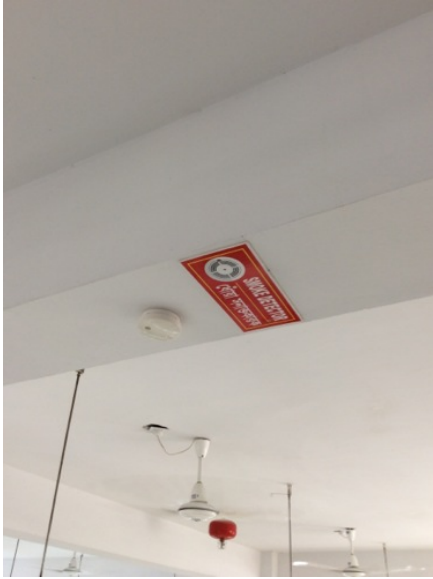
| F-15 | Fire Protection | The building is equipped with single-station smoke alarms. Smoke alarm activation sounds only a local alarm and does not provide automatic fire alarm notification of occupants. | Replace the single-station smoke alarms with automatic smoke detectors tied into the fire alarm system. Configure the fire alarm system to initiate occupant notification upon activation of any two smoke detectors in addition to the manual fire alarm stations. | Within 6 months |

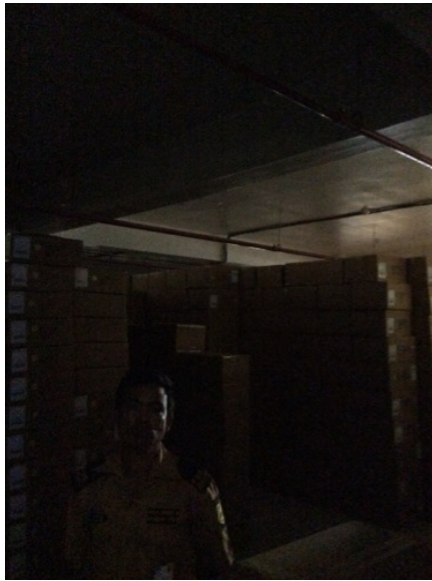
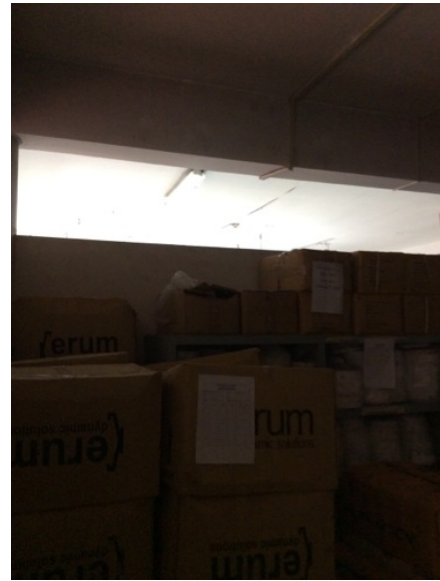
| F-17 | Egress Lighting | Storage areas on various floor levels are dark due to a low level of lighting and storage is stacked above eye level. Illuminated, directional exit signage is not provided. | Provide illuminated, directional exit signage throughout so that the direction of paths of egress are clearly indicated. | Within 1 month |

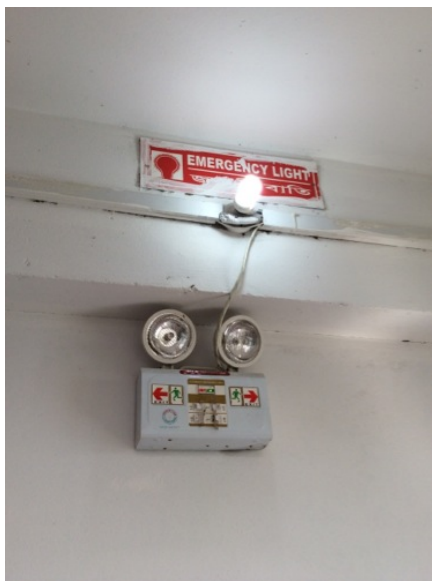
| F-18 | Egress Lighting | <p>Based on the number and location of emergency lights observed, adequate illumination levels are not anticipated along egress routes.</p> <p>Locations:<br/>All areas.</p> | <p>Test the emergency lighting system on each floor and provide additional emergency fixtures to provide adequate illumination along the means of egress. Provide a minimum illumination of 10 lux at the floor level within exit stairs and exit discharge paths and minimum 2.5 lux along exit access aisles.</p> | Within 3 months |
