# **FIRE SAFETY INSPECTION REPORT**

**Factory Name: Regency Three Limited (Unit-5)**

**ADDRESS: Plot 27-30 & 43-48, Sector-8, CEPZ, Chittagong, Bangladesh.**

**Date: 20th November 2016**

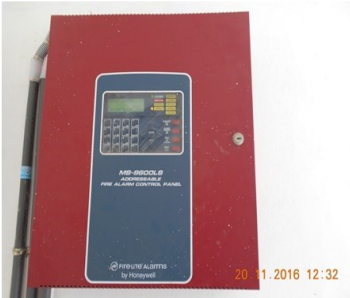
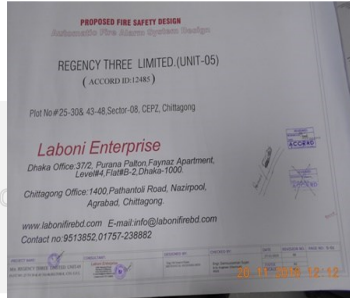
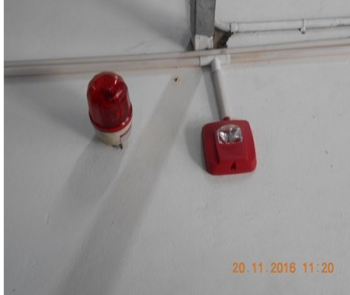
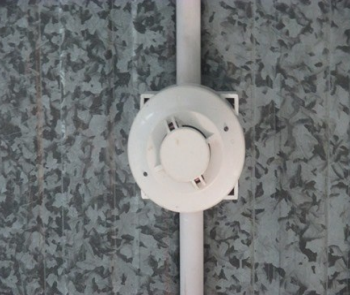
| SI No. | Category | Findings | Required Action | Remediation Time Frame | Pictorial Evidence |
|---|---|---|---|---|---|
| 1 | Fire Detection System | The Existing fire alarm system has not been installed as per NFPA-72, also as build drawing of existing fire alarm system has not been provided. | Reviewed drawing from Accord was available during initial inspection. Installation was going on. Fire doors, HVAC system, fire pump controls shall be interfaced with FACP if applicable. Factory have to prove whether the installed fire alarm cable all fire alarm products has been certified by any third party. (Commissioning of the system in-front of contractor/ 3rd party will be done by Accord) | As built Design within 2 months, Install within 4 months | |

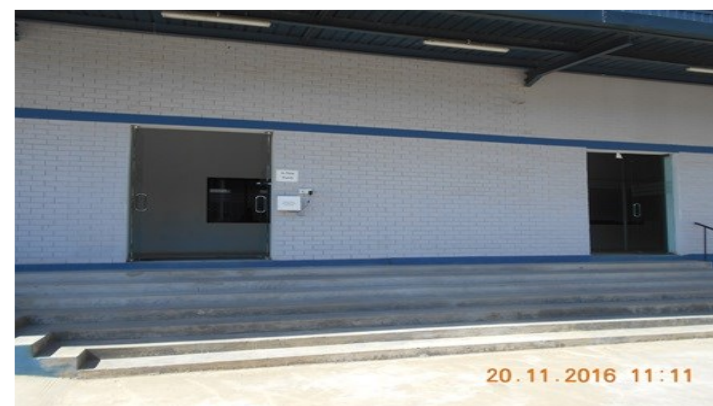
| 3 | Occupant load sign | Building did not have occupant load sign at the required locations. | Post the occupant load for every assembly and production floor in a facility in a conspicuous space near the main exits or exit access doorway for the space. | Within 1 months |

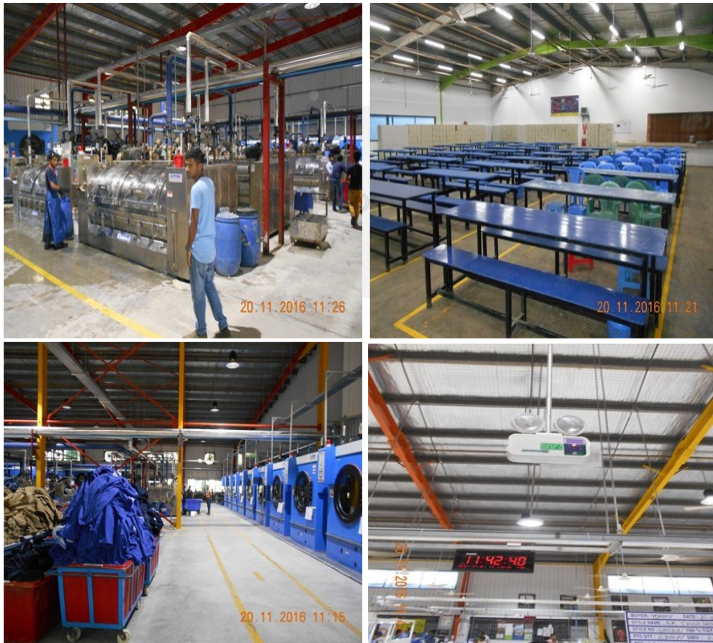
| SI No. | Category | Findings | Required Action | Remediation Time Frame | Pictorial Evidence |
|---|---|---|---|---|---|
| 4 | Emergency Egress Lighting | Based on the number and location of emergency lights observed, adequate illumination levels are not anticipated along egress routes.<br>Location: All production and utility building. | Test the emergency lighting system on each floor and provide additional emergency fixtures to provide adequate illumination along the means of egress. Provide a minimum illumination of 10 lux at the floor level within exit stairs and exit discharge paths and minimum 2.5 lux along exit access aisles. | Within 3 Months | |
