Sharmin Apparels Ltd. Sharmin Fashions Ltd. Ha-Meem Washing Plant Ltd. Sharaf Apparels Ltd.

Narashingapur, Ashulia, Savar, Dhaka

08 April 2014

Observations

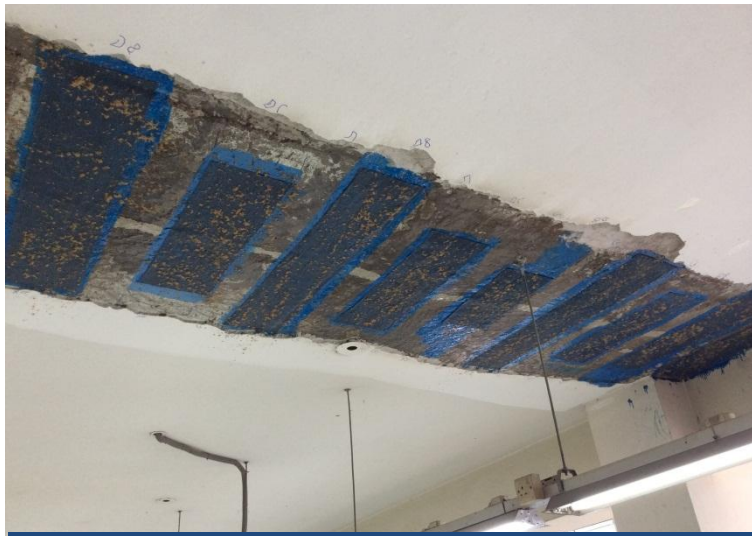
Repairs to cracking on soffit of 5th floor

Building Engineer to carry out a Detail Engineering Assessment including:

- Review of remedial works carried out to date.
- Detailed remedial scheme for any further works, including foundation remedial works, required to ensure that the existing 5 storey building is provided with an adequately robust structural system.
- Documentation of load limitations and preparation of Floor Loading Plans for strict compliance during factory operations.
- Implications of the under-reinforced zones within the post tensioned floor slabs.
- Details of the strengthening works required to the existing structure and foundations if further storeys are to be constructed.

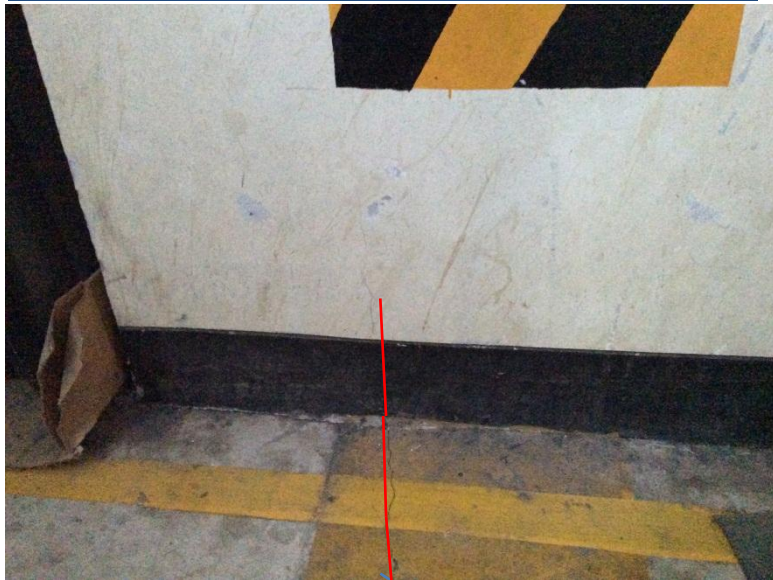
Cracking on ground floor adjacent to column

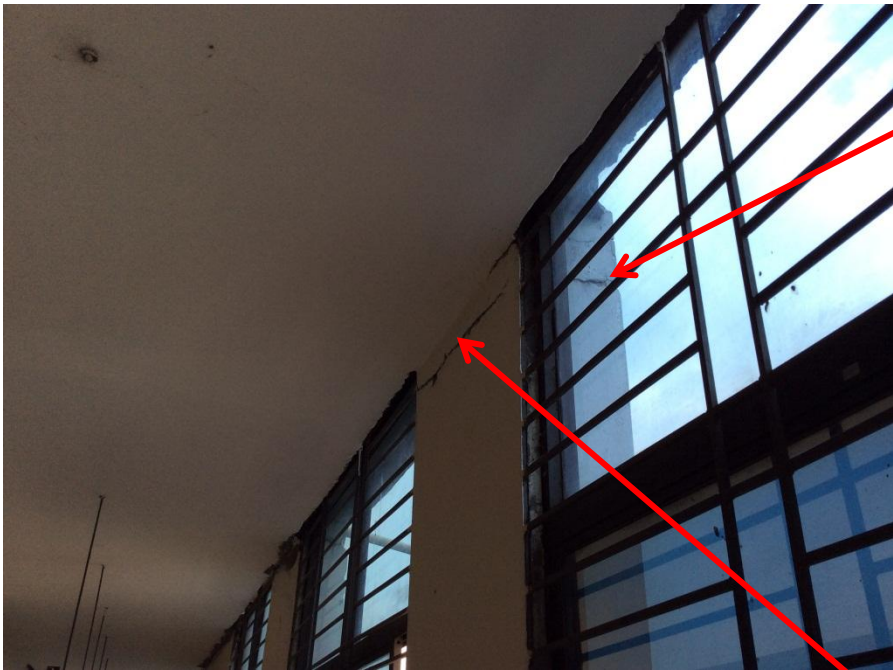
Crack penetrates to outside face of pier at underside of 5th floor

Building Engineer to check that the piers have adequate capacity to resist lateral loads

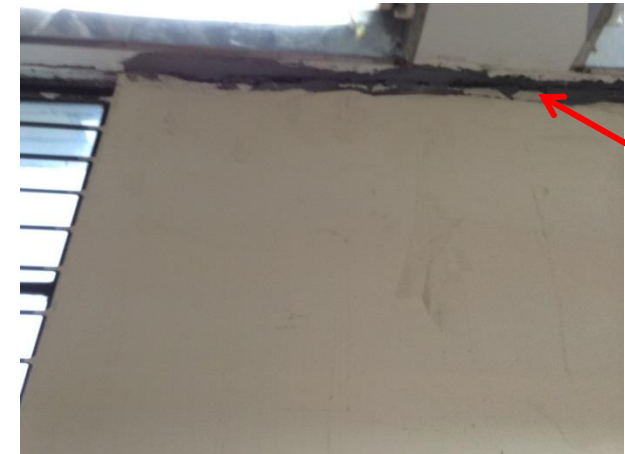
4th floor appears to be deflecting more relative to the 5th floor (roof) causing the pier to separate from the underside of the roof.

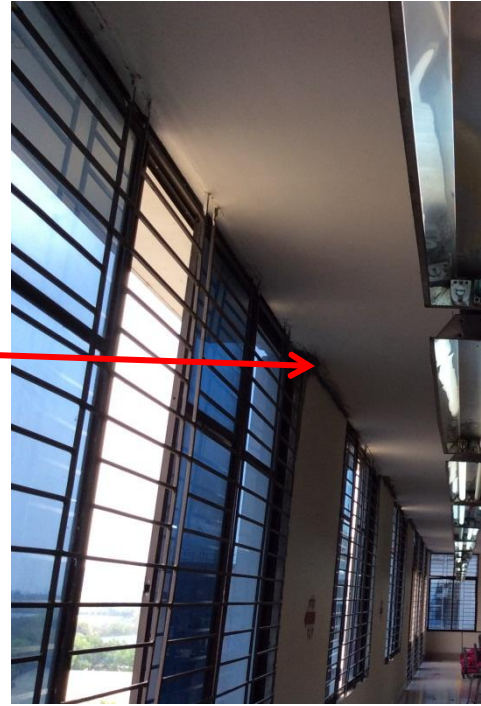
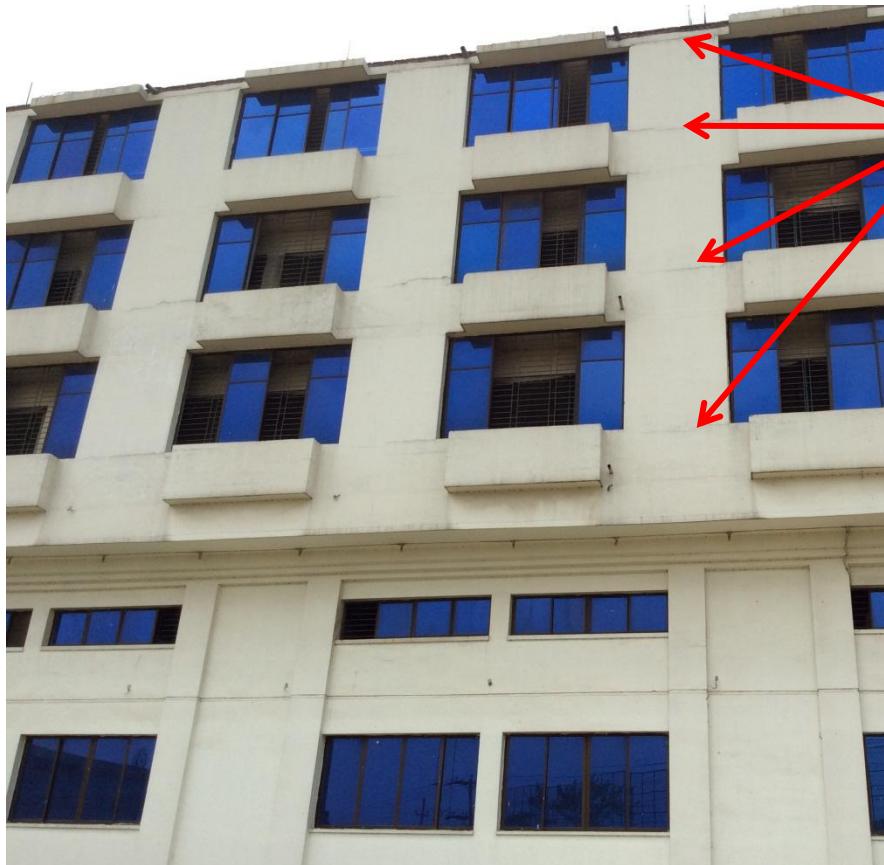
Main Garment Factory - East Elevation

**Cracking in the pier
observed throughout**

**Building Engineer to check that the
piers have adequate capacity to
resist lateral loads.**

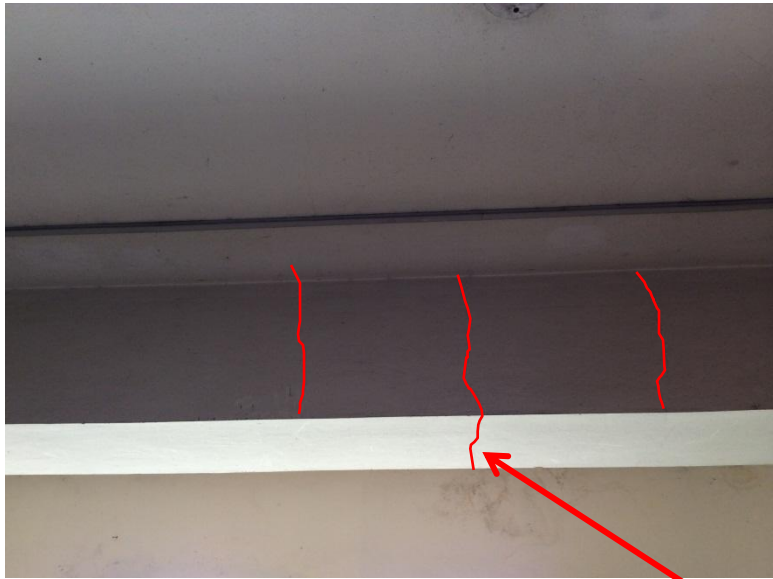
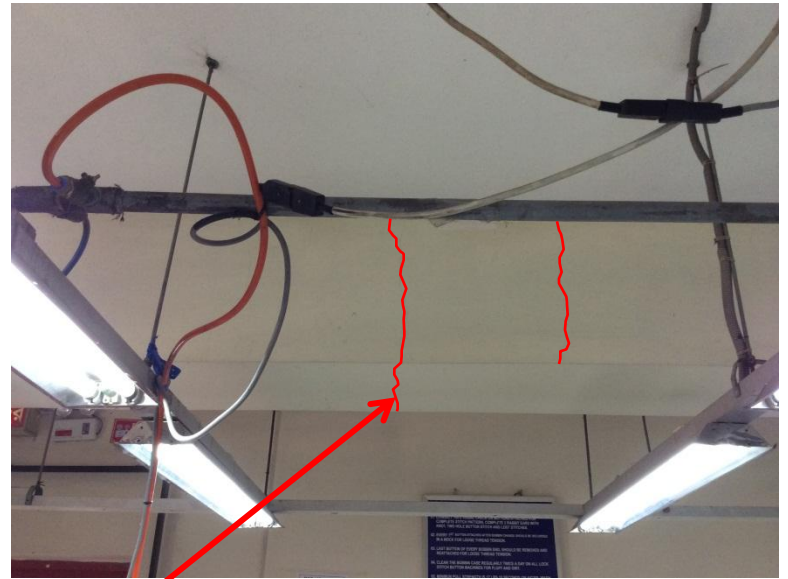
Cracking in RC Beams

Numerous examples of cracking in RC perimeter beams

Cracking in beams to be reviewed by removing plaster to confirm that cracks do not extend into structure.

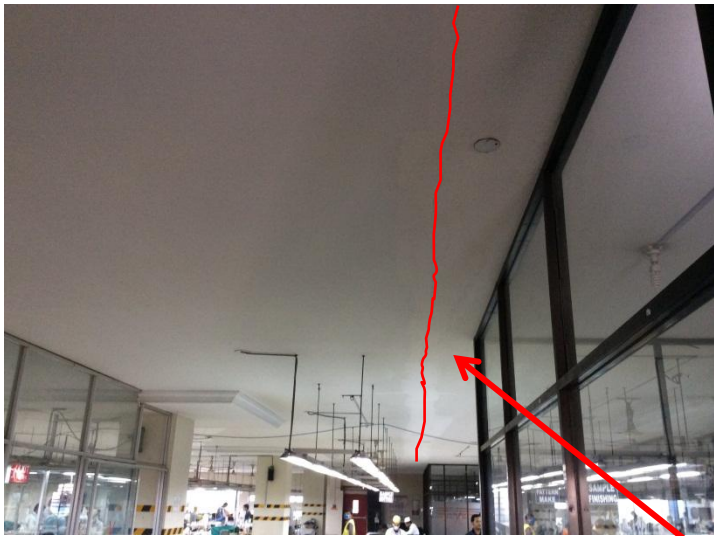
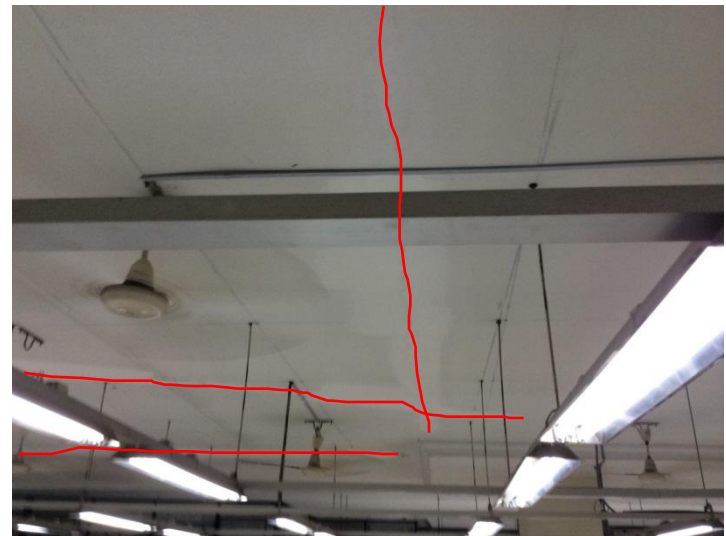
Cracking to underside of PT slab

Numerous examples of cracking and evidence of repair to cracking on soffit of floor slabs

Cracking in soffit of flat slabs to be reviewed by removing plaster to confirm that cracks do not extend into structure.

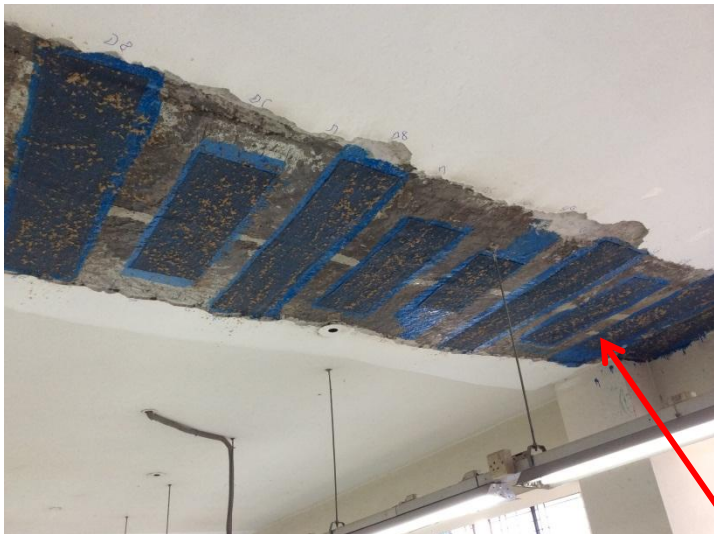
Underside of roof being strengthened as recommended by BUET

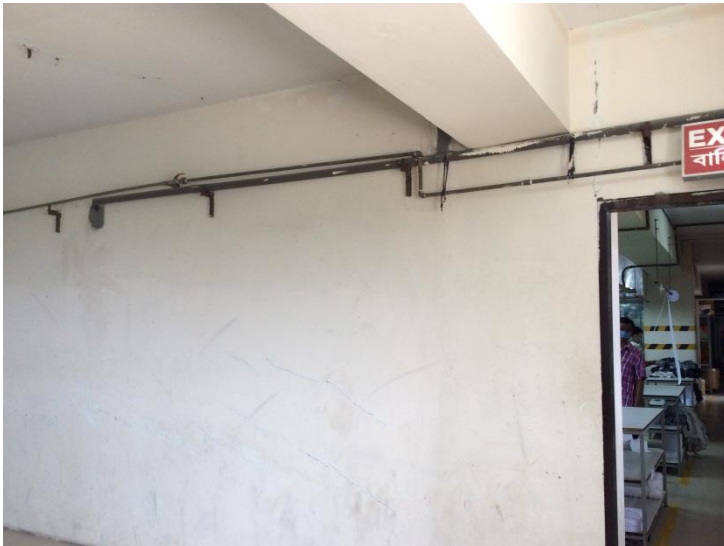
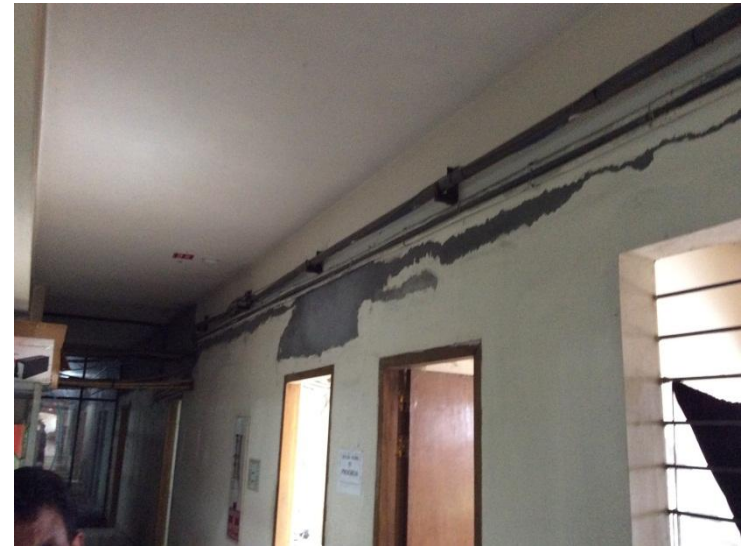
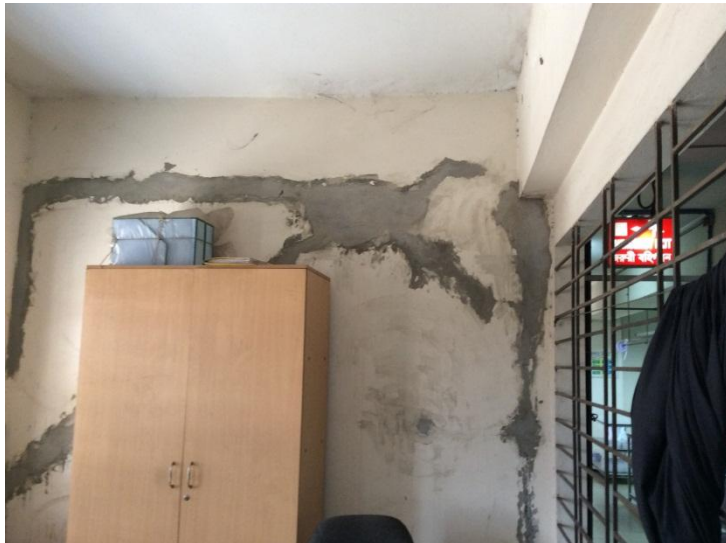
Cracking in internal brickwork wall

Numerous examples of cracking and evidence of repair to cracking

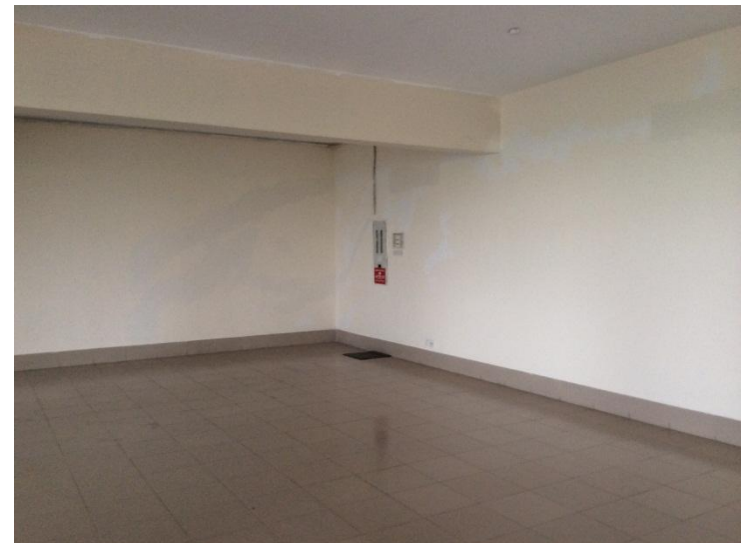
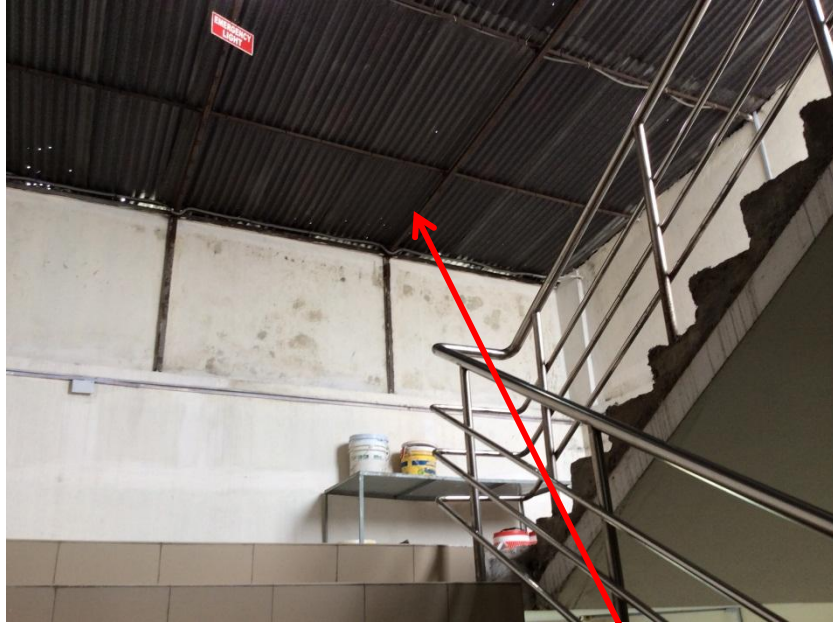
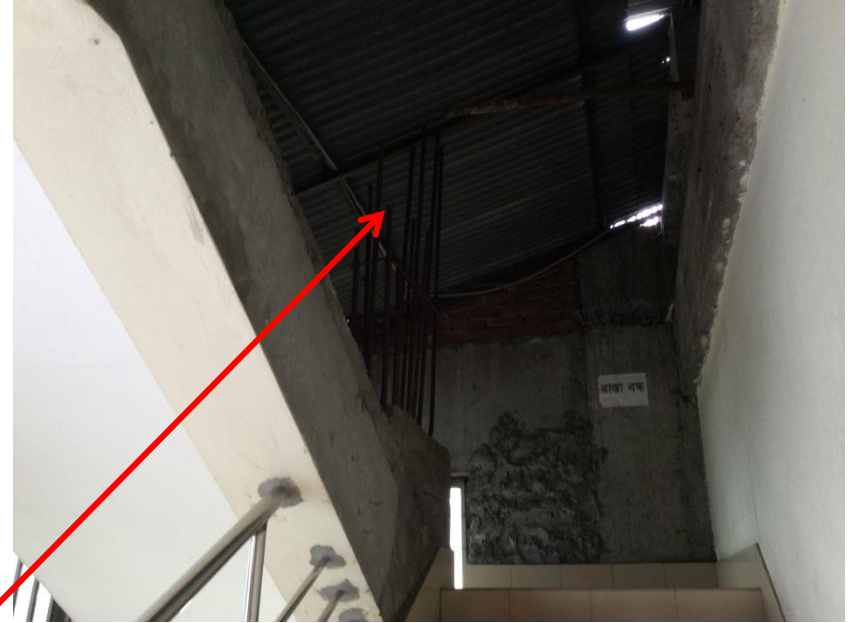
Lightweight Roof Construction

Lightweight steel roof structure.
Building Engineer to review adequacy of
roof structure to resist high wind loading

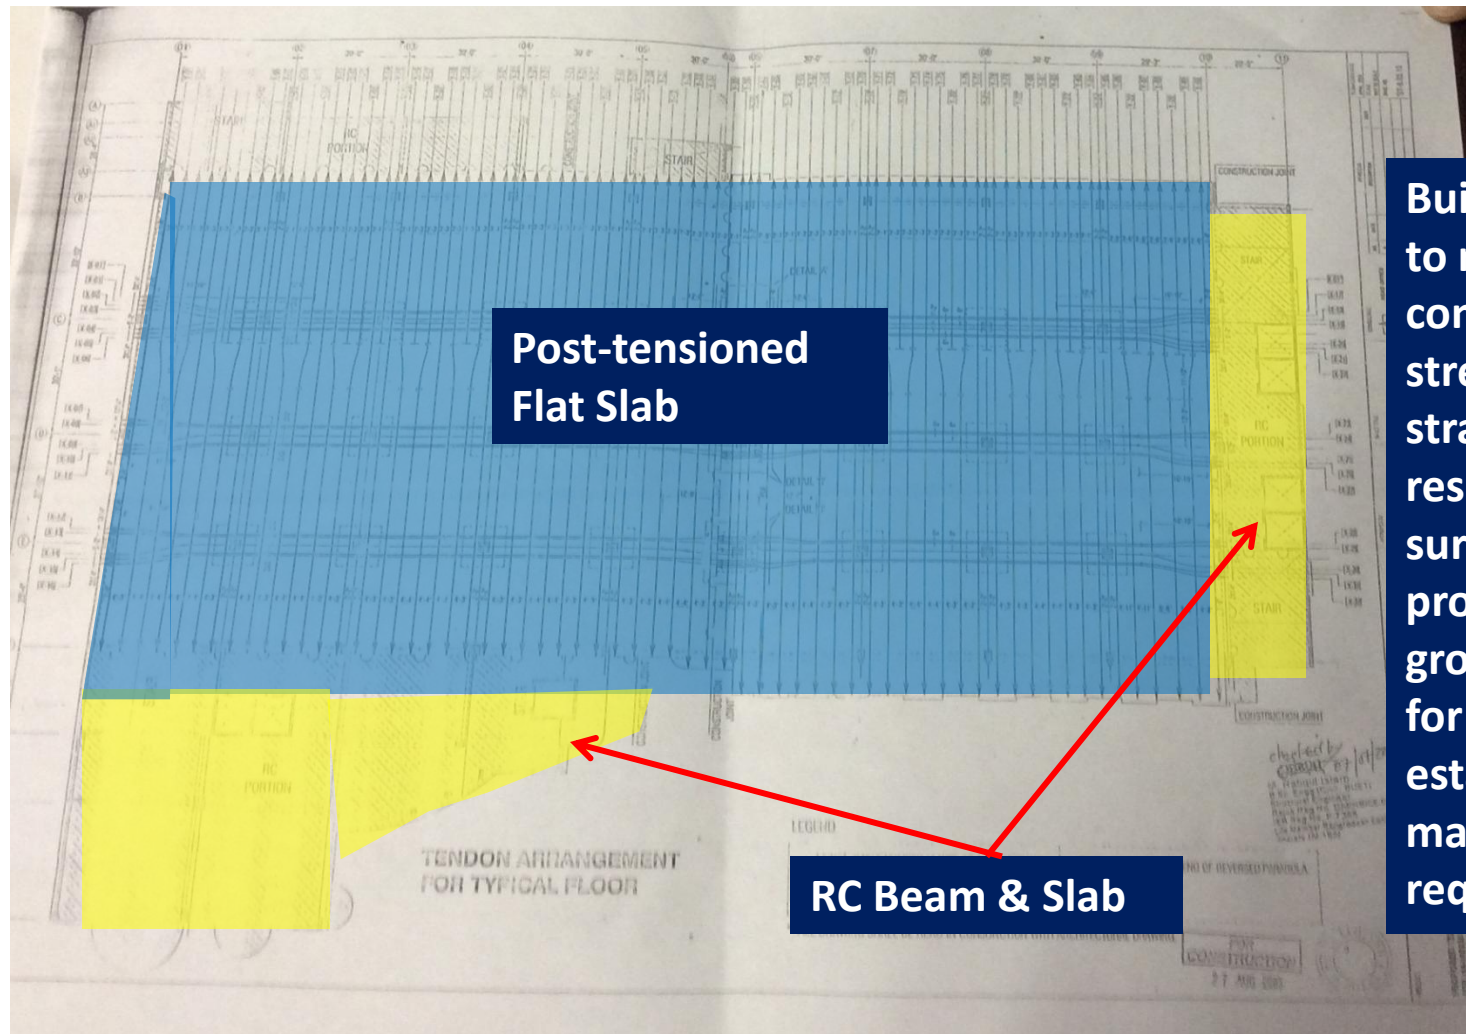
Typical Floor Slab and Tendon Layout

**Post-tensioned floor slab
construction requires a high level
of quality control during
construction**

**Post-tensioned
Flat Slab**

RC Beam & Slab

**Building Engineer
to review
concrete cylinder
strength records,
strand extension
results, as-
surveyed cable
profiles and
grouting records
for PT slabs to
establish if these
match design
requirements**

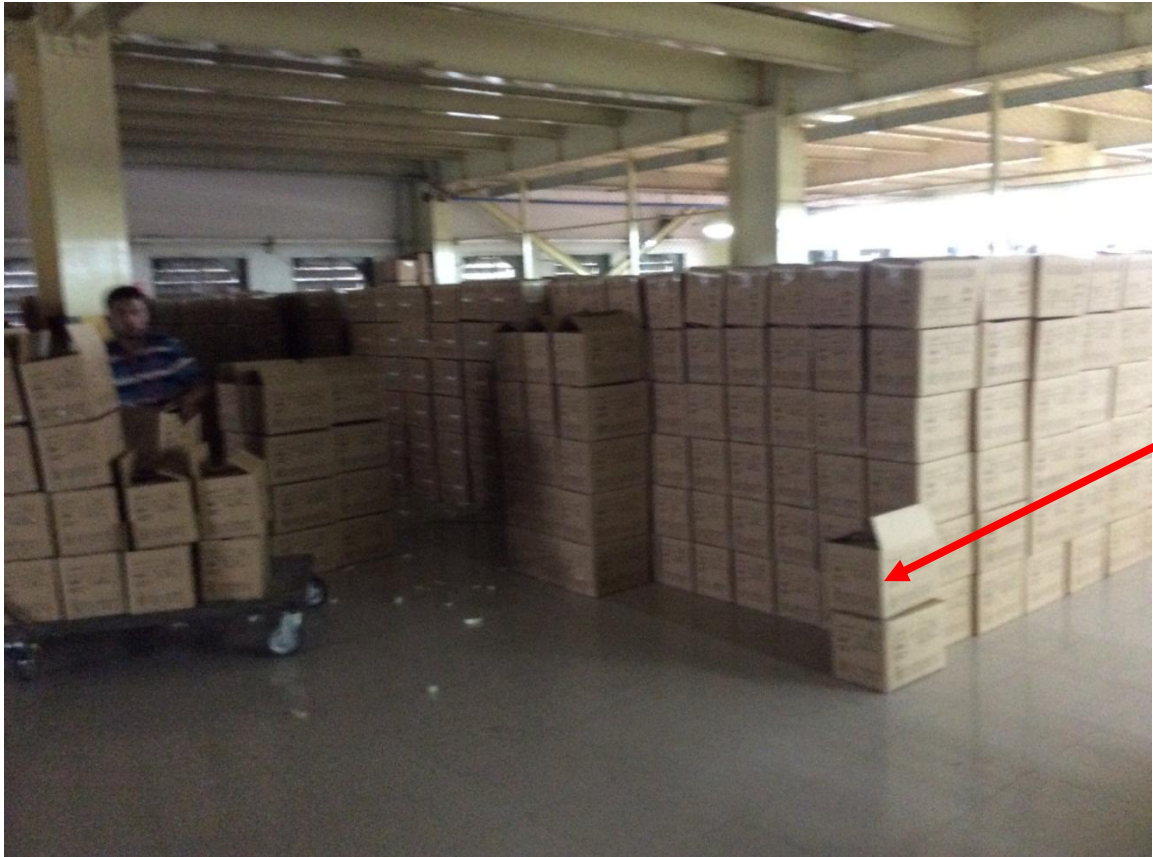
Bonded Warehouse

Storage of Finished Goods

Building Engineer to prepare controlled loading plans, based on floor slab and column capacity, for all floors which will designate storage density and where storage may be placed.
